Project Proposal
1411 Lewis Street and 1444 Madison Street
Santa Clara, California

MADISON AND LEWIS STREET PROJECT DESCRIPTION

Location: 1411 Lewis Street and 1444 Madison Street

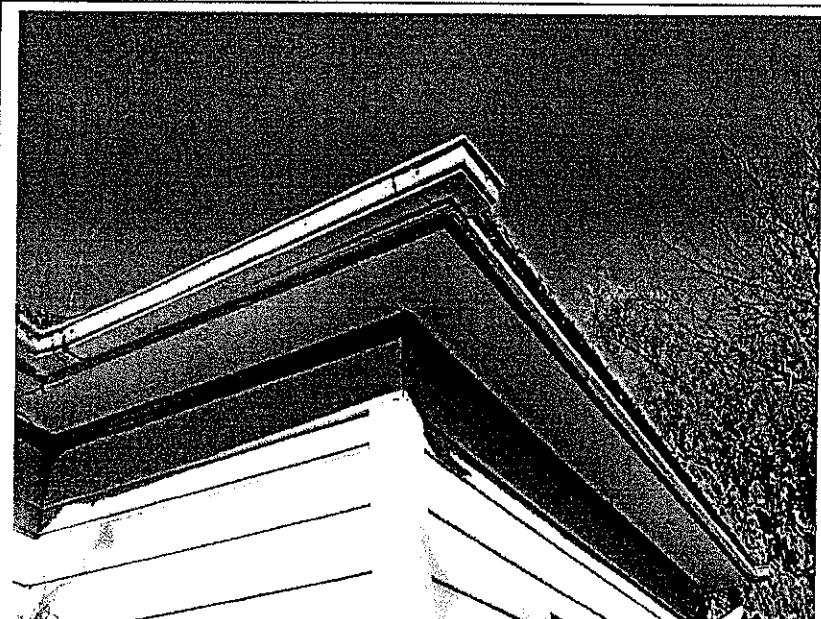
Photo 6: Detail of eaves showing deterioration.

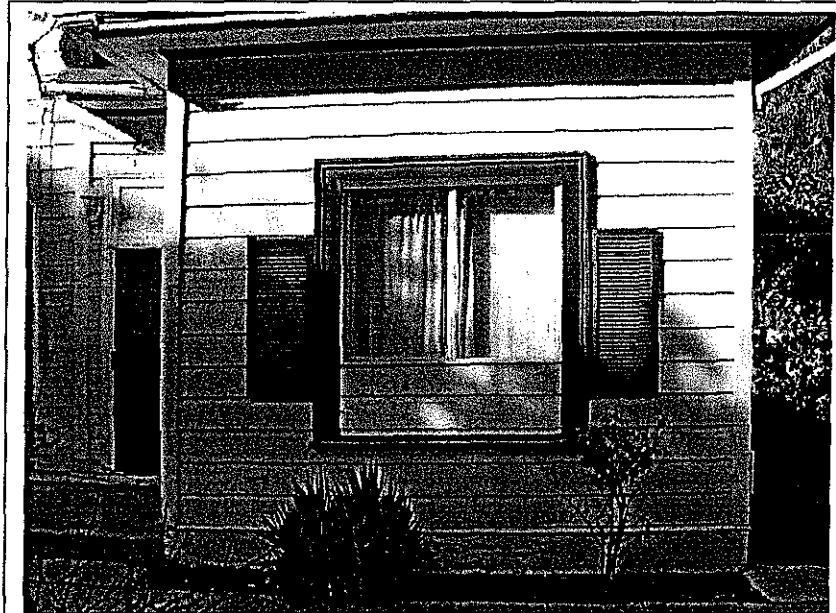
Photo 7: Detail of windows resized and replace with vinyl.

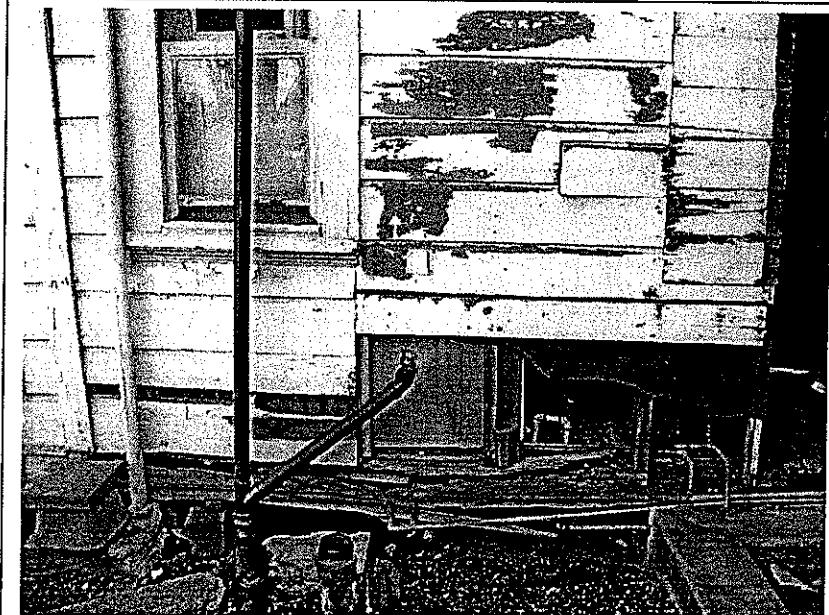
Photo 13: Detail of extensive damage and deterioration on addition.

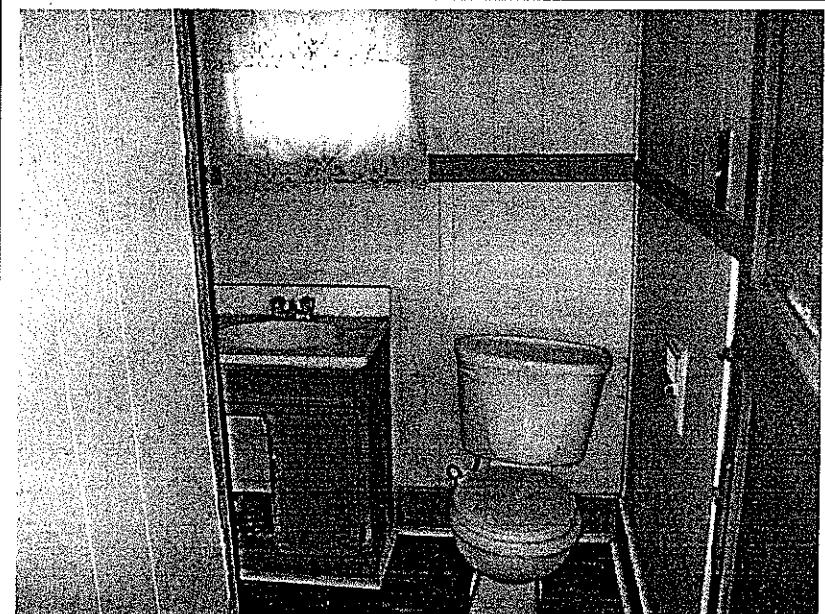
Photo 22: View of the bathroom, note non-original fixtures.

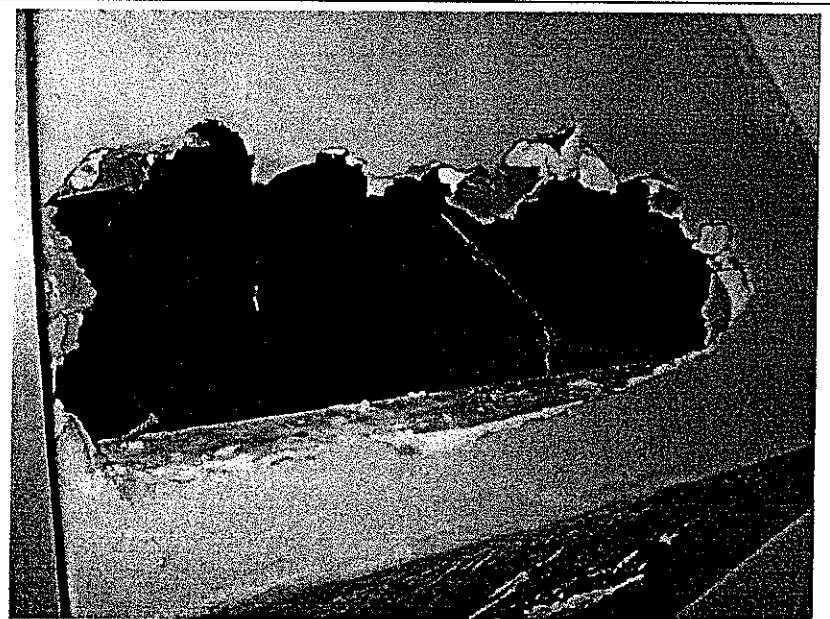
Photo 26: Detail of hole in drywall in the upstairs loft area.

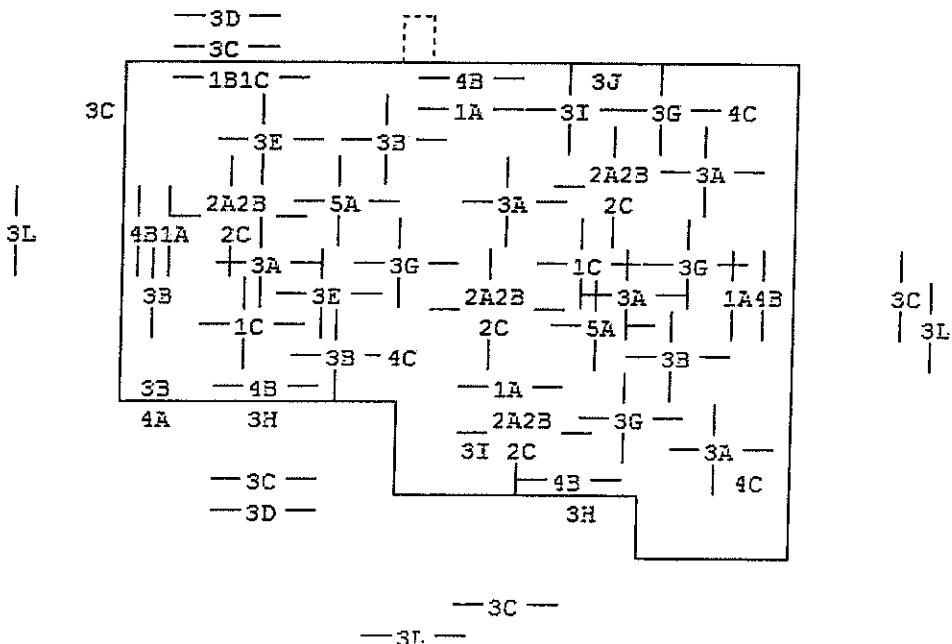
1A. FINDING: Evidence of subterranean termite infestation was observed in one or more locations at the structure, noted as 1A on the diagram.

1B. FINDING: Evidence in the form of shelter tubes for subterranean termites was observed and noted as 1B on the diagram.

1C. FINDING: Subterranean termite damage was observed at the mud sills, girders and joists throughout, noted as 1C on the diagram.

2A. FINDING: Evidence of drywood termites was observed at the areas noted as 2A on the diagram.

2B. FINDING: Evidence of drywood termites, in the form of drywood pellets, was observed, noted as 2B on the diagram.

2C. FINDING: Subterranean termite damage was observed at the framing, subfloor and floors throughout, noted as 2C on the diagram.

3A. FINDING: Fungus damage was observed at the roof framing and sheathing throughout, noted as 3A on the diagram.

3B. FINDING: Fungus damage was observed at the mud sill, joists and framing throughout, noted as 3B on the diagram.

3C. FINDING: Fungus damage was observed at the siding, trim and framing throughout, noted as 3C on the diagram.

3D. FINDING: Fungus damage was observed at the fascia board(s) throughout, noted as 3D on the diagram.

RECOMMENDATION: Perform a guaranteed soil treatment around the entire foundation for the control of subterranean termites using a registered termiticide. (Section I Item)

RECOMMENDATION: Remove all shelter tubes. (Section I)
(SECTION I ITEM)

RECOMMENDATION: Remove and replace damaged wood members. (Section I)

RECOMMENDATION: Tarp, seal, and fumigate with lethal gas, Vikane or other similar chemical. (Section I)

RECOMMENDATION: Mask and/or remove all pellets that are accessible. (Section I) (SECTION I ITEM)

RECOMMENDATION: Remove and replace damaged wood members. If possible, we will chisel or cut out the damage and fill with a plastic or wood filler. (Section I)

RECOMMENDATION: Remove and replace damaged wood members. If possible, we will chisel or cut out the damage and fill with a plastic or wood filler. Primer paint only. (Section I)

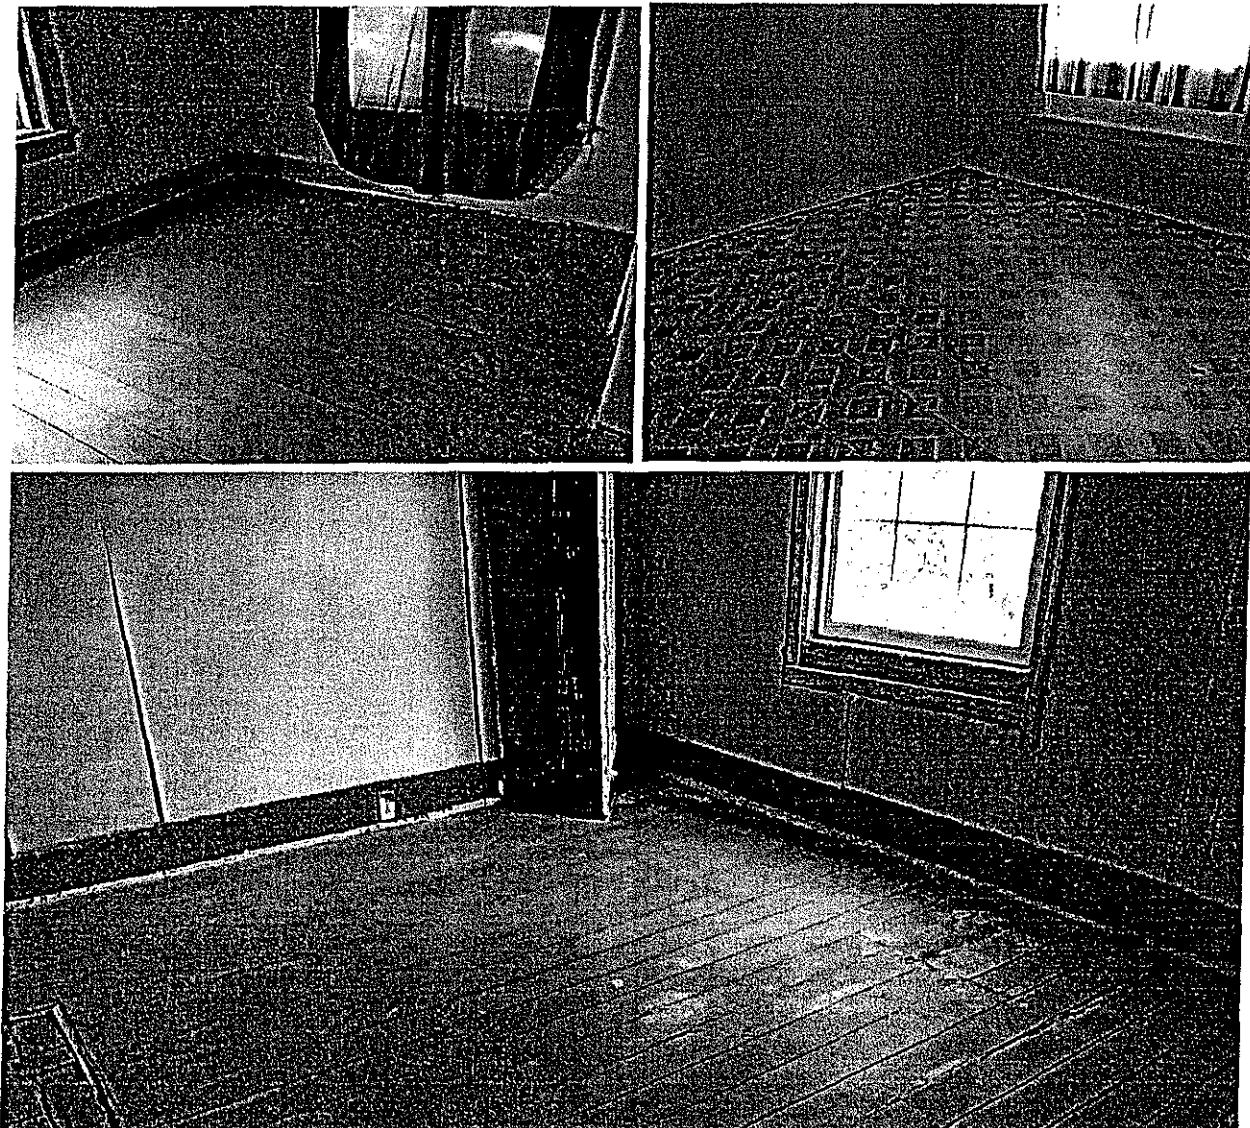
1. Floors

Typical of every room in the house, there is a readily observable slope in the floor towards the exterior walls. It is our opinion that the lack of a concrete foundation had allowed the wood supporting posts to subside into the soil. Since posts along the exterior of the structure are exposed to a soil that tends to have more moisture than that found near the interior of the house, we would expect those post to subside at a faster rate. We also observed significantly sagging in the floor near the pocket door at the common wall at the addition to the left of the structure.

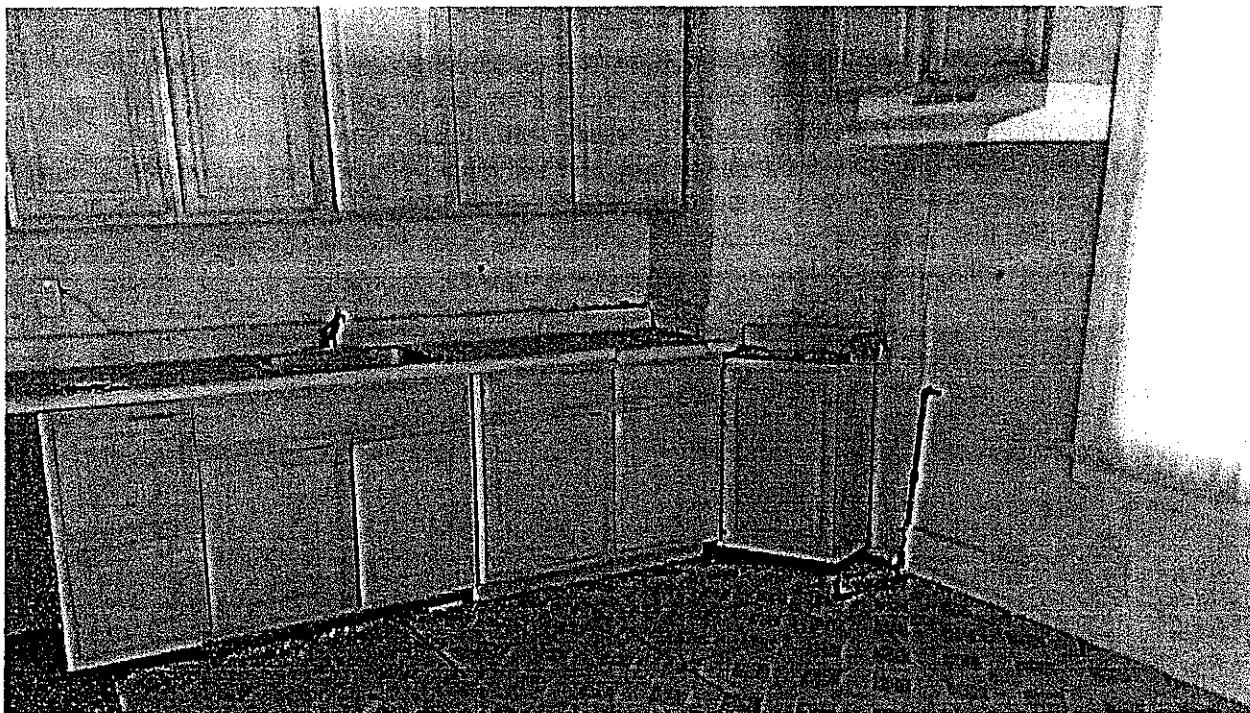
Figure 4: Kitchen looking toward chimney.

The wall and floor of the kitchen near the chimney have sagged several inches. It is our opinion that the chimney had been poorly founded and has subsided considerable thus dragging the adjacent floor and wall down with it. Interestingly, the exterior of the house near the same chimney is not experiencing the same distress, which suggests the chimney might not be positively connected to the exterior wall.

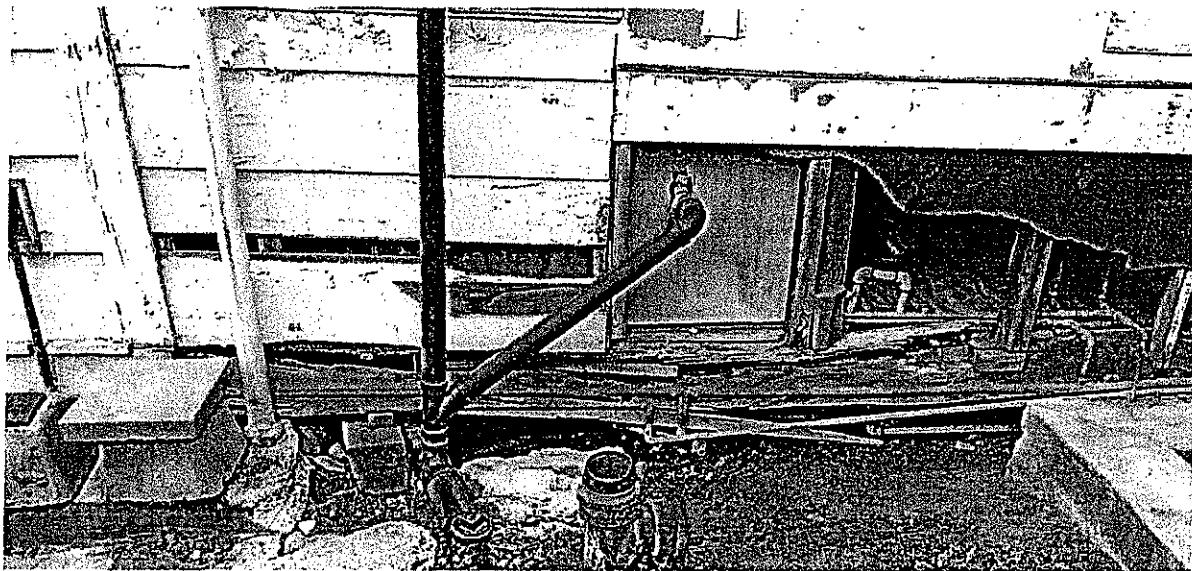
3. Termites

A large portion of the rear foundation are of the structure was open due to missing siding along the rear of the house at the ground level. Severe termite damage was apparent on all of the wood framing members at the edge of the floor.

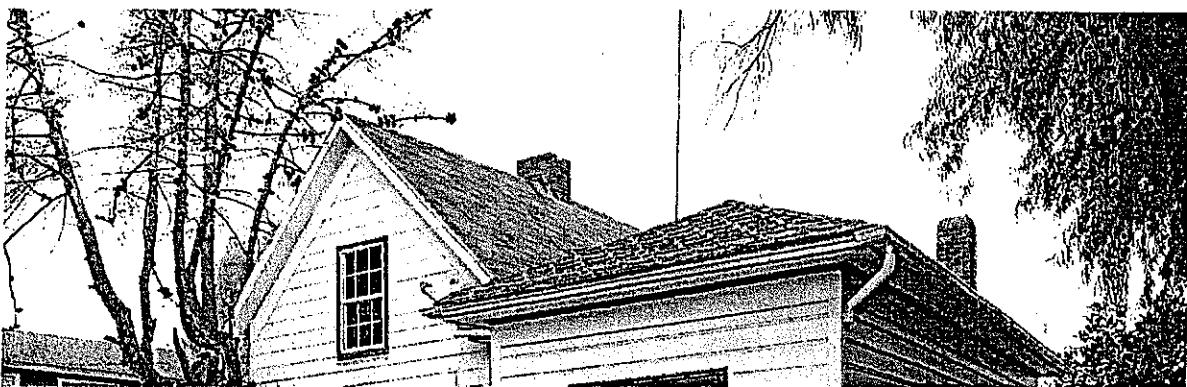
The roof has several layers of composite shingles. The edges look quite weathered and perhaps even attacked by mold. Despite the deterioration at the edges, the roof lines still appear straight which indicates that the framing underneath is likely sound. We did not observe any sagging in the roof which is an obvious sign of persistent water penetration.

Figure 5: Main roof and kitchen addition.

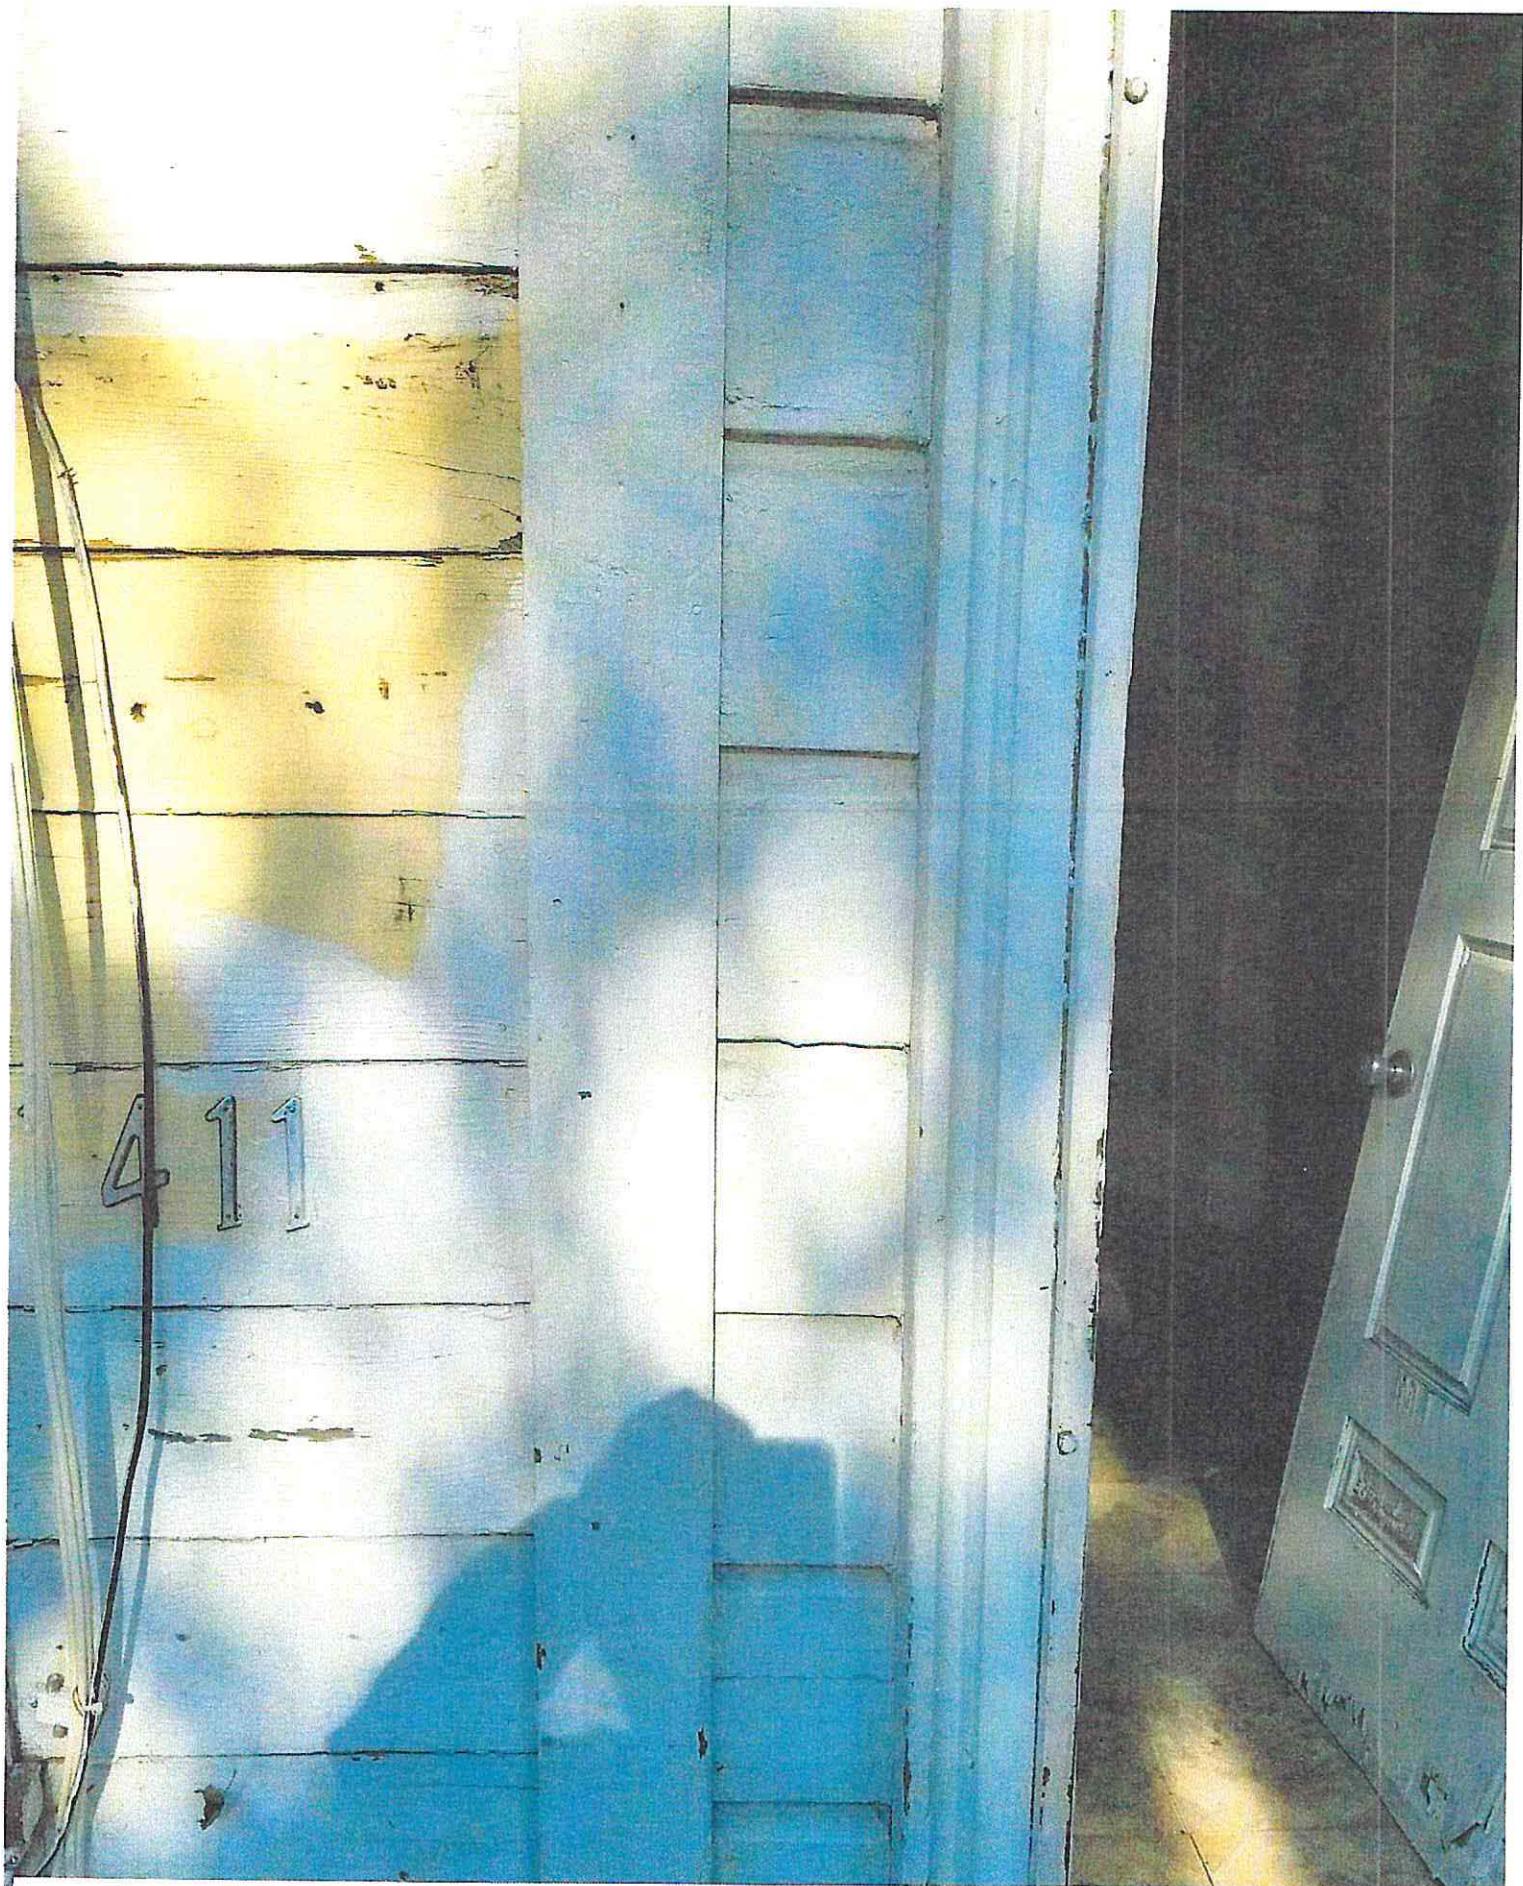
MISMATCHED SIDING WHERE ADDITION WAS DONE

DETERIORATED FRAMING, SIDING AND FOUNDATION

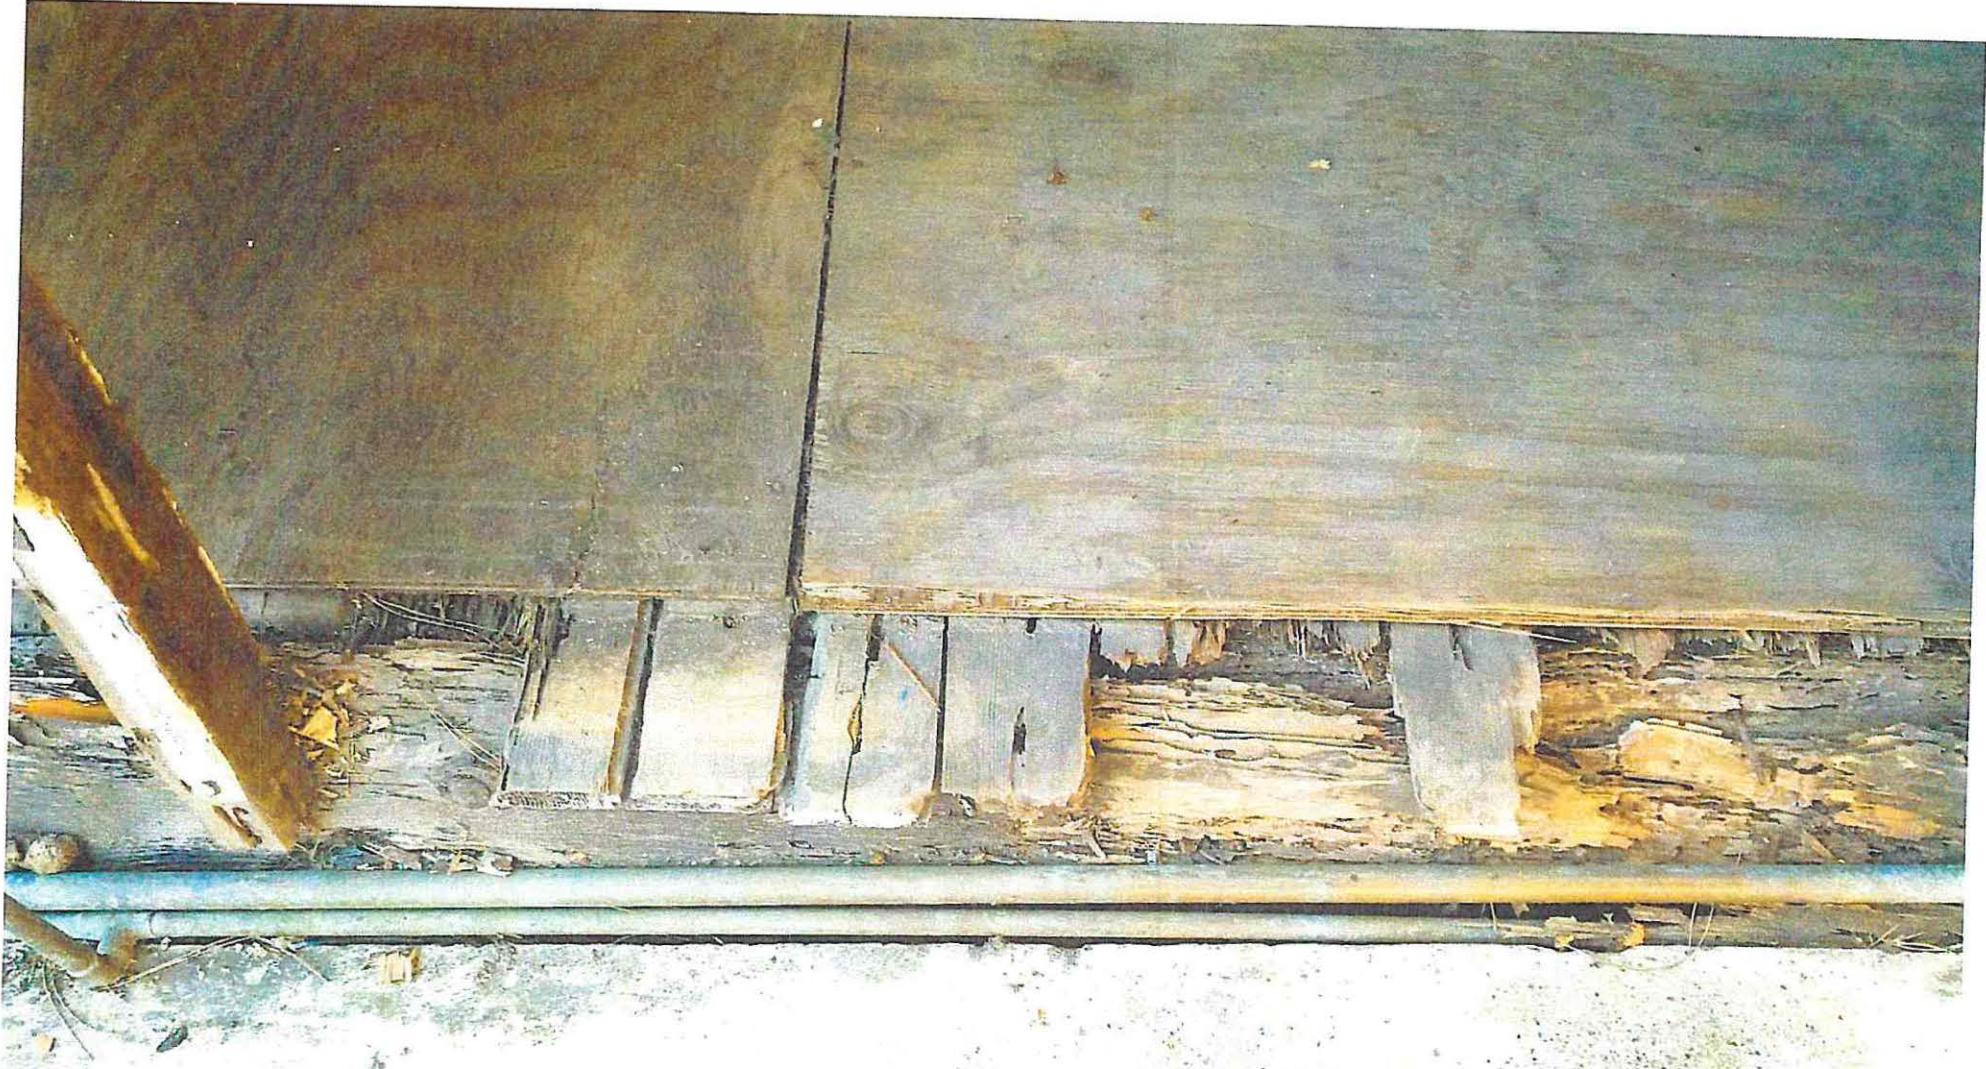
DETERIORATED WOOD FLOOR, FOUNDATION AND FRAMING

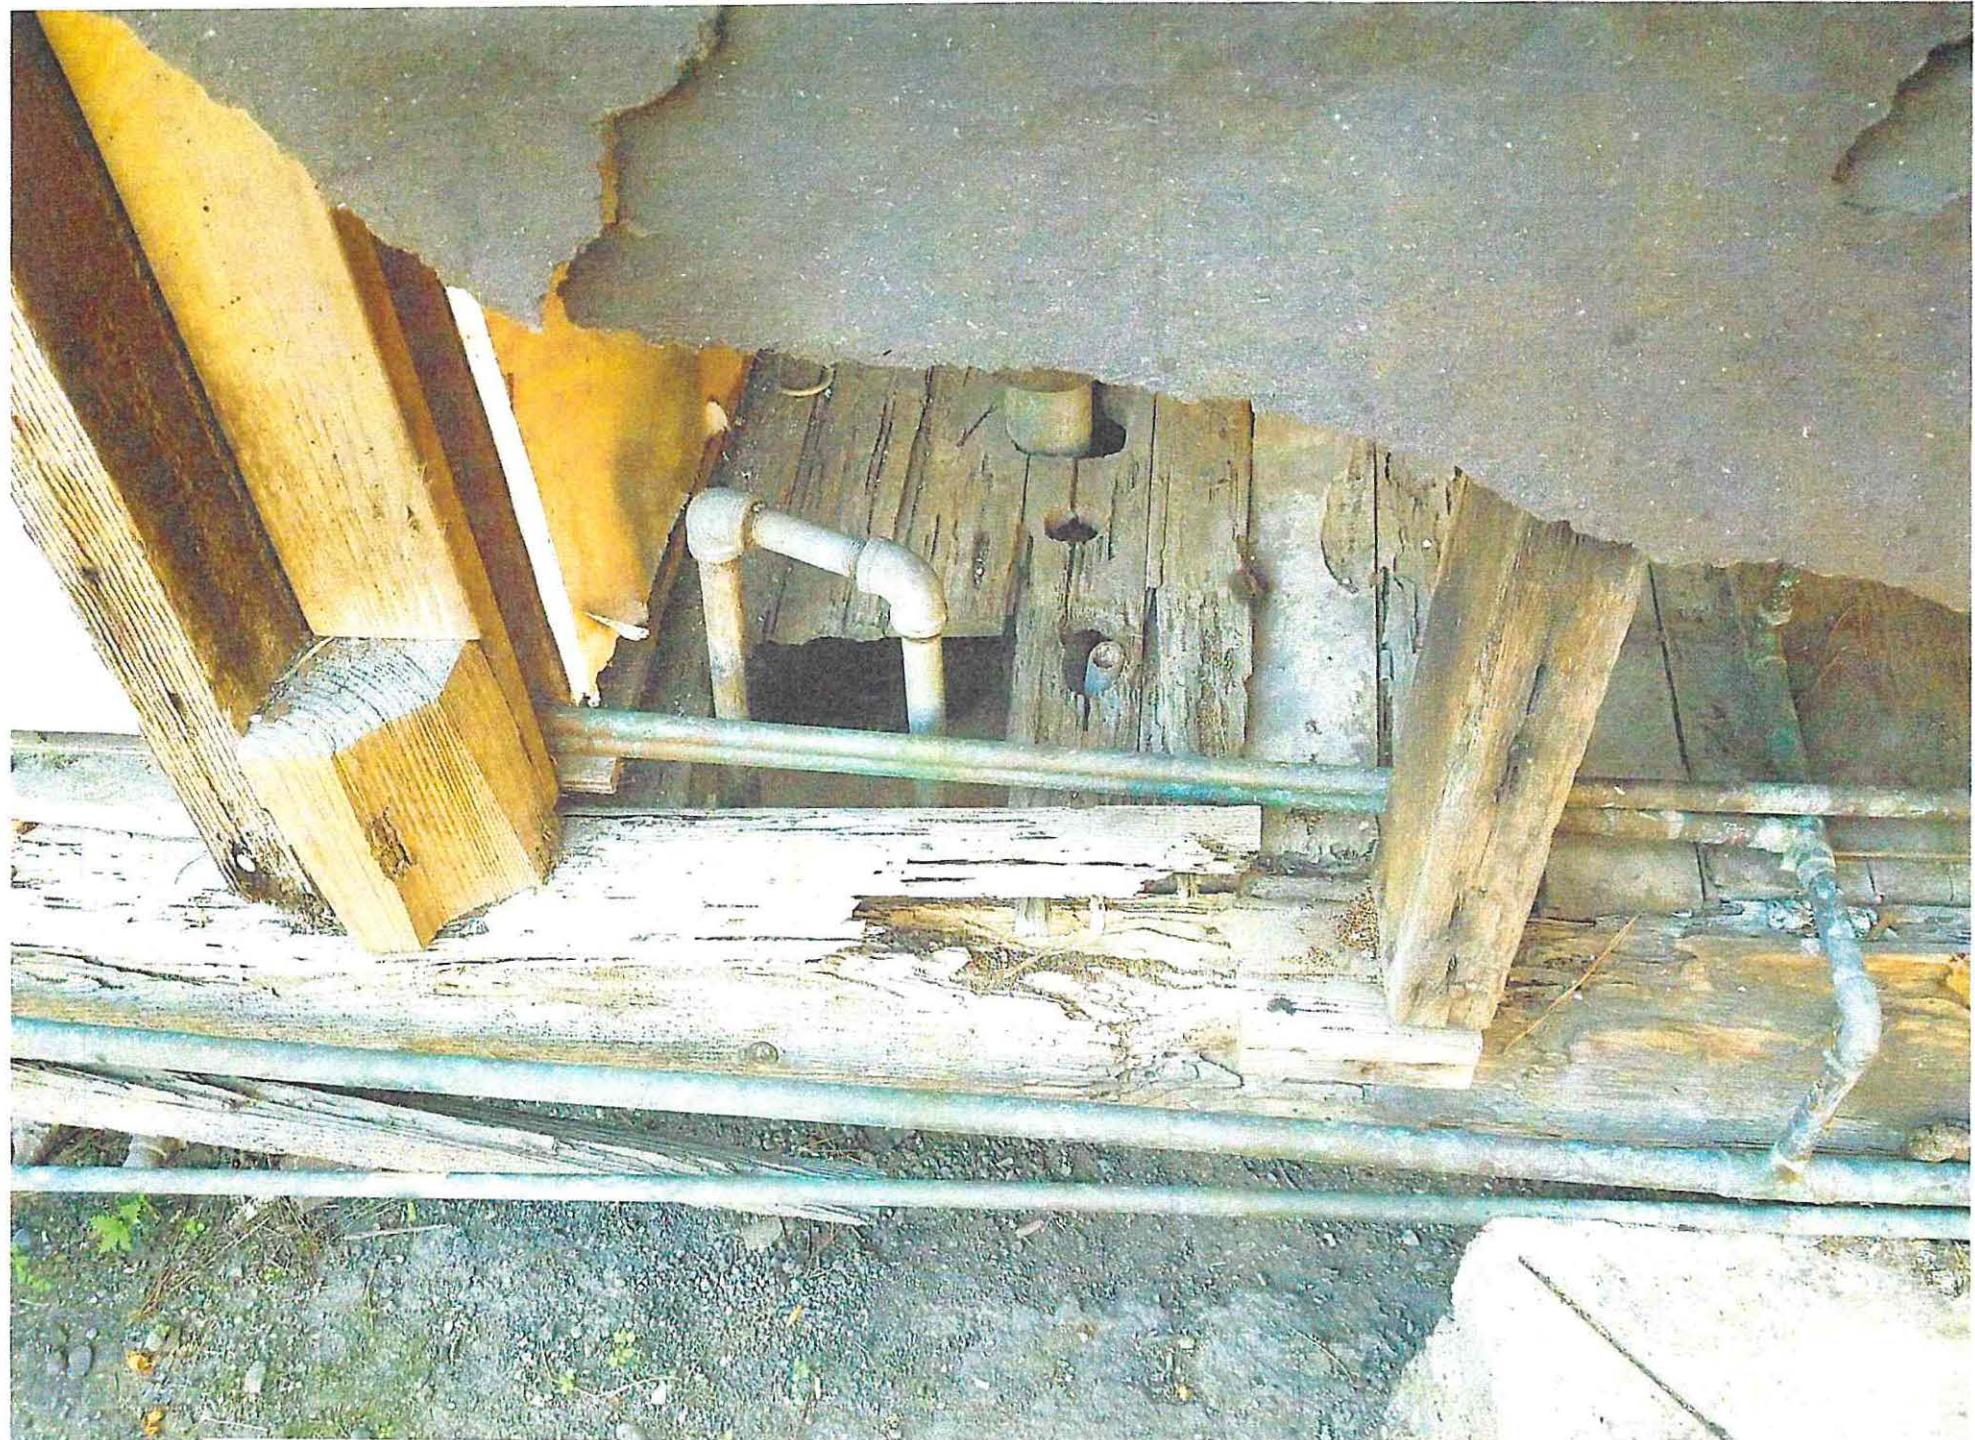
DETERIORATED FRAMING, FOUNDATION AND SUB-FLOOR

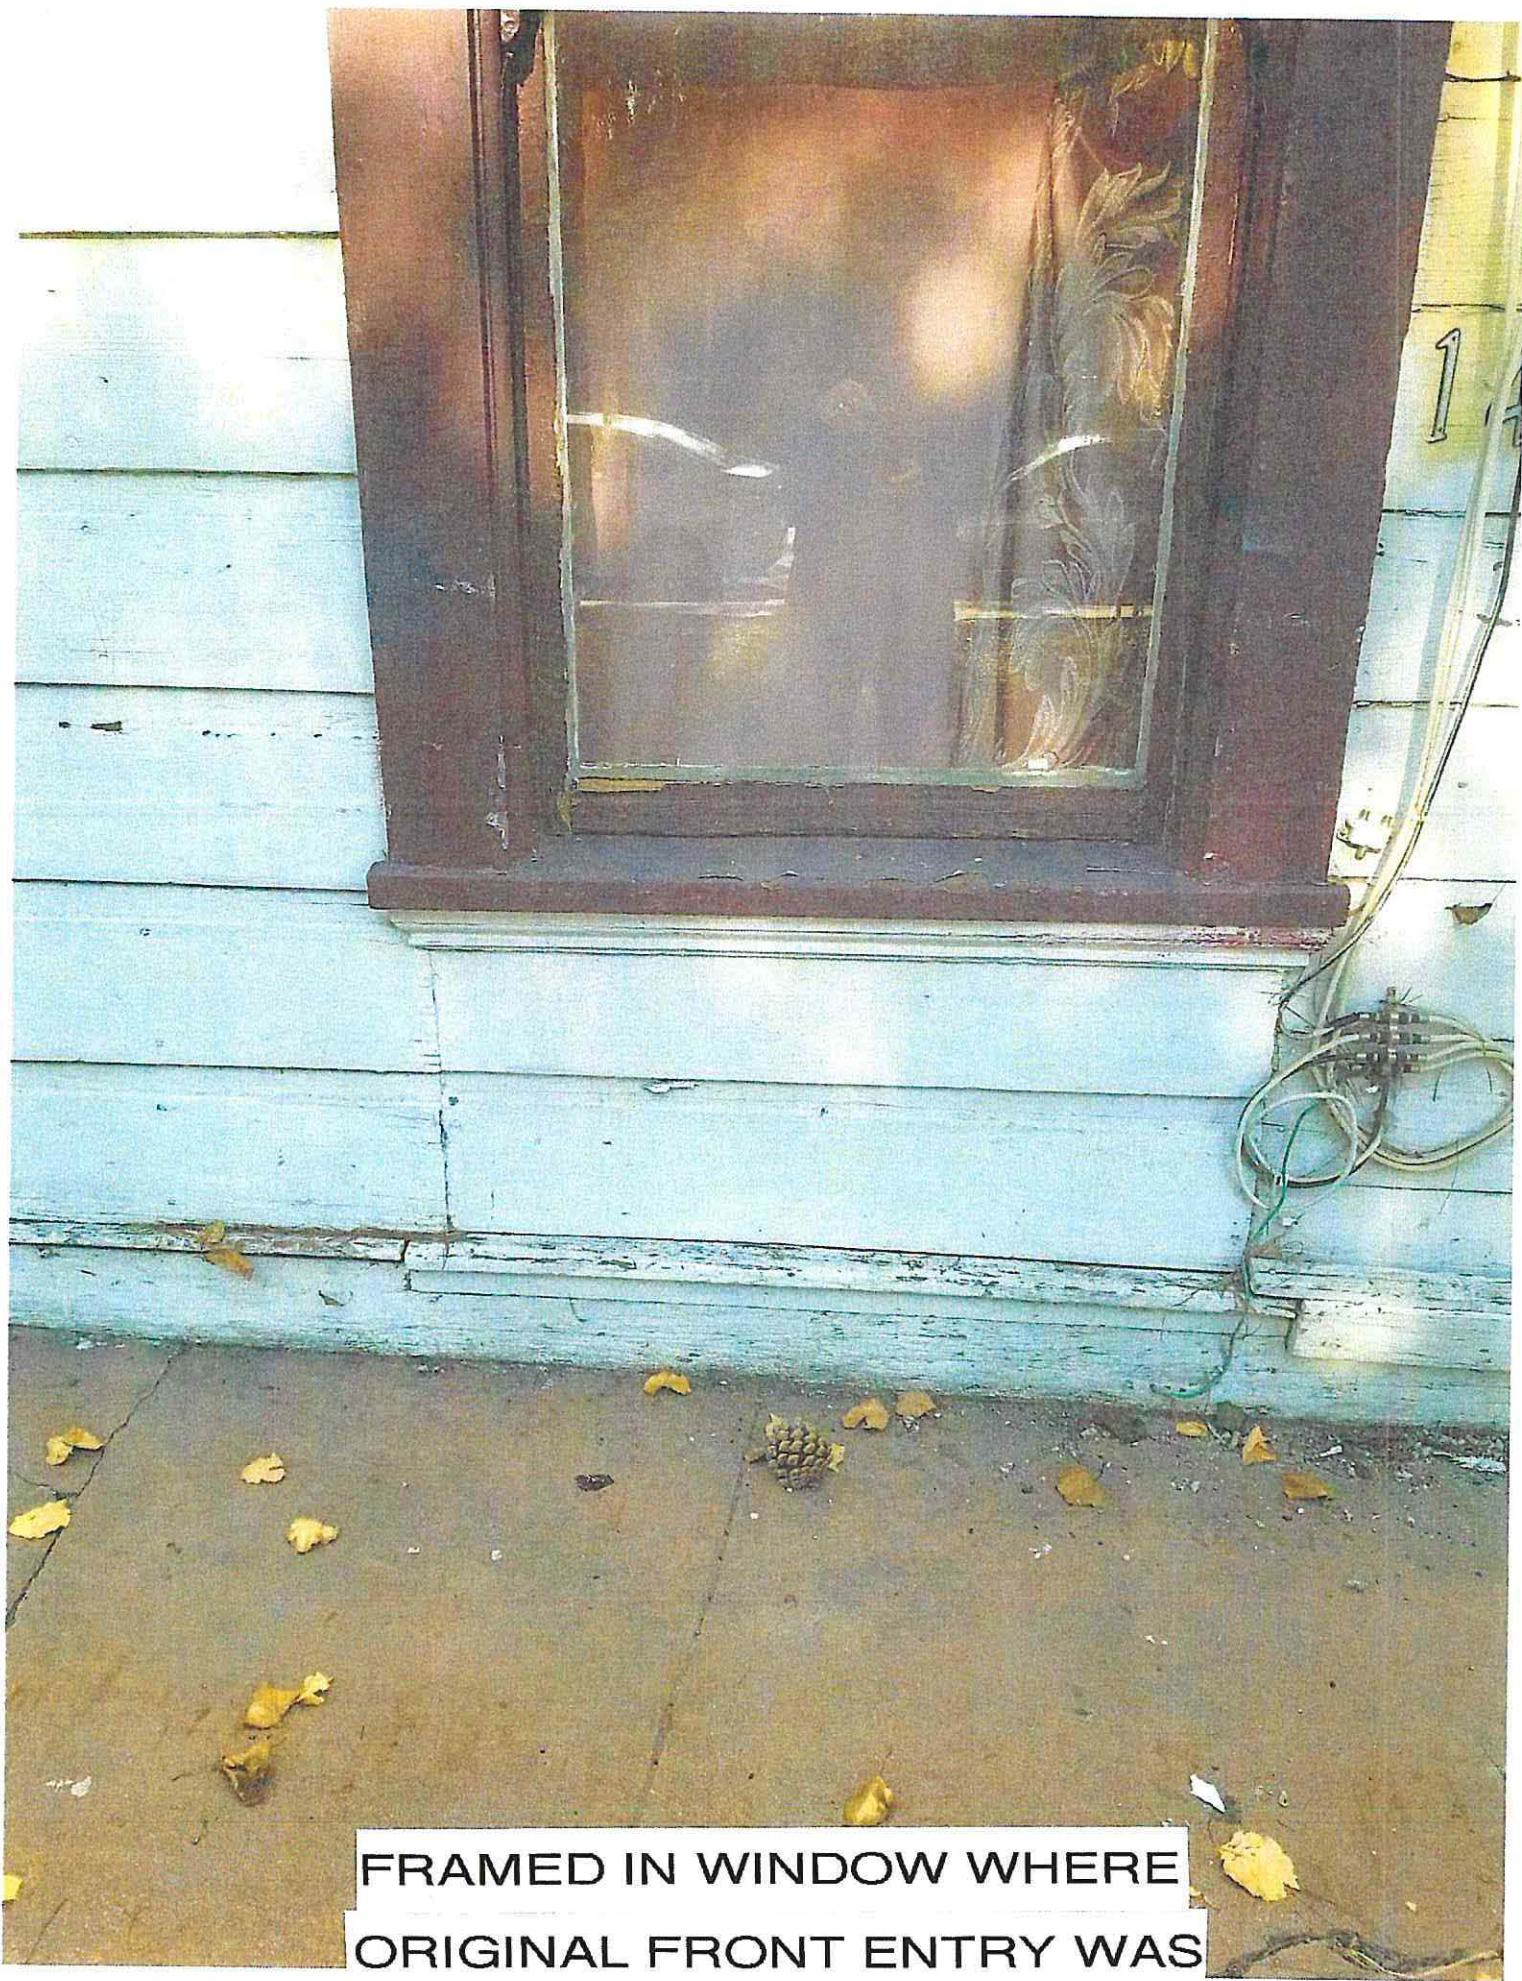
**FRAMED IN WINDOW WHERE
ORIGINAL FRONT ENTRY WAS**

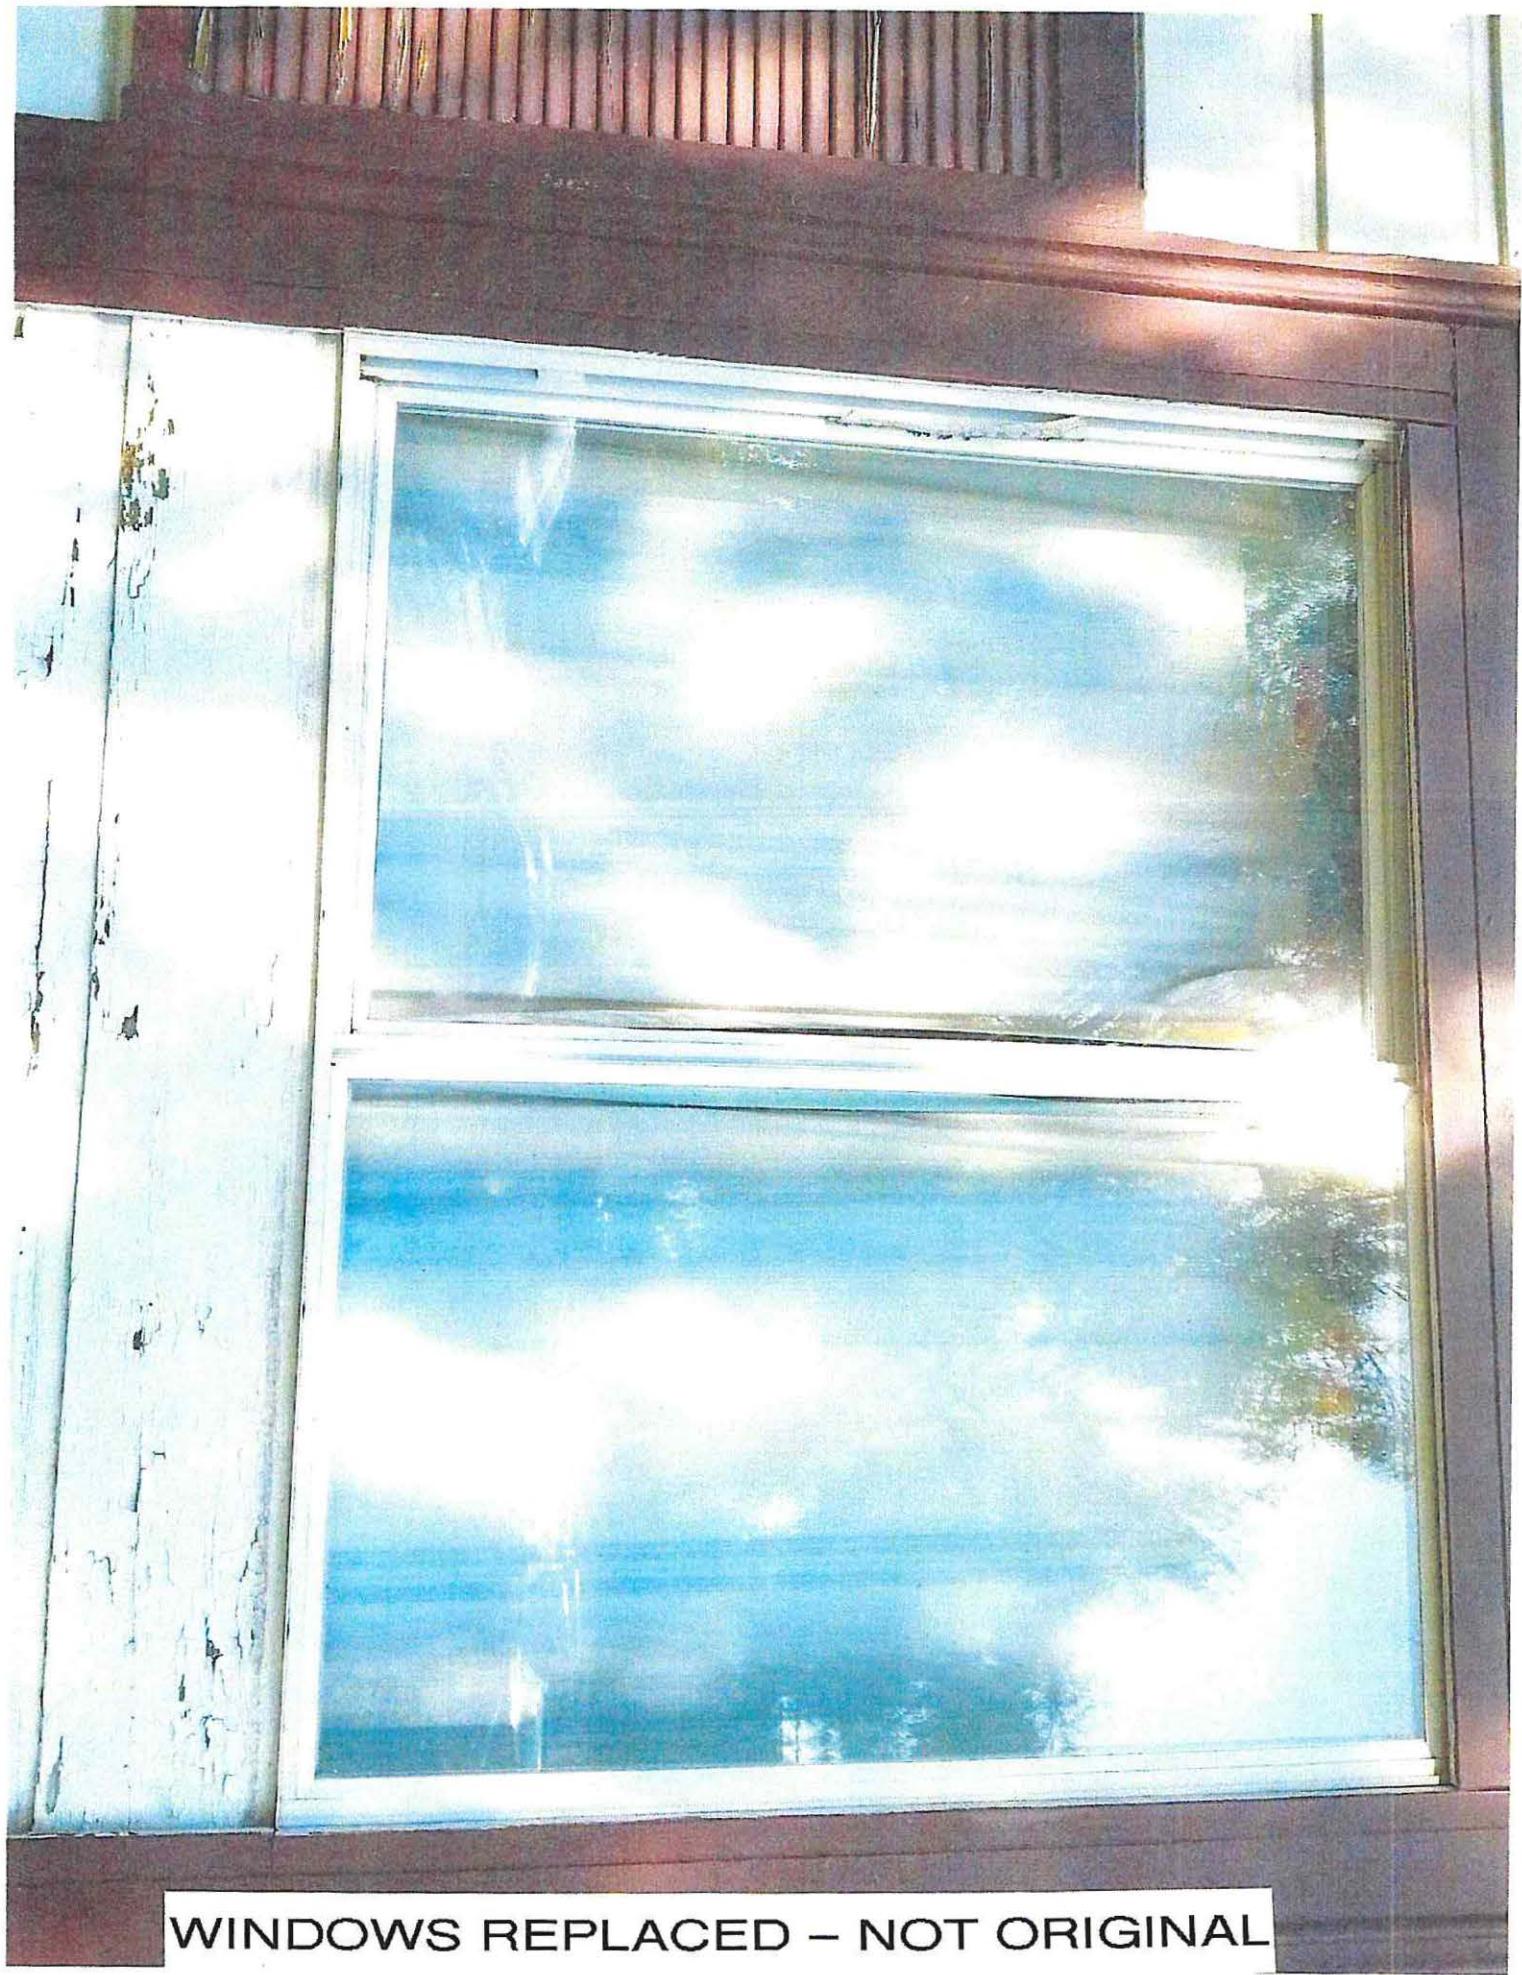
WINDOWS REPLACED – NOT ORIGINAL
