Project Proposal
1411 Lewis Street and 1444 Madison Street
Santa Clara, California

MADISON AND LEWIS STREET PROJECT DESCRIPTION

Location: 1411 Lewis Street and 1444 Madison Street

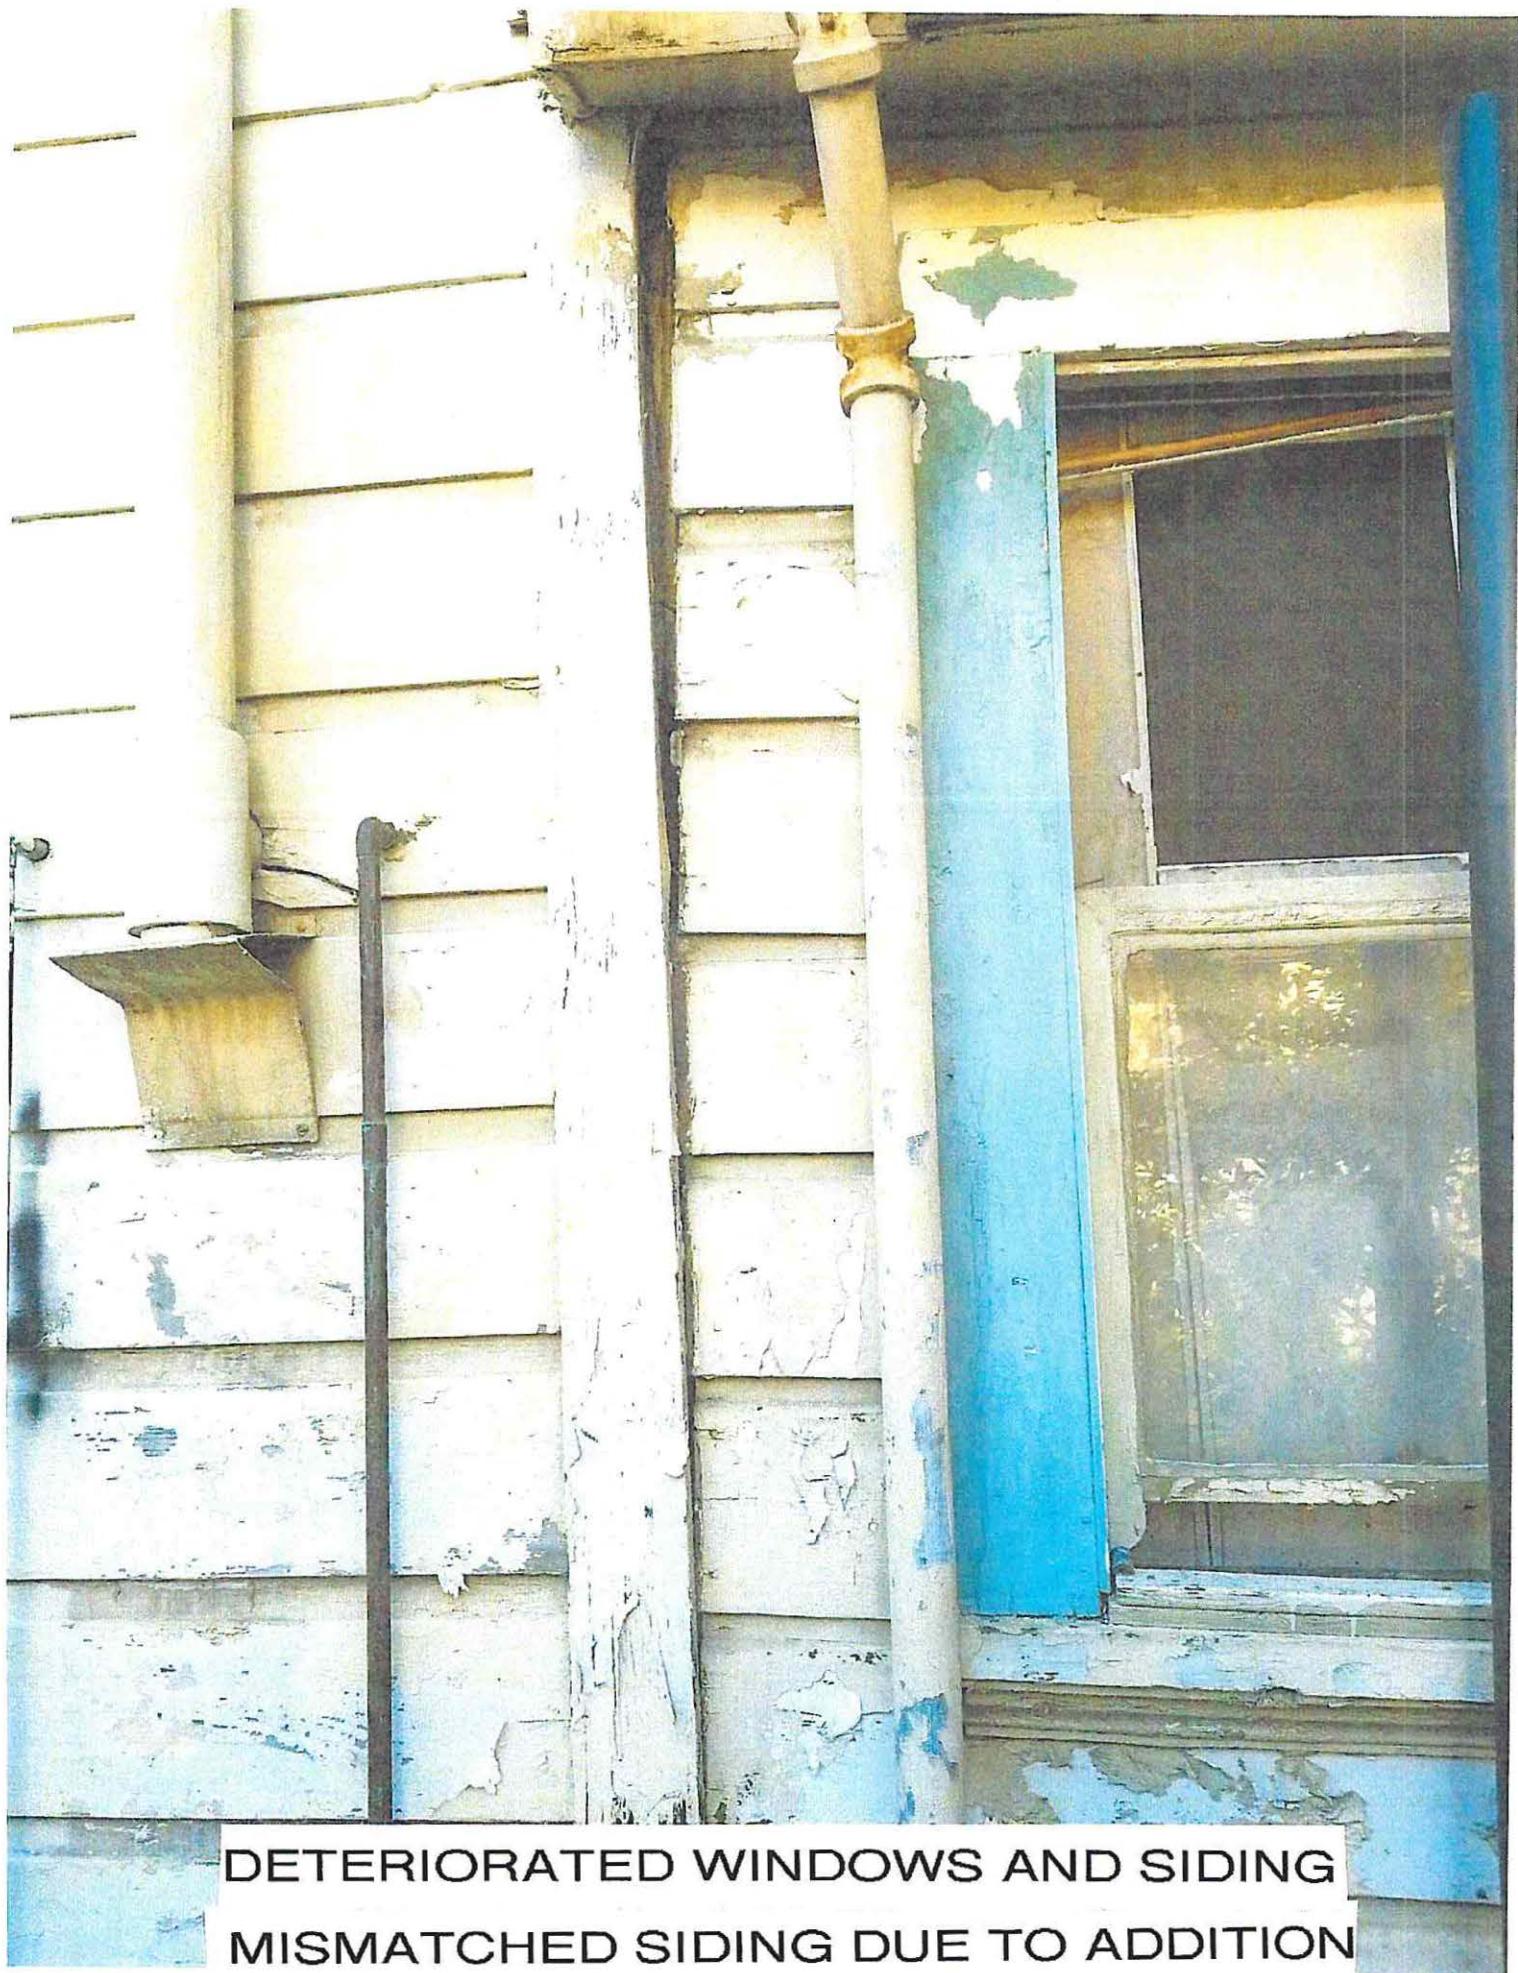
**DETERIORATED WINDOWS AND SIDING
MISMATCHED SIDING DUE TO ADDITION**

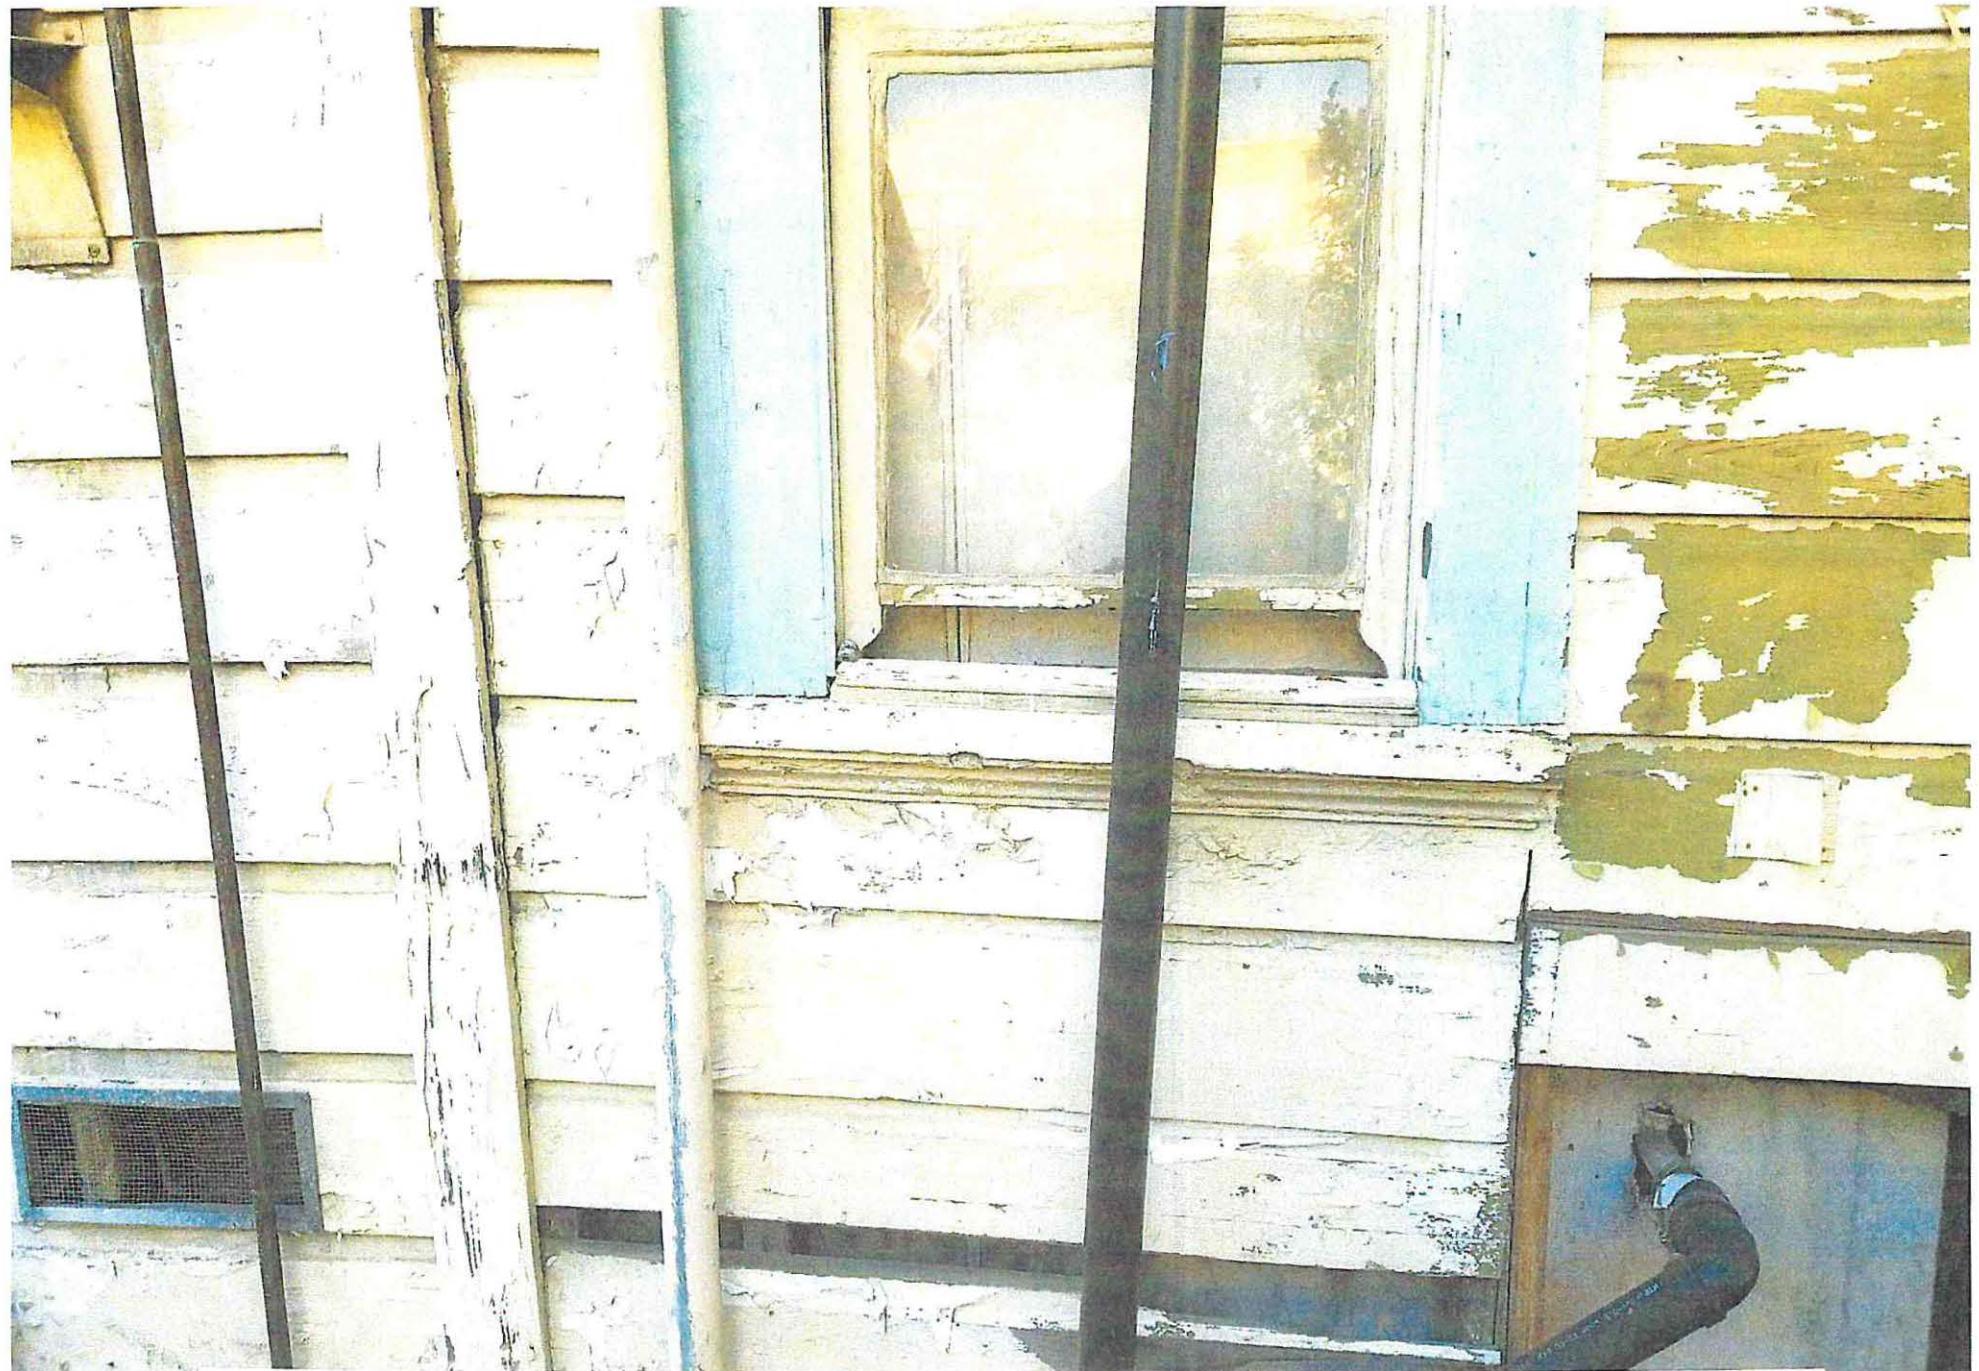
DETERIORATED WOOD SIDING, DRY ROT AND TERMITES

MISMATCHED SIDING

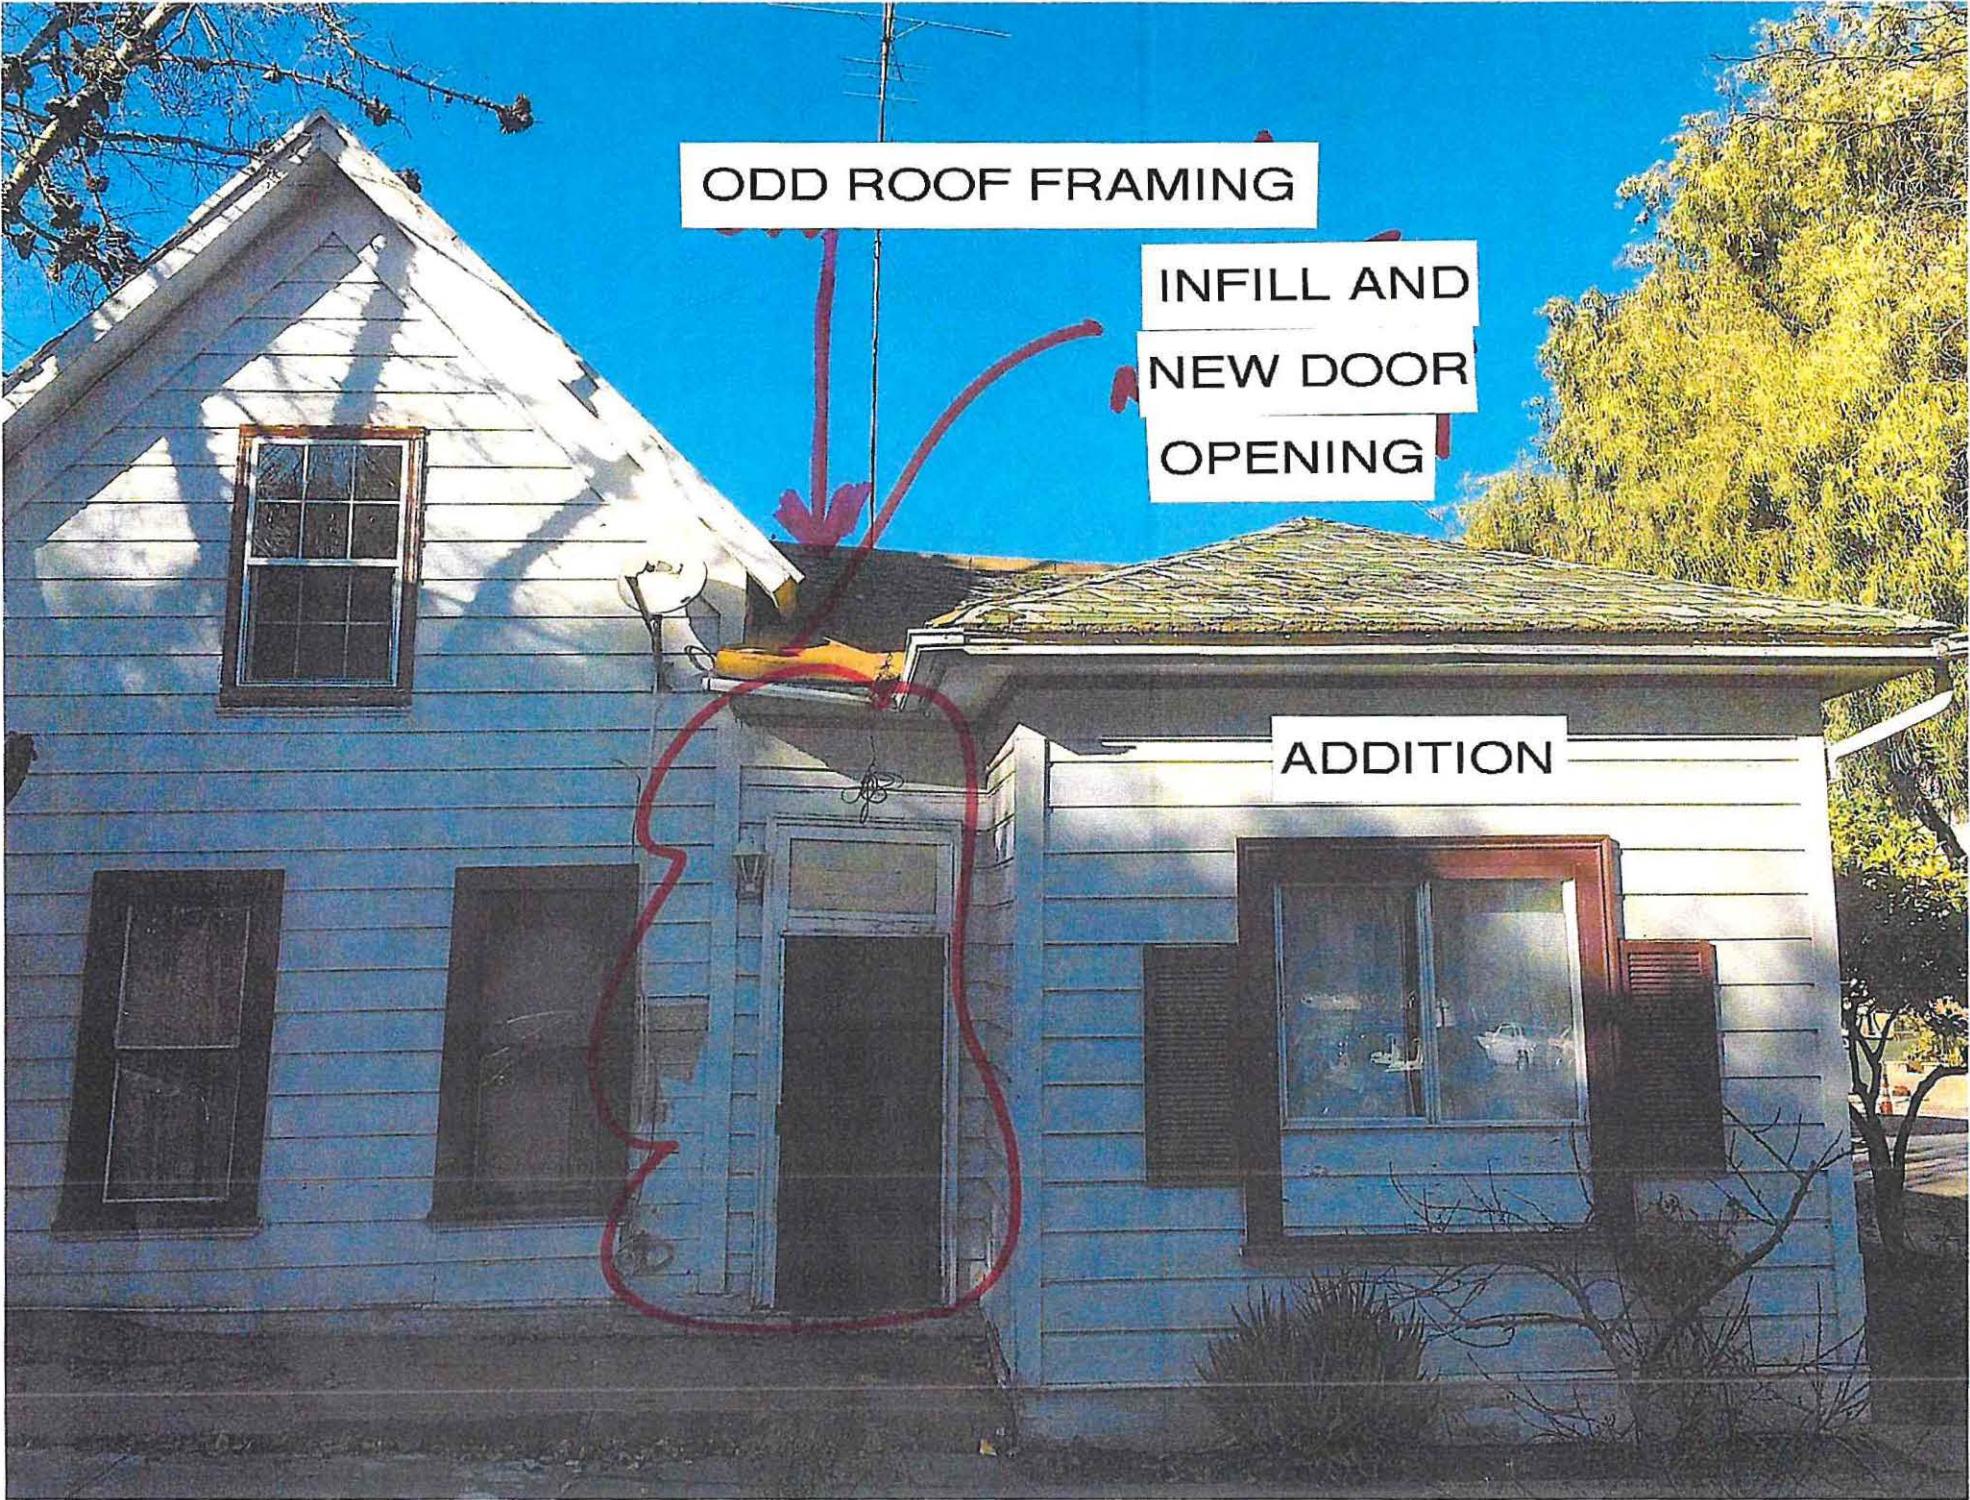
ODD ROOF FRAMING

INFILL AND
NEW DOOR
OPENING
