CITY OF SANTA CLARA GEORGE F. HAINES INTERNATIONAL SWIM CENTER VISUAL OBSERVATION ASSESSMENTS REPORT

01/24/2024
LPA Job No. 31047

VISUAL OBSERVATION ASSESSMENTS REPORT

PREPARED BY
LPA, Inc.
& Aquatic Design Group, Inc.
& Simpson Gumpertz & Heger

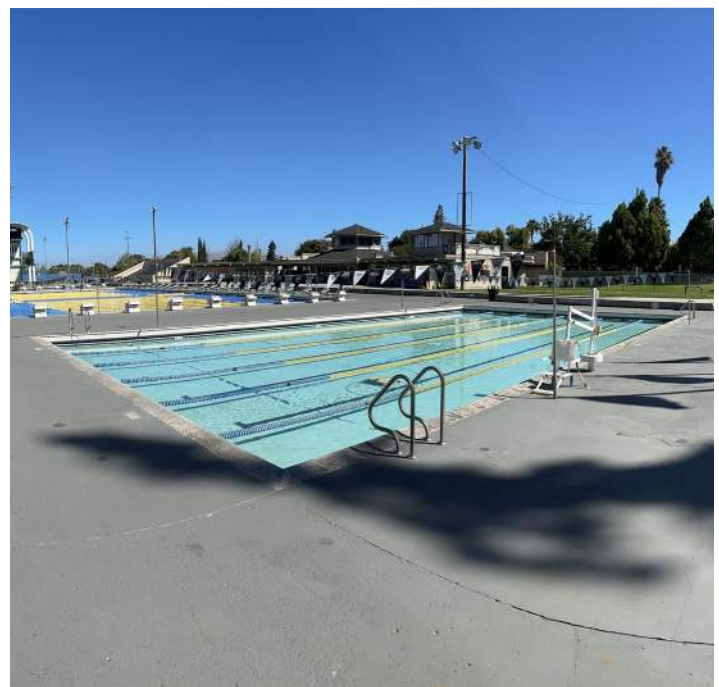
Image 6: 50-Meter and Instructional Pools

The 50-Meter Pool and the Instructional Pool operate on the same recirculation system, despite being separate bodies of water. California code requires each pool to have its own recirculation system. The comingled pools are in violation of CBC, Chapter 31B:

To separate the pools requires installing new piping and corresponding mechanical equipment to operate each individual pool. To accommodate an additional set of mechanical equipment the layout in the mechanical room needs to be reconfigured. During this process existing mechanical equipment that is dated could be, and in some cases would have to be, replaced. Additionally, this process would require draining of the pools as well as demolition of the decks. Upon completion of the install for new piping and mechanical equipment, the decks would have to be reconstructed and the pools replastered and refilled with water.

The following estimate is for new mechanical systems, new underground piping, a new surge tank and removal and replacement of the deck. For the full project scope and cost see page 23.

(Estimated Cost- \$4,579,575.00)

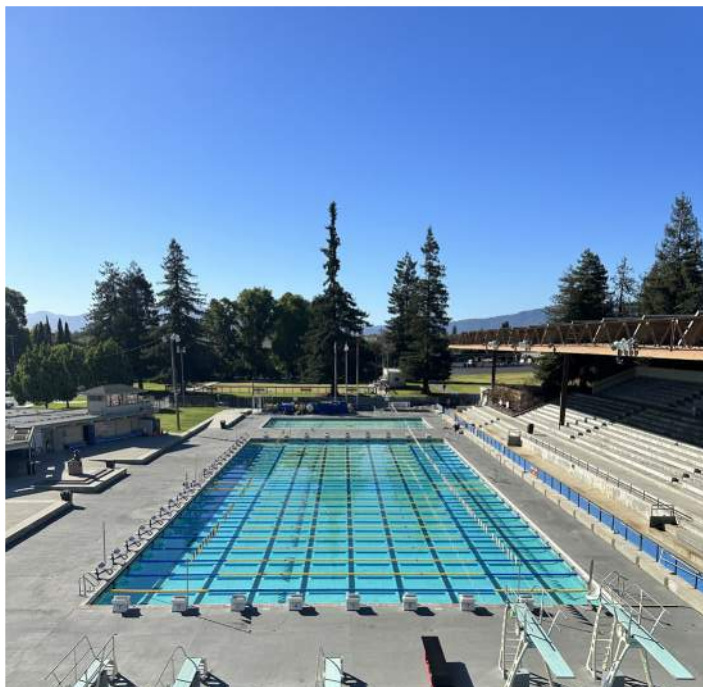
Image 7: 50-Meter and Instructional Pools

The 50-Meter Pool and Instructional Pool's gutters are operating below the gutter lip due to flooding when the pools are full of swimmers. As a result, the pools do not skim the surface water when the pools are not full of swimmers. This condition is in violation of CBC, Chapter 31B:

The gutter and gutter piping should be modified to meet the code requirement for constant skimming. The following estimate is for gutter and gutter piping replacement for both pools (this item is included in the project scope on page 23).

(Estimated Cost- \$882,000.00)

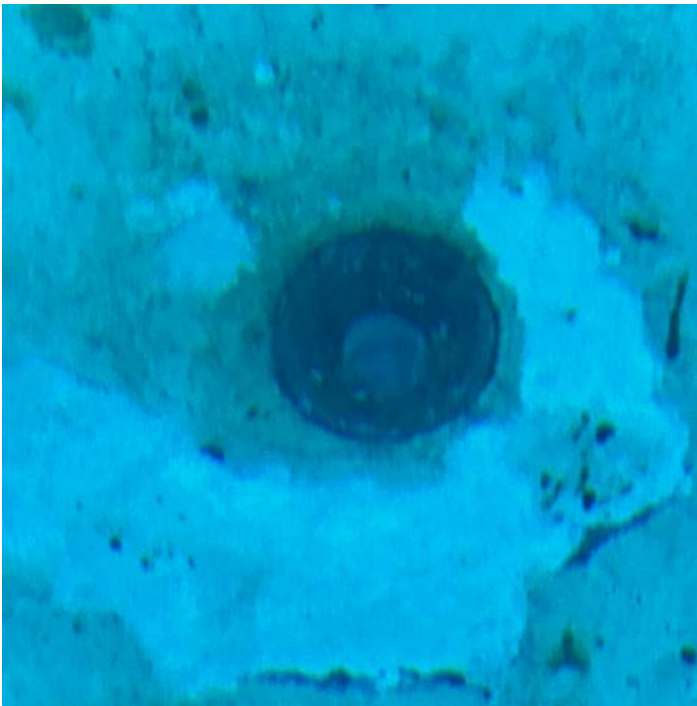
Image 14: Diving Pool Floor Inlet Without Flow Insert

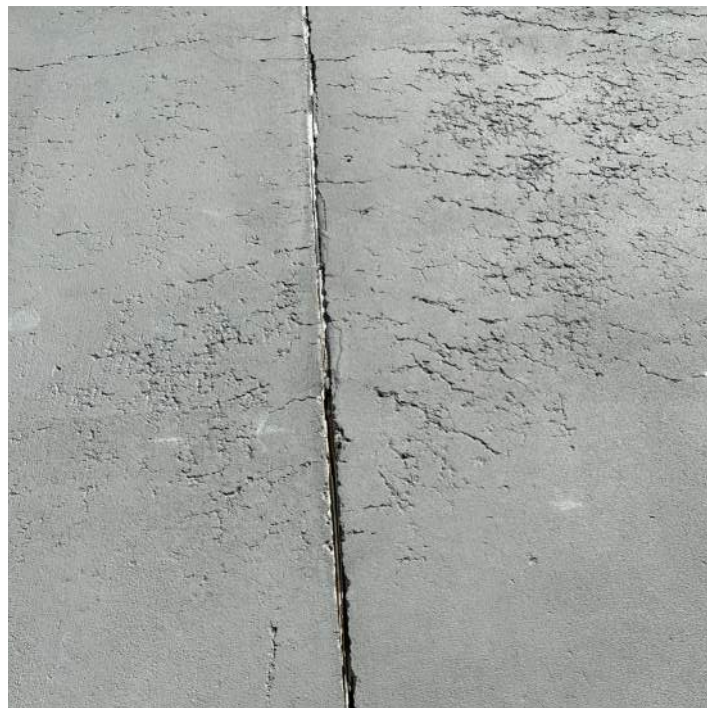
Image 18: Failing Pool Deck

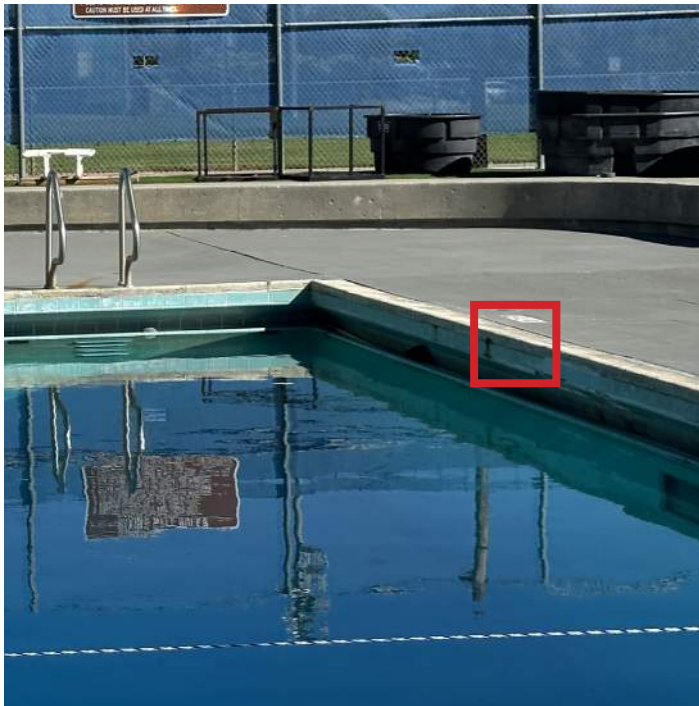
Image 19: No Waterline Depth Marker

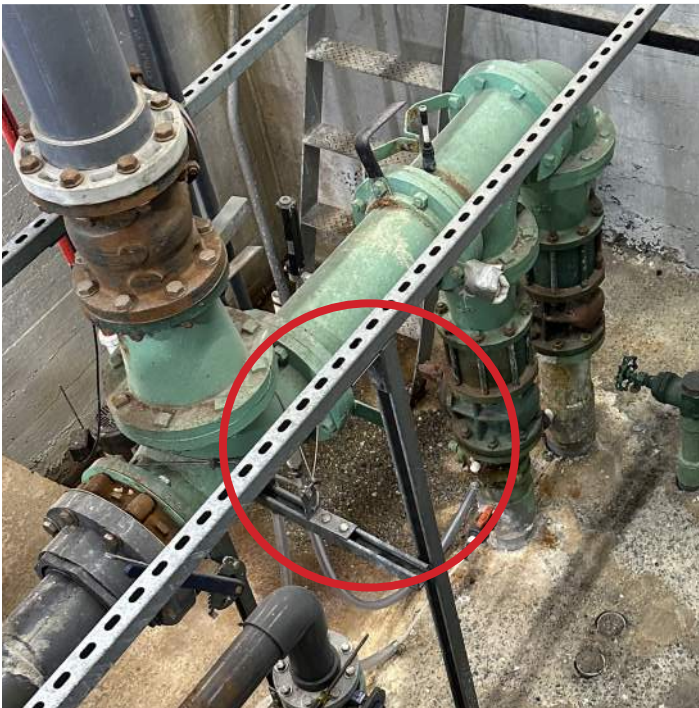
Image 21: Evidence of Leak in Pump Pit

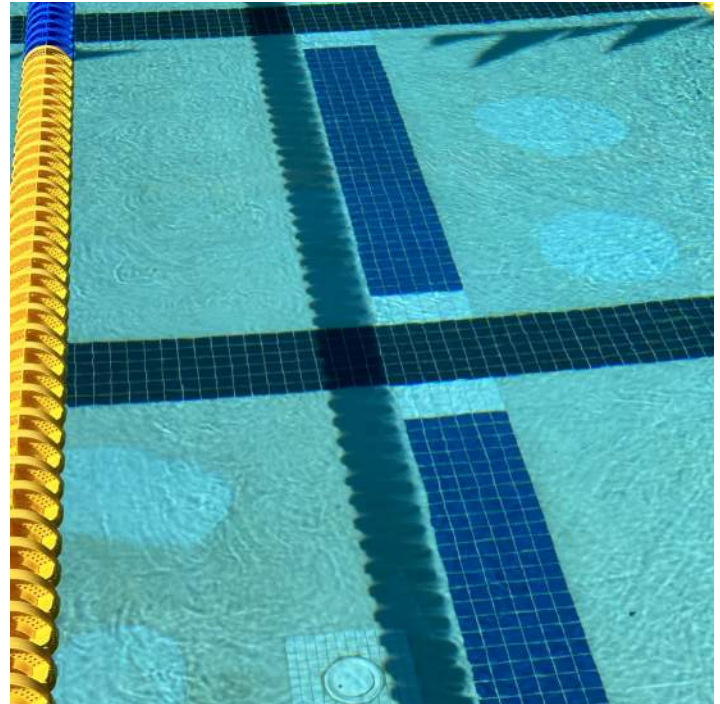
Image 22: Plaster Delaminating in 50-Meter Pool

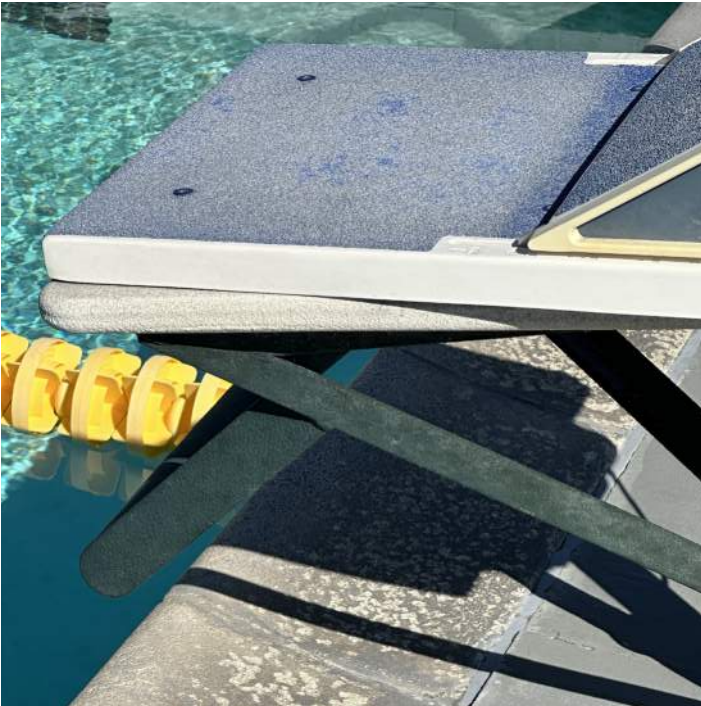
Image 23: Aging Anti-Slip Finish on Racing Platforms

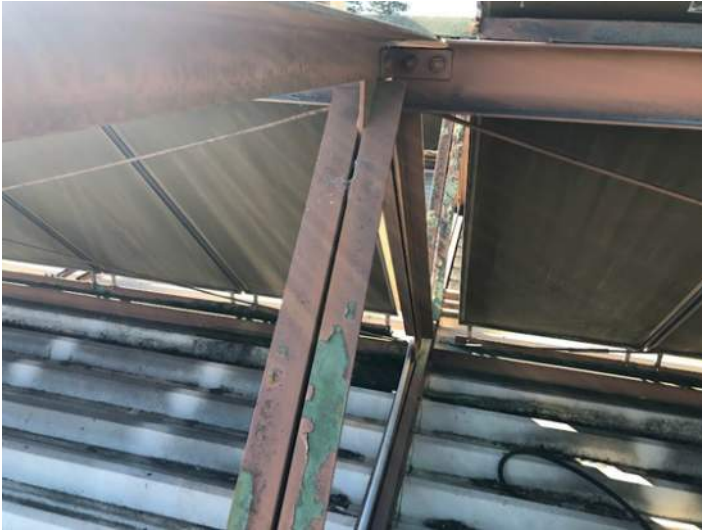
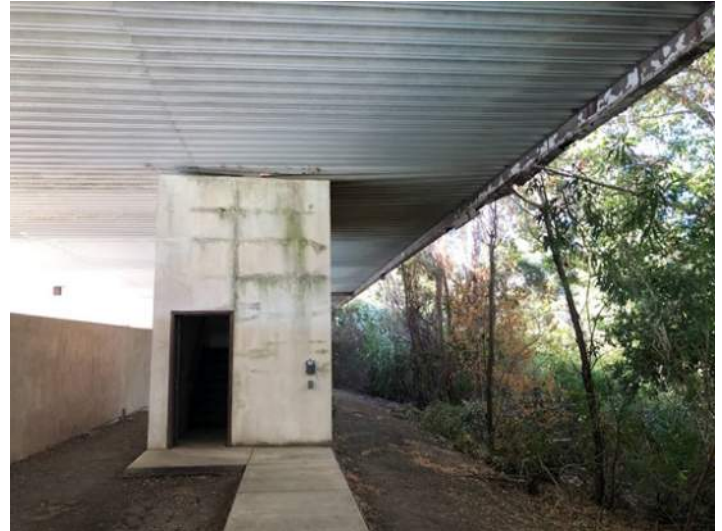
- b. Roof trusses of the canopy roof appear in reasonably sound condition. Some of the cover coating has been worn off and exposed the base primer. The original primer appears to be in reasonable shape with minor rusting observed.

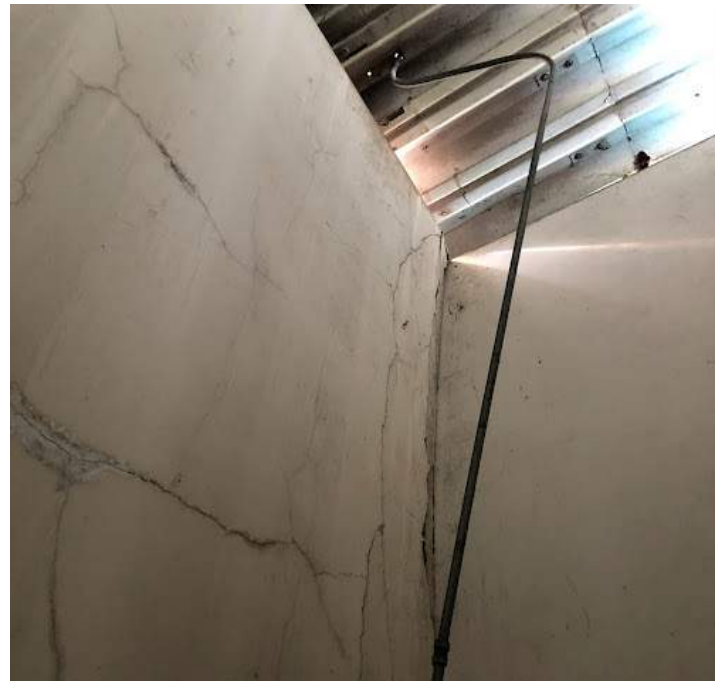
- c. The canopy tower access structure that houses the access ladder to the top of roof deck is badly damaged. Severe water damage and drywall cracks are observed on all walls of the structure. Rusting of metal stud bottom tracks are observed. Metal stud walls enclosed by the gypsum wall board are anticipated to be badly rusted as well. This is a stand-alone structure without connection to the roof structure. The gravity and lateral load resisting system is primarily metal studs and drywall. With the severity of the damage observed, most of the lateral load resisting system have been compromised, it is unsafe to be inside the structure.

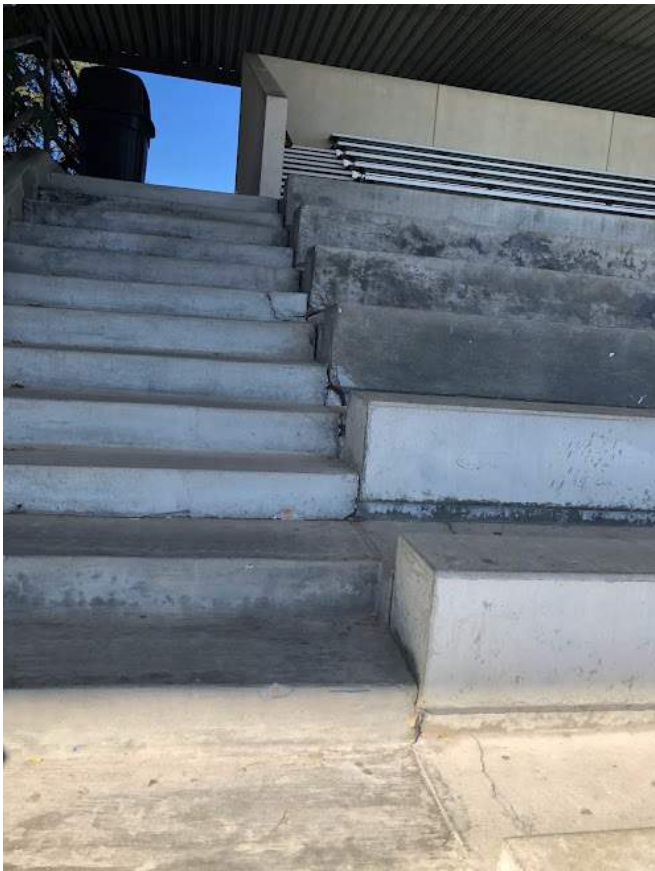
- d. There are (8) steel cantilever columns supporting the entire roof structure. Columns are most likely not in compliance with the current building code standard and should be evaluated. An additional steel member, or reinforcing the existing member by welding new member, will be required to strengthen the existing structure. Further analysis will be required to provide recommendations.
5. Canopy Bleachers
- a. Metal stud walls behind the aluminum bleachers appears to be rusted and indicates signs of water damage. Studs shall be replaced and protected.
 - b. Severe concrete cracks on steps are found along south end of the bleacher. Evident of differential settlement is observed. Geotechnical engineer should review the existing soil condition and provide recommendations.

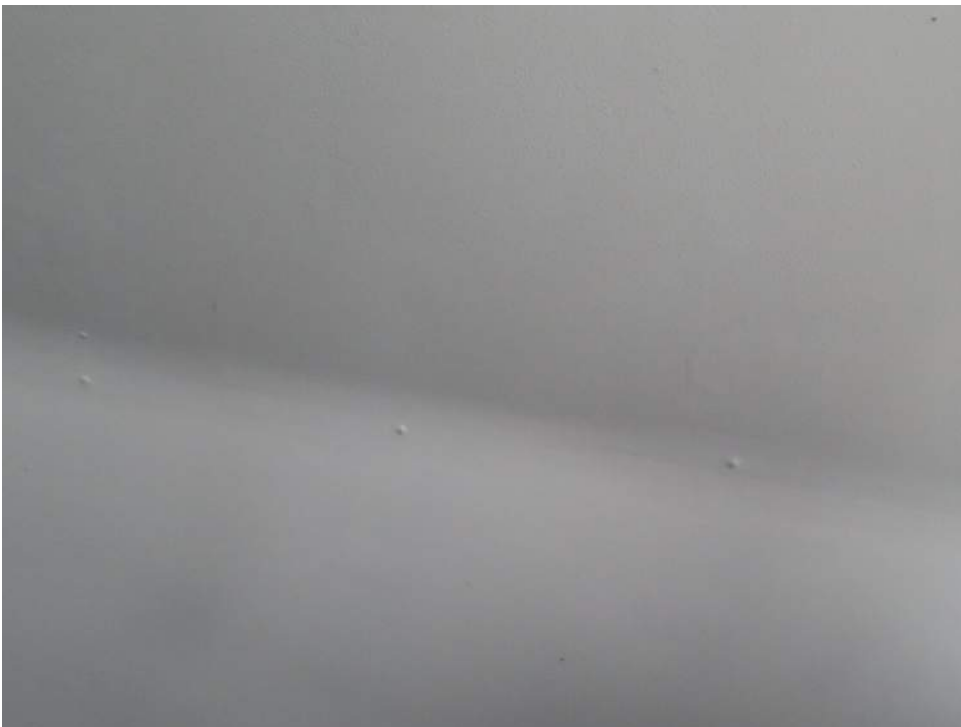
Photo 10

Missing shingles on the roof hips align with the ceiling crack, nail pops, and bubbling in the gypsum wallboard.

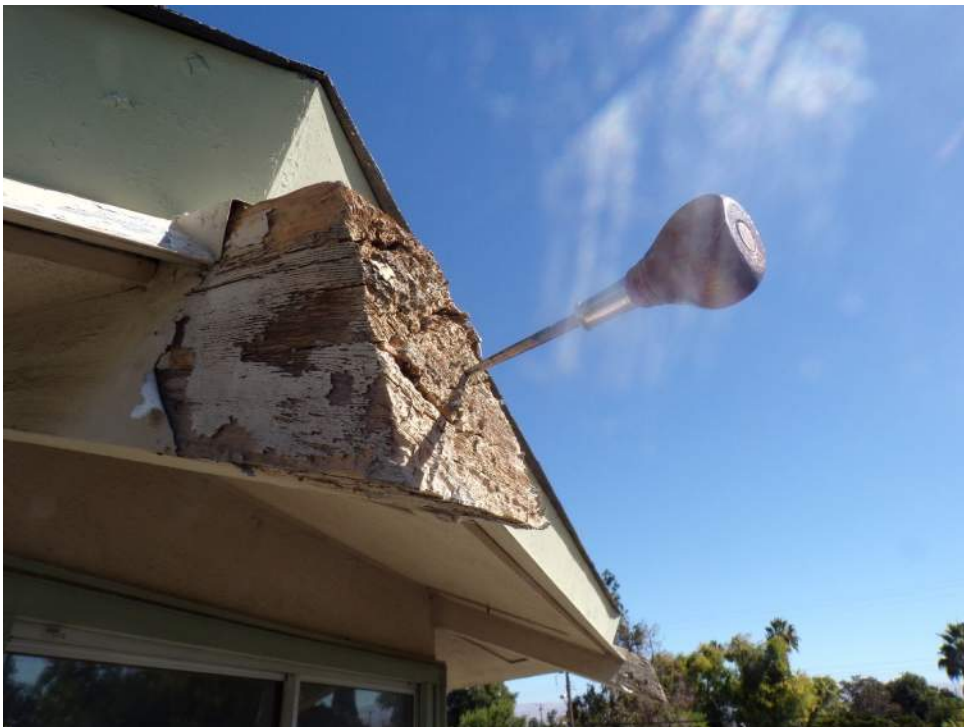
Photo 16

Significant wood decay at the exposed ends of common and hip rafters.

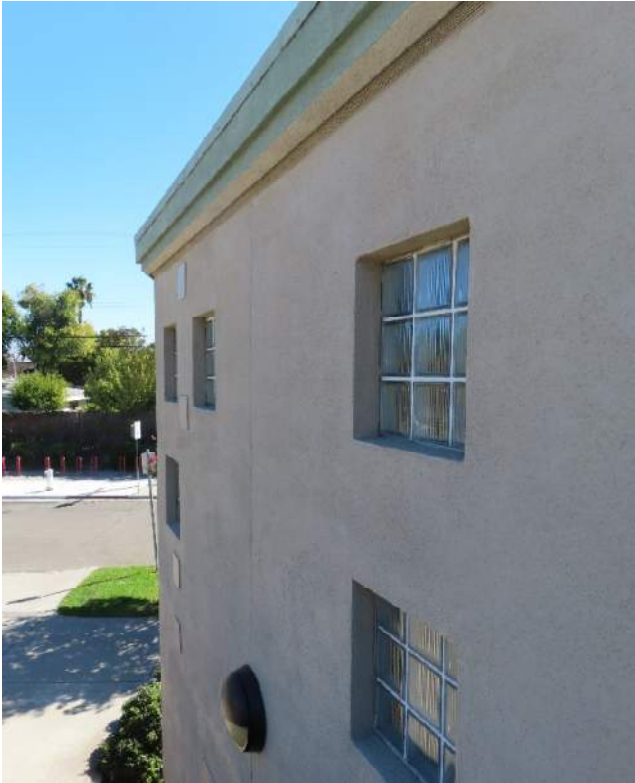
Photo 18

Window frames are worn
and glazing seals are
deteriorated.

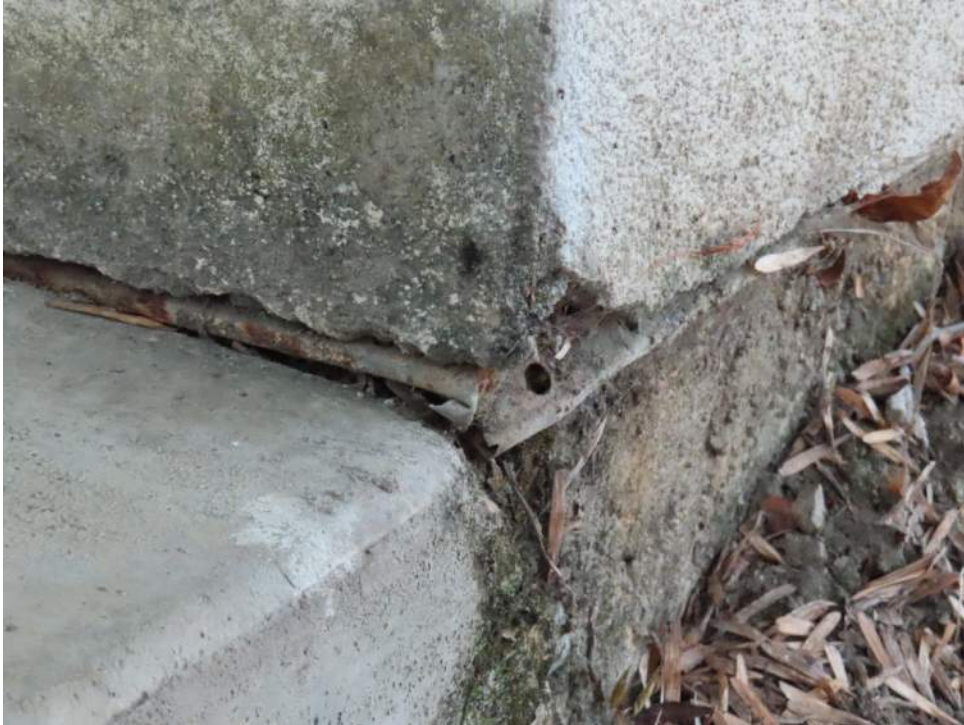
Photo 25

Soil erosion occurs around column foundations and along the concrete slab walkway. The roof deck downspouts have separated from the foundations.

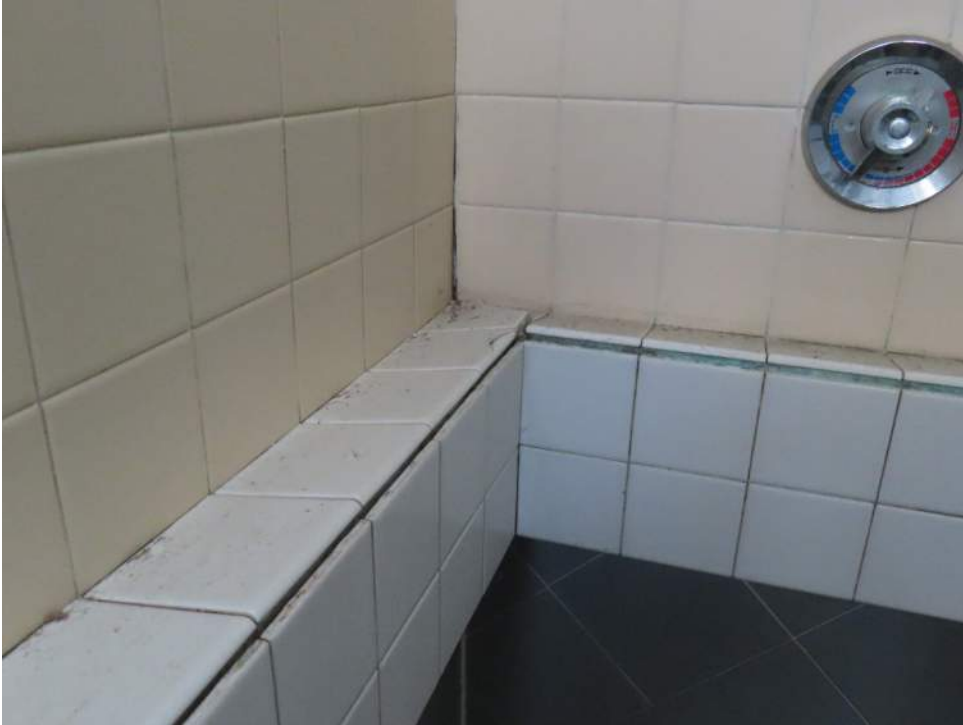
Photo 29

Over 1/8 in. wide cracks exist in the plaster wall finish adjacent to tile.

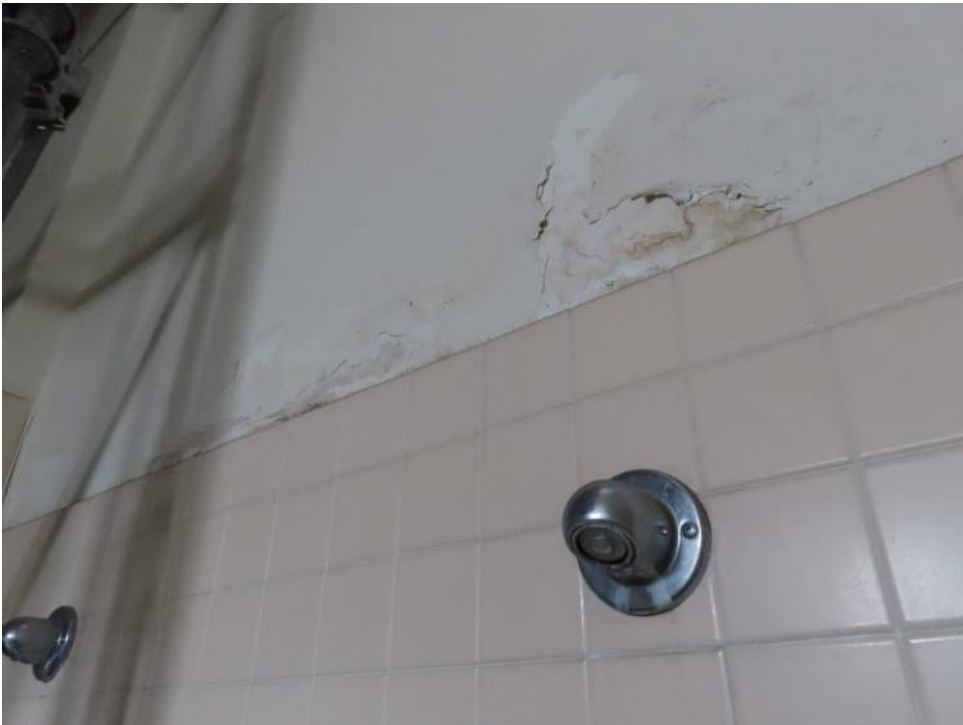
Photo 30

Cracks and gaps within the tile assembly particularly at inside wall corners and at tile ledges.

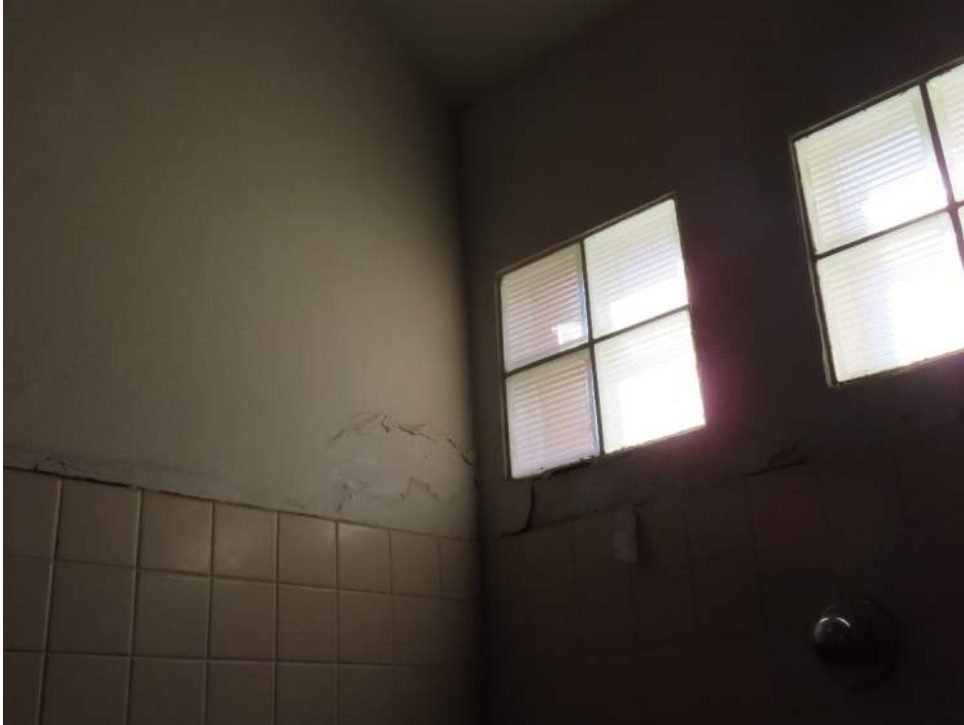
Photo 31

Water stains and chipped paint exist on the non-tiled portion of the shower enclosures indicative of water damage.

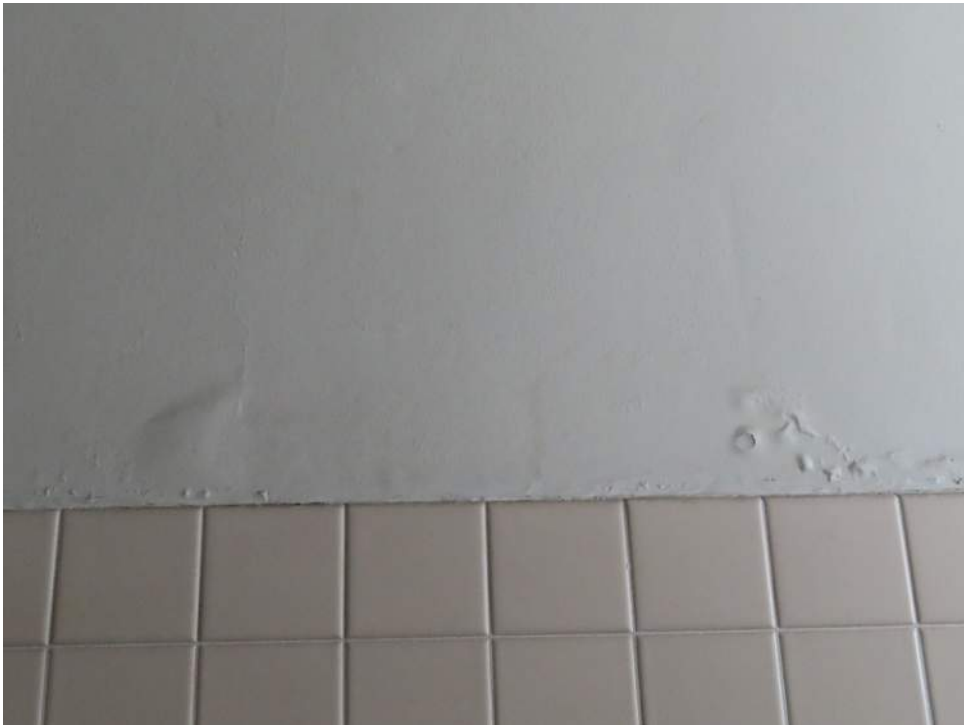
Photo 32

Water stains and chipped paint exist on the non-tiled portion of the shower enclosures.
