# CITY OF SANTA CLARA GEORGE F. HAINES INTERNATIONAL SWIM CENTER VISUAL OBSERVATION ASSESSMENTS REPORT

01/24/2024  
LPA Job No. 31047

**PREPARED BY**  
LPA, Inc.  
& Aquatic Design Group, Inc.  
& Simpson Gumpertz & Heger

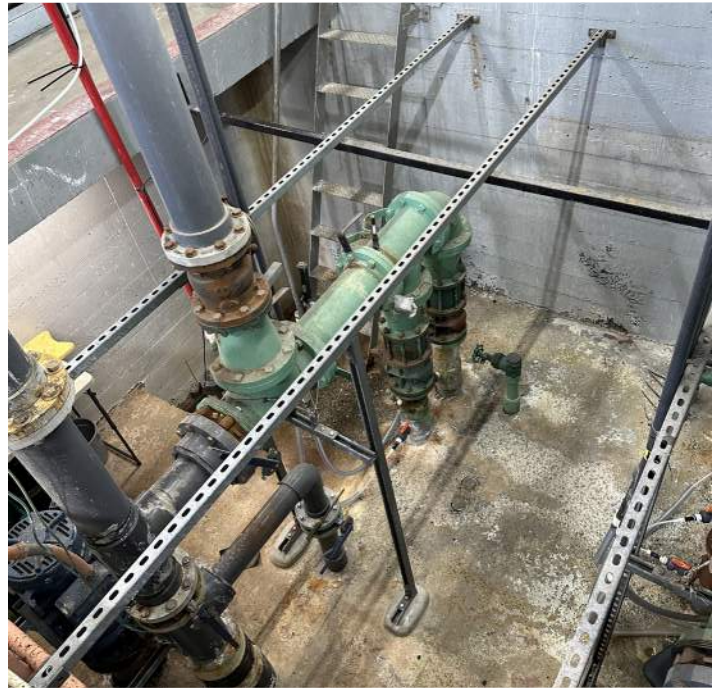
Image 2: Diving Pool Piping

- Liquid Acid (Hydrochloric Acid)
- No access to room during site visit
- **Diving Pool Suction Pipe Size and Flow Velocity**
  - Suction Pipe Size: 10-inch schedule 80
  - Suction Flow Velocity: 5.45 Feet Per Second (FPS)
- **Diving Pool Return Pipe Size and Flow Velocity**
  - Return Pipe Size: 6-inch schedule 80
  - Return Flow Velocity: 6.7 FPS

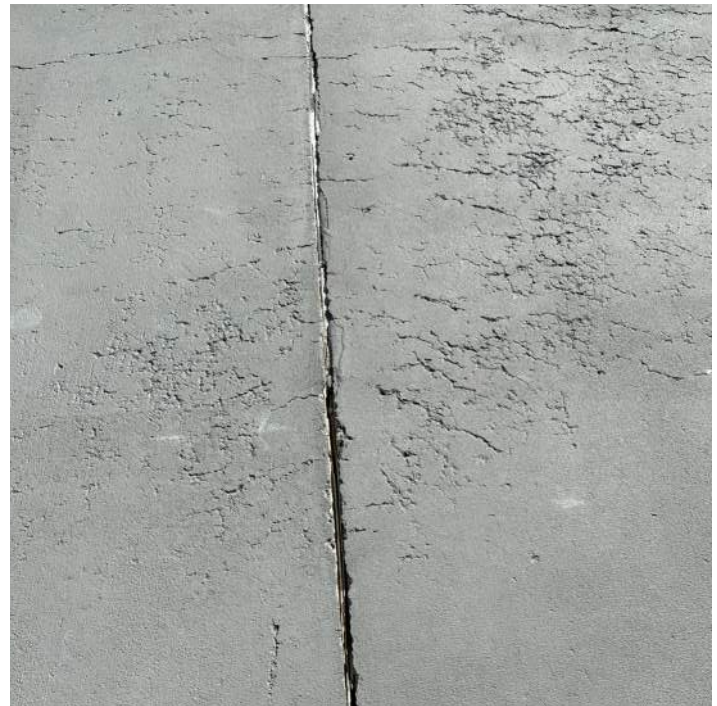
Image 18: Failing Pool Deck

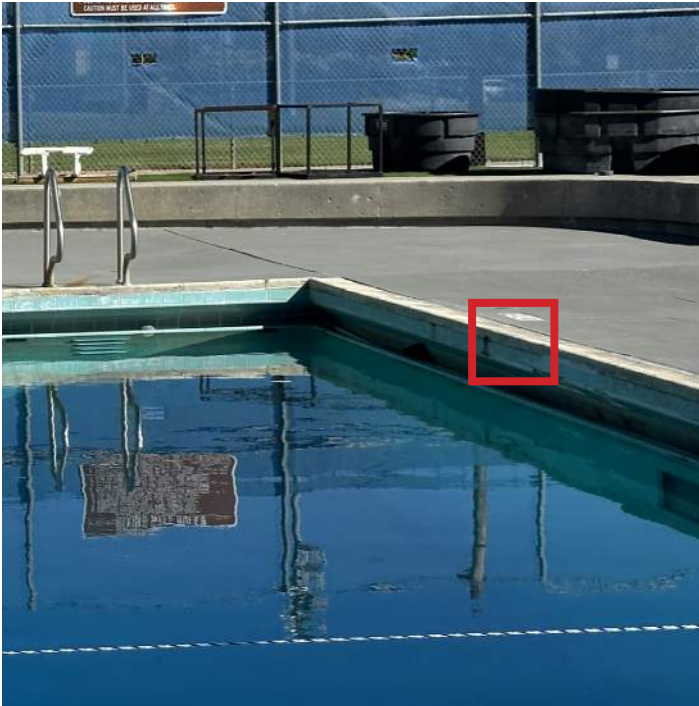
Image 19: No Waterline Depth Marker

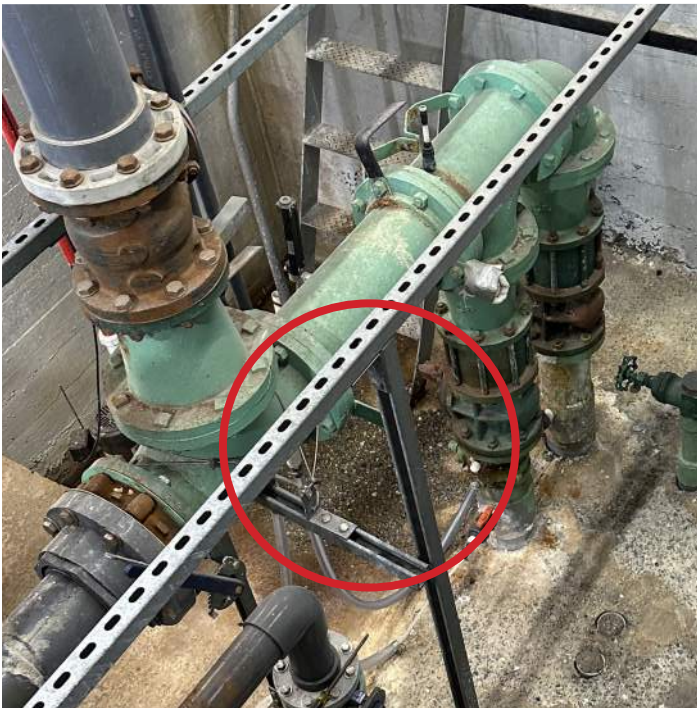
*Image 21: Evidence of Leak in Pump Pit*

**(Estimated Cost- \$100,000.00)**

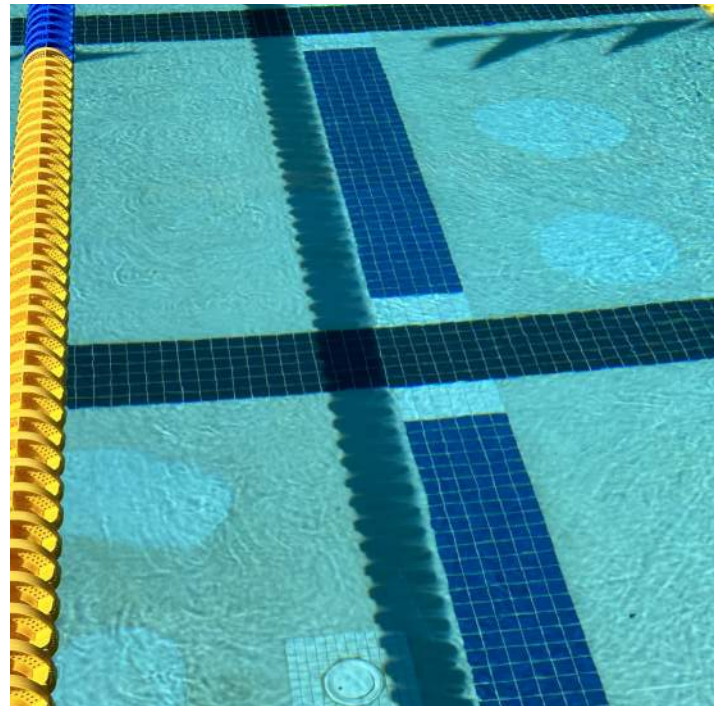
Image 22: Plaster Delaminating in 50-Meter Pool

**(Estimated Cost- \$738,000.00)**

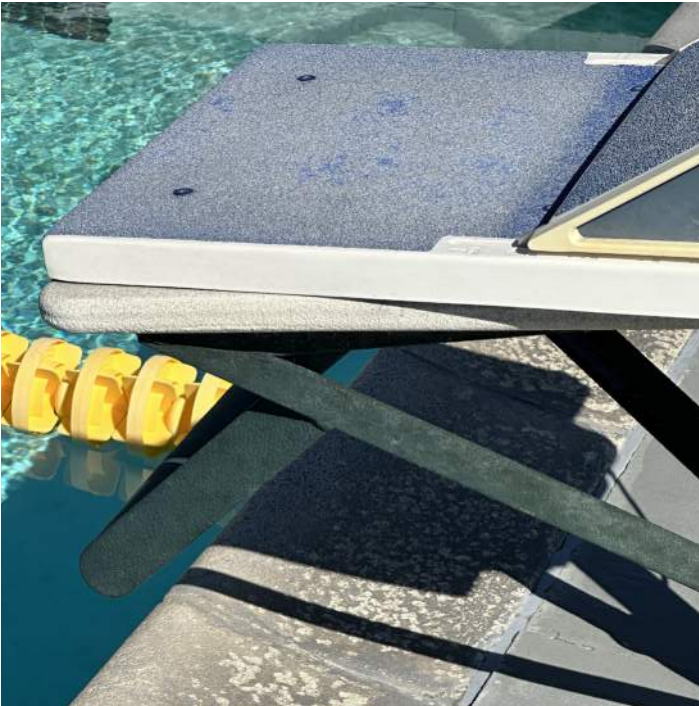
Image 23: Aging Anti-Slip Finish on Racing Platforms

**(Estimated Cost- \$40,000.00)**

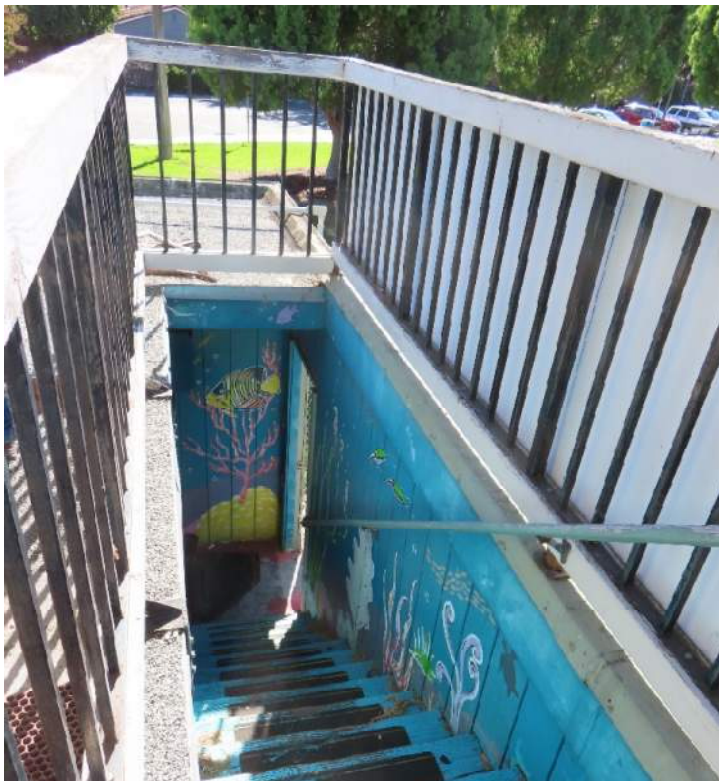
**Photo 2**

Unprotected roof openings pose a potential fall hazard to the ground level below.

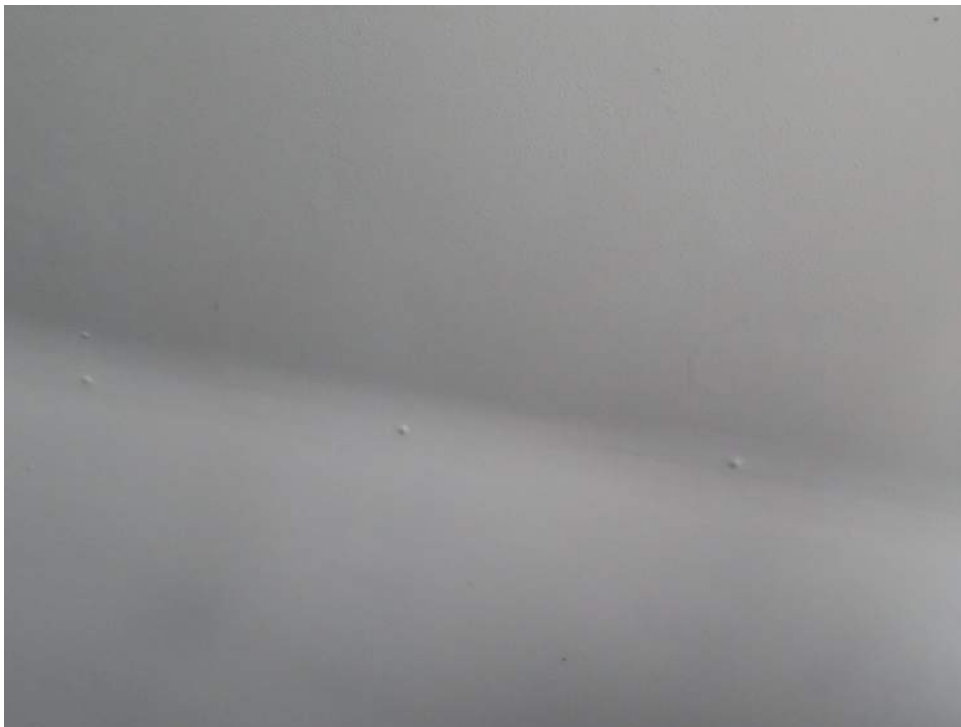
**Photo 10**

- Approximately 70% of the asphalt shingles we checked at the octagonal, steep slope roof are dislodged or inadequately adhered. Most of the asphalt shingles on the hips are dislodged, missing, or have significant granular and • The missing shingles on the hips align with the ceiling cracks, nail pops, and bubbling in the gypsum wallboard below (Appendix A, Photos 9 & 10).

Missing shingles on the roof hips align with the ceiling crack, nail pops, and bubbling in the gypsum wallboard.

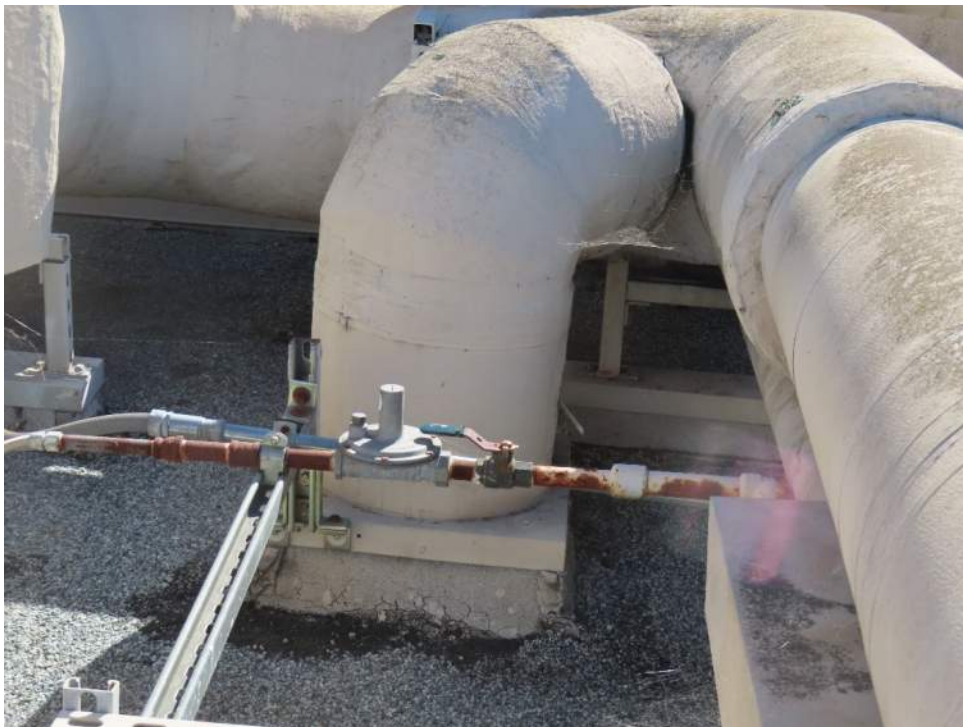
**Photo 12**

Sheet metal flashings, rooftop mechanical equipment, and other metal roof components exhibit moderate to severe corrosion.

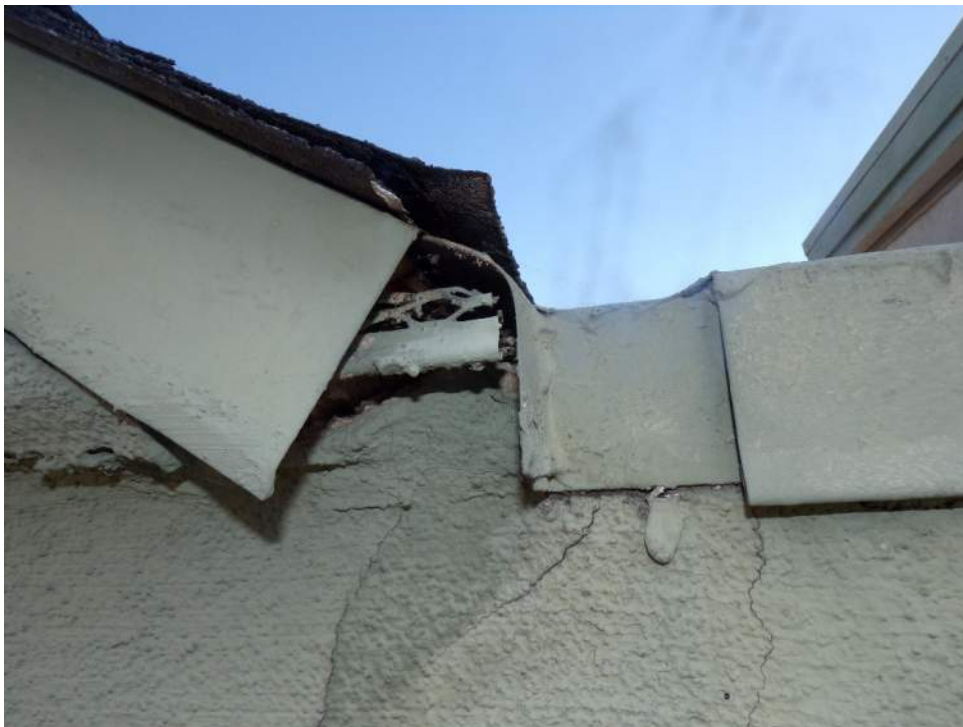
**Photo 14**

Previous sealant repairs at flashing are splitting and deteriorated.

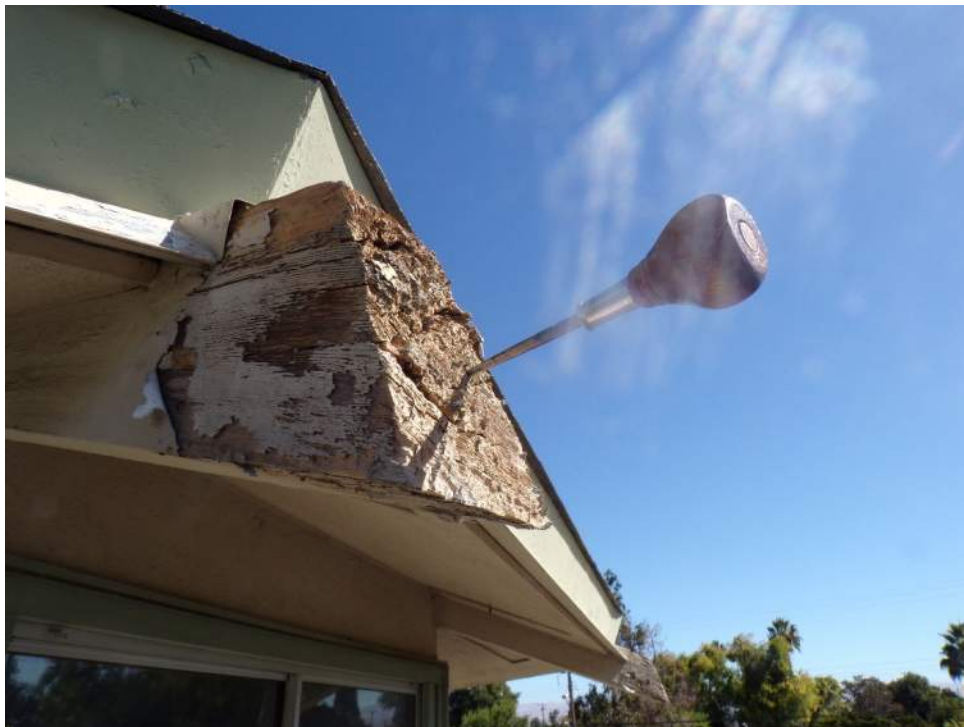
**Photo 16**

Significant wood decay at the exposed ends of common and hip rafters.

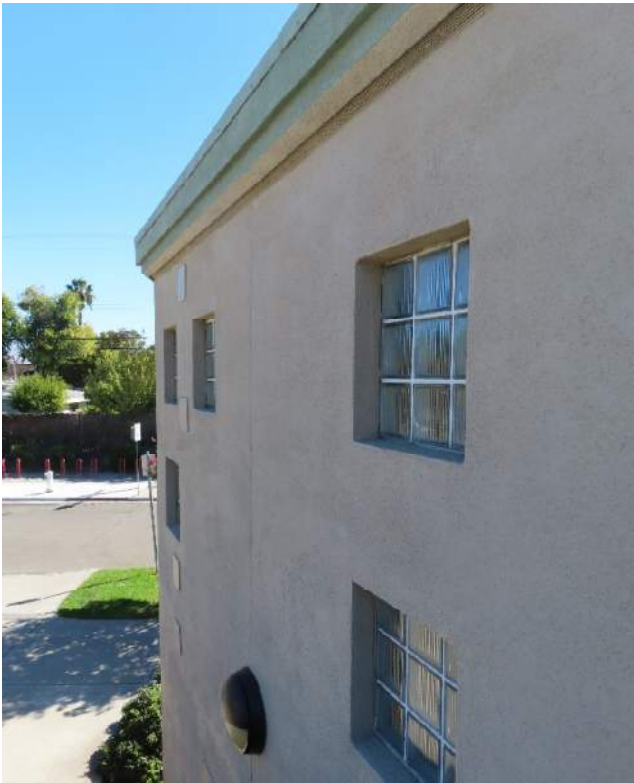
**Photo 18**

Window frames are worn  
and glazing seals are  
deteriorated.

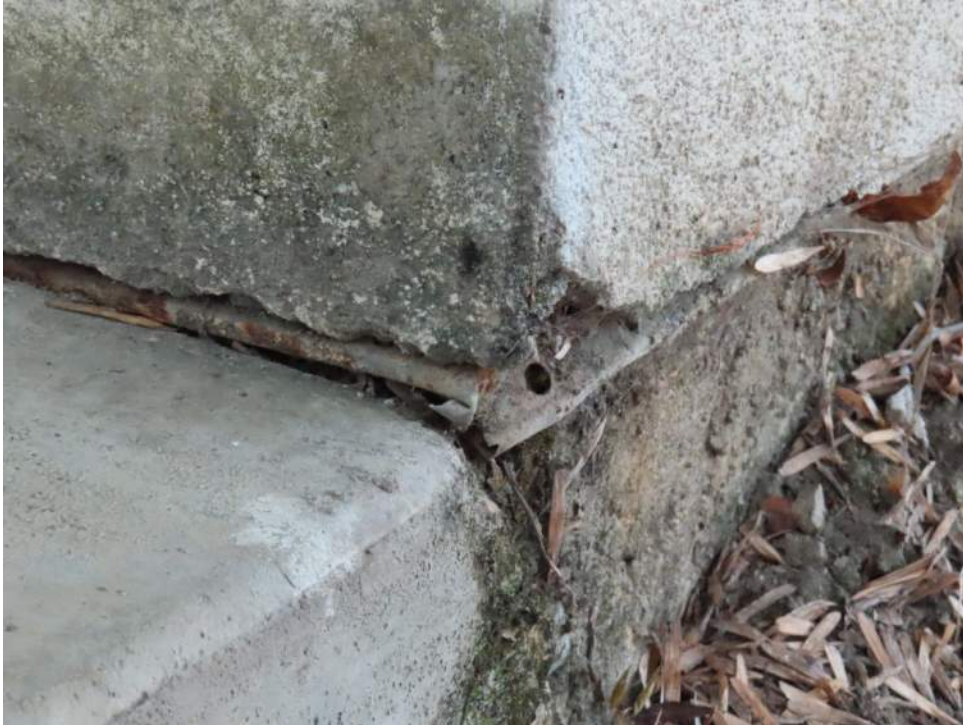
**Photo 25**

- The soil erosion behind the canopy bleachers and around the canopy tower has caused vertical offsets in the concrete walkway, excessive stucco cracks at the canopy bleacher walls (Appendix A, Photo 23) and shifted the walkway and the roof deck downspouts (Appendix A, Photo 24).
- The weep screed abuts the concrete flatwork (Appendix A, Photo 25) or is less than 4 in. from grade (Appendix A, Photo 26). Section 2512.1.2 of the 2022 CBC requires a 2 in. clearance between a weep screed and hardscape and a 4 in. clearance between a weep screed and grade. The current condition violates the code.

Soil erosion occurs around column foundations and along the concrete slab walkway. The roof deck downspouts have separated from the foundations.

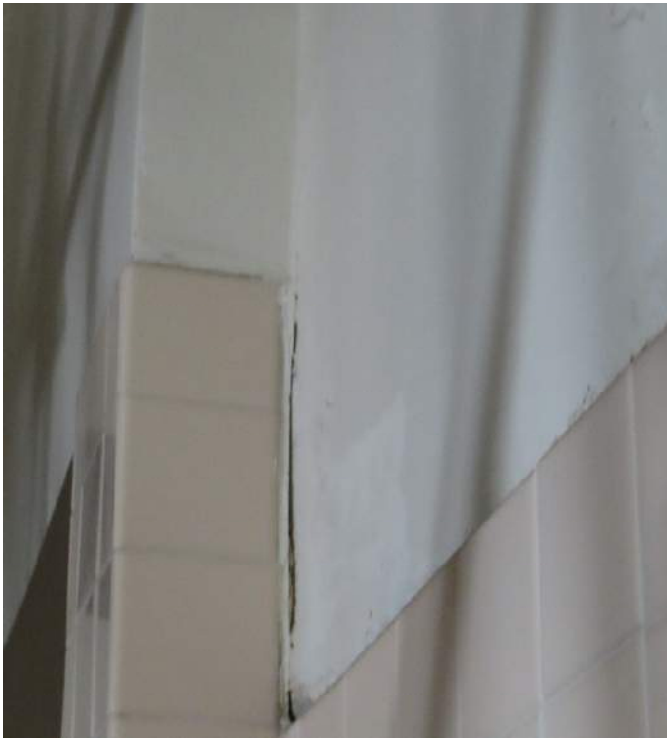
**Photo 28**

Sizeable cracks exist in the plaster ceiling and wall finishes. The location and pattern of cracking indicate wall movement.

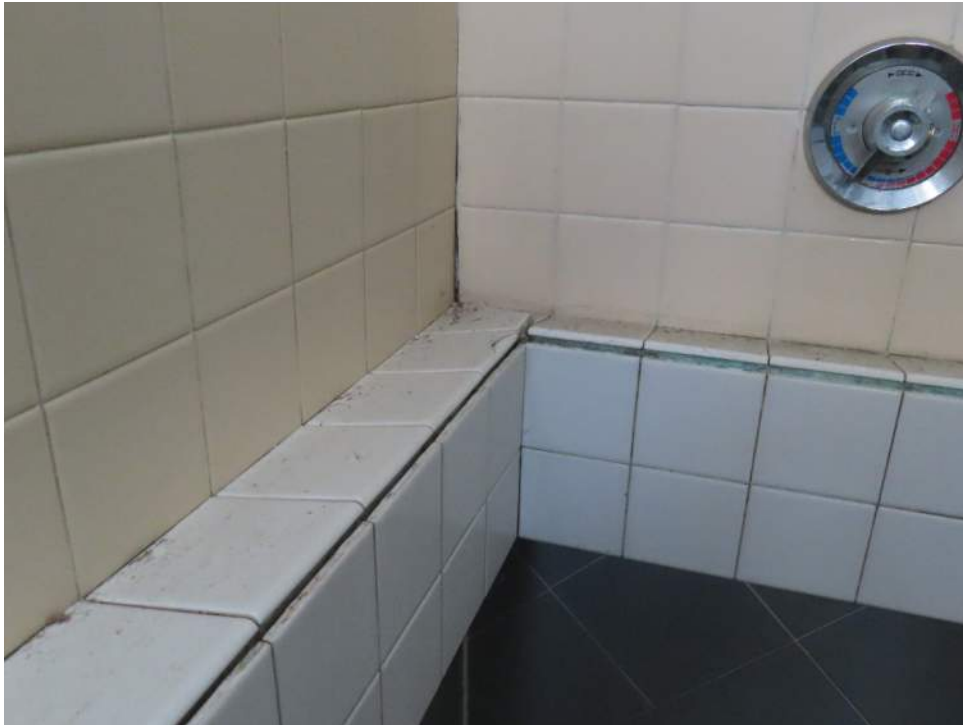
**Photo 29**

Over 1/8 in. wide cracks exist in the plaster wall finish adjacent to tile.

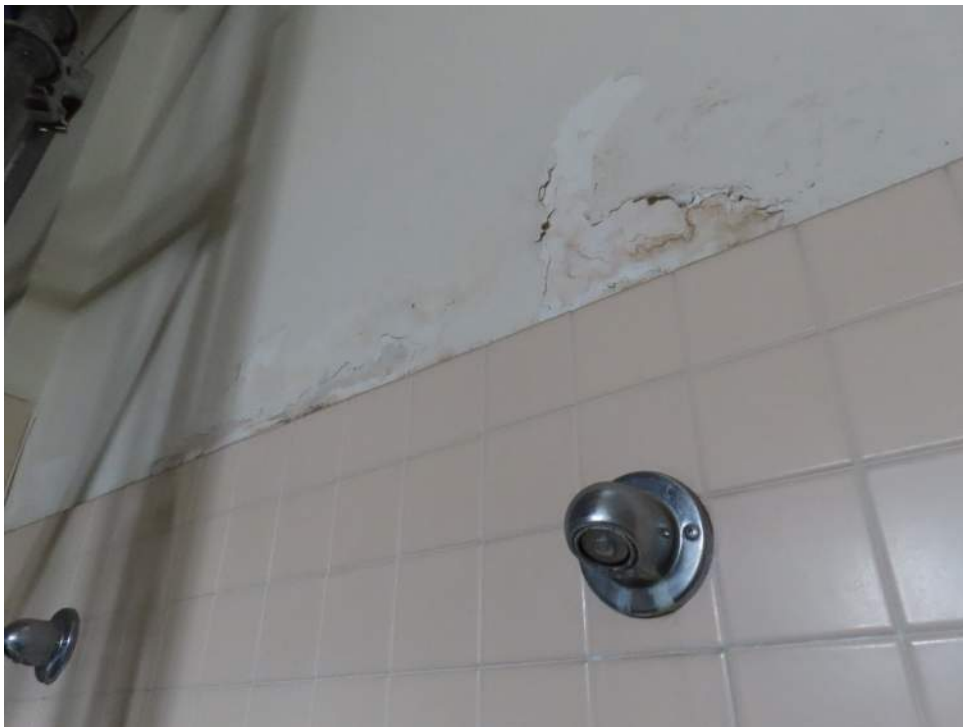
**Photo 30**

Cracks and gaps within the tile assembly particularly at inside wall corners and at tile ledges.

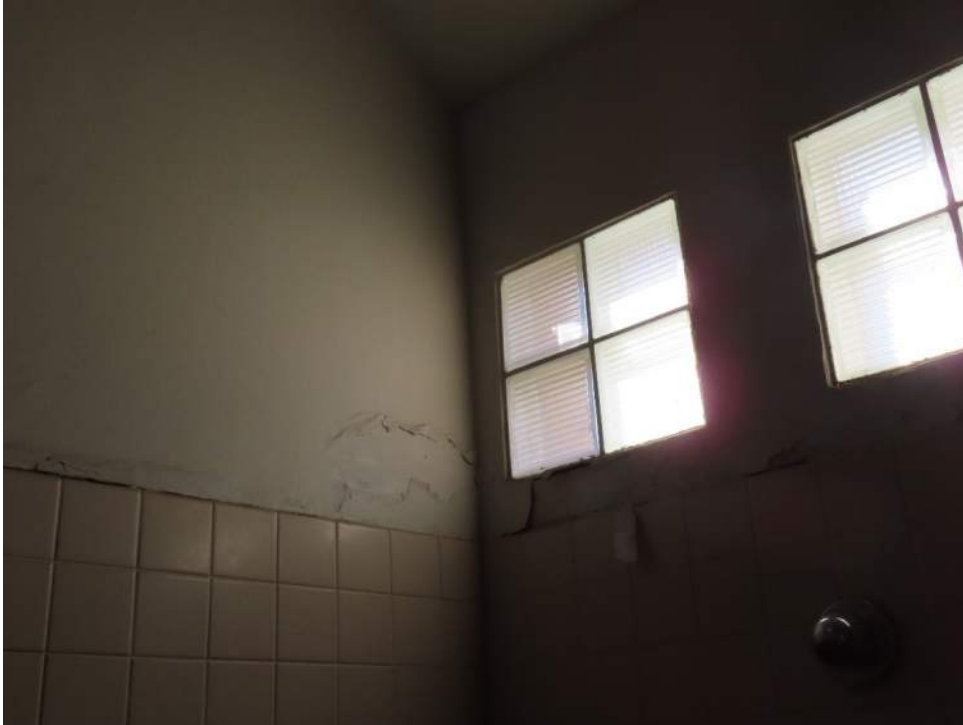
**Photo 31**

Water stains and chipped paint exist on the non-tiled portion of the shower enclosures indicative of water damage.

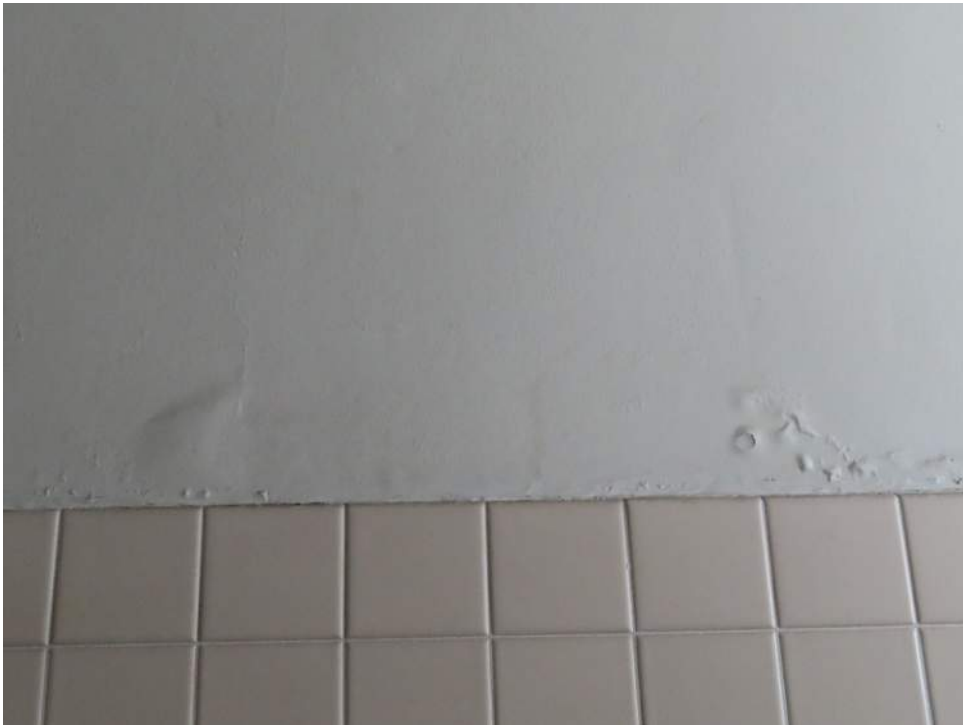
**Photo 32**

Water stains and chipped paint exist on the non-tiled portion of the shower enclosures.
