March 17, 2023

Re: **Structural Observation Summary**
1957 Pruneridge Avenue – Church Structure
Santa Clara, CA

The following paragraphs summarize the scope and resulting comments of our structural observation of the church structure located at 1957 Pruneridge Avenue in Santa Clara, California on 3/2/23.

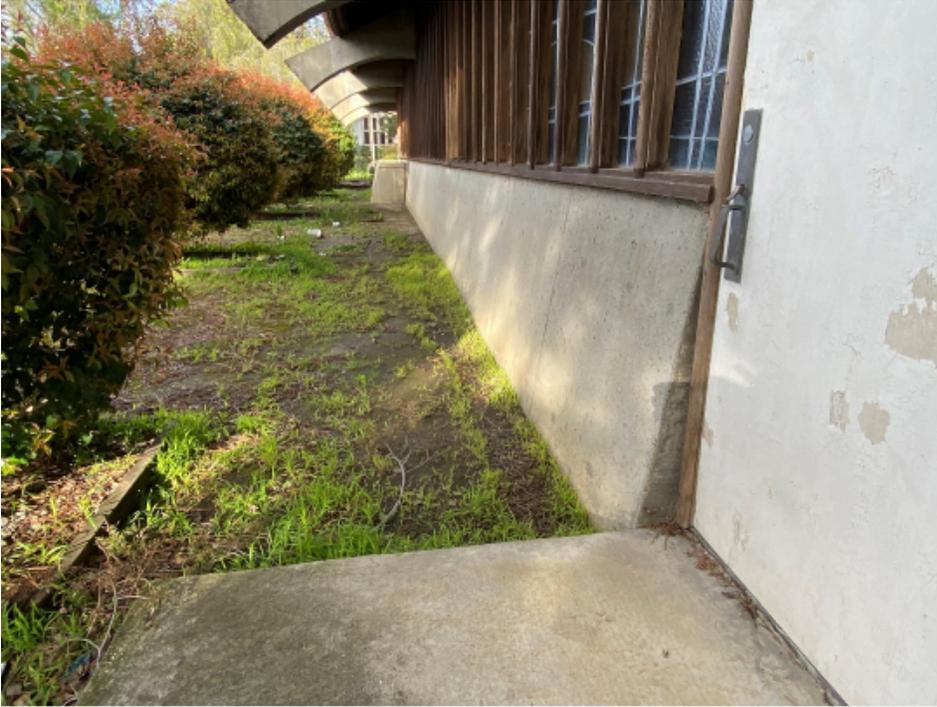
Photo 3: Battered partial height concrete wall along South face (North same)

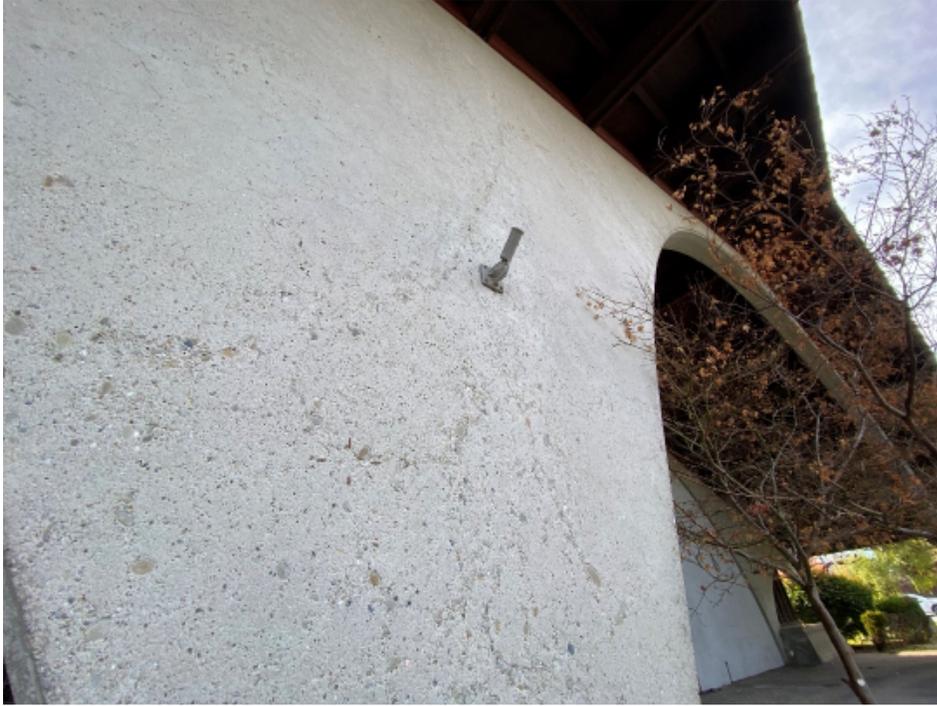
1. Pitting and cracking of exposed precast concrete arches was observed at the noted locations at the West side of the building and periodically elsewhere.
 - See Photo 7 in *Attachment B*.
2. Cracking at the partial height battered retaining wall was observed periodically along the North and South sides of the building.
 - See Photo 8 in *Attachment B*.
3. Web pattern cracking of exposed precast concrete arches was observed at the noted locations at the East side of the building and periodically elsewhere.
 - See Photos 9 & 10 in *Attachment B*.
4. Cracking across exposed precast concrete arches was observed at the noted locations at the East side of the building and periodically elsewhere.
 - See Photos 11 & 12 in *Attachment B*.
5. Pitting and cracking of interior precast concrete arches was observed at the noted locations and periodically elsewhere.
 - See Photo 14 in *Attachment B*.

Photo 7: Localized pitting and cracking of exterior arch at West side

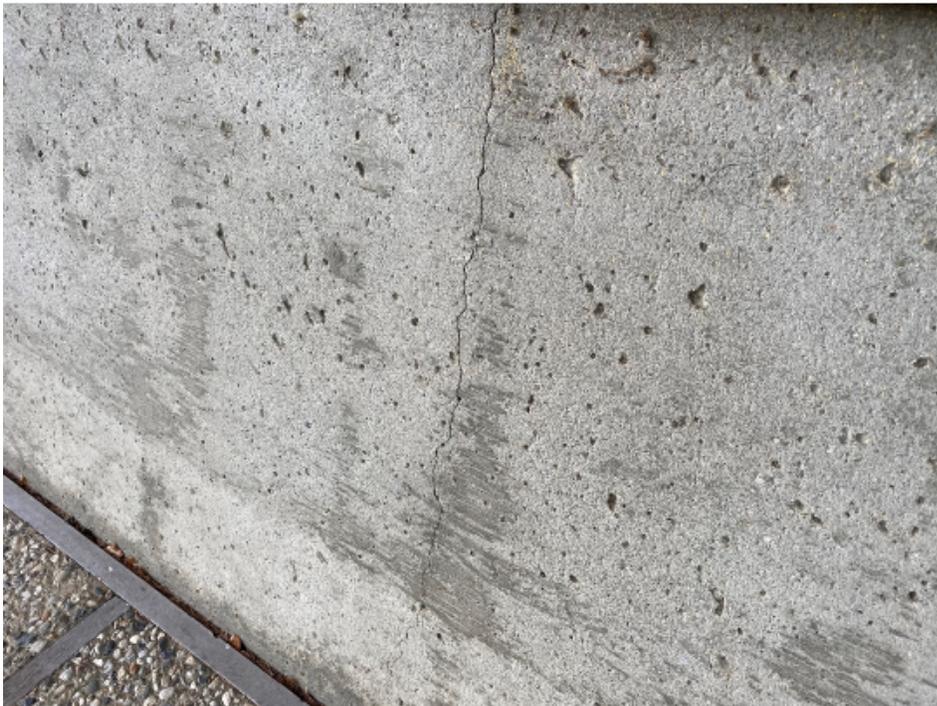
Photo 8: Periodic cracking at partial height battered concrete walls

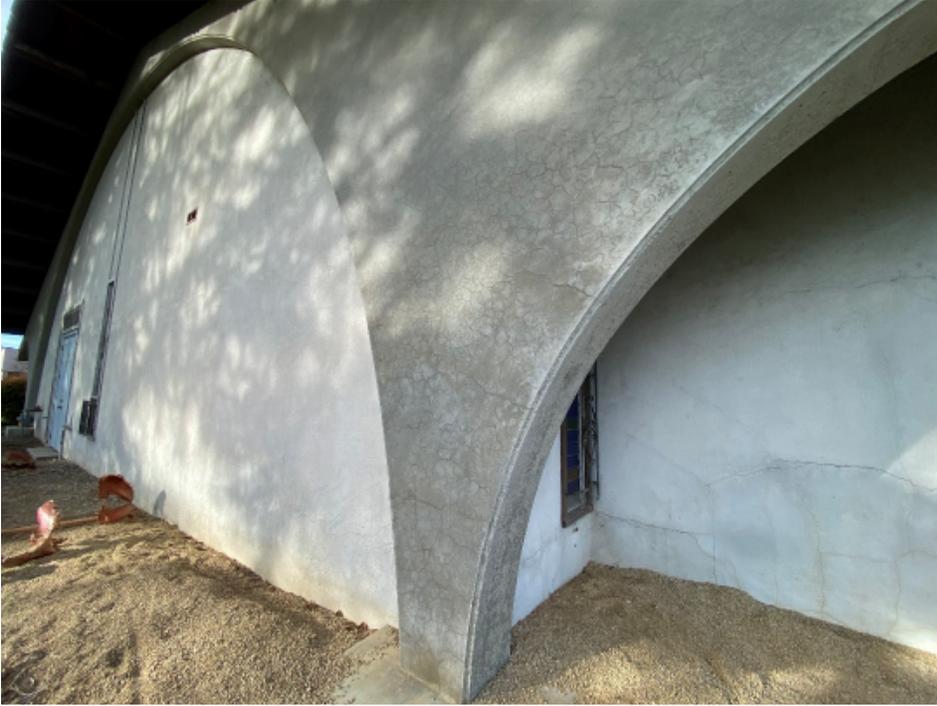
Photo 9: Webbed cracking at South side exposed precast arch

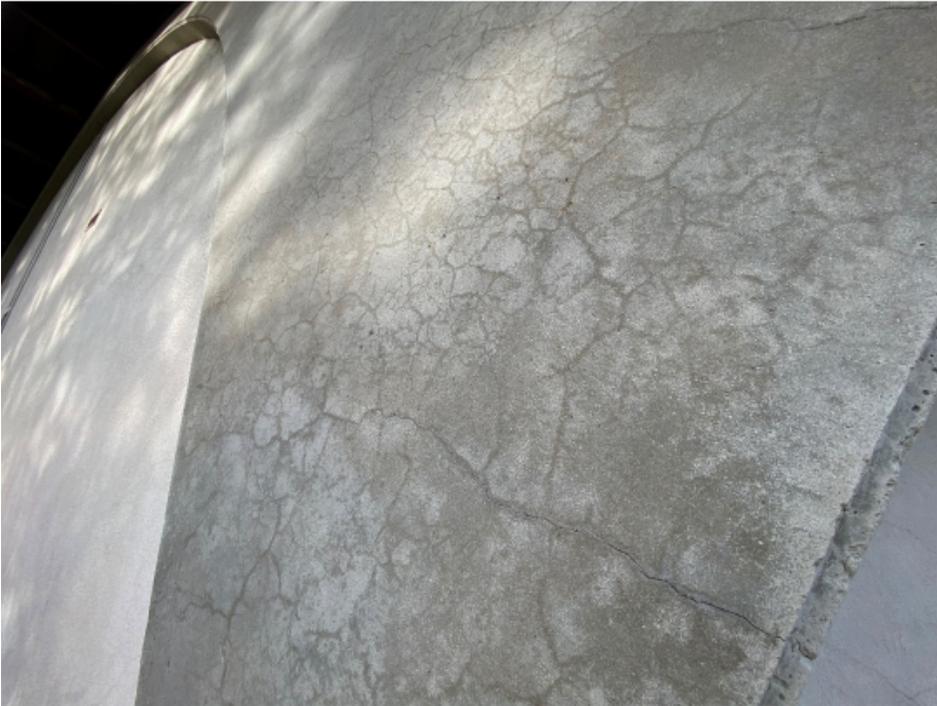
Photo 10: Webbed cracking at South side exposed precast arch

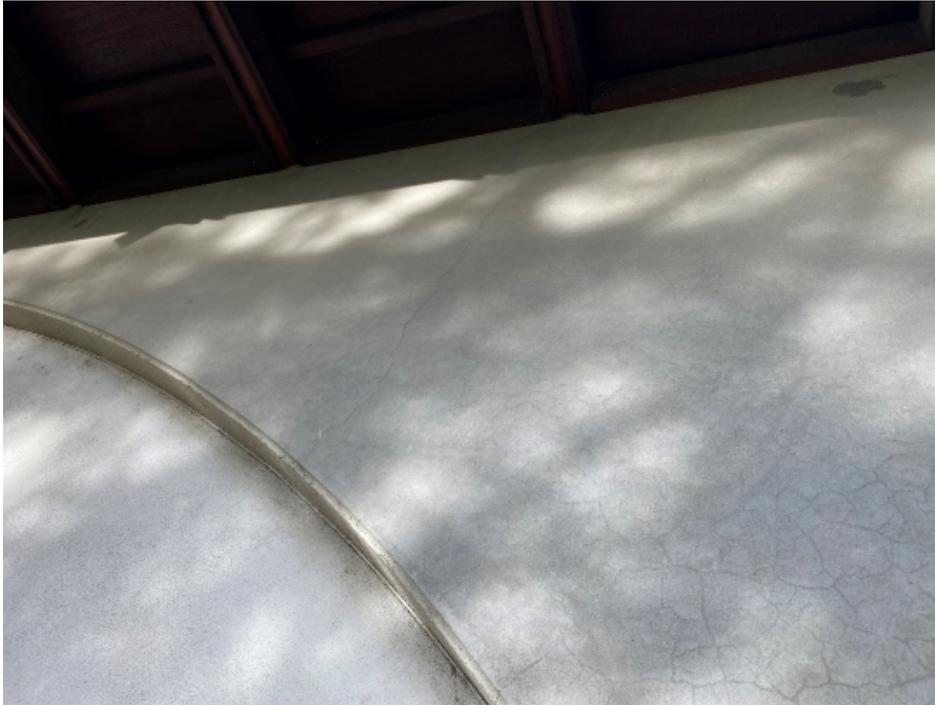
Photo 11: Cracking across exposed precast arch at South side

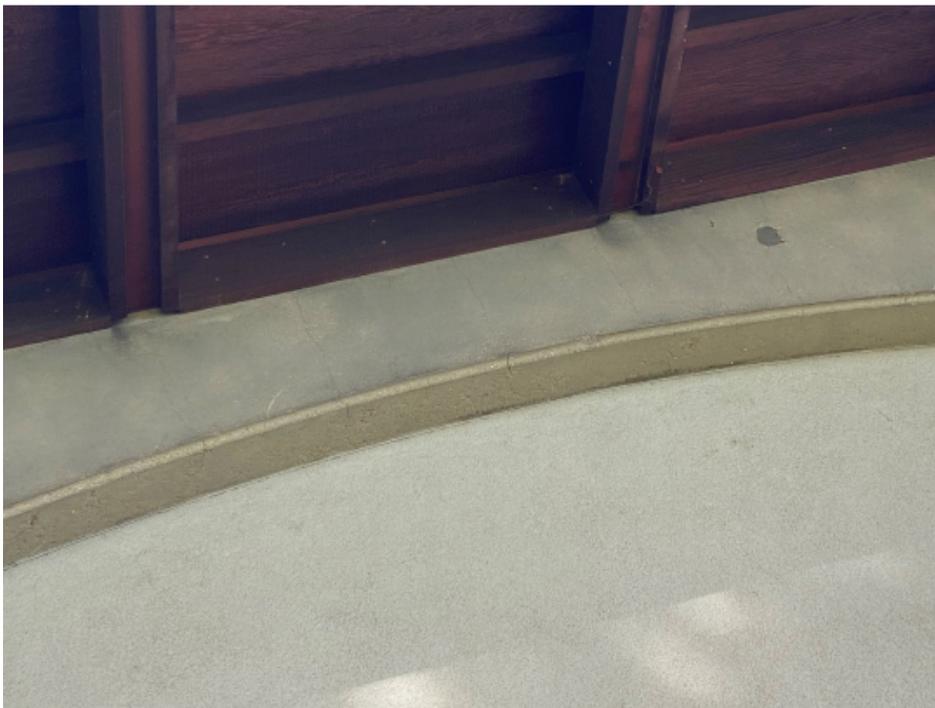
Photo 12: Cracking across exposed precast arch at South side

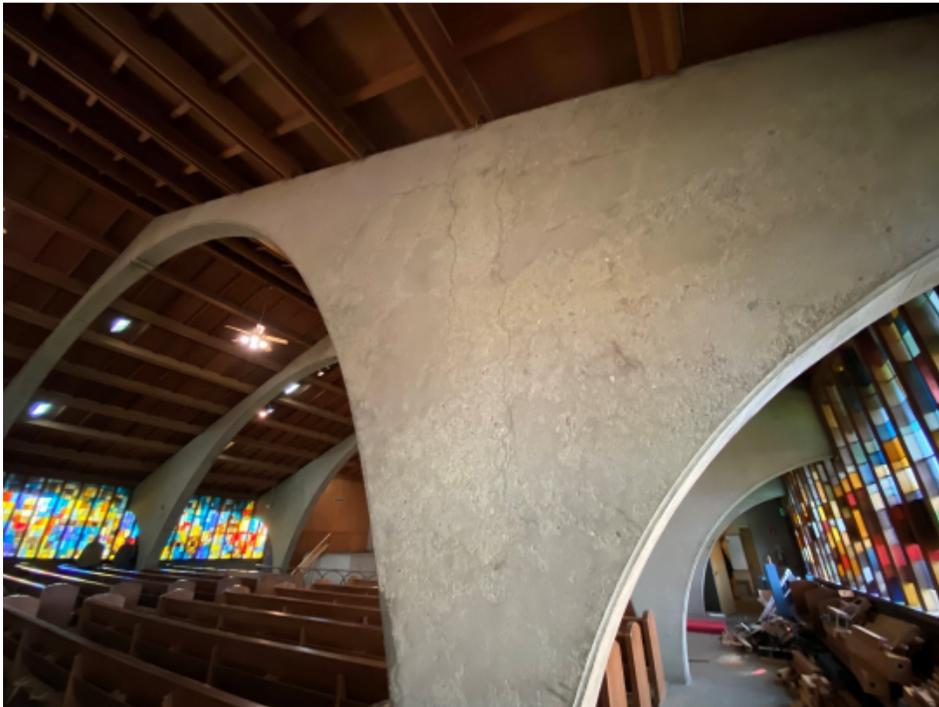
Photo14: Cracking and pitting at interior precast arch
