**Project Proposal**  
**1411 Lewis Street and 1444 Madison Street**  
**Santa Clara, California**

# **MADISON AND LEWIS STREET PROJECT DESCRIPTION**

**Location: 1411 Lewis Street and 1444 Madison Street**

**March 5, 2018**

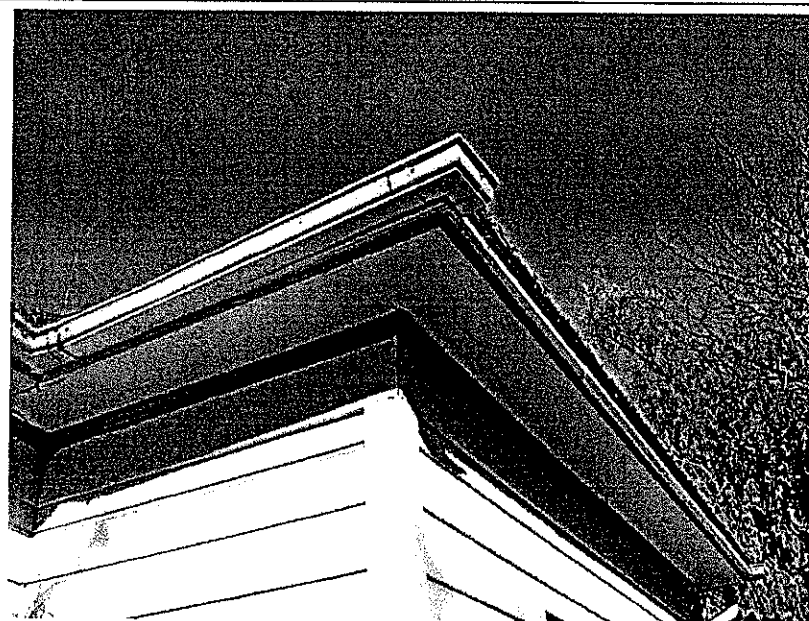
Photo 6: Detail of eaves showing deterioration.

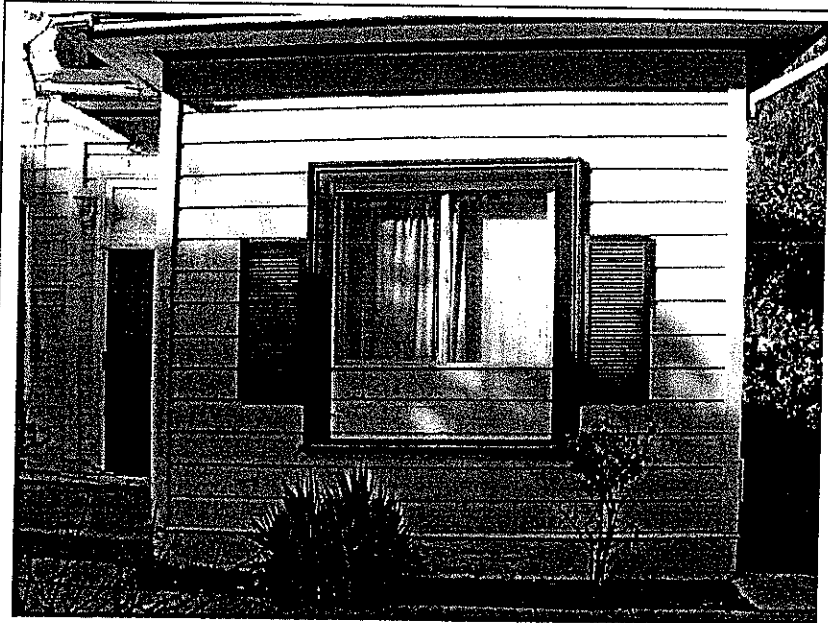
Photo 7: Detail of windows resized and replace with vinyl.

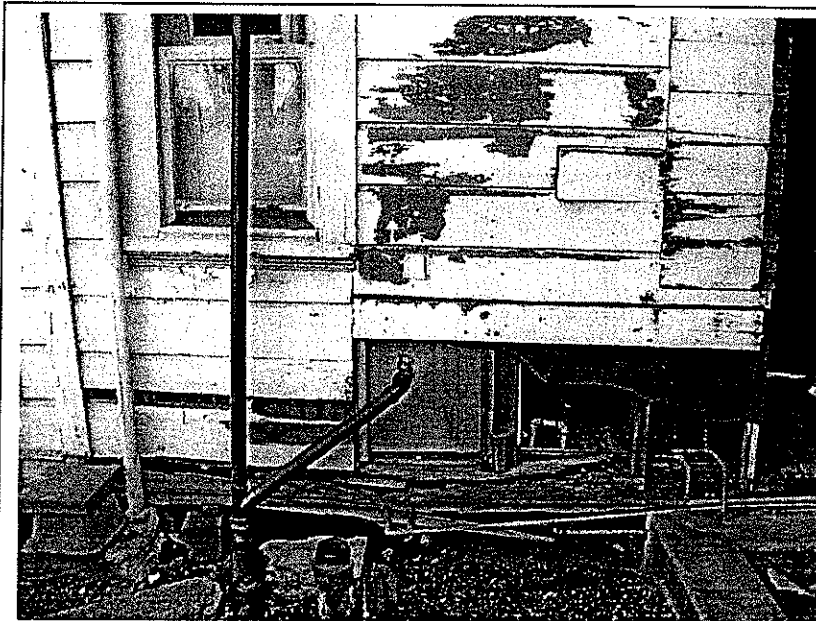
Photo 13: Detail of extensive damage and deterioration on addition.

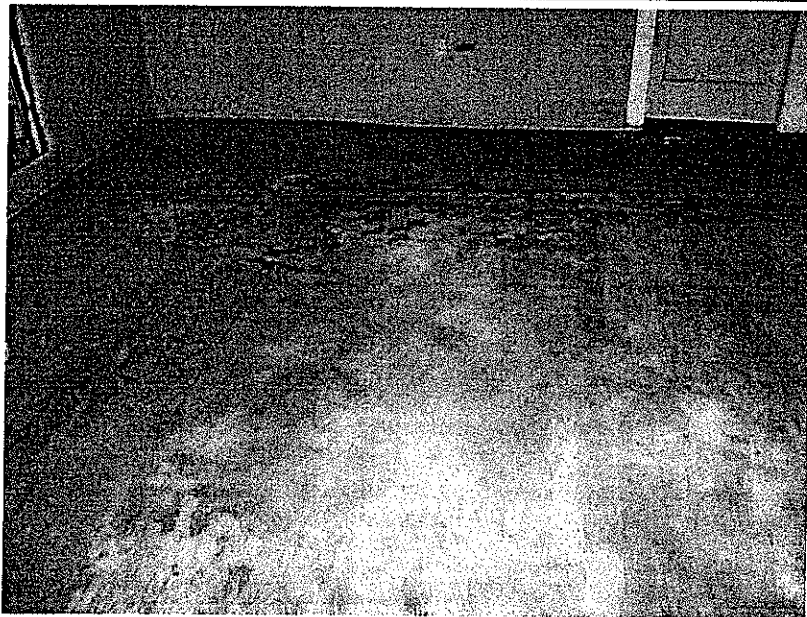
Photo 18: Detail of the stripped and damage flooring in the living room.

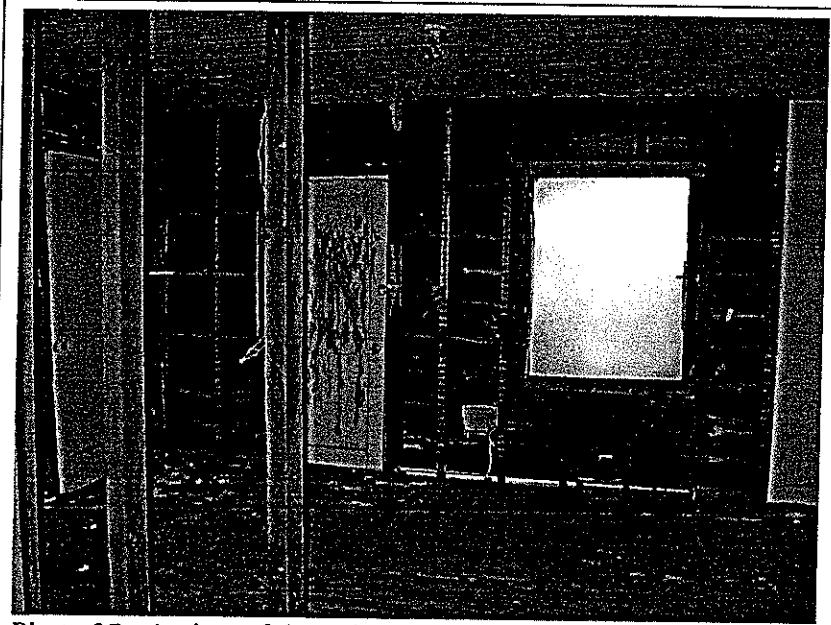
Photo 27: A view of the stripped interior of the western addition.

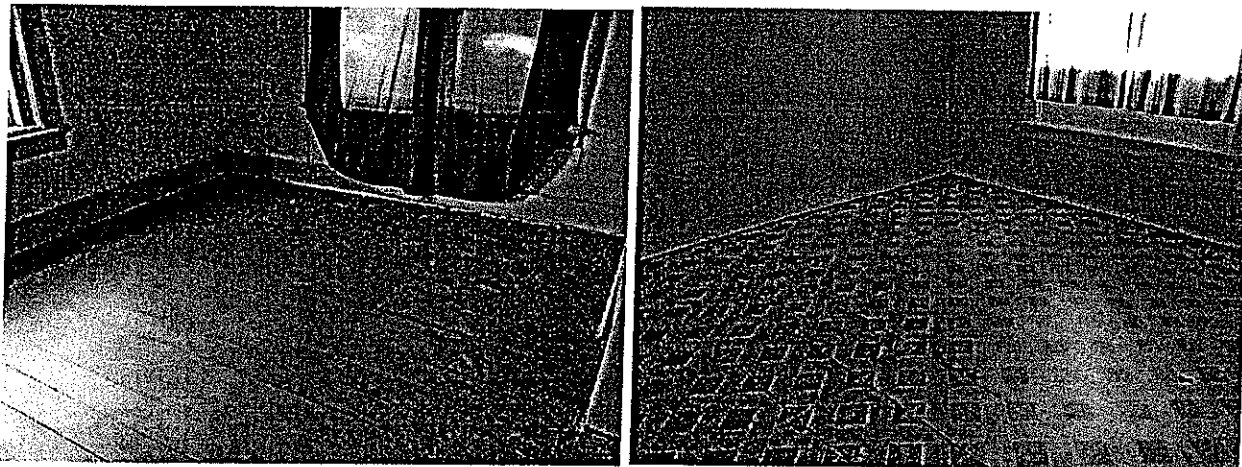
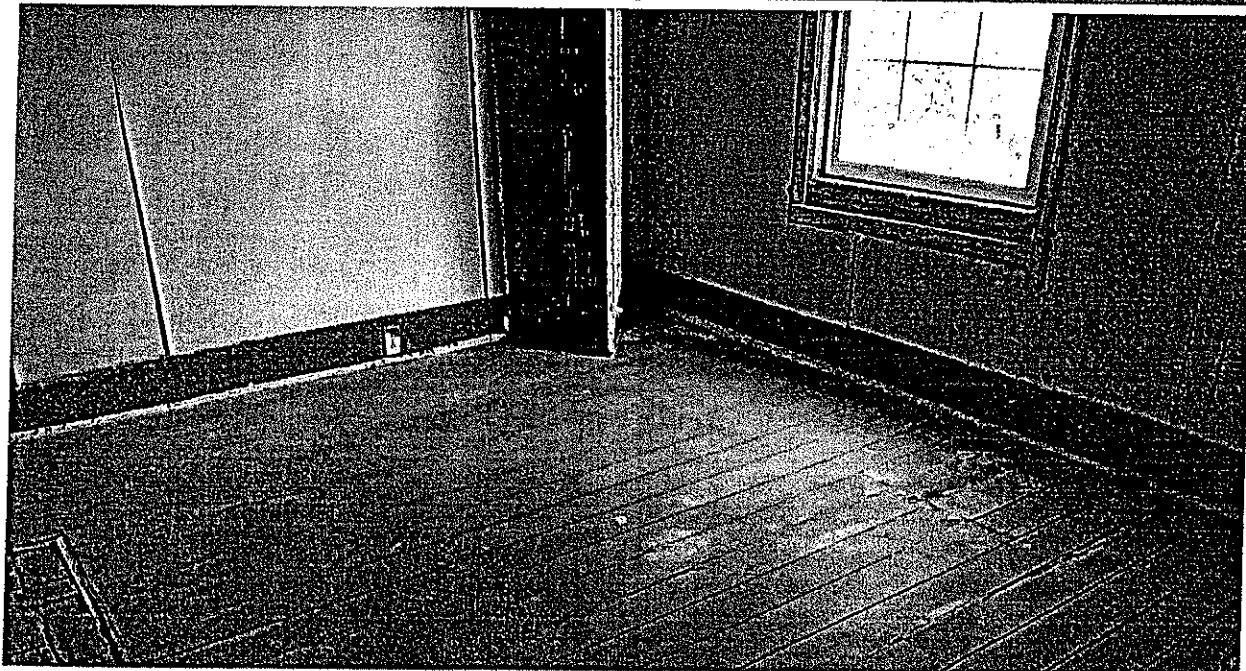
Typical of every room in the house, there is a readily observable slope in the floor towards the exterior walls. It is our opinion that the lack of a concrete foundation had allowed the wood supporting posts to subside into the soil. Since posts along the exterior of the structure are exposed to a soil that tends to have more moisture than that found near the interior of the house, we would expect those post to subside at a faster rate. We also observed significantly sagging in the floor near the pocket door at the common wall at the addition to the left of the structure.

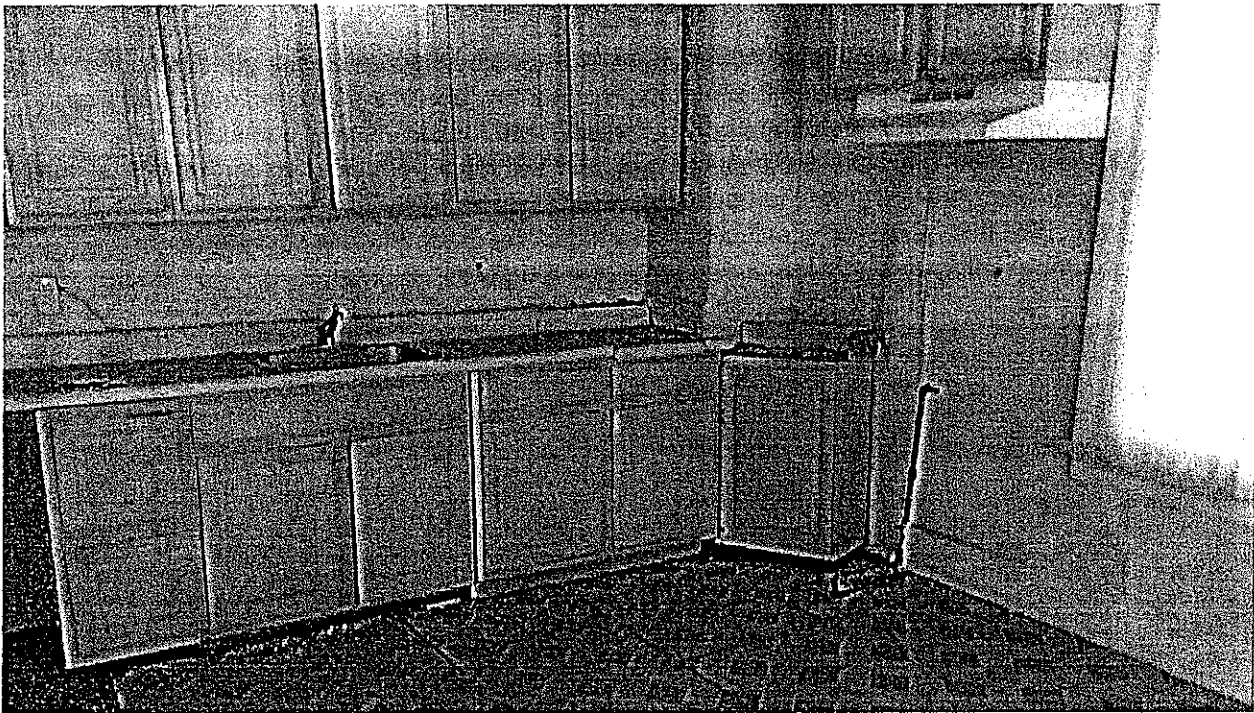
The wall and floor of the kitchen near the chimney have sagged several inches. It is our opinion that the chimney had been poorly founded and has subsided considerable thus dragging the adjacent floor and wall down with it. Interestingly, the exterior of the house near the same chimney is not experiencing the same distress, which suggests the chimney might not be positively connected to the exterior wall.

*Figure 4: Kitchen looking toward chimney.*

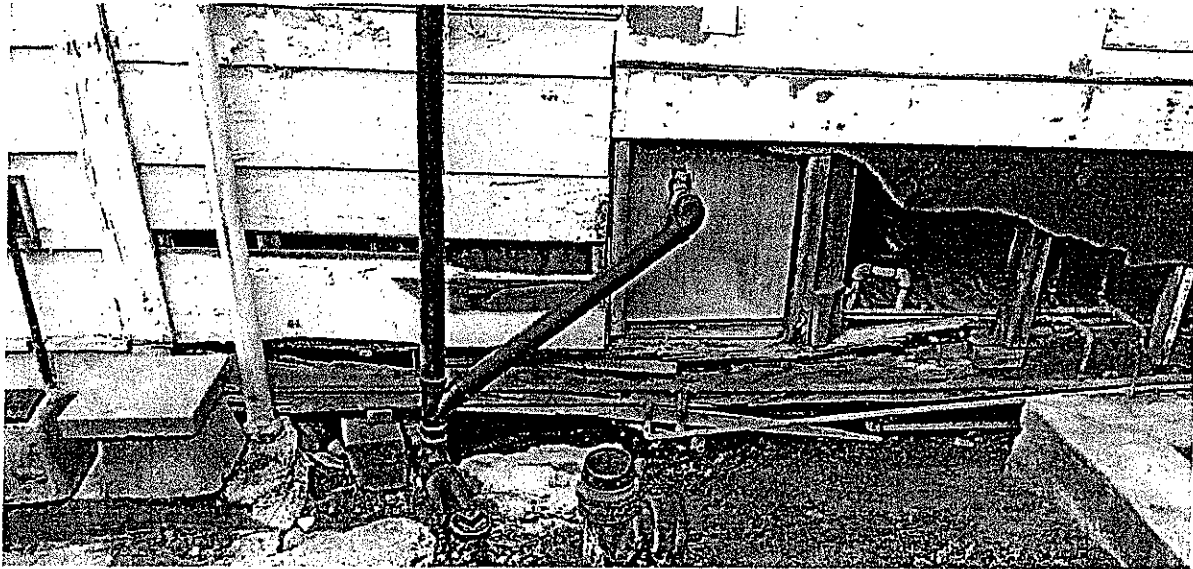
A large portion of the rear foundation area of the structure was open due to missing siding along the rear of the house at the ground level. Severe termite damage was apparent on all of the wood framing members at the edge of the floor.

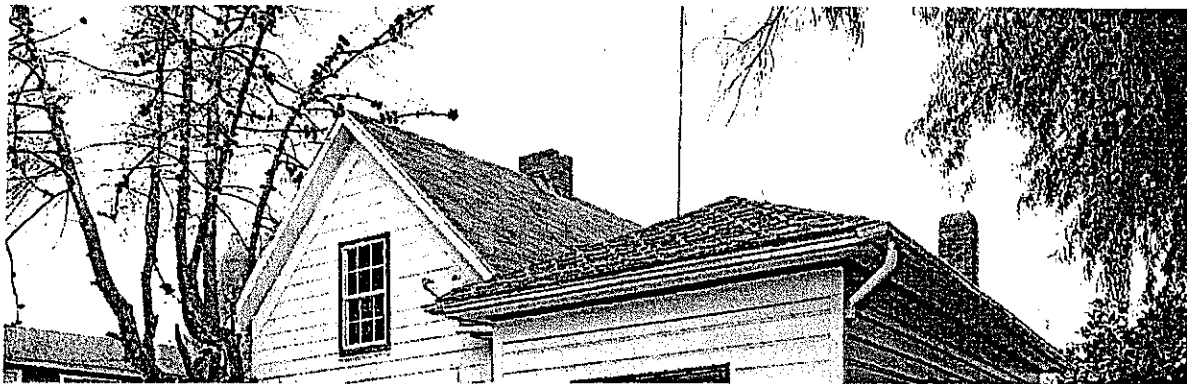
The roof has several layers of composite shingles. The edges look quite weathered and perhaps even attacked by mold. Despite the deterioration at the edges, the roof lines still appear straight which indicates that the framing underneath is likely sound. We did not observe any sagging in the roof with is an obvious sign of persistent water penetration.

*Figure 5: Main roof and kitchen addition.*

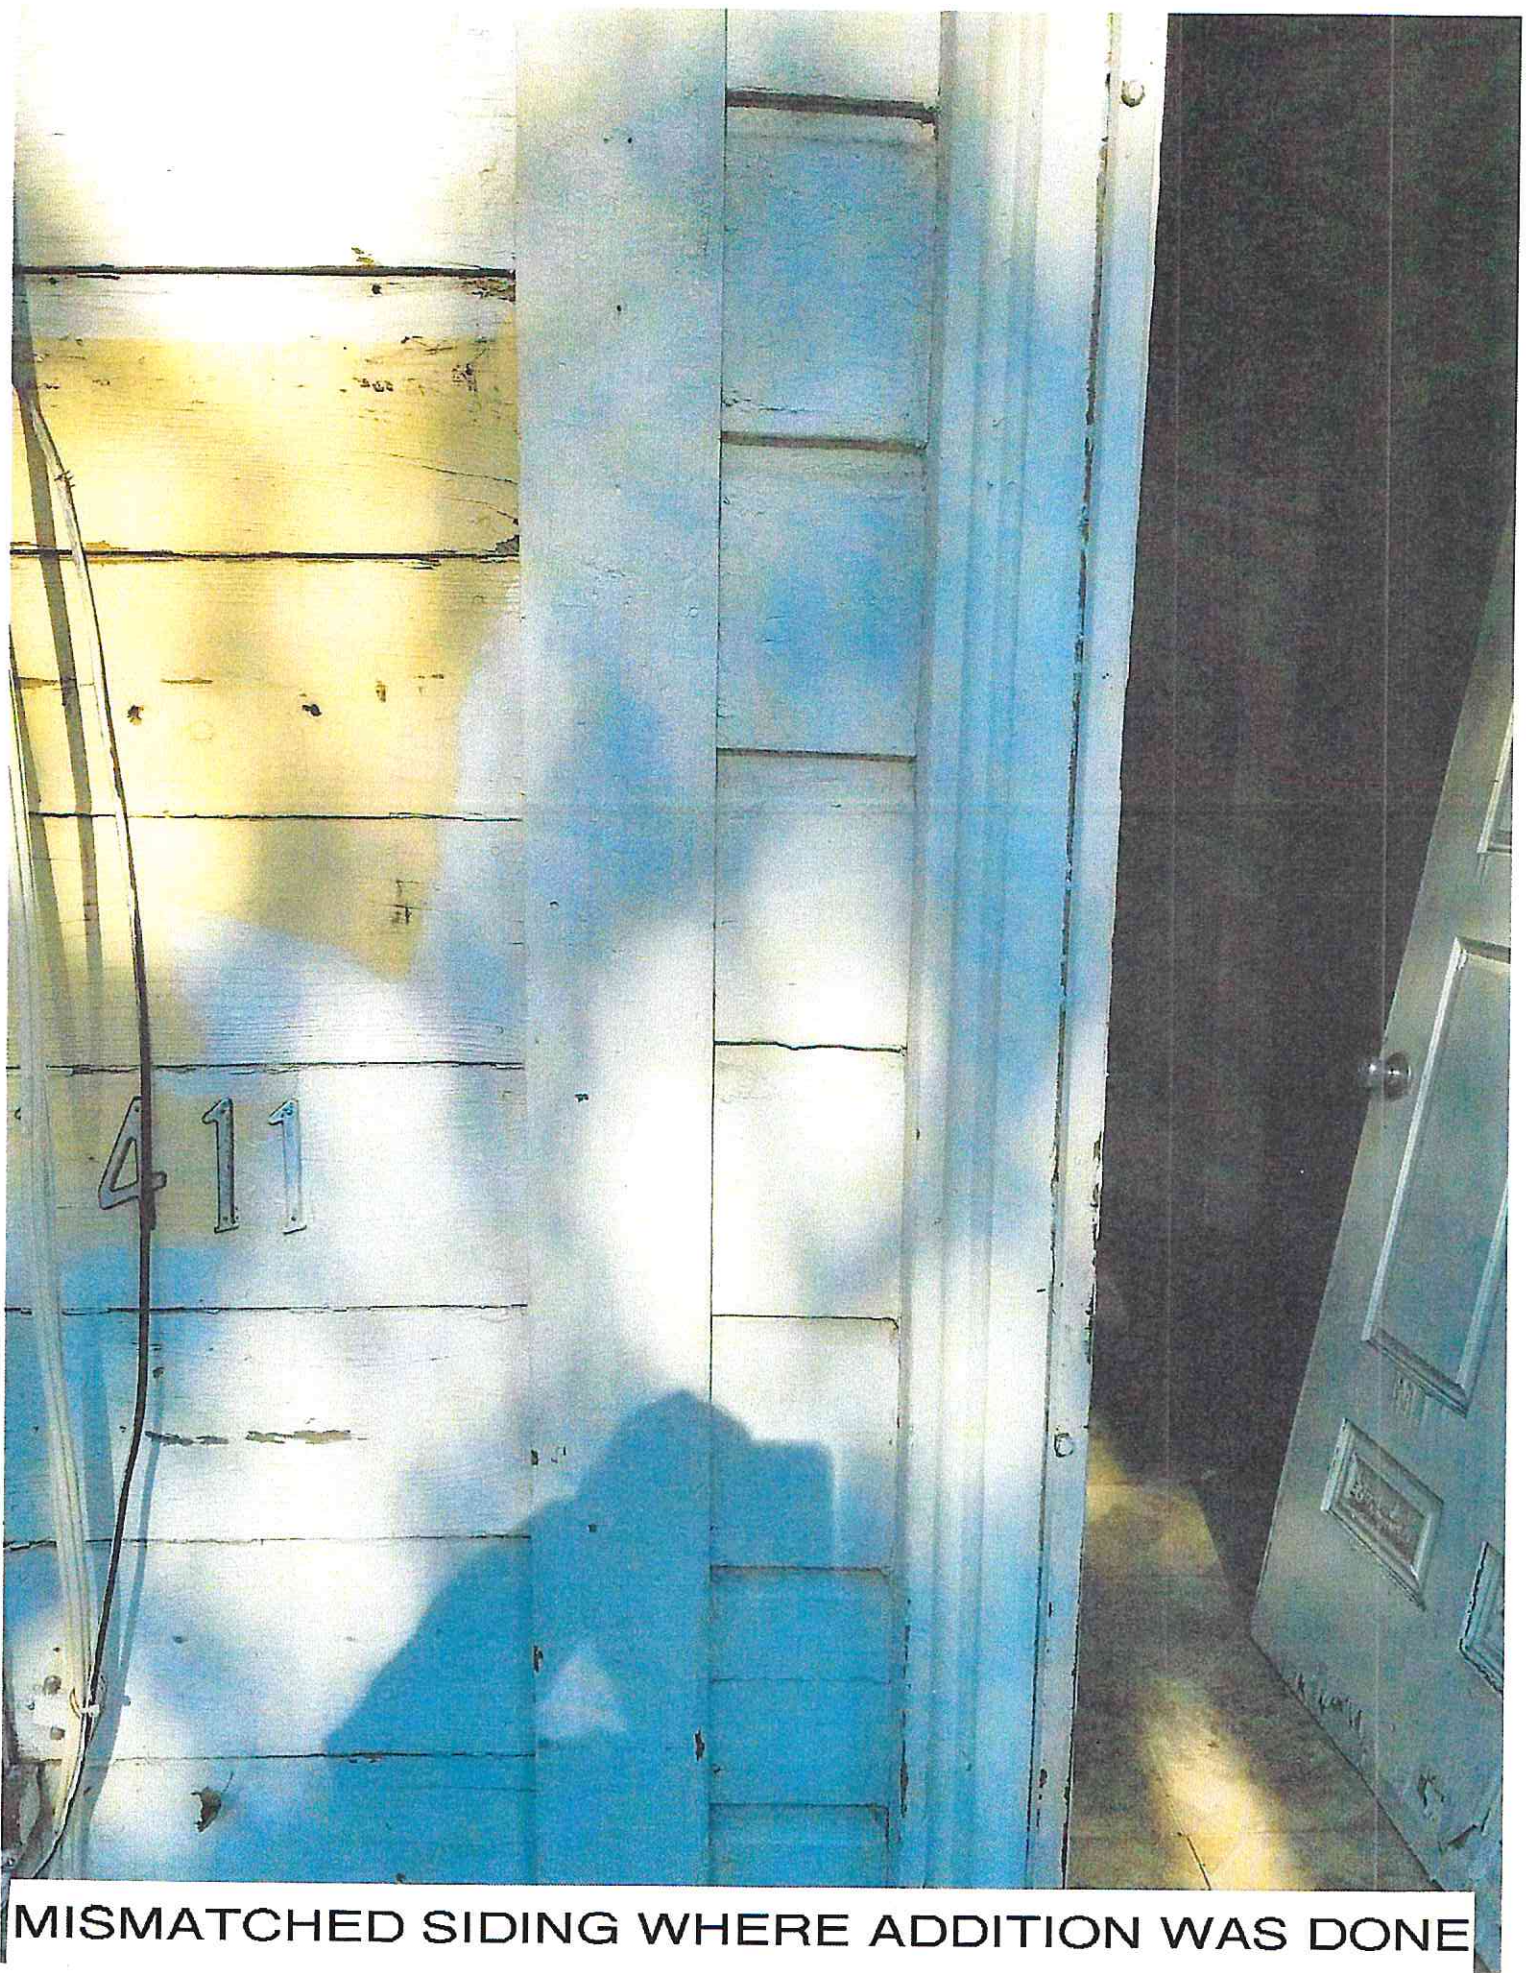
MISMATCHED SIDING WHERE ADDITION WAS DONE

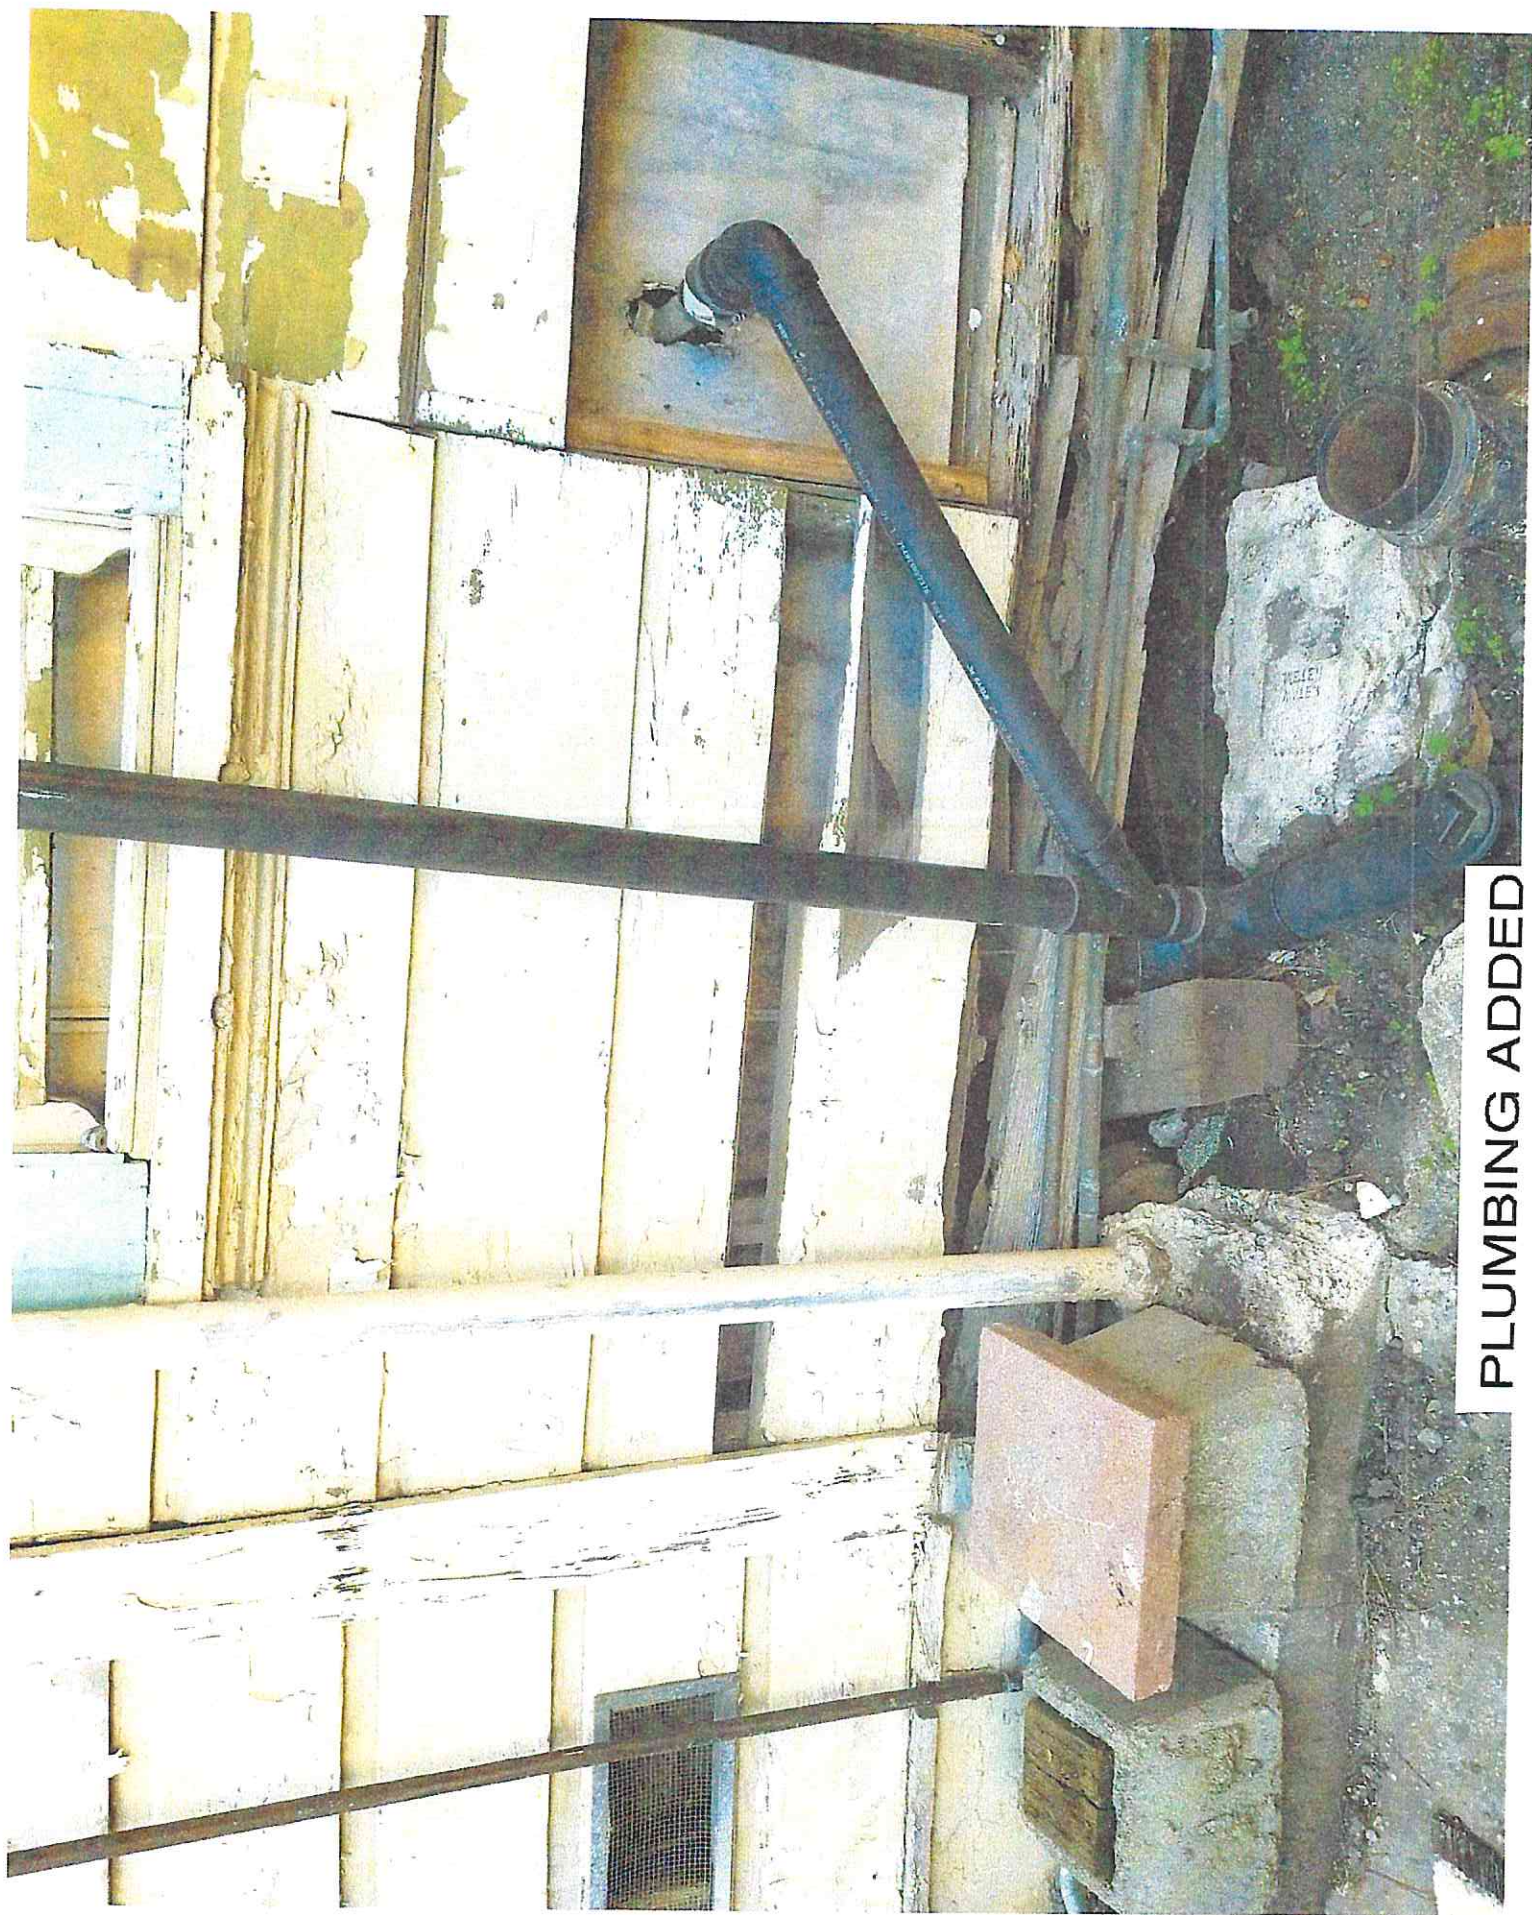
PLUMBING ADDED

DETERIORATED FRAMING, SIDING AND FOUNDATION

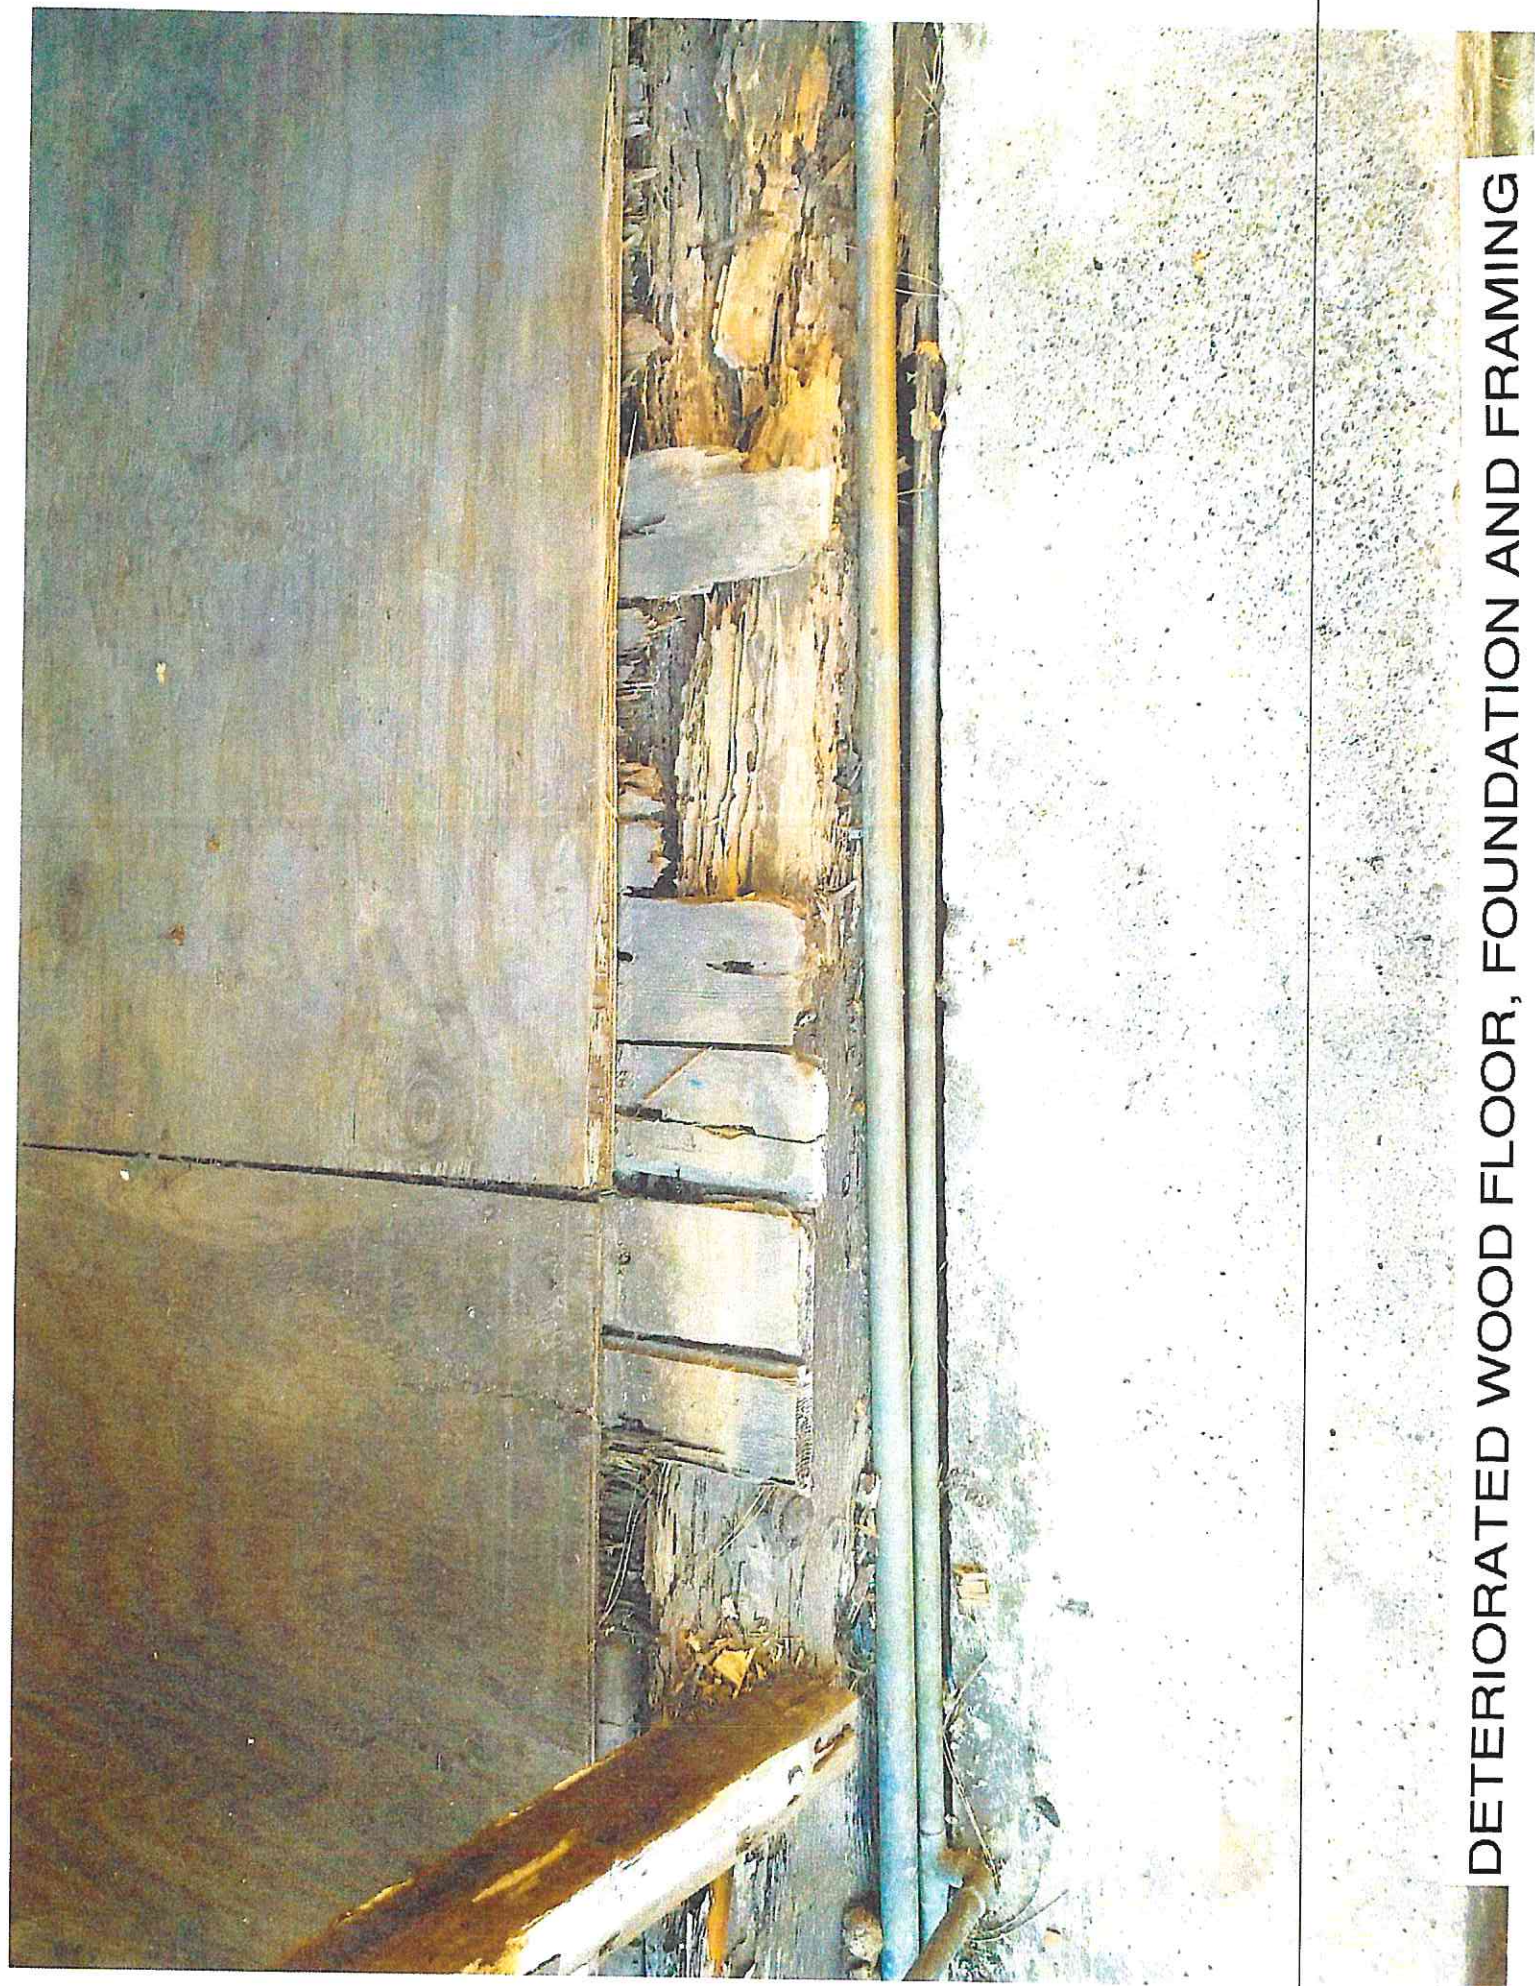
DETERIORATED WOOD FLOOR, FOUNDATION AND FRAMING

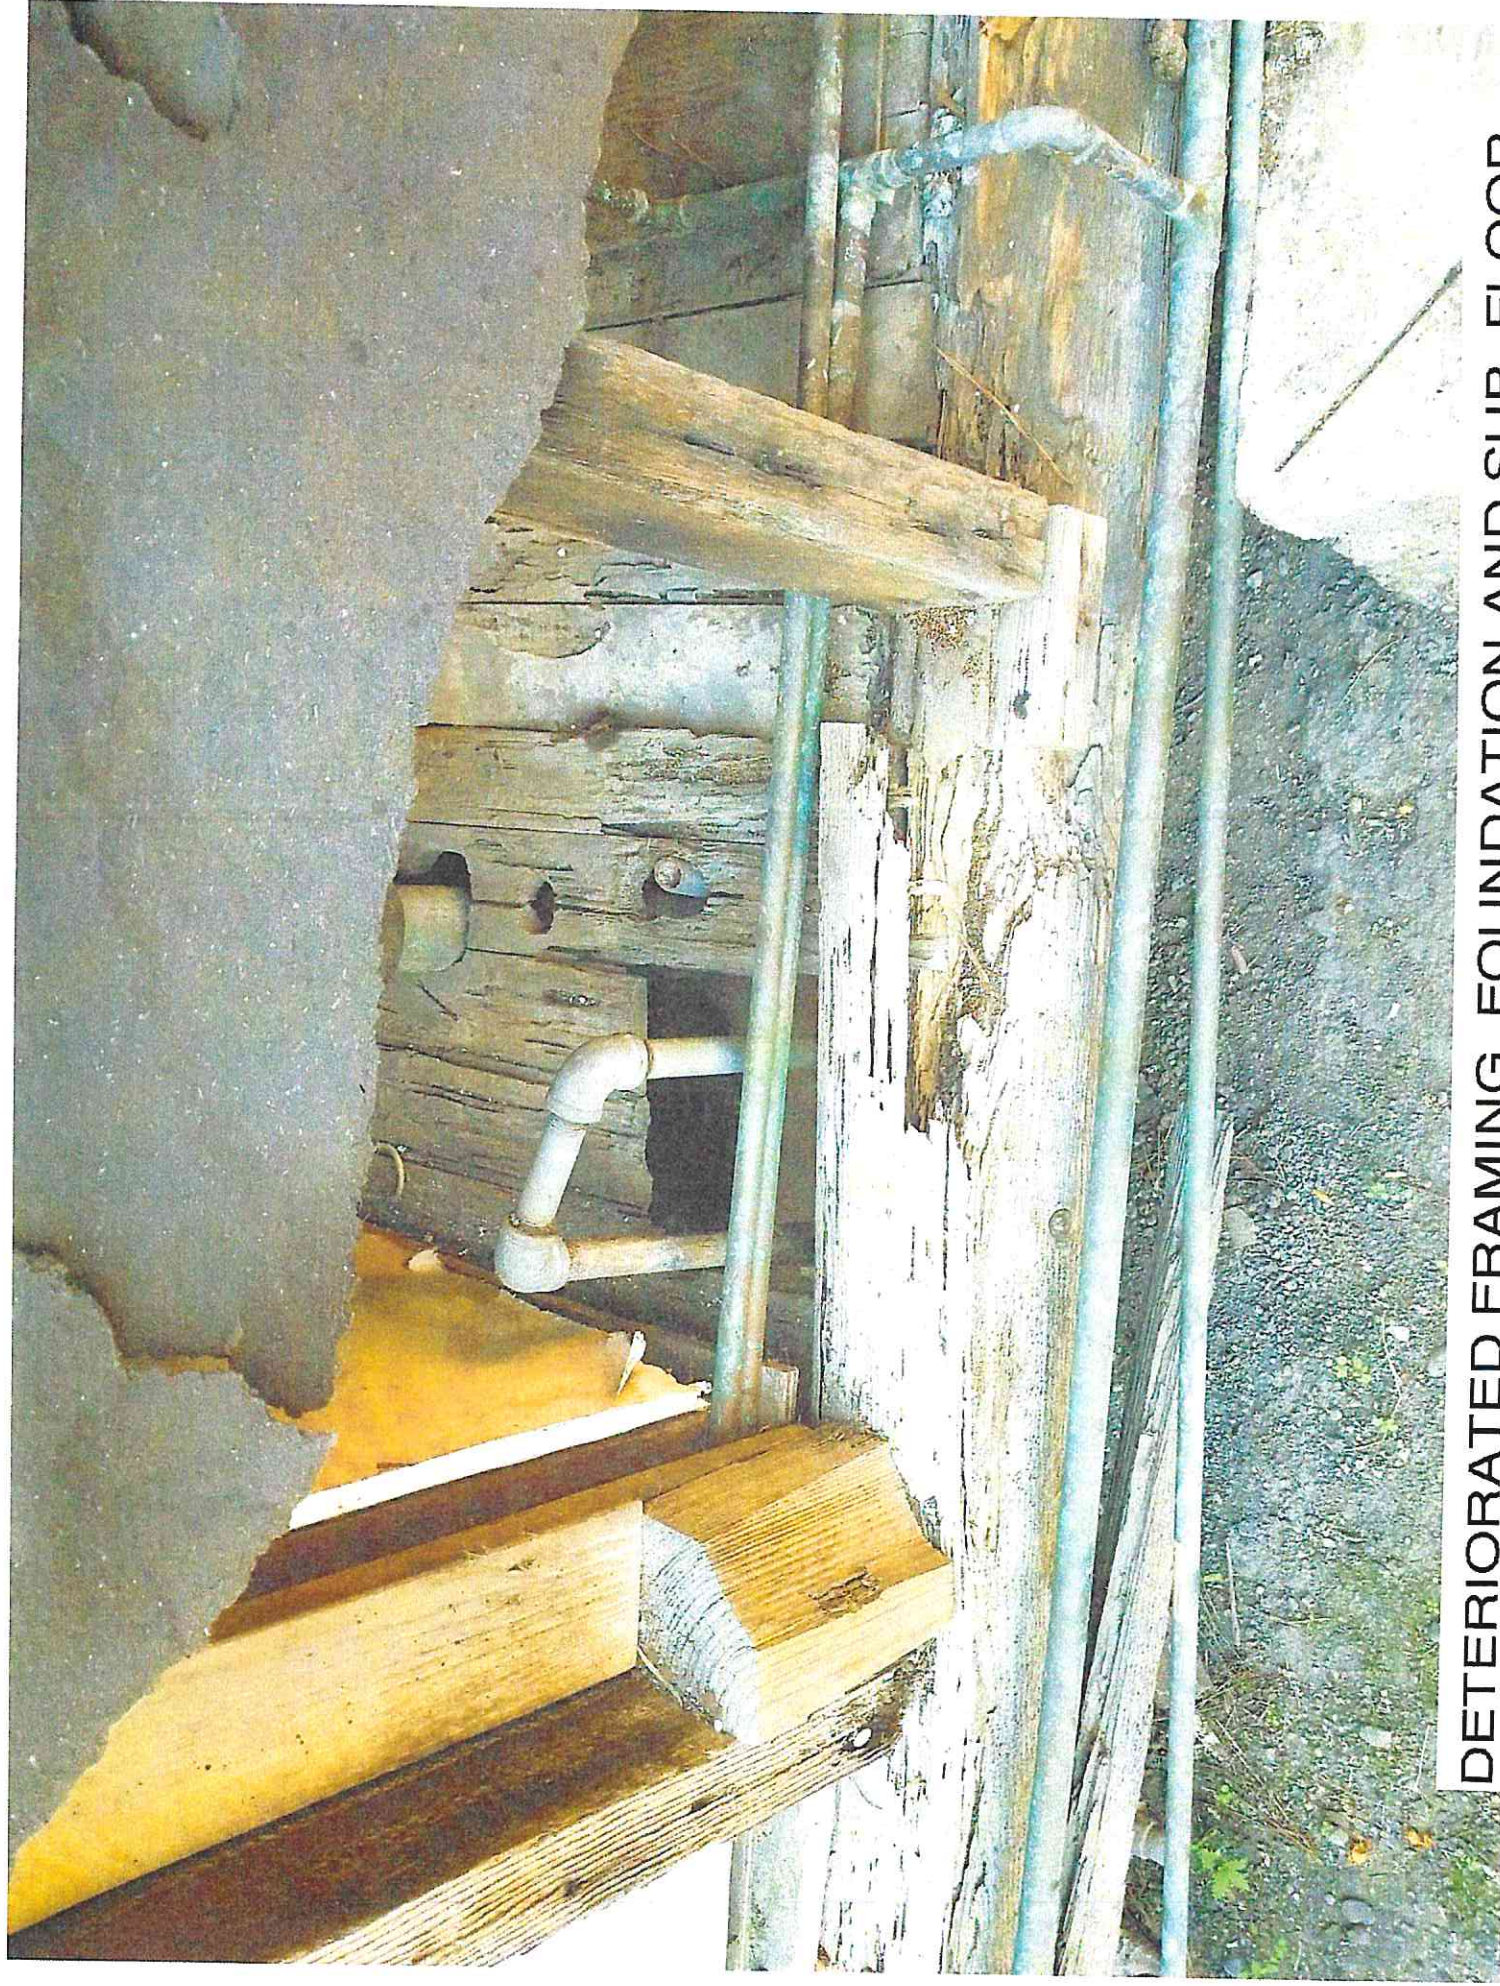
DETERIORATED FRAMING, FOUNDATION AND SUB-FLOOR

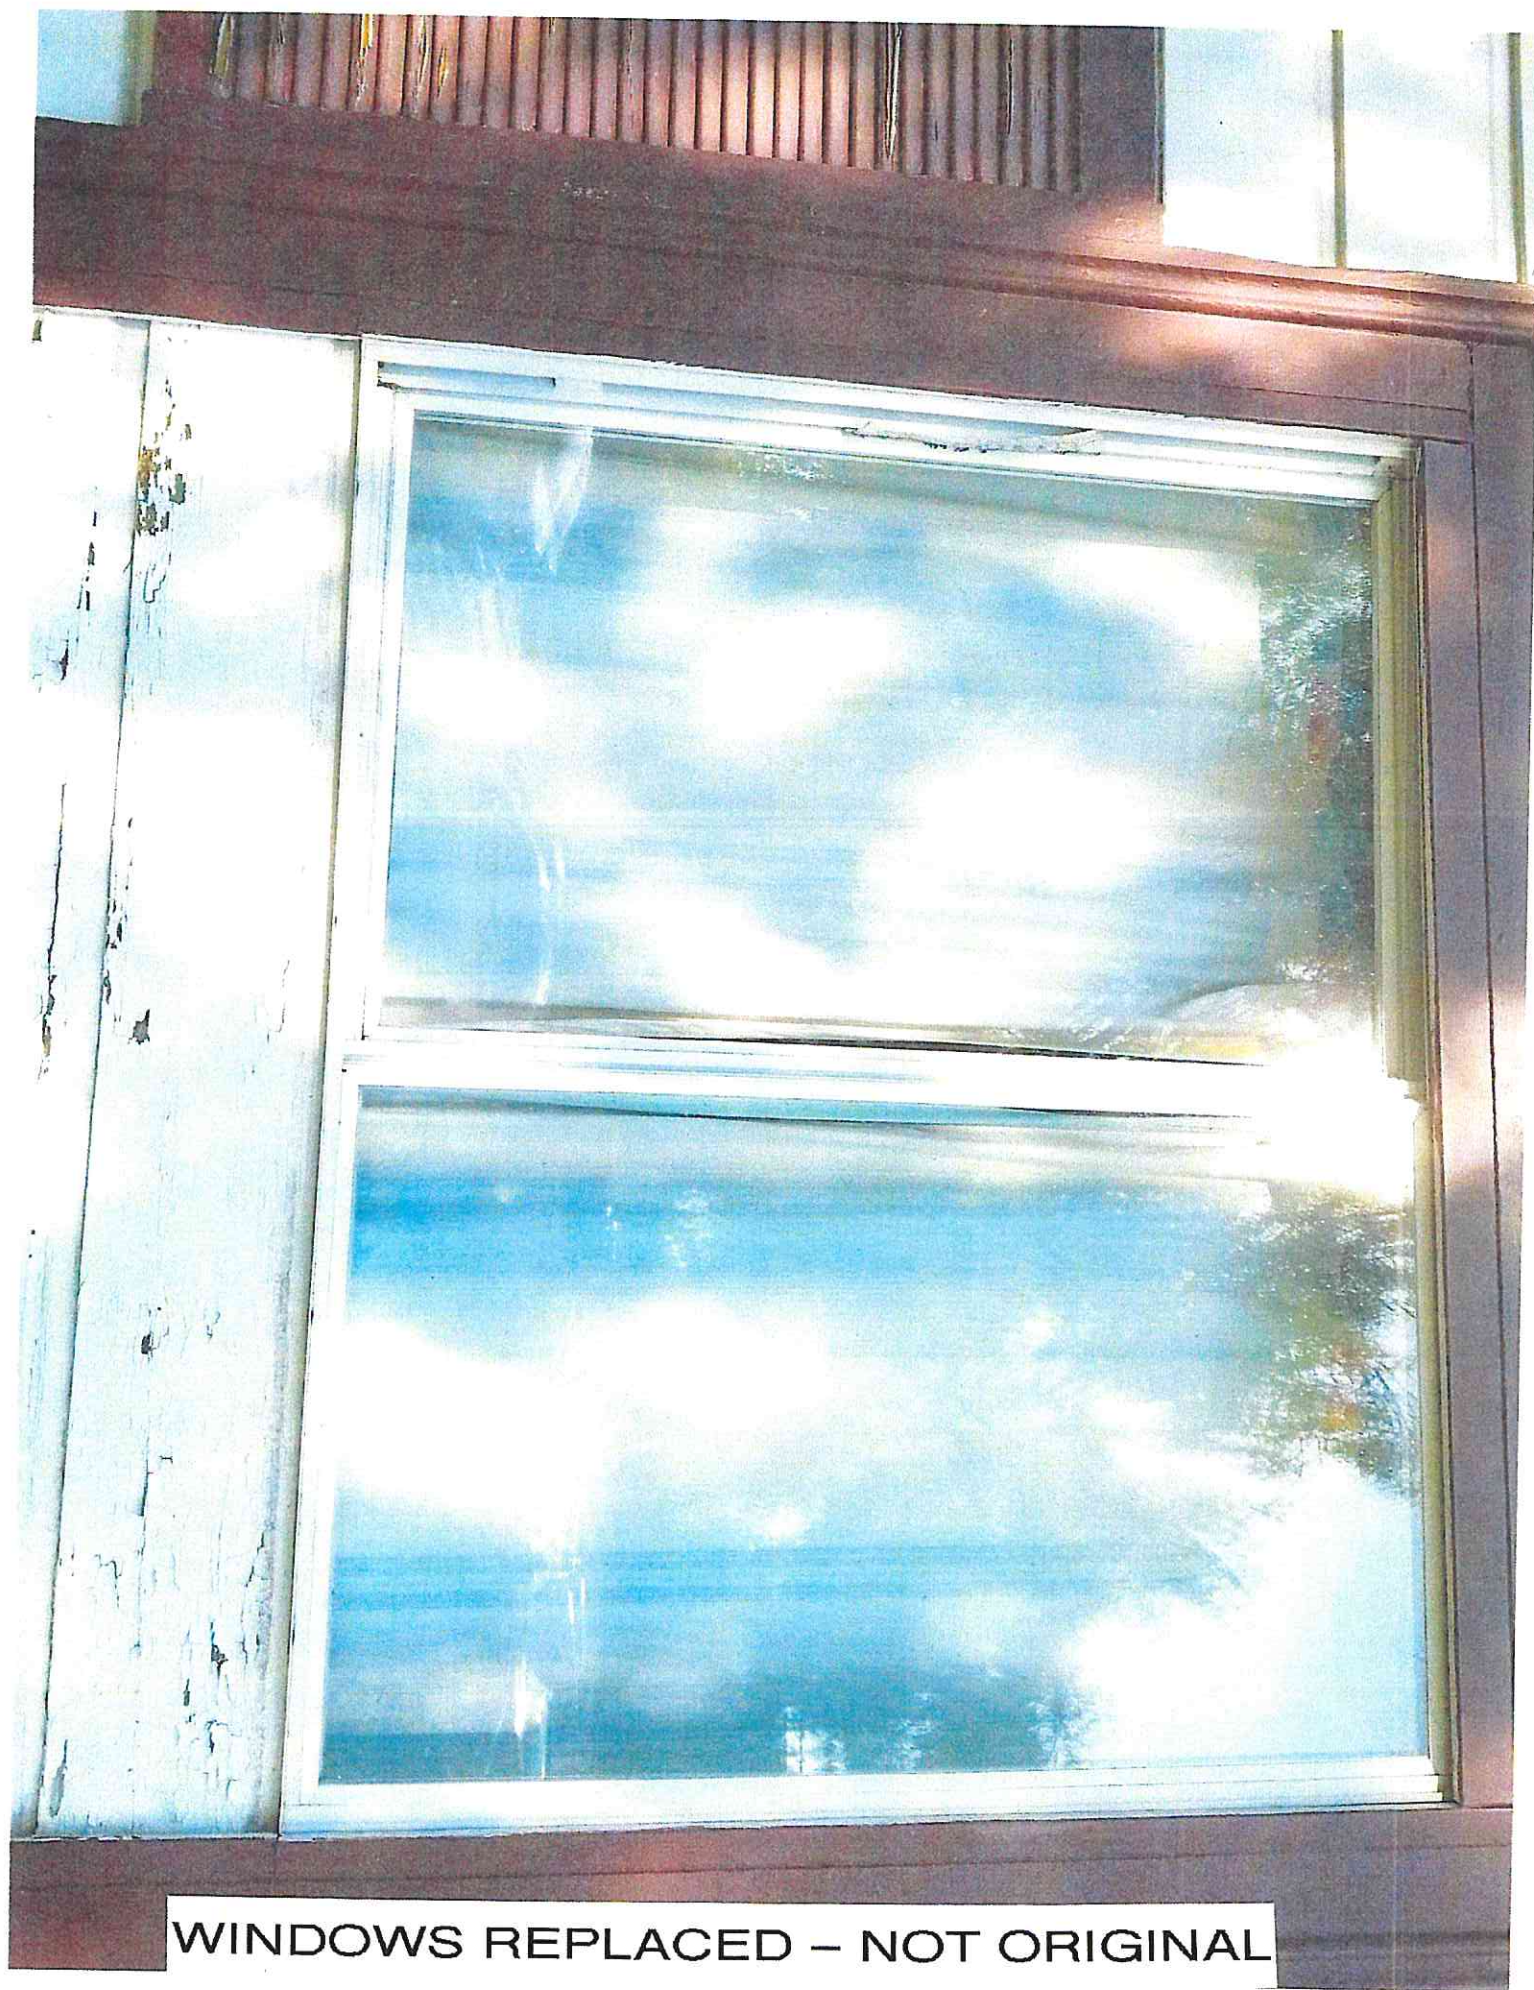
WINDOWS REPLACED – NOT ORIGINAL
