**Project Proposal**  
**1411 Lewis Street and 1444 Madison Street**  
**Santa Clara, California**

# **MADISON AND LEWIS STREET PROJECT DESCRIPTION**

**Location: 1411 Lewis Street and 1444 Madison Street**

**March 5, 2018**

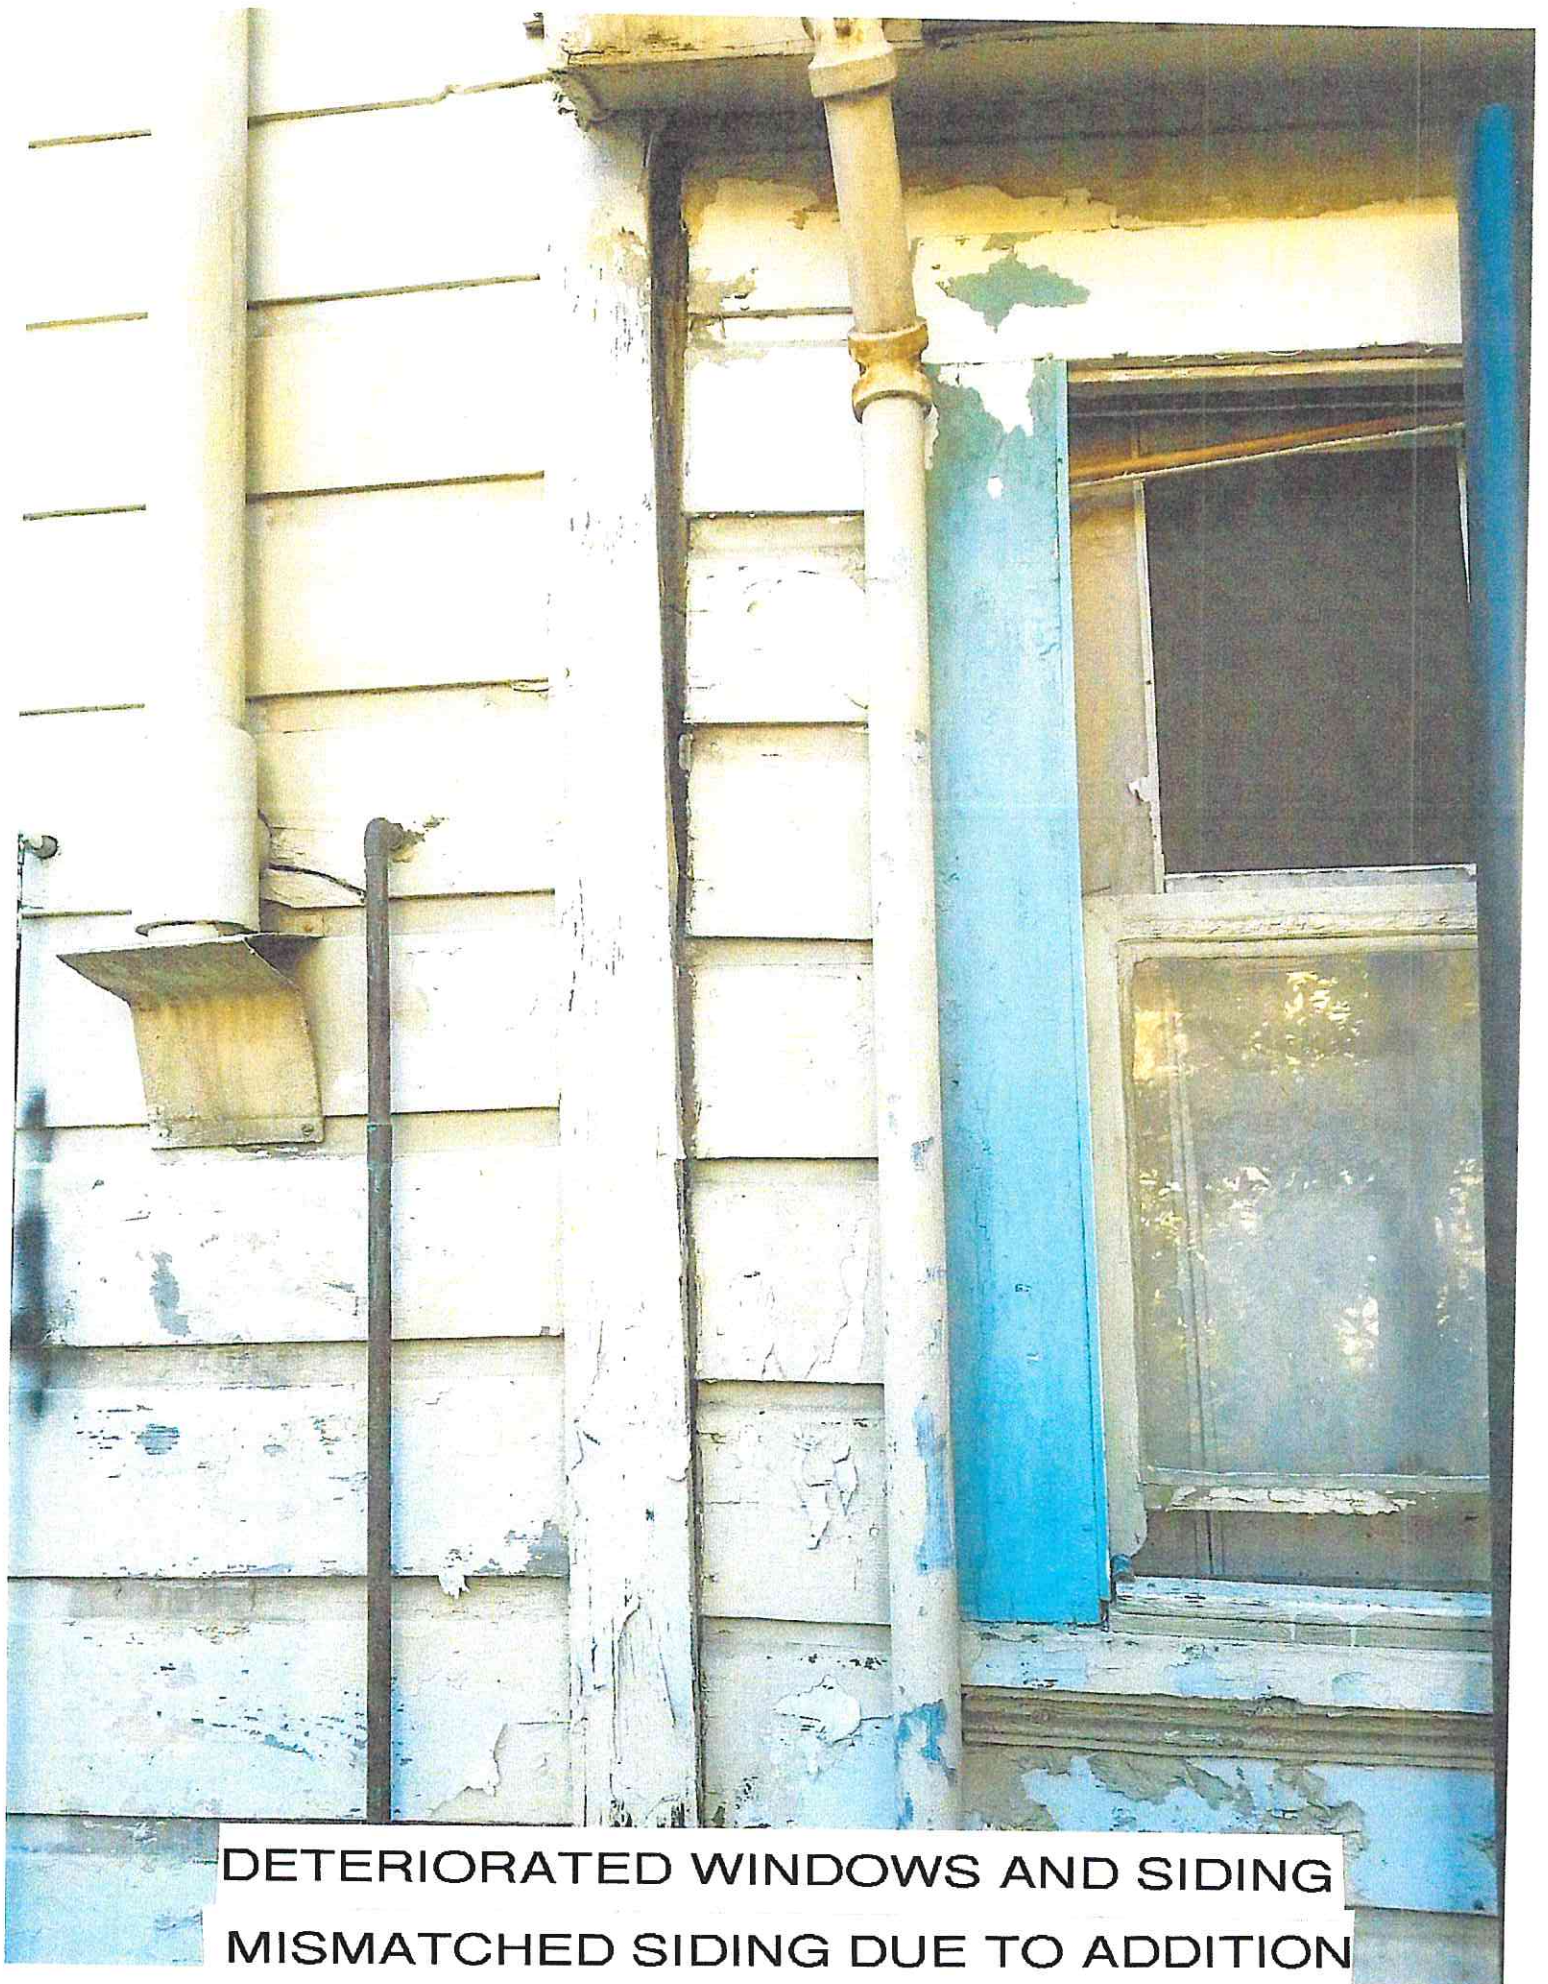
DETERIORATED WINDOWS AND SIDING  
MISMATCHED SIDING DUE TO ADDITION

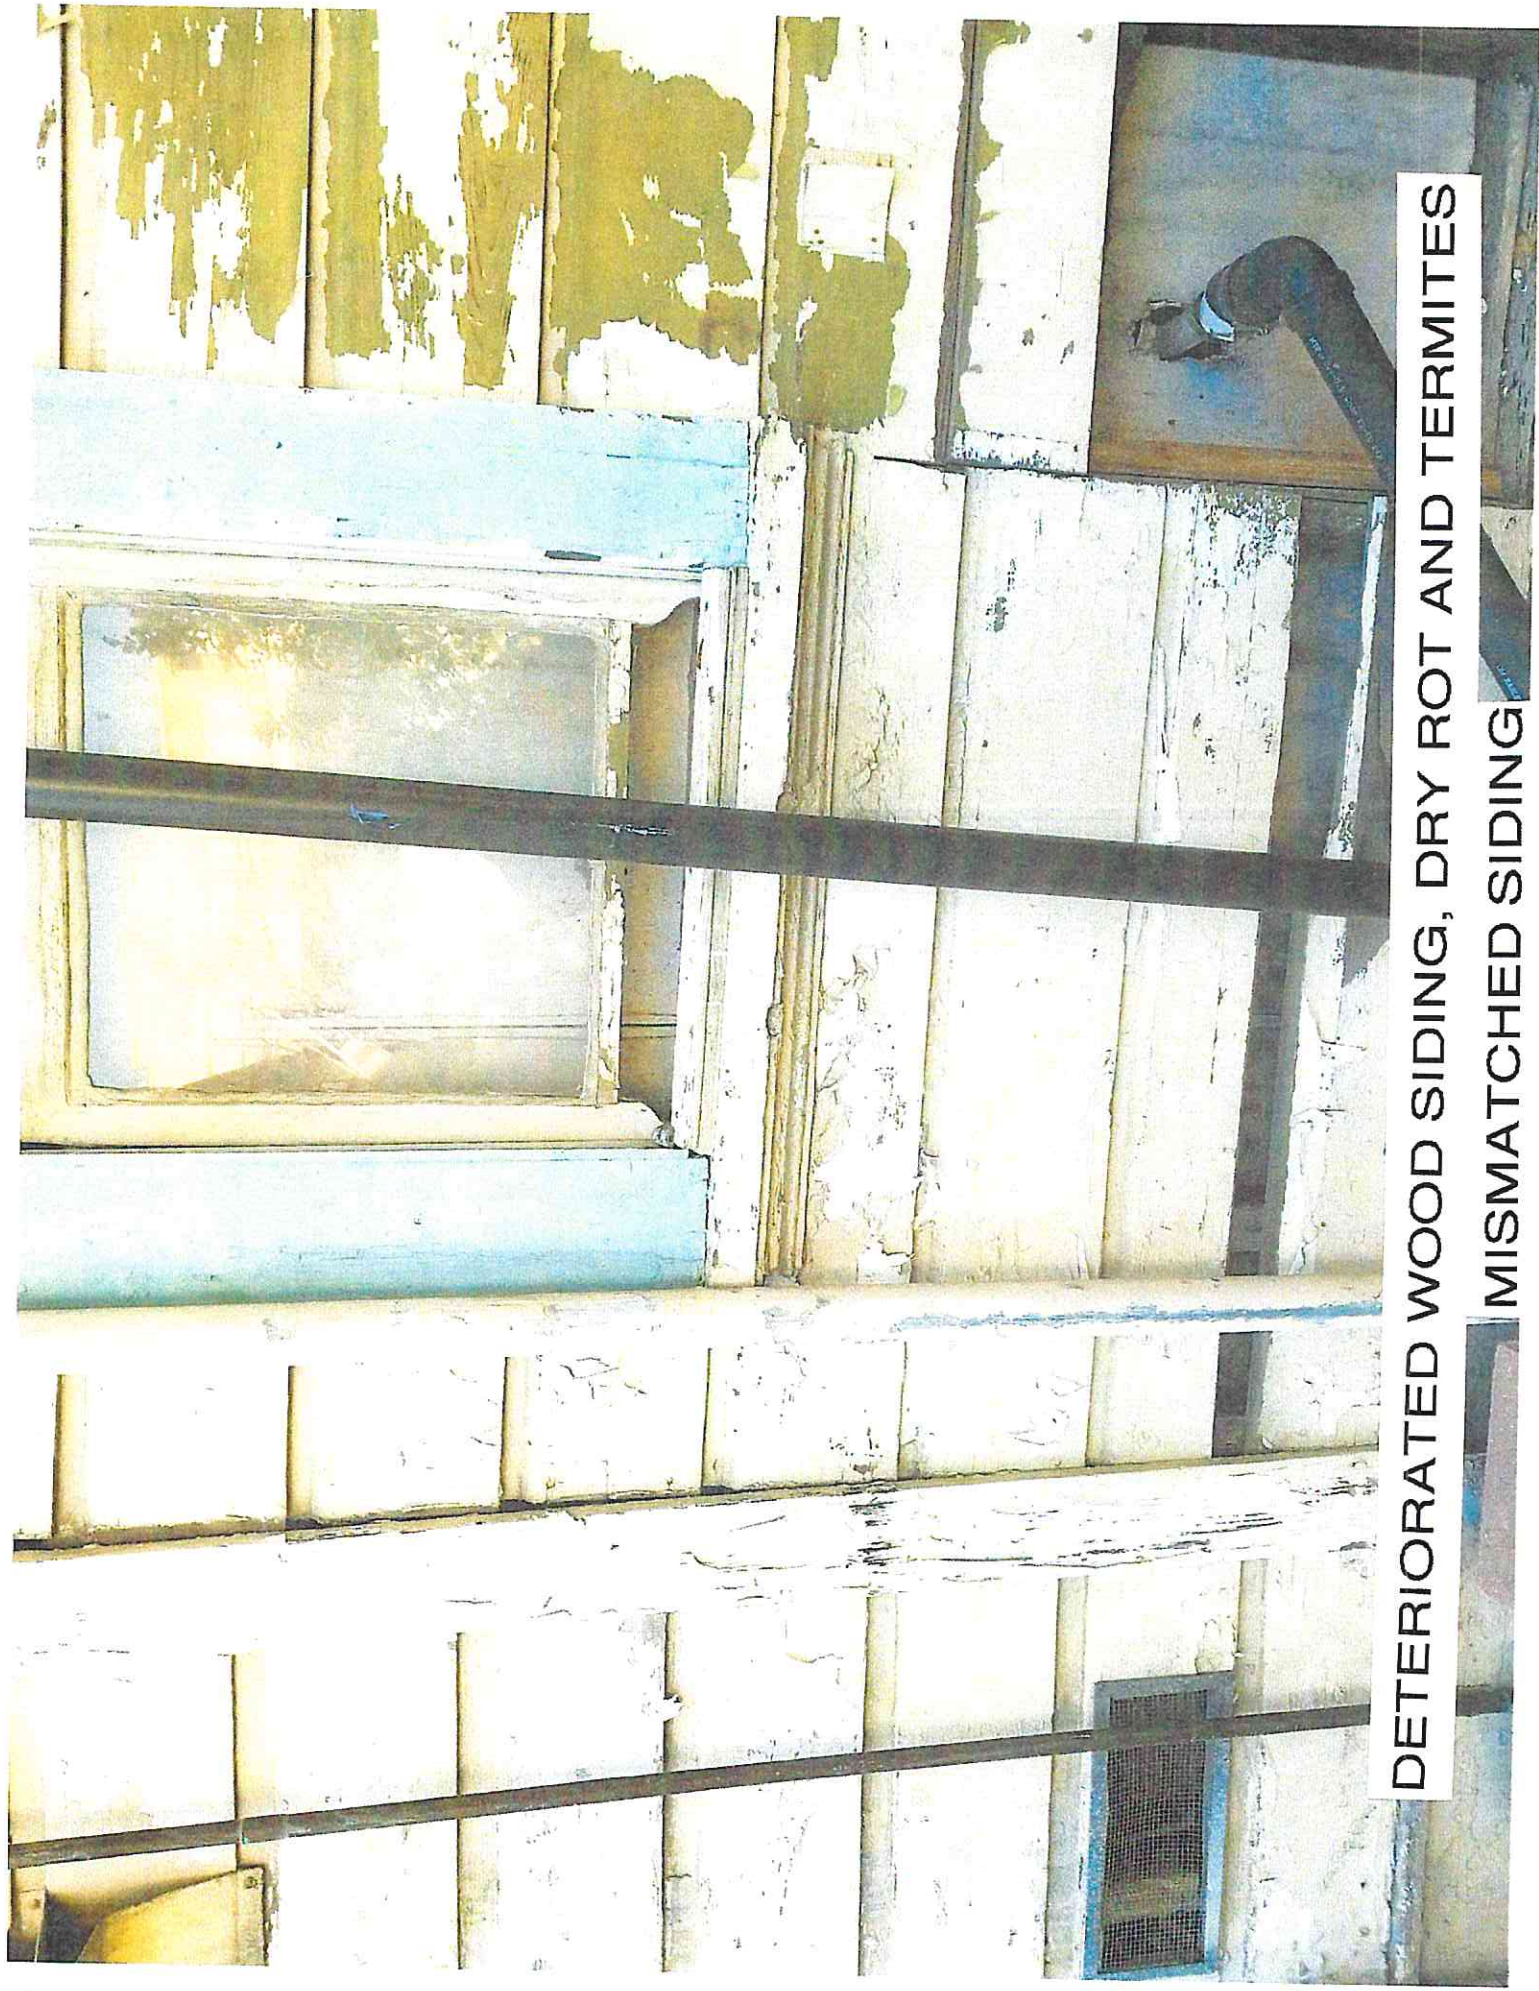
DETERIORATED WOOD SIDING, DRY ROT AND TERMITES  
MISMATCHED SIDING

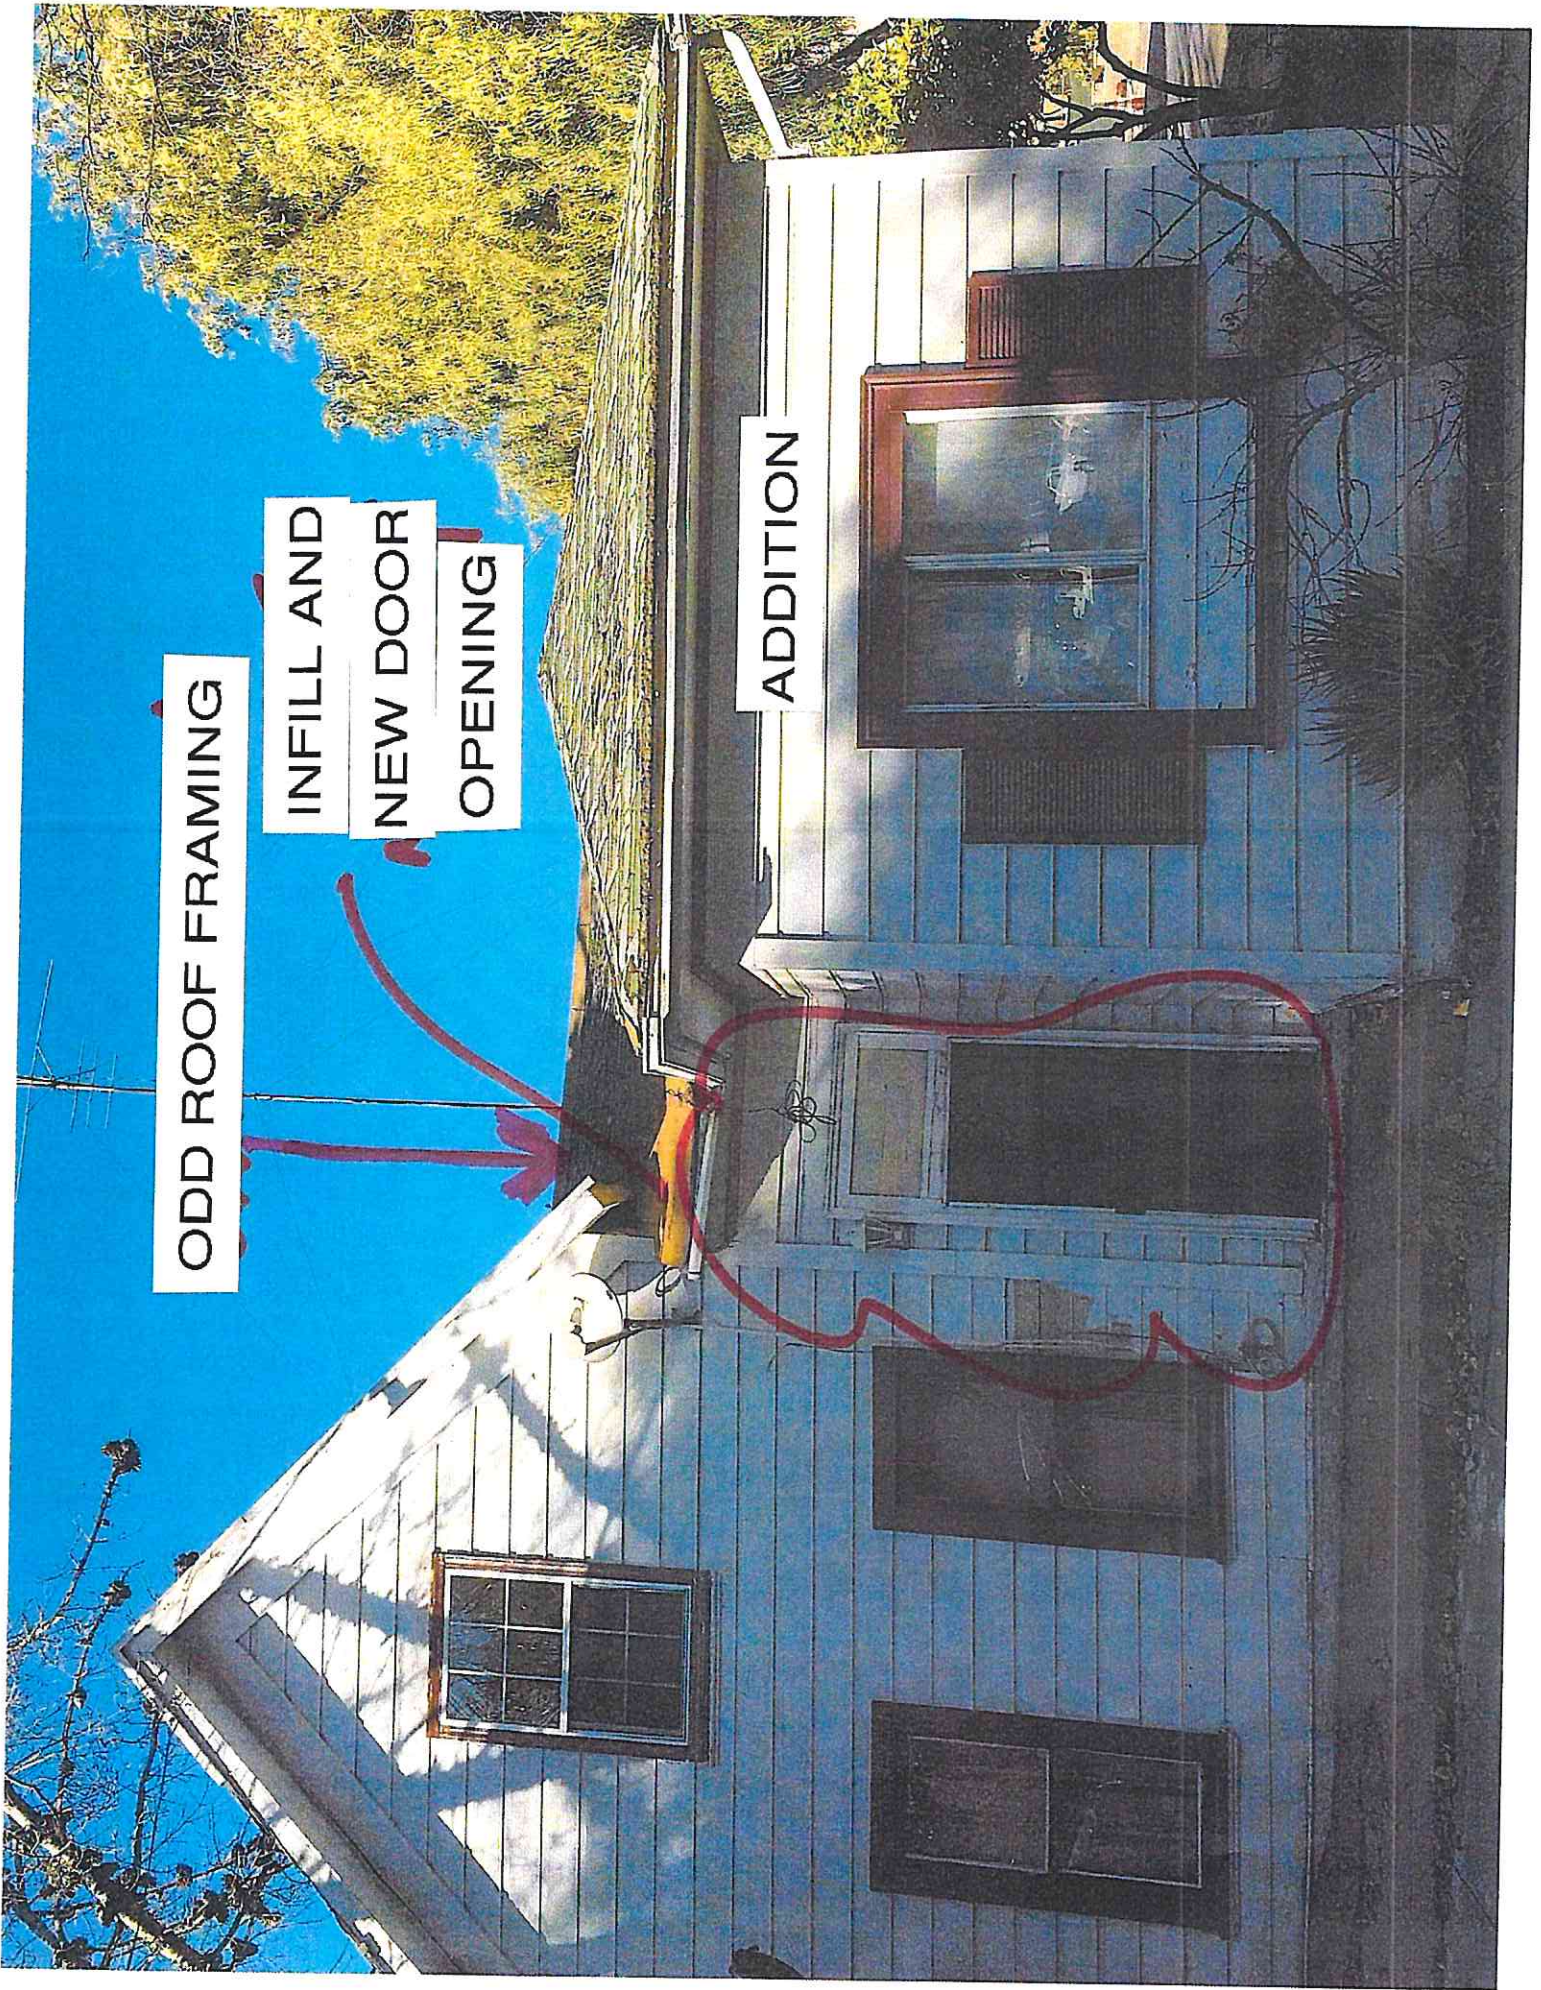
ODD ROOF FRAMING
