Project Proposal
1411 Lewis Street and 1444 Madison Street
Santa Clara, California

MADISON AND LEWIS STREET PROJECT DESCRIPTION

Location: 1411 Lewis Street and 1444 Madison Street

March 5, 2018

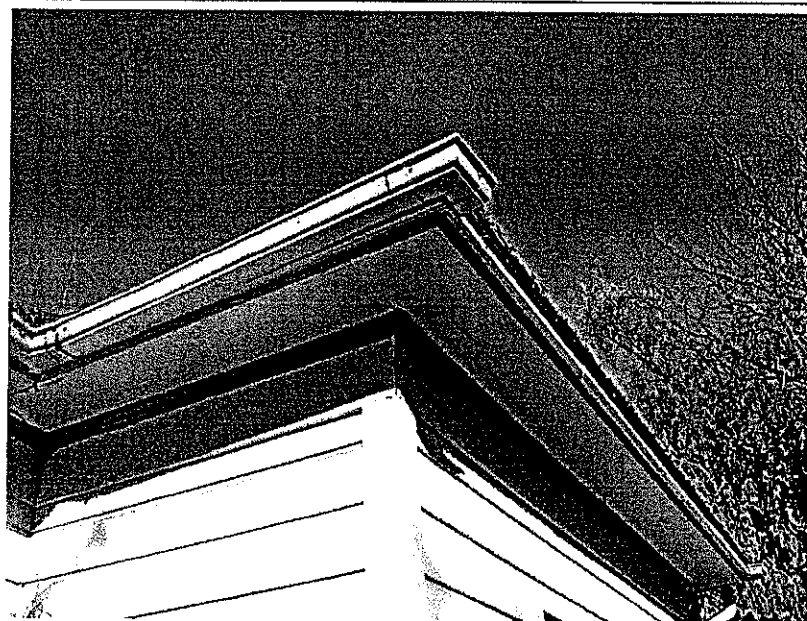
Photo 6: Detail of eaves showing deterioration.

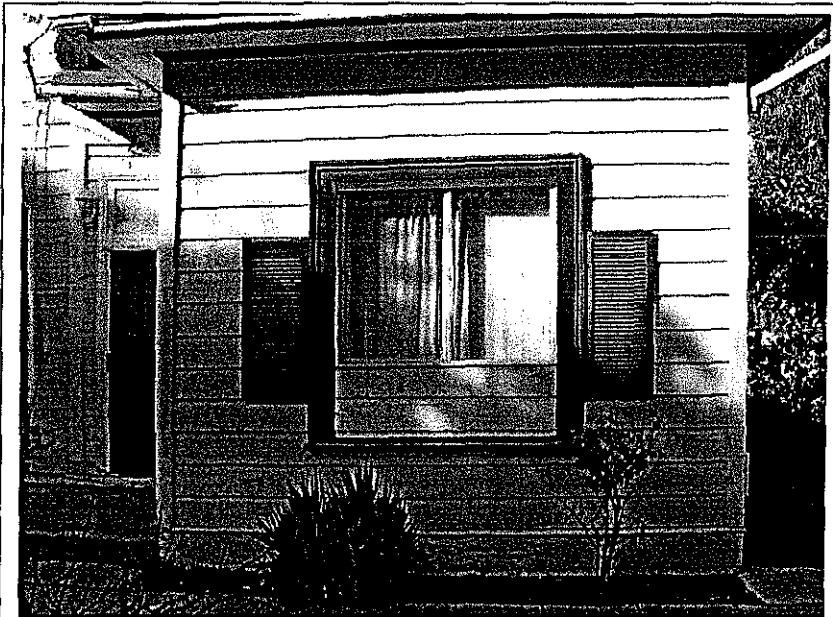
Photo 7: Detail of windows resized and replace with vinyl.

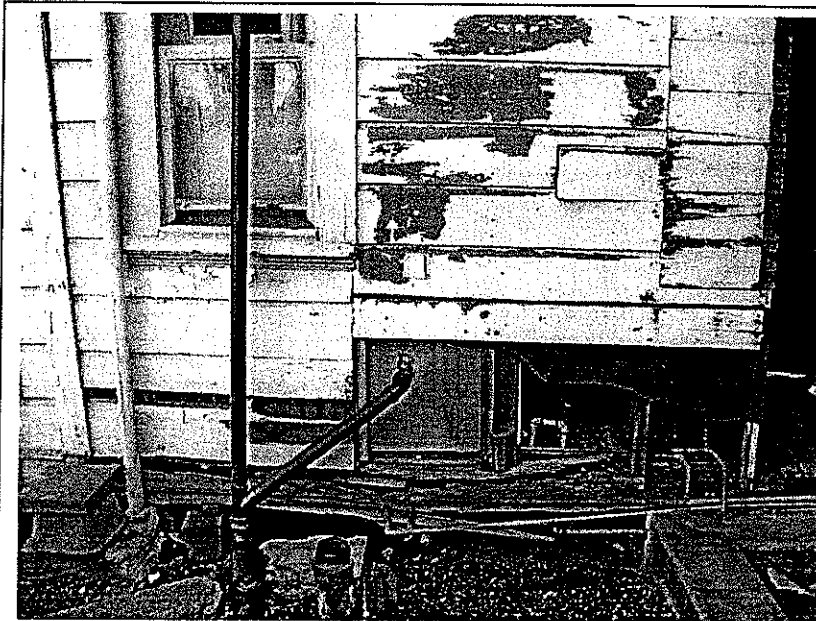
Photo 13: Detail of extensive damage and deterioration on addition.

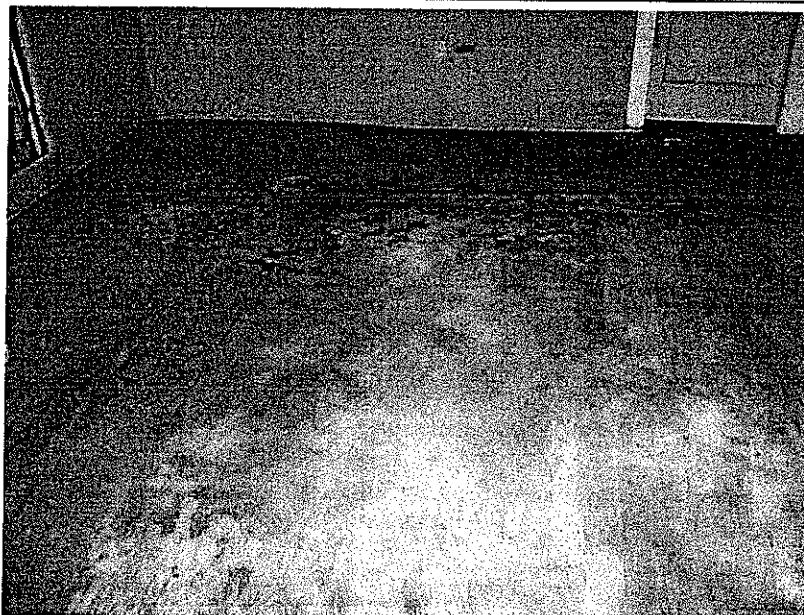
Photo 18: Detail of the stripped and damage flooring in the living room.

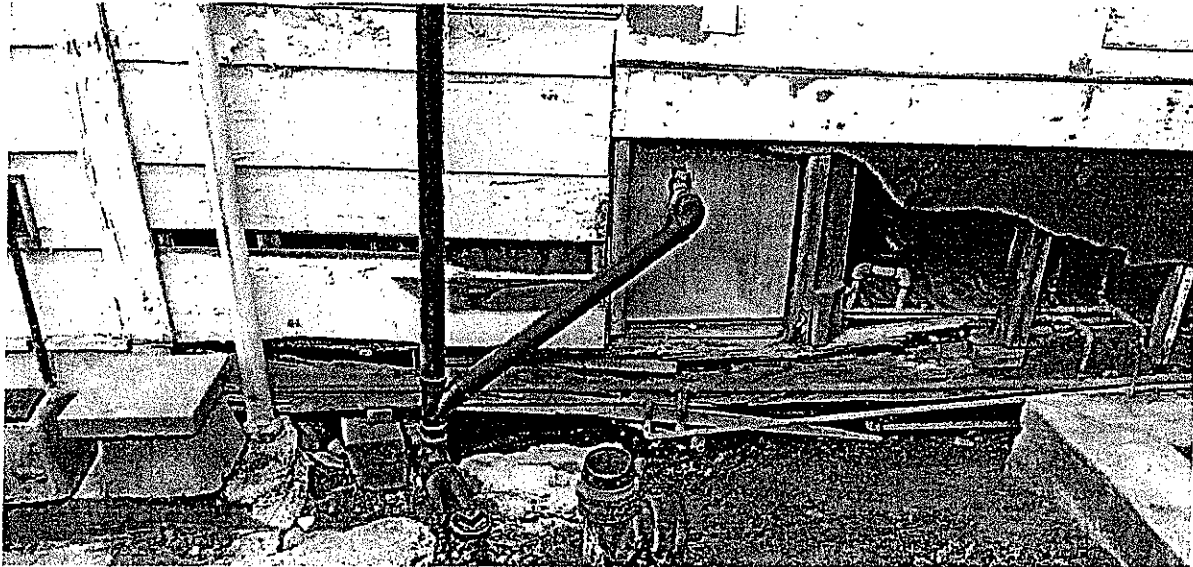
A large portion of the rear foundation area of the structure was open due to missing siding along the rear of the house at the ground level. Severe termite damage was apparent on all of the wood framing members at the edge of the floor.

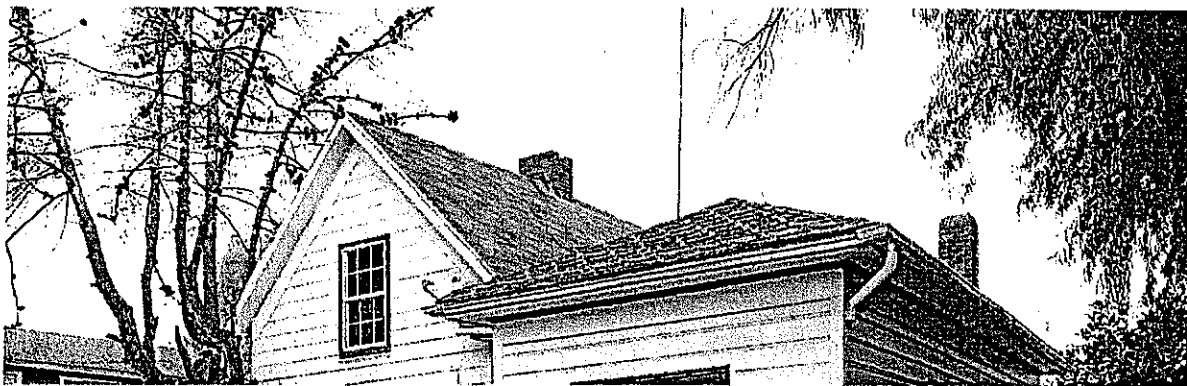
Figure 5: Main roof and kitchen addition.

The roof has several layers of composite shingles. The edges look quite weathered and perhaps even attacked by mold. Despite the deterioration at the edges, the roof lines still appear straight which indicates that the framing underneath is likely sound. We did not observe any sagging in the roof with is an obvious sign of persistent water penetration.

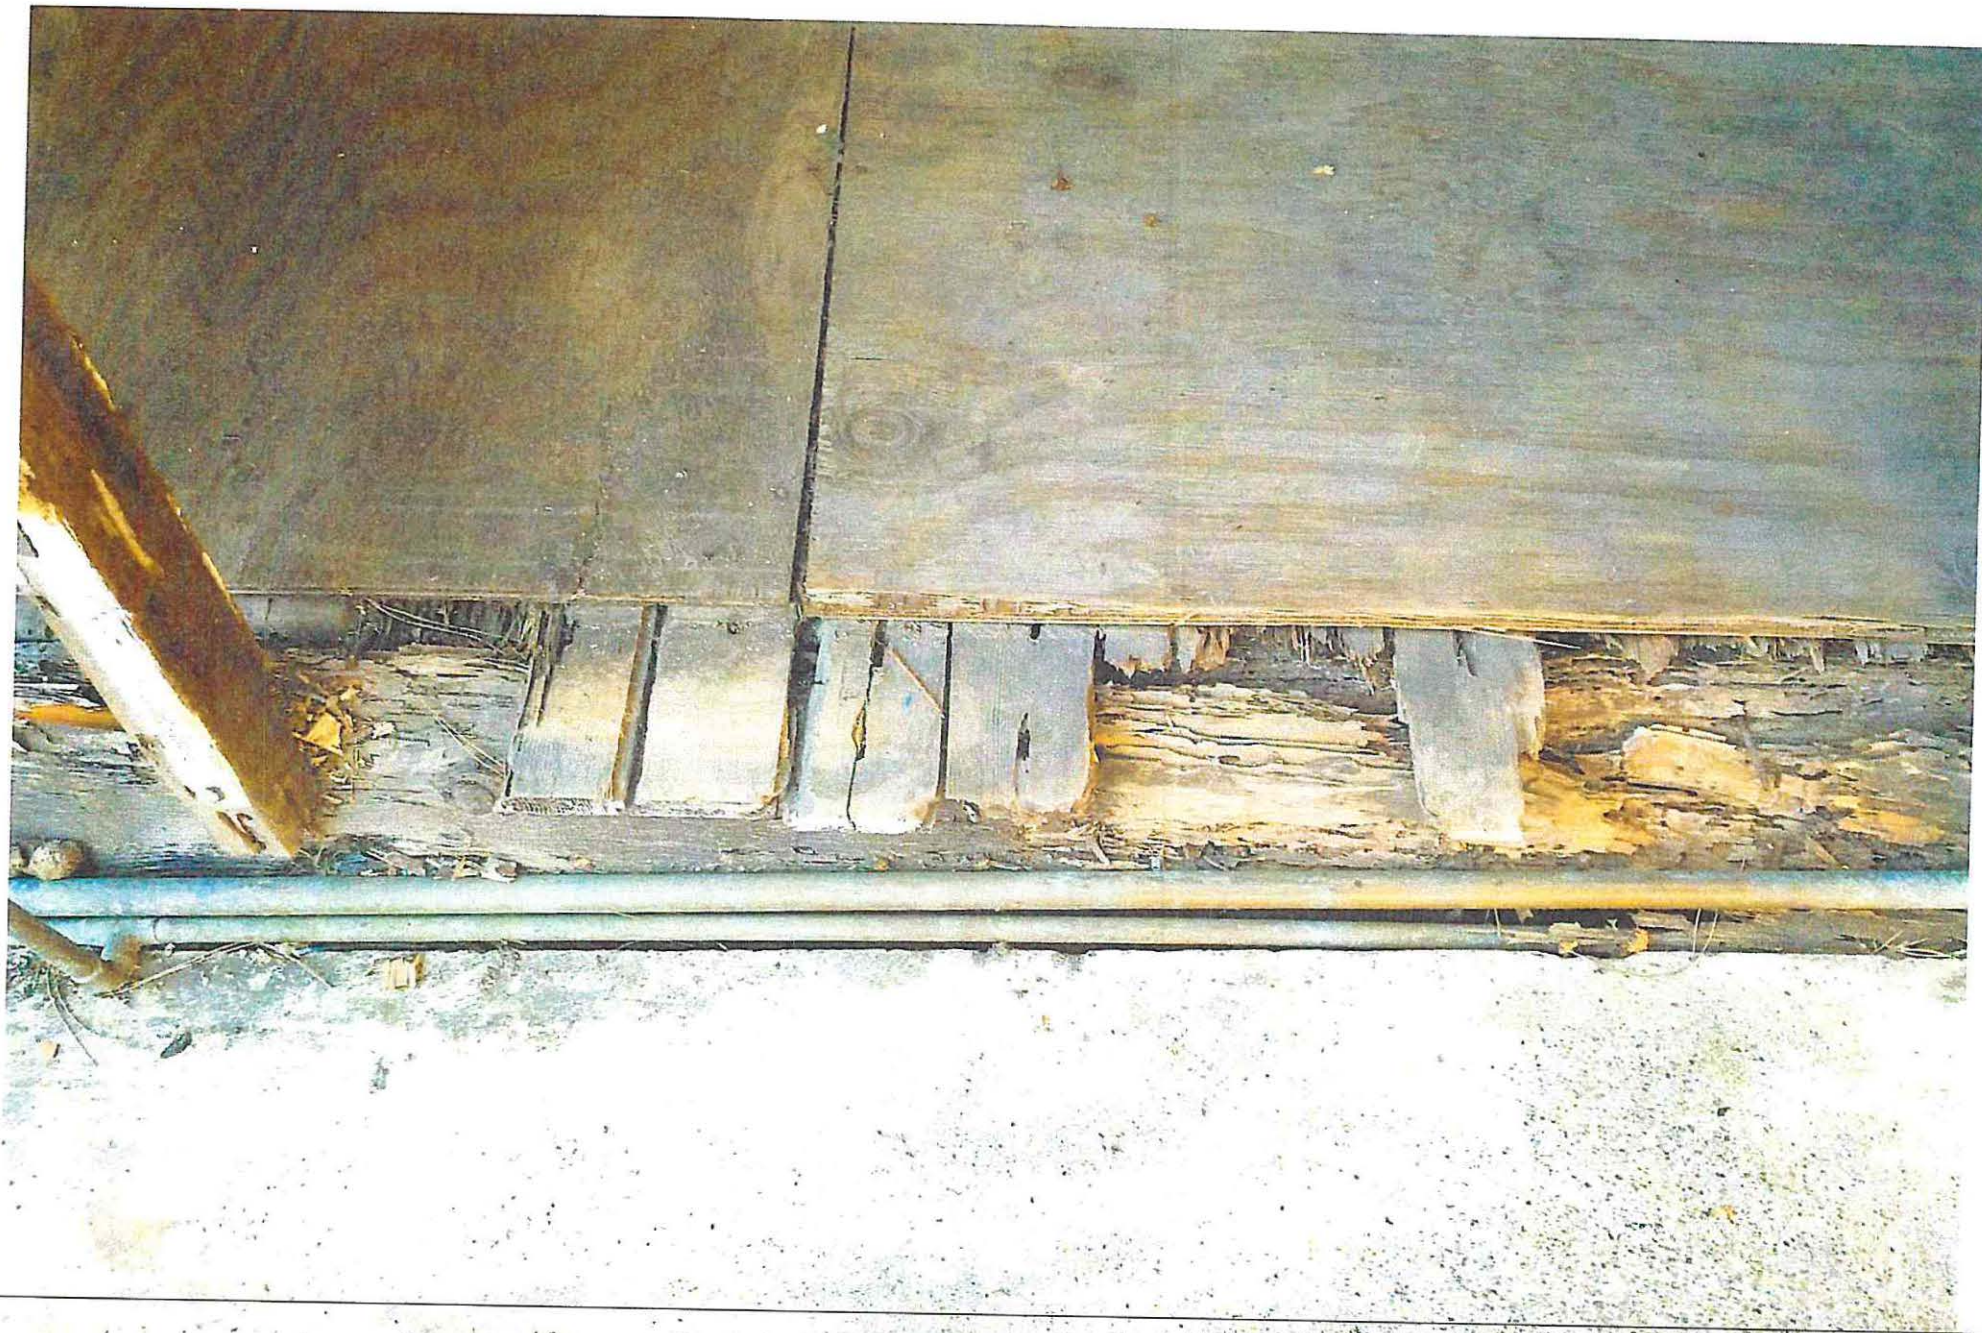
DETERIORATED WOOD FLOOR, FOUNDATION AND FRAMING

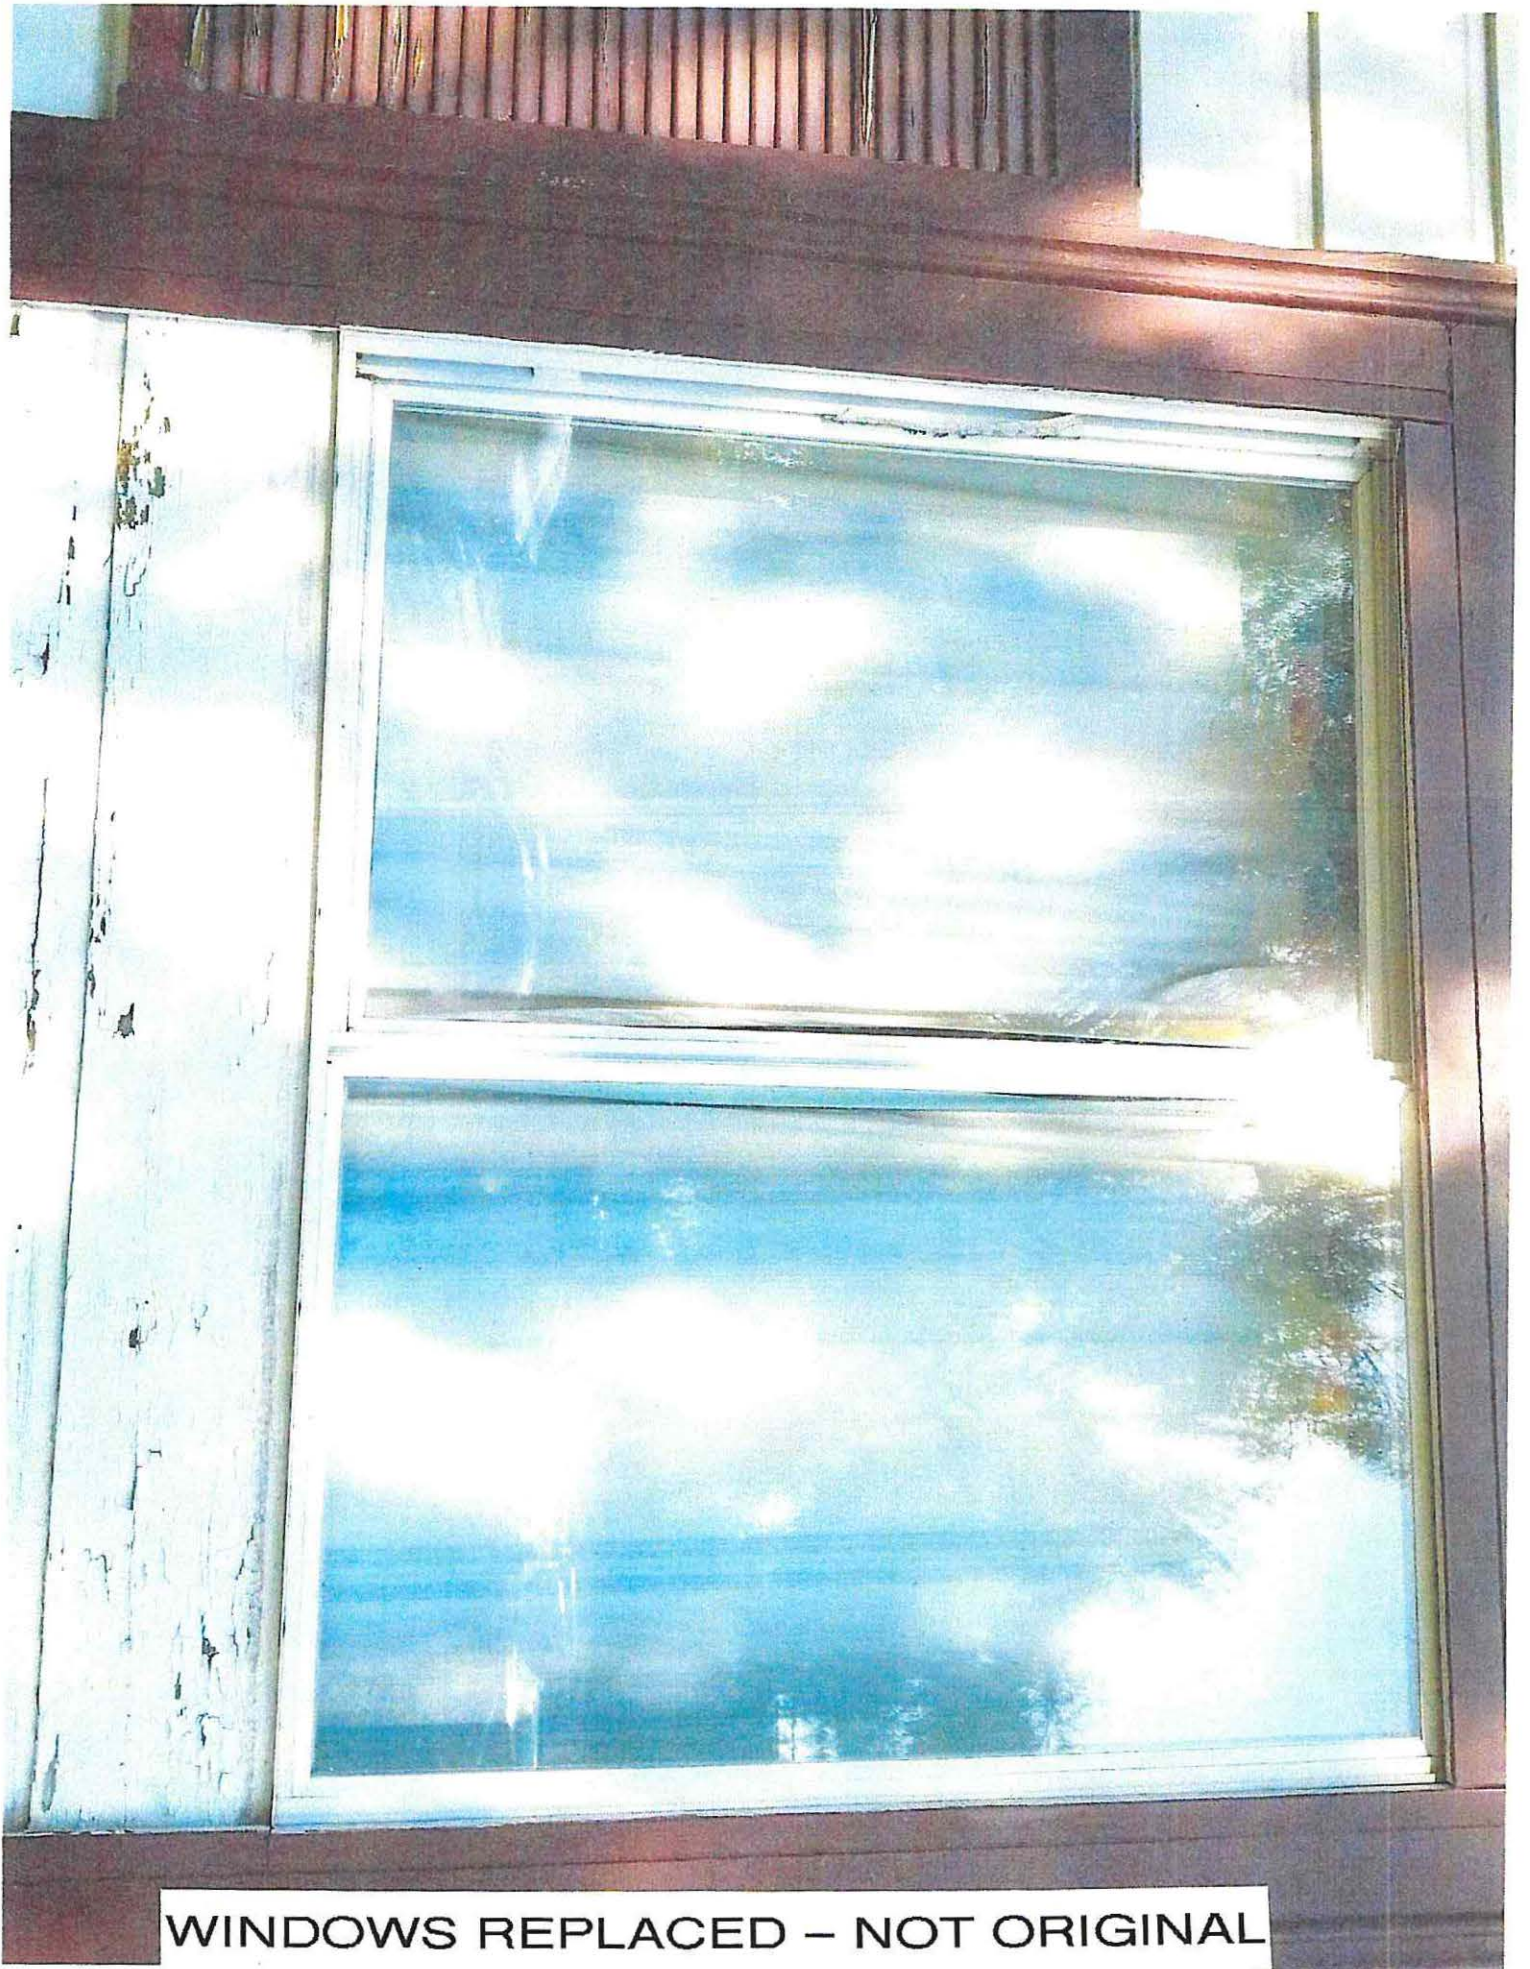
WINDOWS REPLACED - NOT ORIGINAL

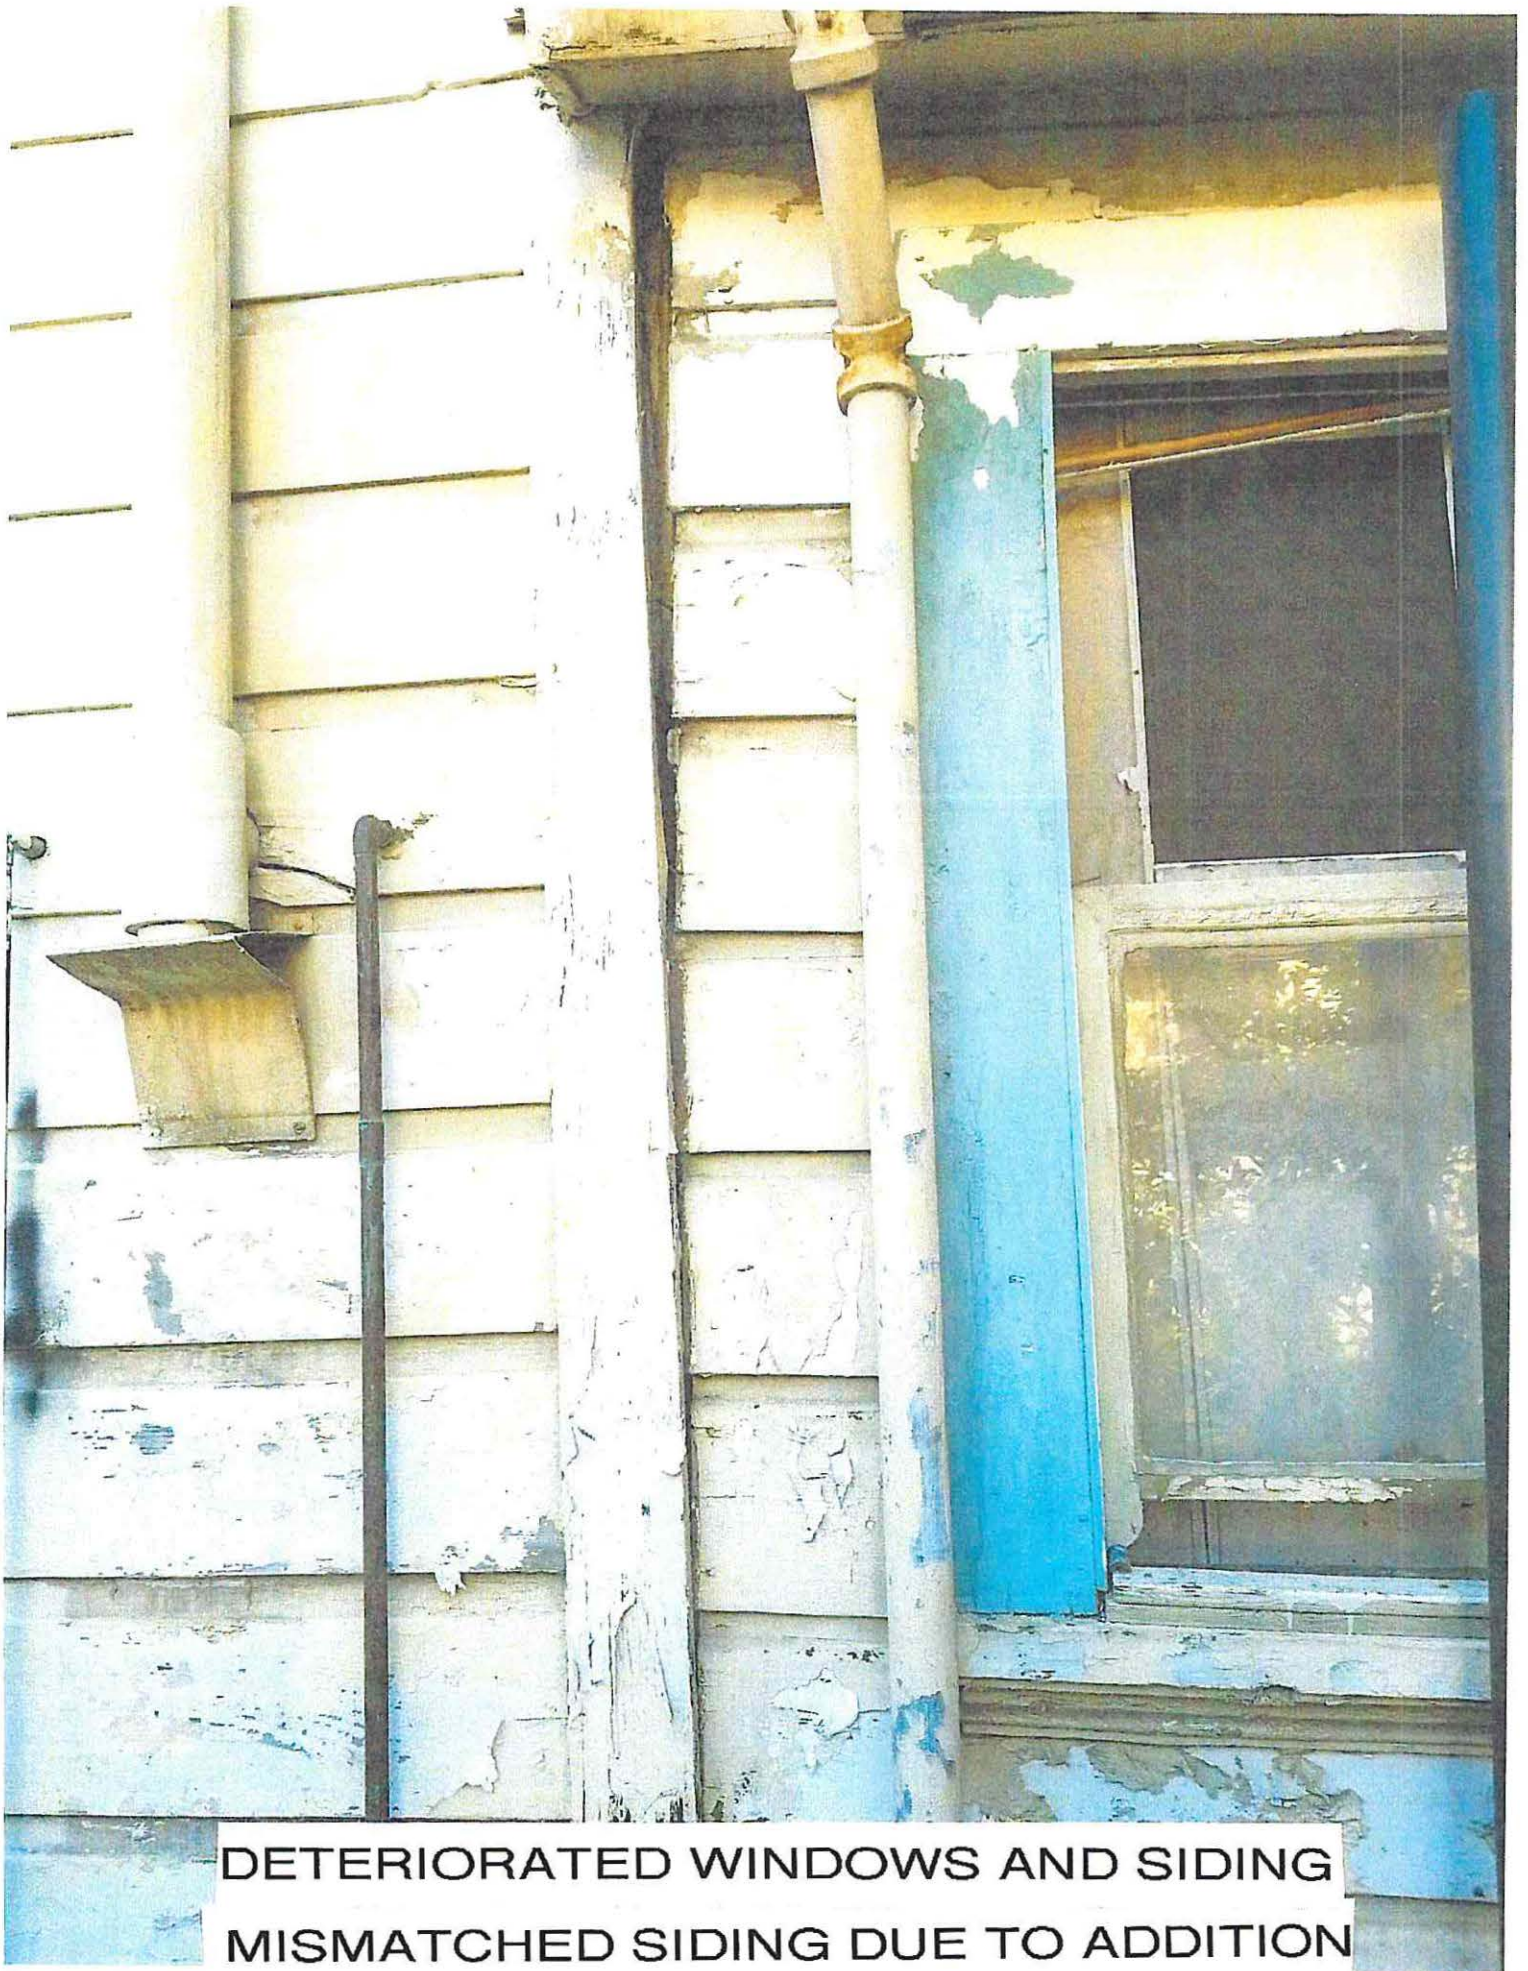
DETERIORATED WINDOWS AND SIDING
MISMATCHED SIDING DUE TO ADDITION

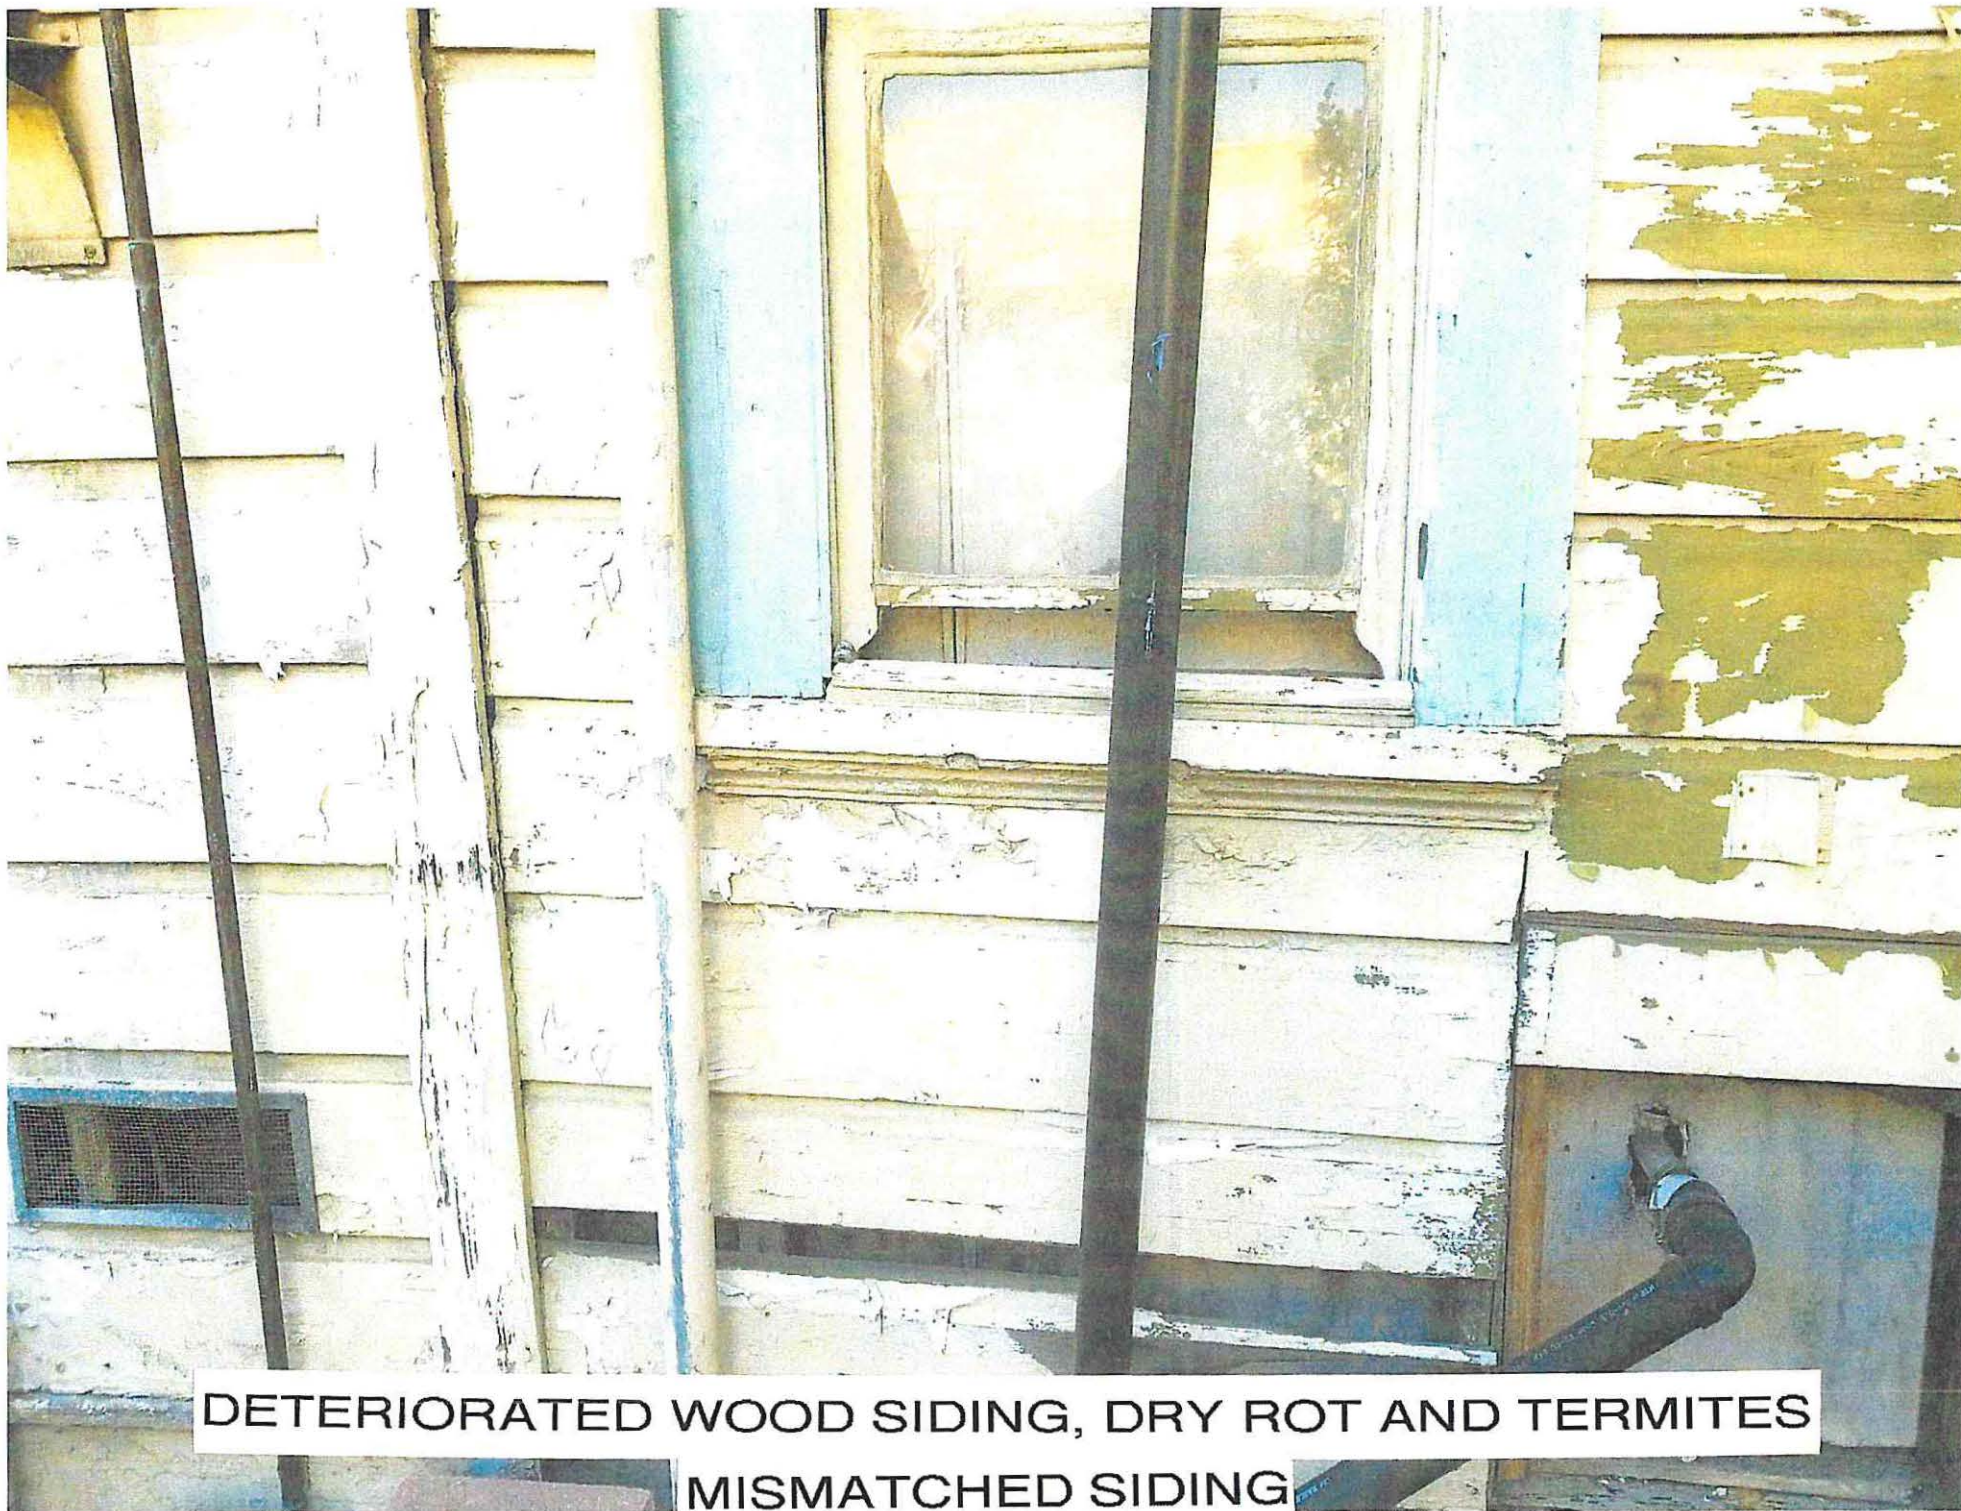
DETERIORATED WOOD SIDING, DRY ROT AND TERMITES
MISMATCHED SIDING
