Home Inspection Report

1226 Jackson Street, Santa Clara

Luis Sevilla
April 4, 2018

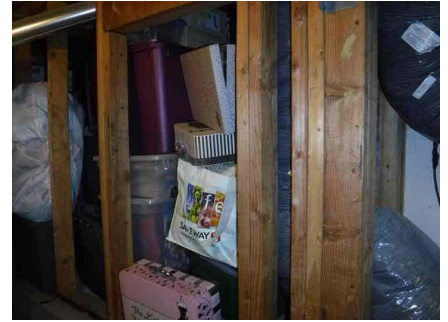
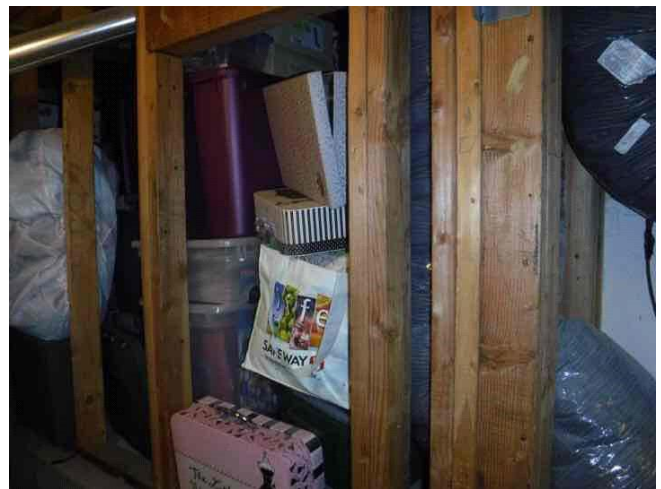
Photo 22

4. Personal storage was blocking access to the basement/crawl space area. Therefore, the area is considered inaccessible and was not fully inspected. With access and an opportunity for a complete inspection, conditions in need of attention may be discovered. Ideally, the personal belongings should be removed so the area may be inspected. (See Photo 22)

- ! 4. Personal storage was blocking access to the basement/crawl space area. Therefore, the area is considered inaccessible and was not fully inspected. With access and an opportunity for a complete inspection, conditions in need of attention may be discovered. Ideally, the personal belongings should be removed so the area may be inspected. (See Photo 22)

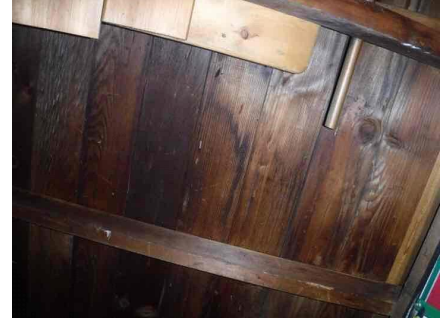
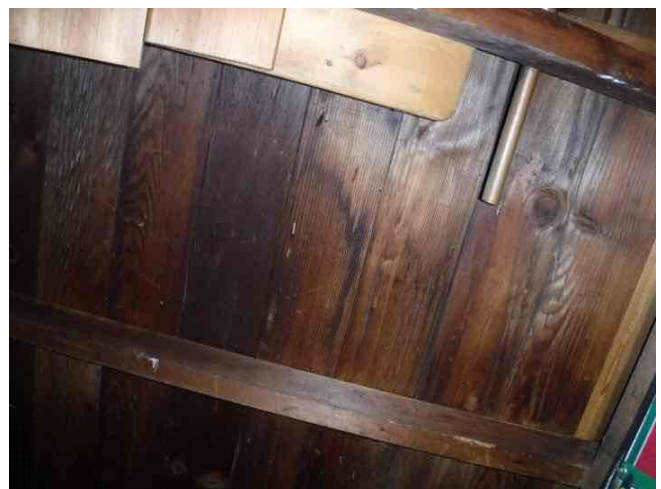
Photo 18

5. Water stains were evident in the garage ceiling sheathing. This could indicate leakage through the roof covering. We recommend the services of a licensed roofing contractor to further evaluate this condition. (See Photo 18)

- ! 5. Water stains were evident in the garage ceiling sheathing. This could indicate leakage through the roof covering. We recommend the services of a licensed roofing contractor to further evaluate this condition. (See Photo 18)

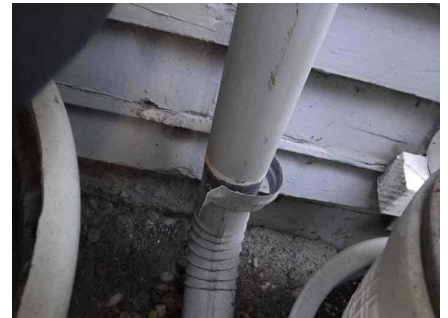
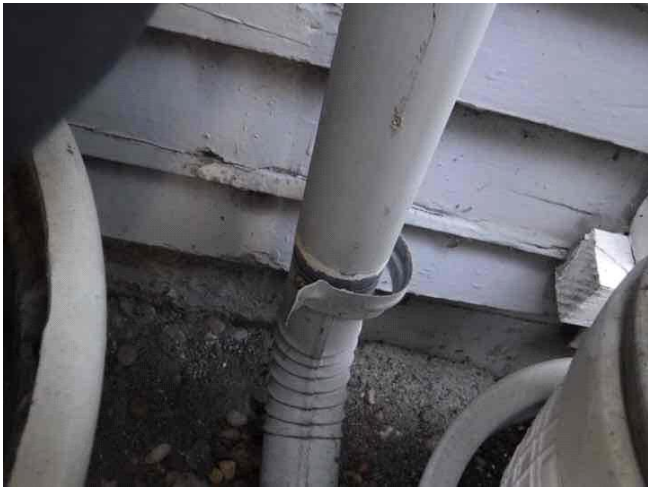
Photo 07

6. Loose downspouts at the right should be repaired or replaced. (See Photo 7)

- ! 1. Loose downspouts at the right should be repaired or replaced. (See Photo 7)**
- The gutters are in serviceable condition but only portions of the roof are so equipped, depending upon the soil condition and drainage patterns it may be beneficial to add more gutters and downspouts. (See Illustration 2K)

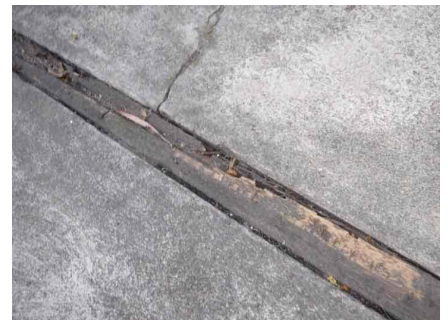
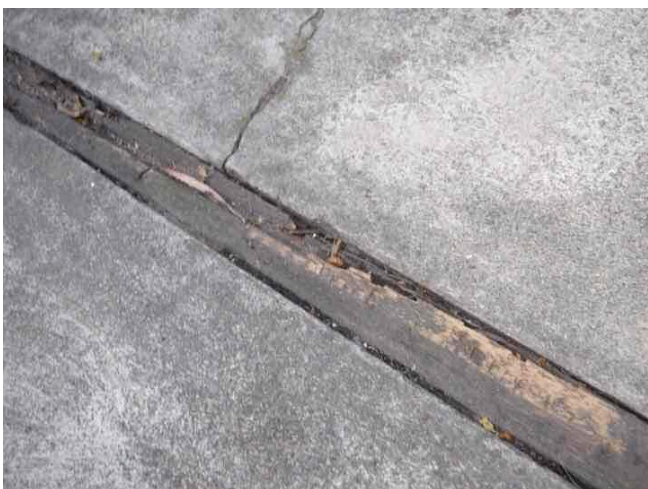
Photo 11

7. The wood borders between the slab sections of the patio have deteriorated. These voids create a trip hazard and should be filled in or replaced with treated wood or mortar. (See Photo 11)

- ! 1. The wood borders between the slab sections of the patio have deteriorated. These voids create a trip hazard and should be filled in or replaced with treated wood or mortar.rear (See Photo 11)

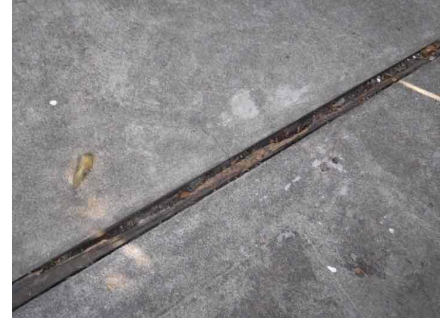
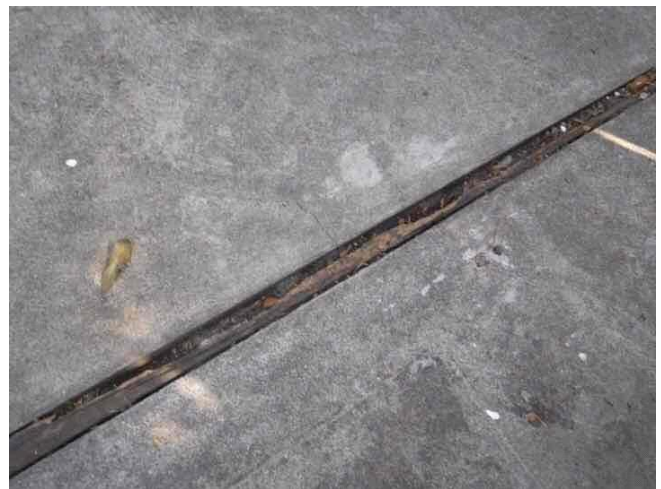
Photo 10

8. The cracked and heaved section of the patio presents a trip hazard. This condition should be corrected for improved safety.rear (See Photo 10)

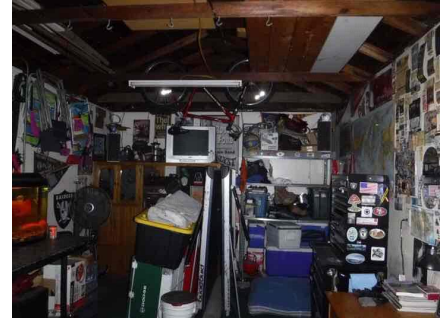
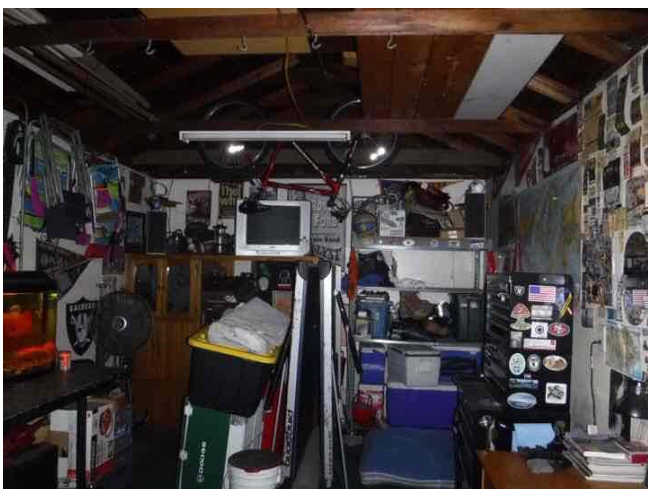
Photo 17

9. Personal storage was blocking access to the interior of the garage. Therefore, the area is considered inaccessible and was not fully inspected. With access and an opportunity for complete inspection, conditions in need of attention may be discovered. Ideally, the personal belongings should be removed so the area may be inspected. (See Photo 17)

Personal storage was blocking access to the interior of the garage. Therefore, the area is considered inaccessible and was not fully inspected. With access and an opportunity for complete inspection, conditions in need of attention may be discovered. Ideally, the personal belongings should be removed so the area may be inspected. (See Photo 17)

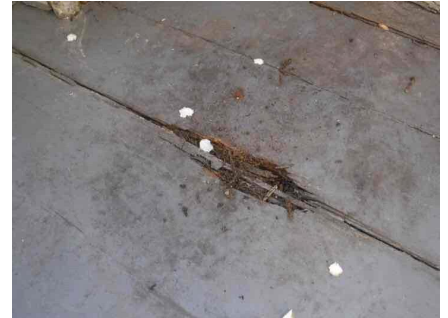
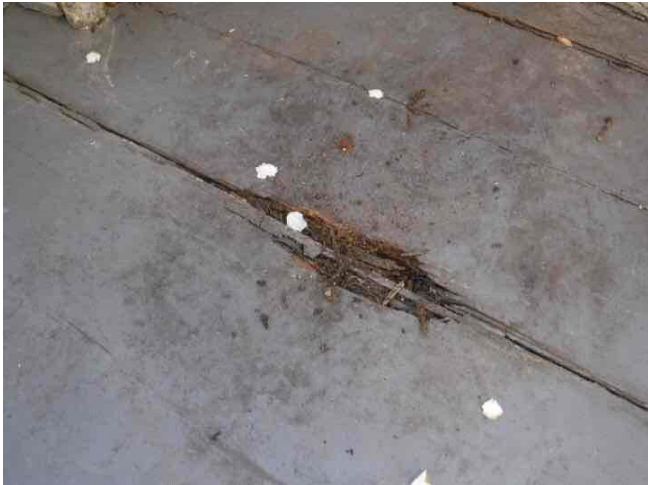
Photo 01

10. Water damage was noted at the front deck(s). We recommend the services of a licensed general contractor and/or structural pest control company. (See Photo 1)

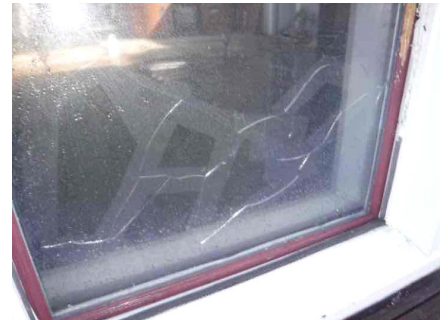
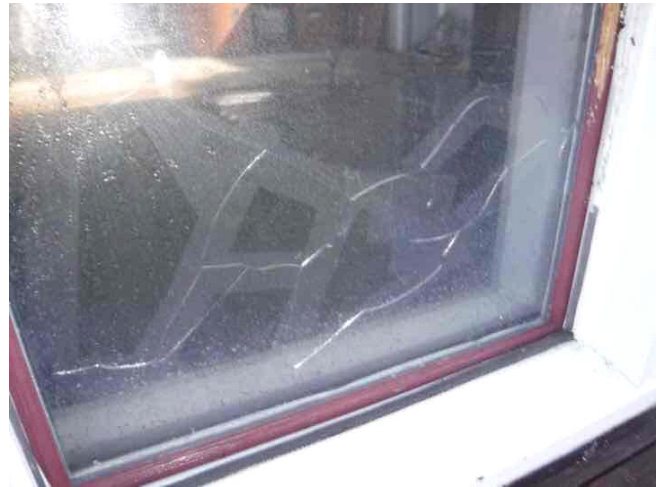
Photo 08

11. Cracked or broken exterior window glass at the rear should be replaced. (See Photo 8)

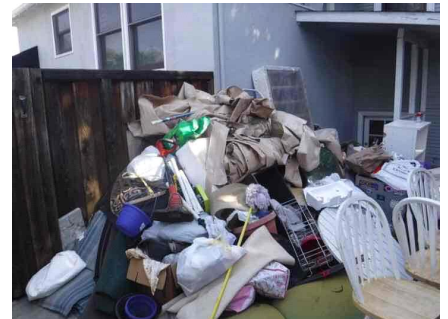
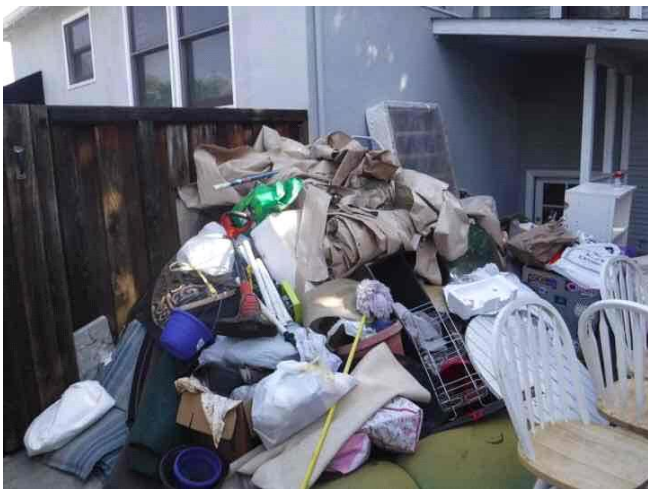
Photo 09

12. Portions of the exterior of the structure or property at the rear were inaccessible due to owner storage. Reportable conditions may be hidden from inspection. We recommend this area be cleared to allow for further inspection. (See Photo 9)

Portions of the exterior of the structure or property at the rear were inaccessible due to owner storage. Reportable conditions may be hidden from inspection. We recommend this area be cleared to allow for further inspection. (See Photo 9)

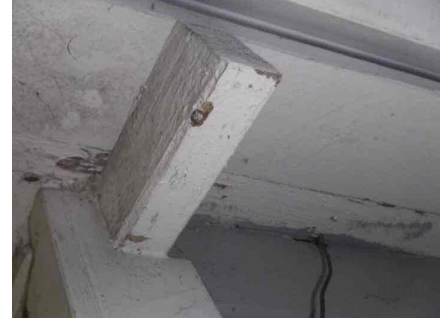
Photo 25

13. Water damage was observed to the rafters at the rear garage structure. We recommend the services of a licensed general contractor and/or structural pest control company. (See Photo 25)

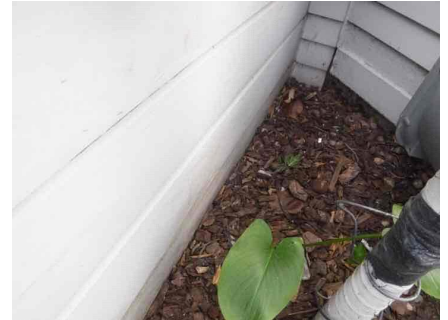
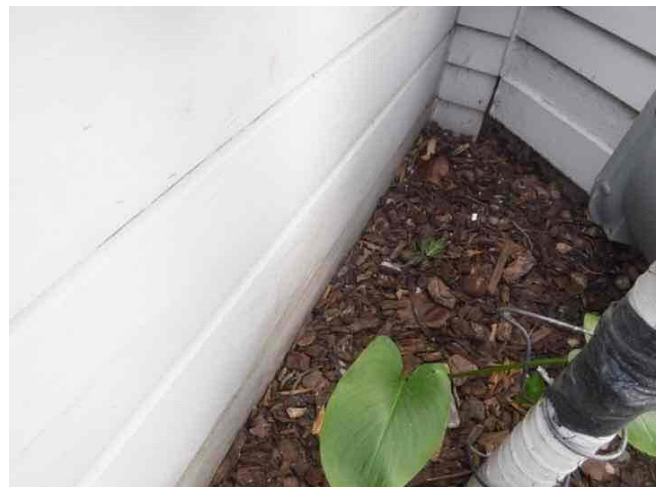
Photo 04

14. Wood/soil contact at the base of the wood siding at various locations should be eliminated. If rotted or damaged siding is found consult a licensed structural pest control operator regarding repairs. (See Illustration 3S) (See Photo 4)

- ! 6. Wood/soil contact at the base of the wood siding at various locations should be eliminated. If rotted or damaged siding is found consult a licensed structural pest control operator regarding repairs. (See Illustration 3S) (See Photo 4)

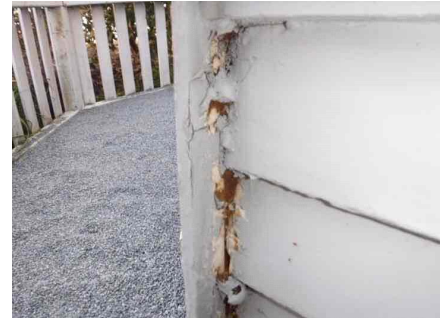
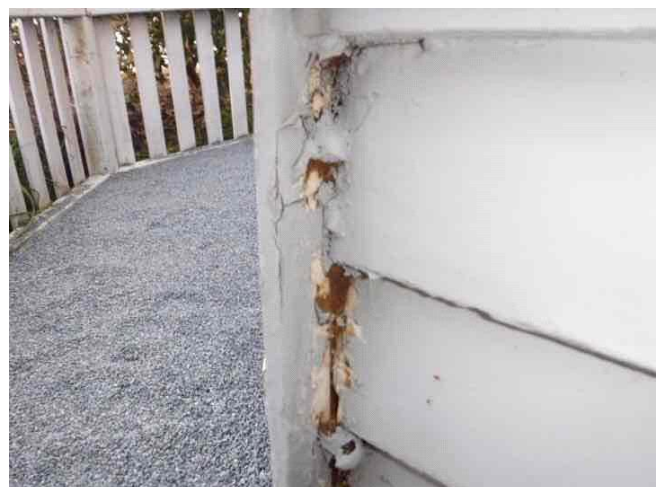
Photo 06

15. Water damage was observed to the wood siding at several locations exterior walls. We recommend the services of a licensed general contractor and/or structural pest control company. (See Photo 6)

- ! 7. Water damage was observed to the wood siding at several locations exterior walls. We recommend the services of a licensed general contractor and/or structural pest control company. (See Photo 6)

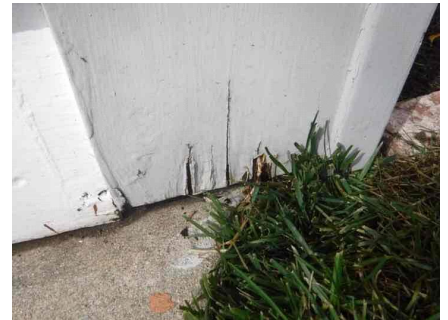
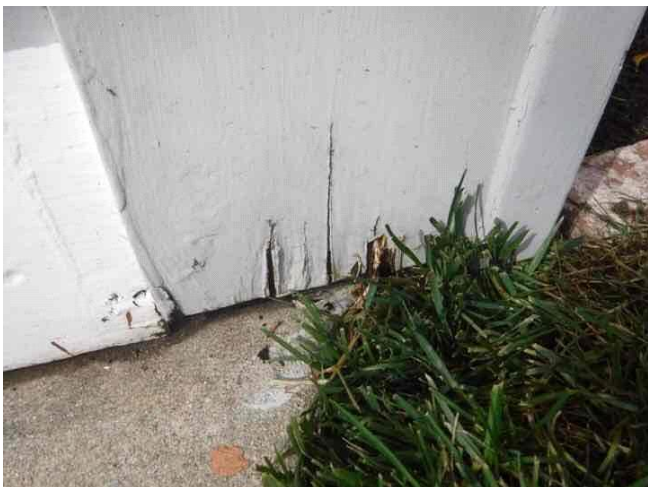
Photo 03

16. Water damage was observed to the exterior trim at several locations. We recommend the services of a licensed general contractor and/or structural pest control company. (See Photo 3)

- ! 8. Water damage was observed to the exterior trim at several locations. We recommend the services of a licensed general contractor and/or structural pest control company. (See Photo 3)

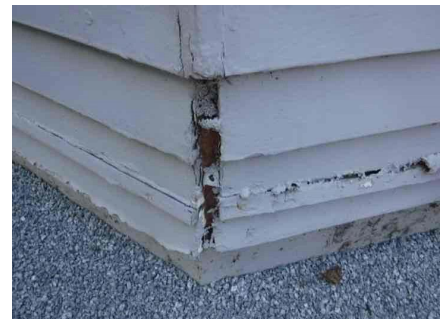
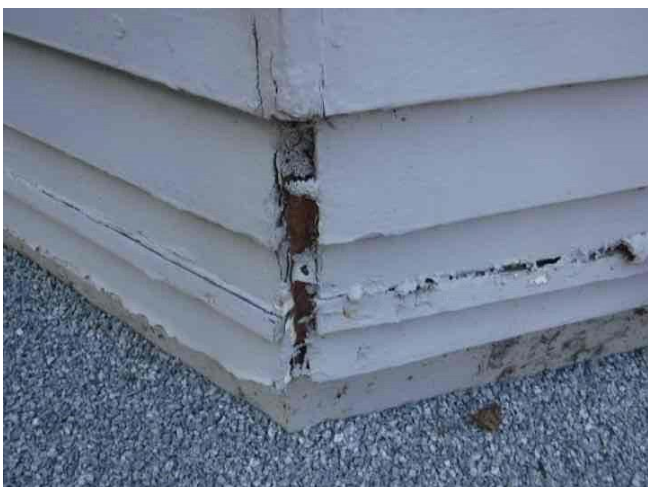
Photo 05

17. The missing trim at the right should be replaced and caulked. (See Photo 5)

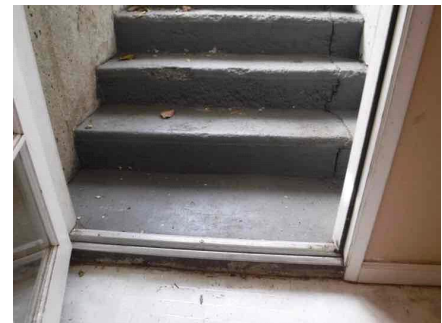
Photo 38

19. The steps at the rear appear to be non-conforming. This could create a potential fall hazard. We recommend the services of a licensed general contractor. (See Illustration 3R) (See Photo 38)

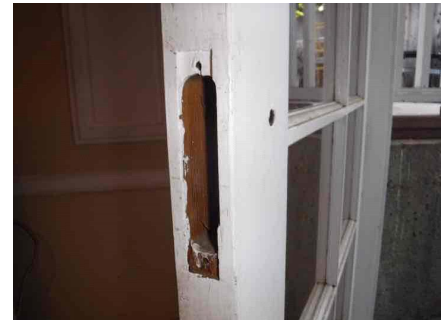
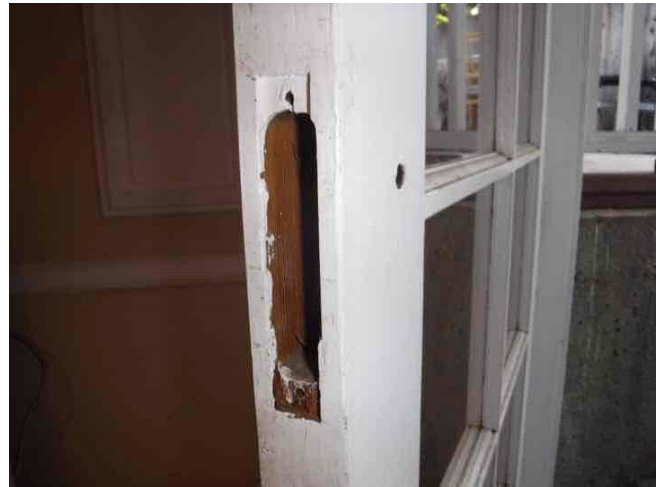
Photo 20

20. Missing hardware was noted at the rear french door. We recommend that hinges, knobs, latches and strike plates be adjusted or replaced to restore full operation. (See Photo 20)

- ! 11. Missing hardware was noted at the rear french door. We recommend that hinges, knobs, latches and strike plates be adjusted or replaced to restore full operation. (See Photo 20)

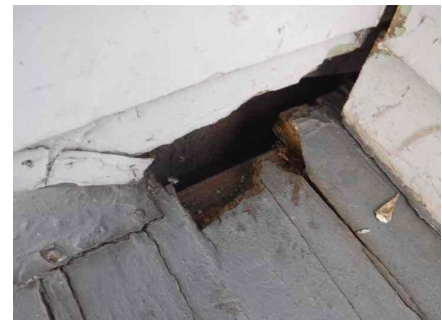
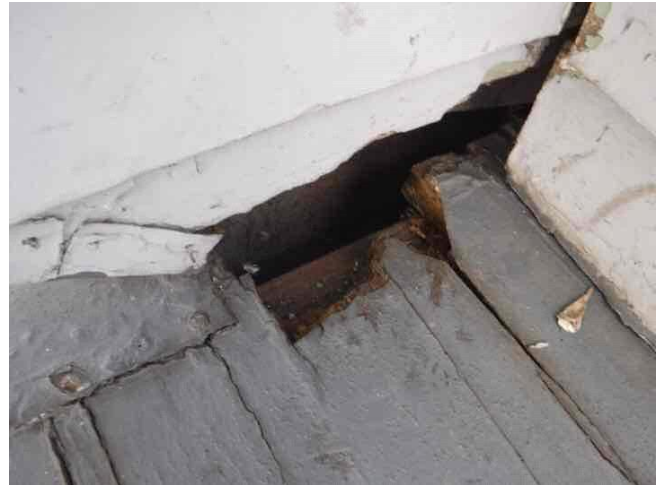
Photo 02

21. Some of the front deck boards were noted to be incomplete. We recommend the boards to be repaired or replaced. (See Photo 2)

! 12. Some of the front deck boards were noted to be incomplete. We recommend the boards to be repaired or replaced.
(See Photo 2)

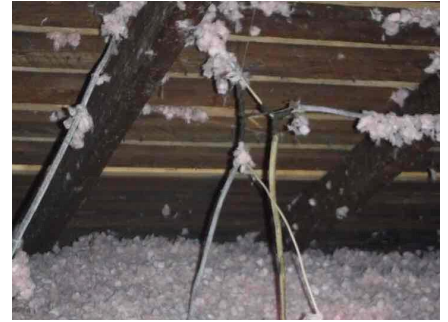
Photo 29

22. Running splices, which are improper connections outside of a junction box, were observed in the attic and crawlspace. We recommend connections be joined with approved connectors inside a junction box to prevent accidental contacts or mechanical damage. (See Photo 29)

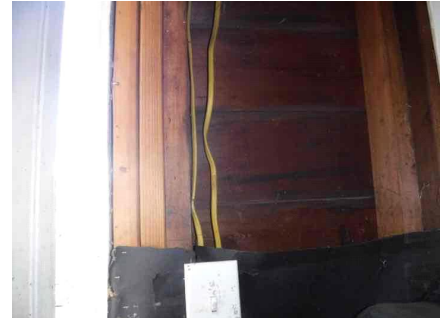
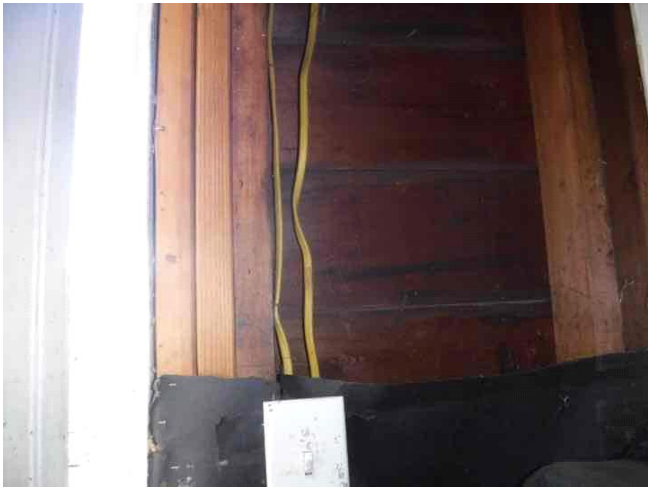
Photo 19

23. We found exposed wiring at the garage walls below 7' feet. Even if insulated, we recommend all wiring be encased in conduit or otherwise protected in accordance with present standards. (See Illustration 4E) (See Photo 19)

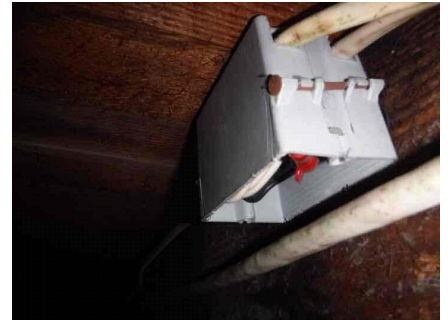
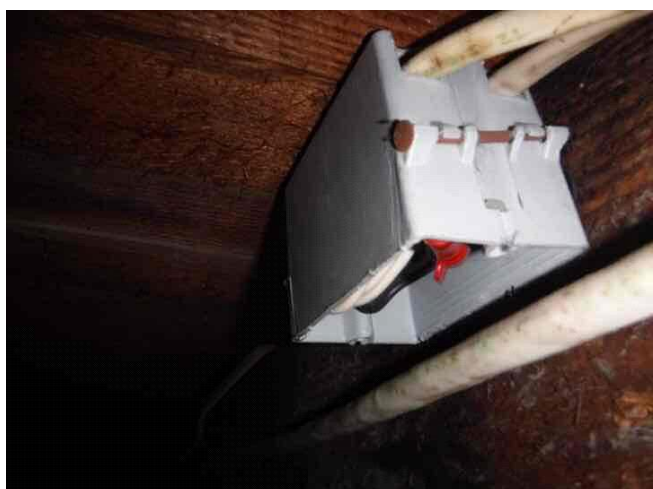
Photo 33

24. Exposed electrical connections or open junction boxes at the crawlspace should be corrected. All electrical connections should be made inside approved junction boxes fitted with proper cover plates. (See Photo 33)

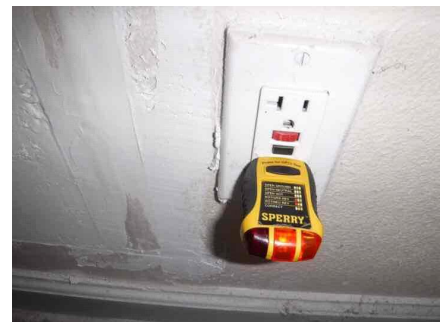
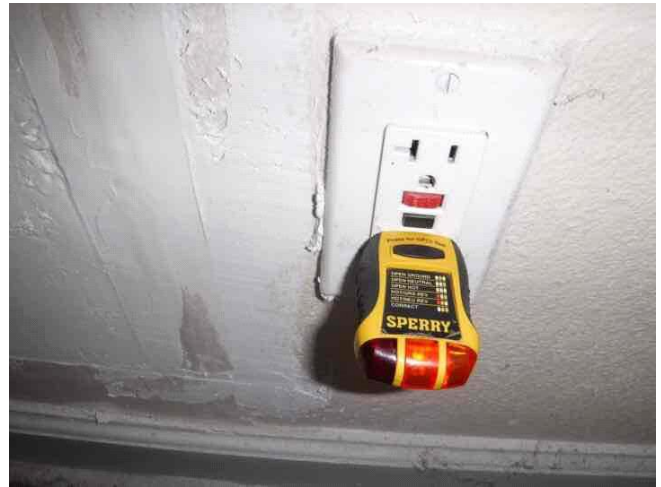
Photo 14

25. Ungrounded "3-prong" outlets at several locations should be improved. A grounded cable or ground wire could be installed at these outlets, the outlet labeled as ungrounded or the original "2-prong" receptacle could be reinstalled. Based upon our inspection of a representative number of outlets, we recommend testing of every outlet. Repairs or rewiring are recommended at all deficient locations. For additional information we recommend a licensed electrician be consulted. (See Illustration 4O) (See Photo 14)

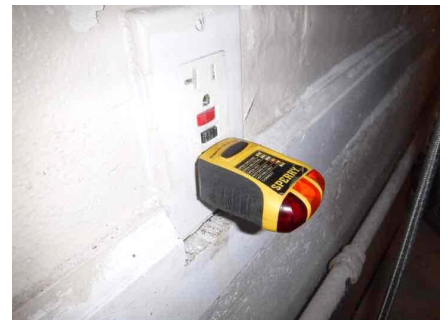
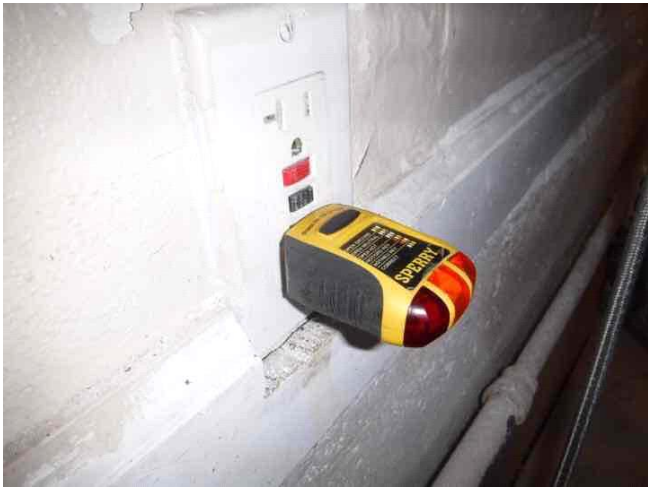
Photo 13

26. A ground fault circuit interrupter (GFCI) outlet at the laundry did not function or did not trip when tested with an outside source and/or the test button. This outlet and circuit should be investigated and repaired. (See Photo 13)

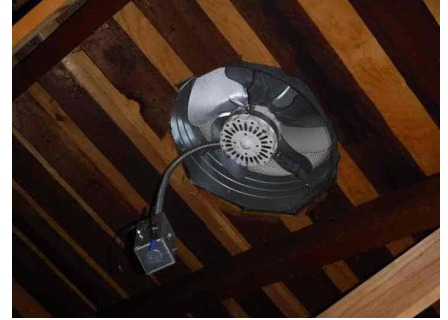
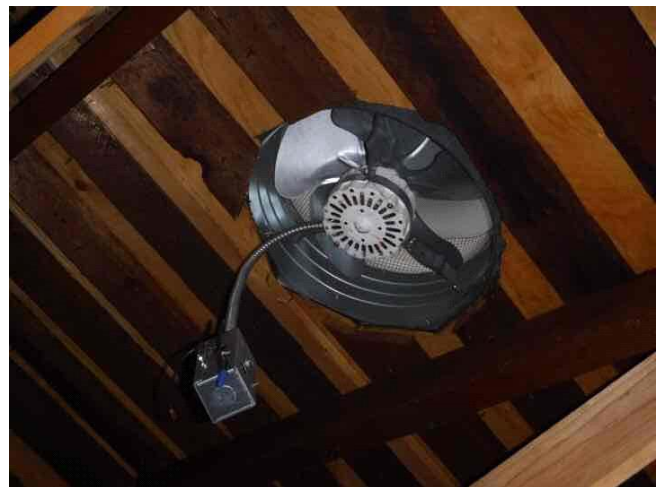
Photo 30

27. The attic is equipped with ventilation fan(s). The fan(s) is disconnected. We recommend it be connected and tested. (See Photo 30)

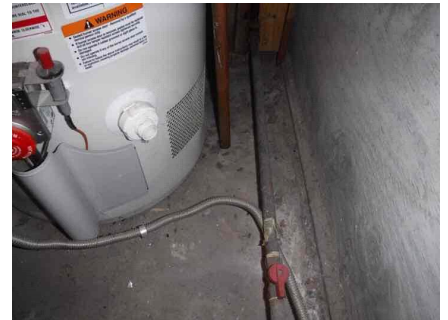
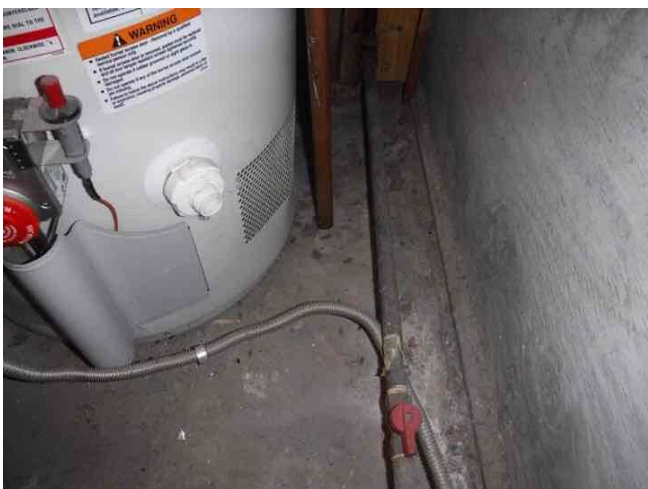
Photo 23

28. The temperature and pressure relief discharge pipe for the water heater is improper. We recommend the installation of a proper discharge pipe to an approved location. (See Photo 23)

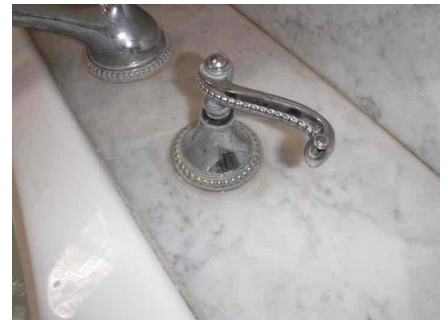
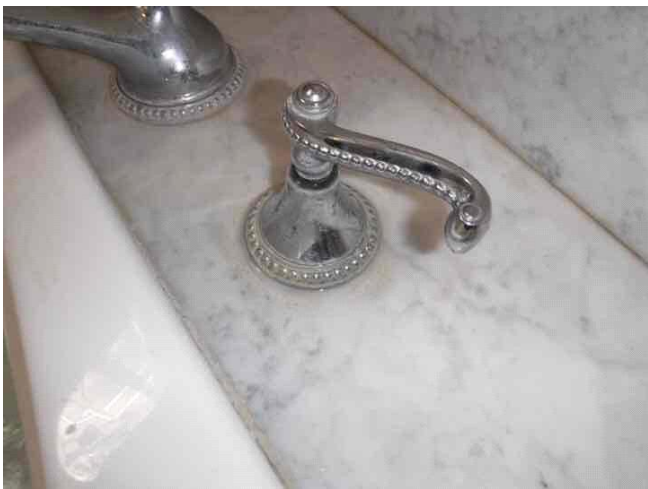
Photo 27

29. The tub cold water faucet handle is loose and leaking at the master bathroom. We recommend all leaks be repaired. (See Photo 27)

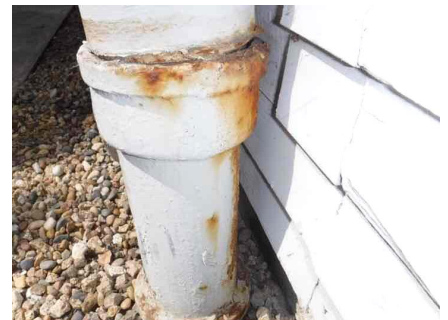
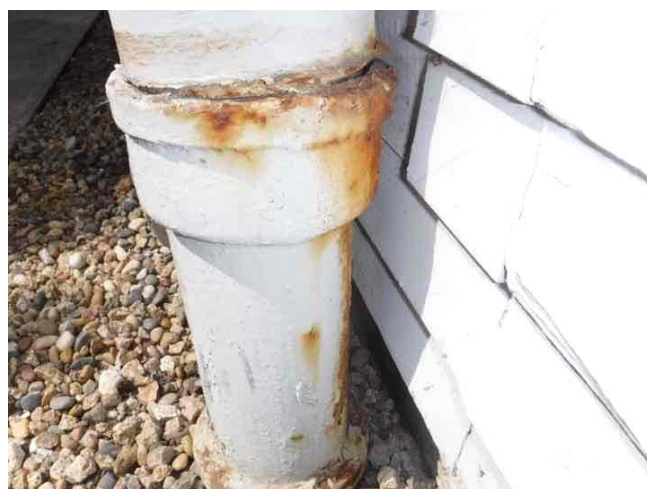
Photo 36

30. There is evidence of heavy corrosion and rust, but no leakage on the exterior of the exposed and accessible metal drain piping in the exterior left. This piping should be monitored for leakage and repaired as necessary. Upgrading this piping and connections should also be considered. (See Photo 36)

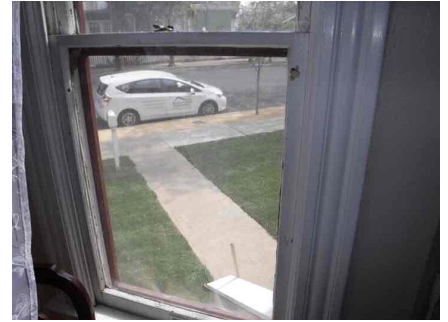
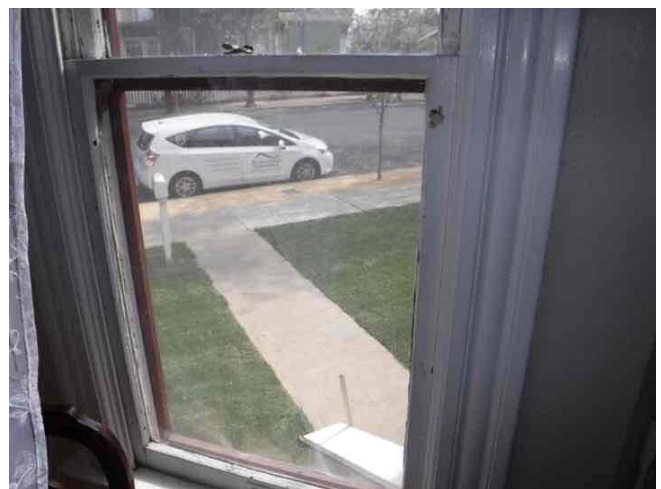
Photo 24

31. One or more of the windows are not fully serviceable because their lift mechanism sash cords or springs are missing or damaged. We recommend these windows be repaired and their full functional use restored. (See Photo 24)

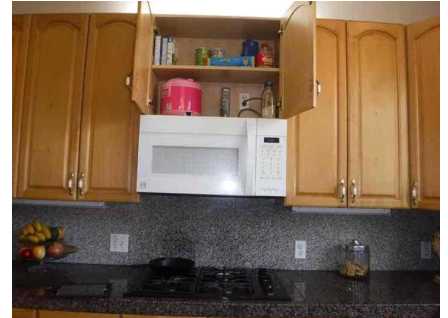
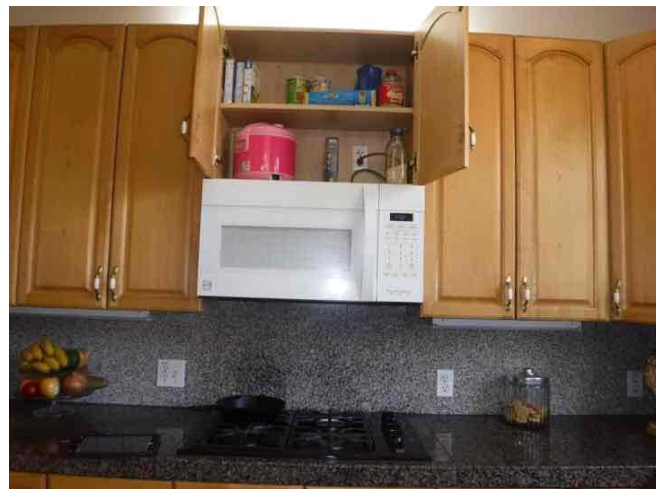
Photo 28

32. There is no "exterior vented" exhaust fan for the gas appliances installed in the kitchen. It is recommended that all gas appliances be vented to the exterior. (See Photo 28)

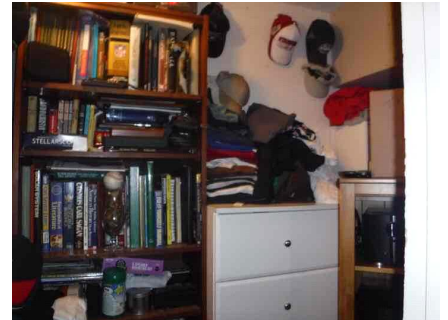
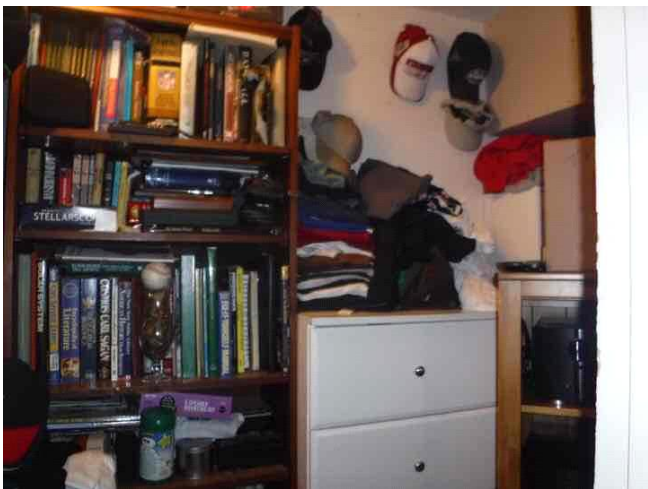
Photo 21

33. Personal storage was blocking access to the interior of the bathroom sink cabinets, closets and living areas. Therefore, the area is considered inaccessible and was not fully inspected. With access and a opportunity for complete inspection, conditions in need of attention may be discovered. The personal belongings should be removed so the area may be examined. (See Photo 21)

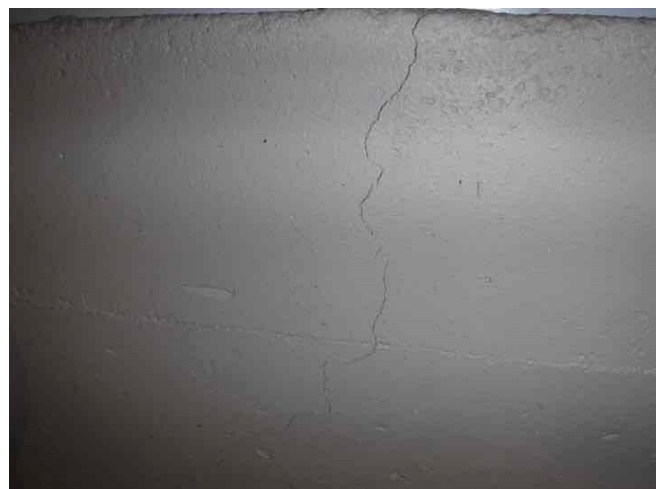
Photo 12

- ! 1. Foundation cracking and/or movement was observed at the foundation walls in the basement. The rate of movement cannot be predicted during a one-time inspection. A thorough evaluation of this condition is beyond our qualifications. For additional information we recommend a licensed foundation specialist be retained. (See Photo 12)

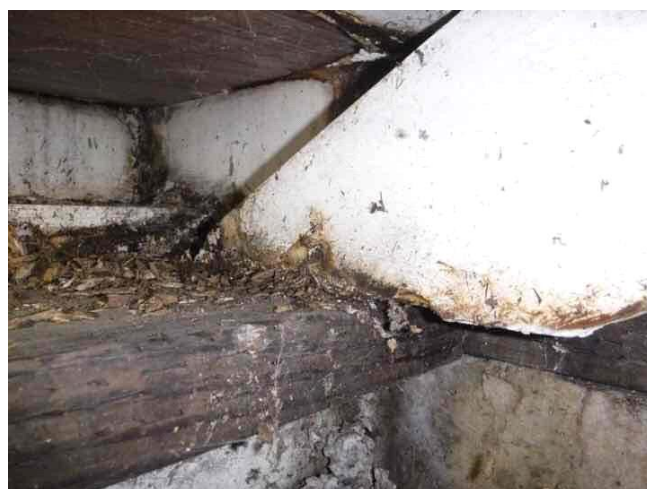
Photo 34

- ! 2. The wood members at the crawl space under the front stairs and front left area show evidence of water damage. We recommend the services of a licensed structural pest control operator for investigation of this condition. (See Photo 34)
