Project Proposal
1411 Lewis Street and 1444 Madison Street
Santa Clara, California

MADISON AND LEWIS STREET PROJECT DESCRIPTION

Location: 1411 Lewis Street and 1444 Madison Street

March 5, 2018

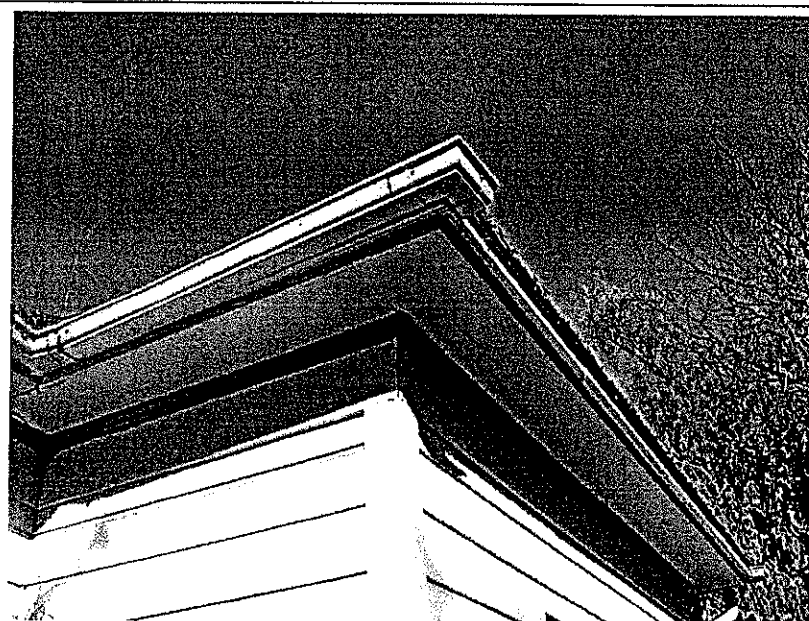
Photo 6: Detail of eaves showing deterioration.

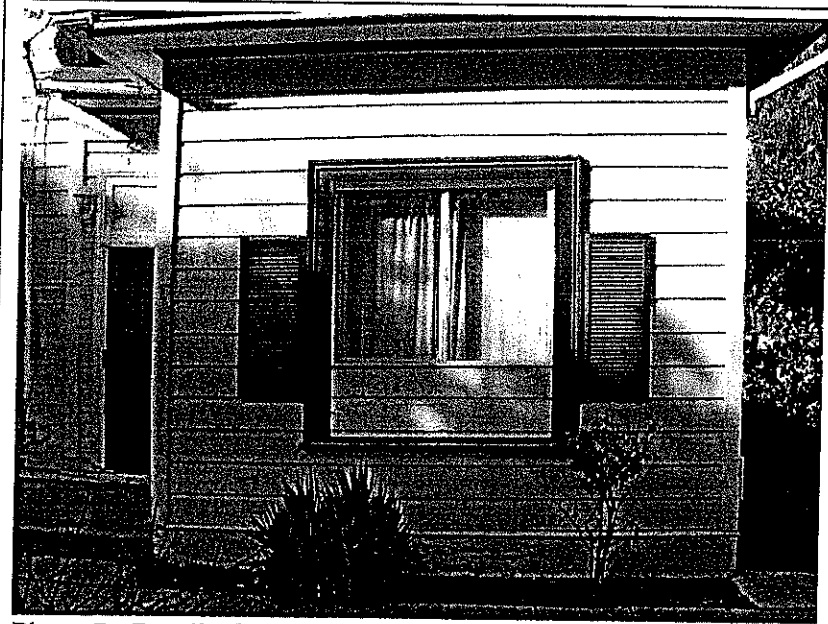
Photo 7: Detail of windows resized and replace with vinyl.

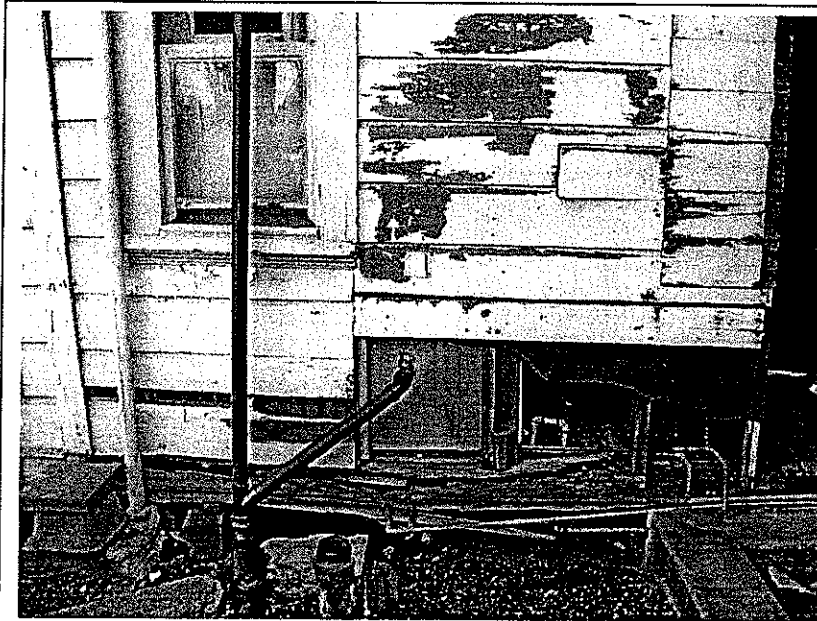
Photo 13: Detail of extensive damage and deterioration on addition.

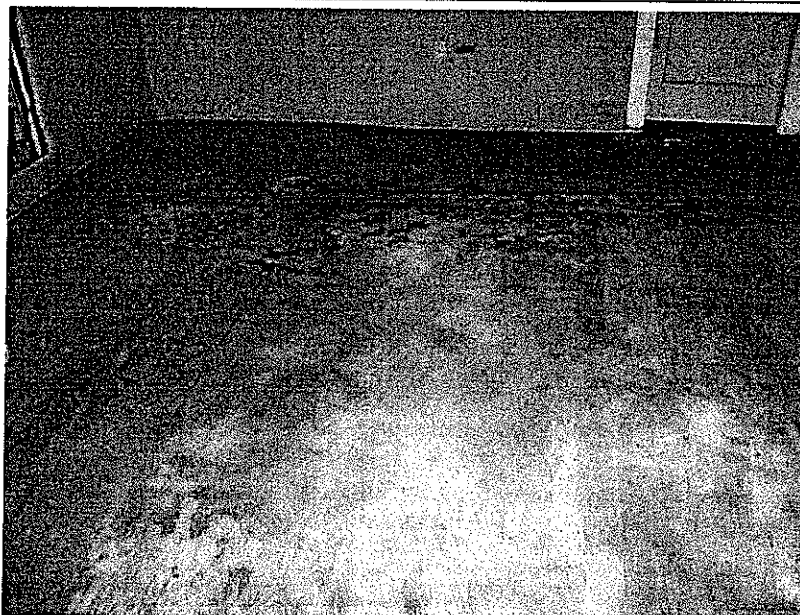
Photo 18: Detail of the stripped and damage flooring in the living room.

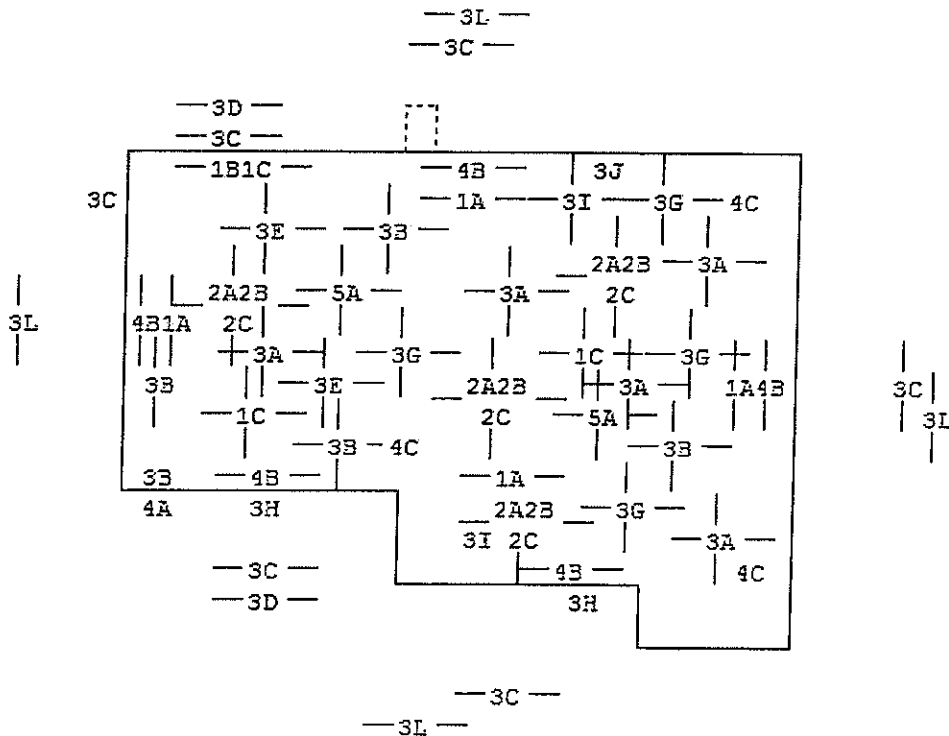
1A. FINDING: Evidence of subterranean termite infestation was observed in one or more locations at the structure, noted as 1A on the diagram.

1B. FINDING: Evidence in the form of shelter tubes for subterranean termites was observed and noted as 1B on the diagram.

1C. FINDING: Subterranean termite damage was observed at the mud sills, girders and joists throughout, noted as 1C on the diagram.

2A. FINDING: Evidence of drywood termites was observed at the areas noted as 2A on the diagram.

2B. FINDING: Evidence of drywood termites, in the form of drywood pellets, was observed, noted as 2B on the diagram.

2C. FINDING: Subterranean termite damage was observed at the framing, subfloor and floors throughout, noted as 2C on the diagram.

3A. FINDING: Fungus damage was observed at the roof framing and sheathing throughout, noted as 3A on the diagram.

3B. FINDING: Fungus damage was observed at the mud sill, joists and framing throughout, noted as 3B on the diagram.

3C. FINDING: Fungus damage was observed at the siding, trim and framing throughout, noted as 3C on the diagram.

3D. FINDING: Fungus damage was observed at the fascia board(s) throughout, noted as 3D on the diagram.

3E. FINDING: Fungus, drywood termite and subterranean termite damage was observed at the floors throughout, noted as 3E on the diagram.

3F. FINDING: Fungus damage was observed at the basement door and door framing, noted as 3F on the diagram.

RECOMMENDATION: Perform a guaranteed soil treatment around the entire foundation for the control of subterranean termites using a registered termiticide. (Section I Item)

RECOMMENDATION: Remove all shelter tubes. (Section I)
(SECTION I ITEM)

RECOMMENDATION: Remove and replace damaged wood members. (Section I)

RECOMMENDATION: Tarp, seal, and fumigate with lethal gas, Vikane or other similar chemical. (Section I)

RECOMMENDATION: Mask and/or remove all pellets that are accessible. (Section I) (SECTION I ITEM)

RECOMMENDATION: Remove and replace damaged wood members. If possible, we will chisel or cut out the damage and fill with a plastic or wood filler. (Section I)

RECOMMENDATION: Remove and replace damaged wood members. If possible, we will chisel or cut out the damage and fill with a plastic or wood filler. Primer paint only. (Section I)

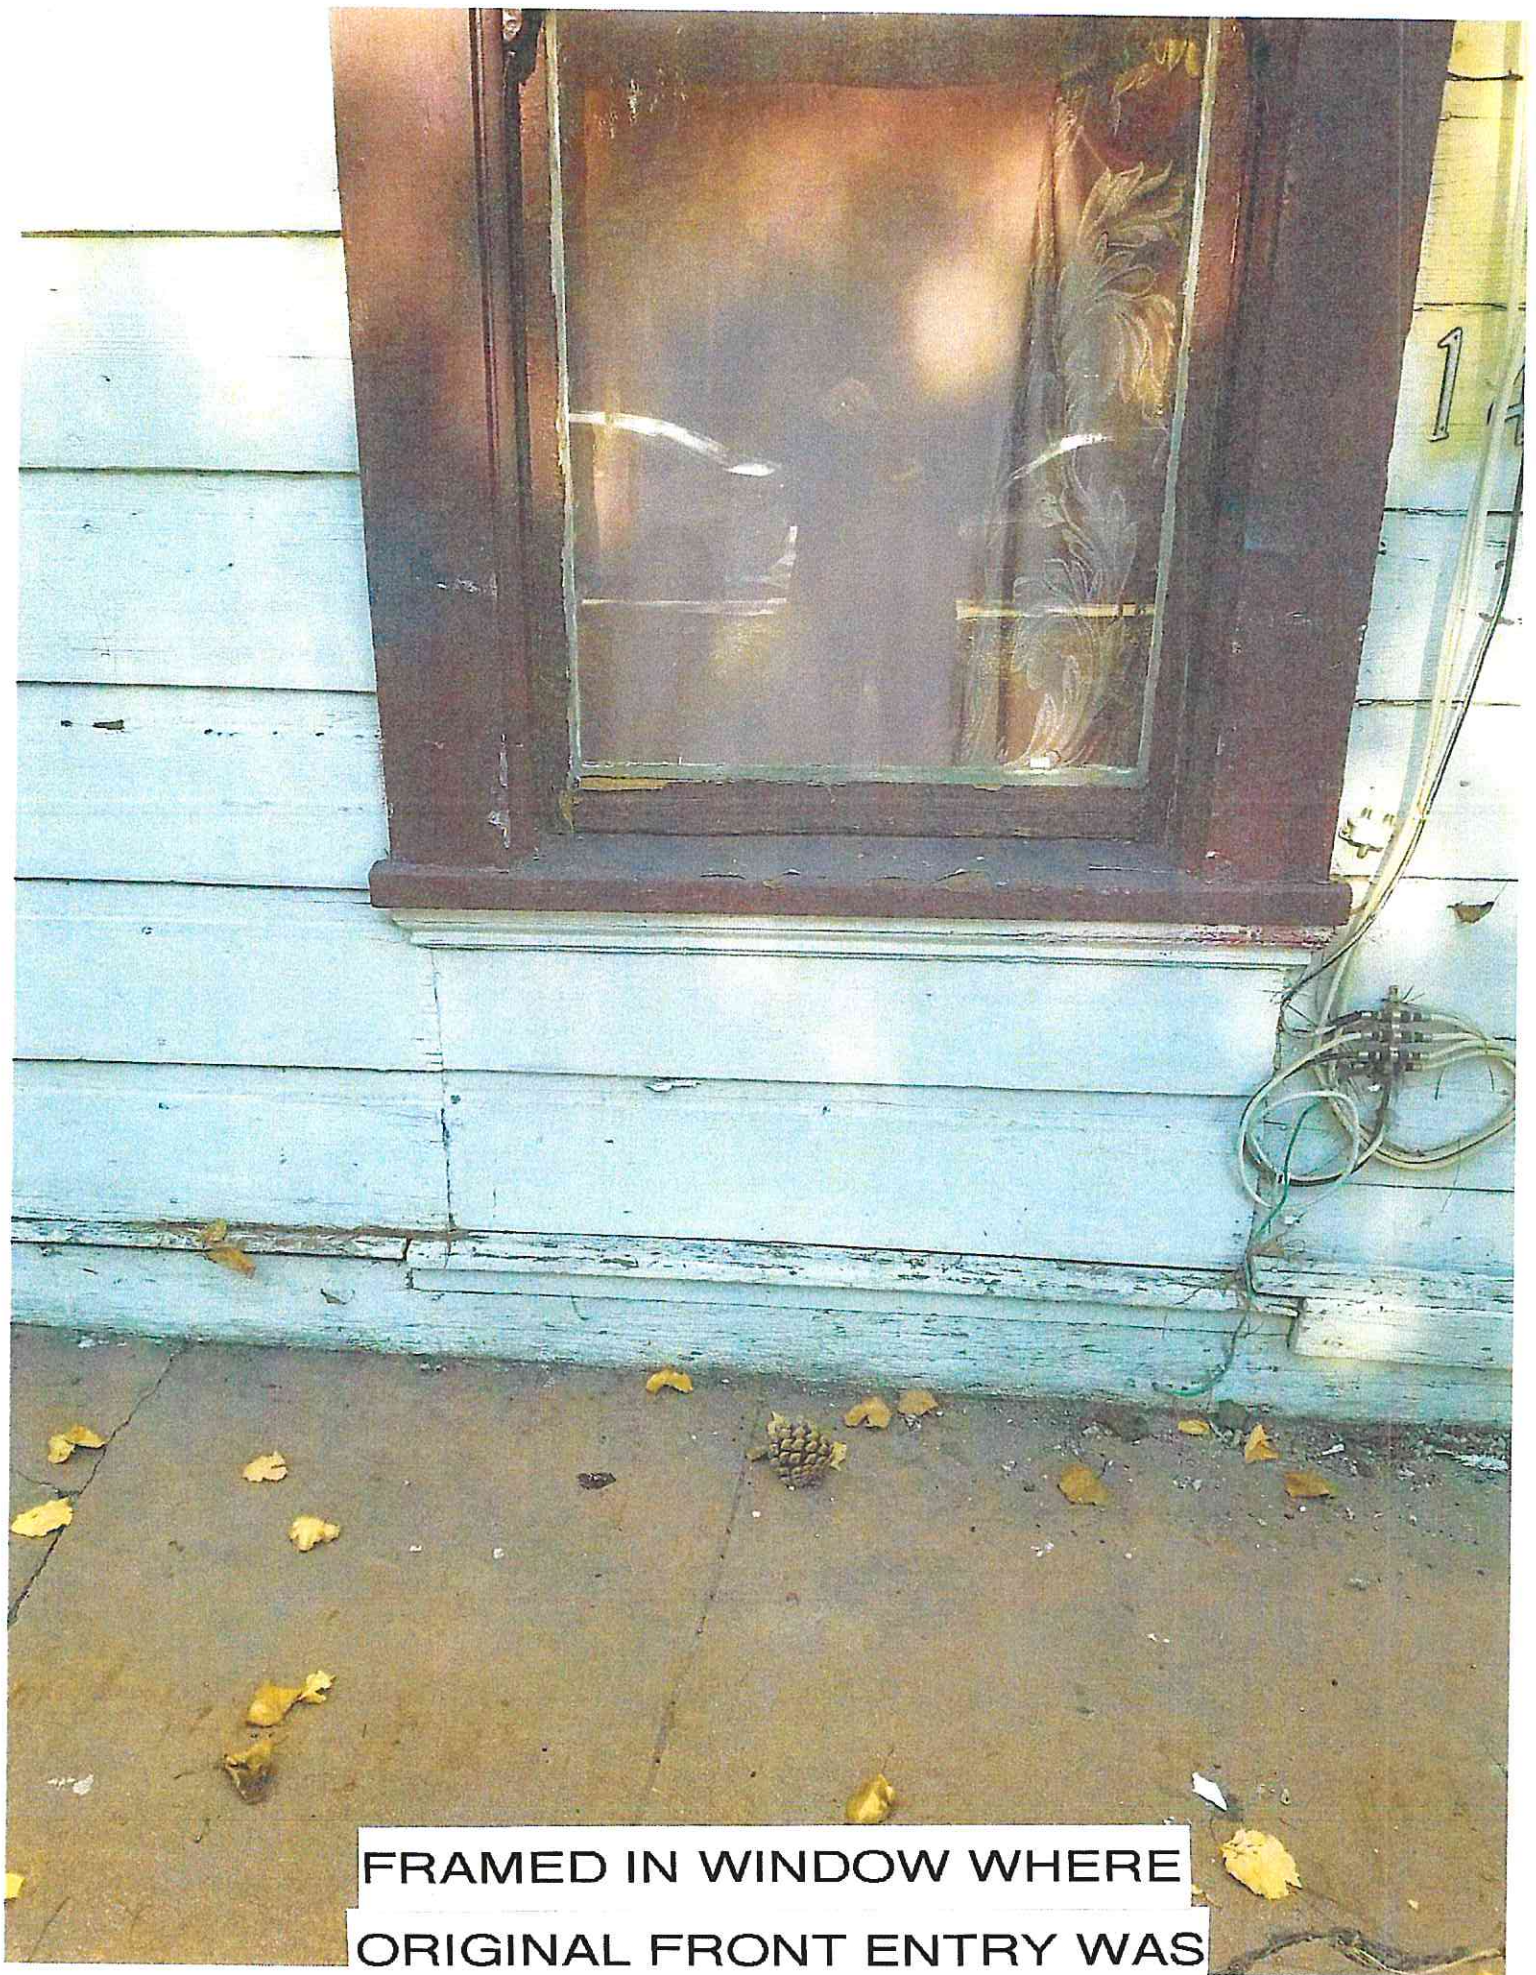
FRAMED IN WINDOW WHERE
ORIGINAL FRONT ENTRY WAS

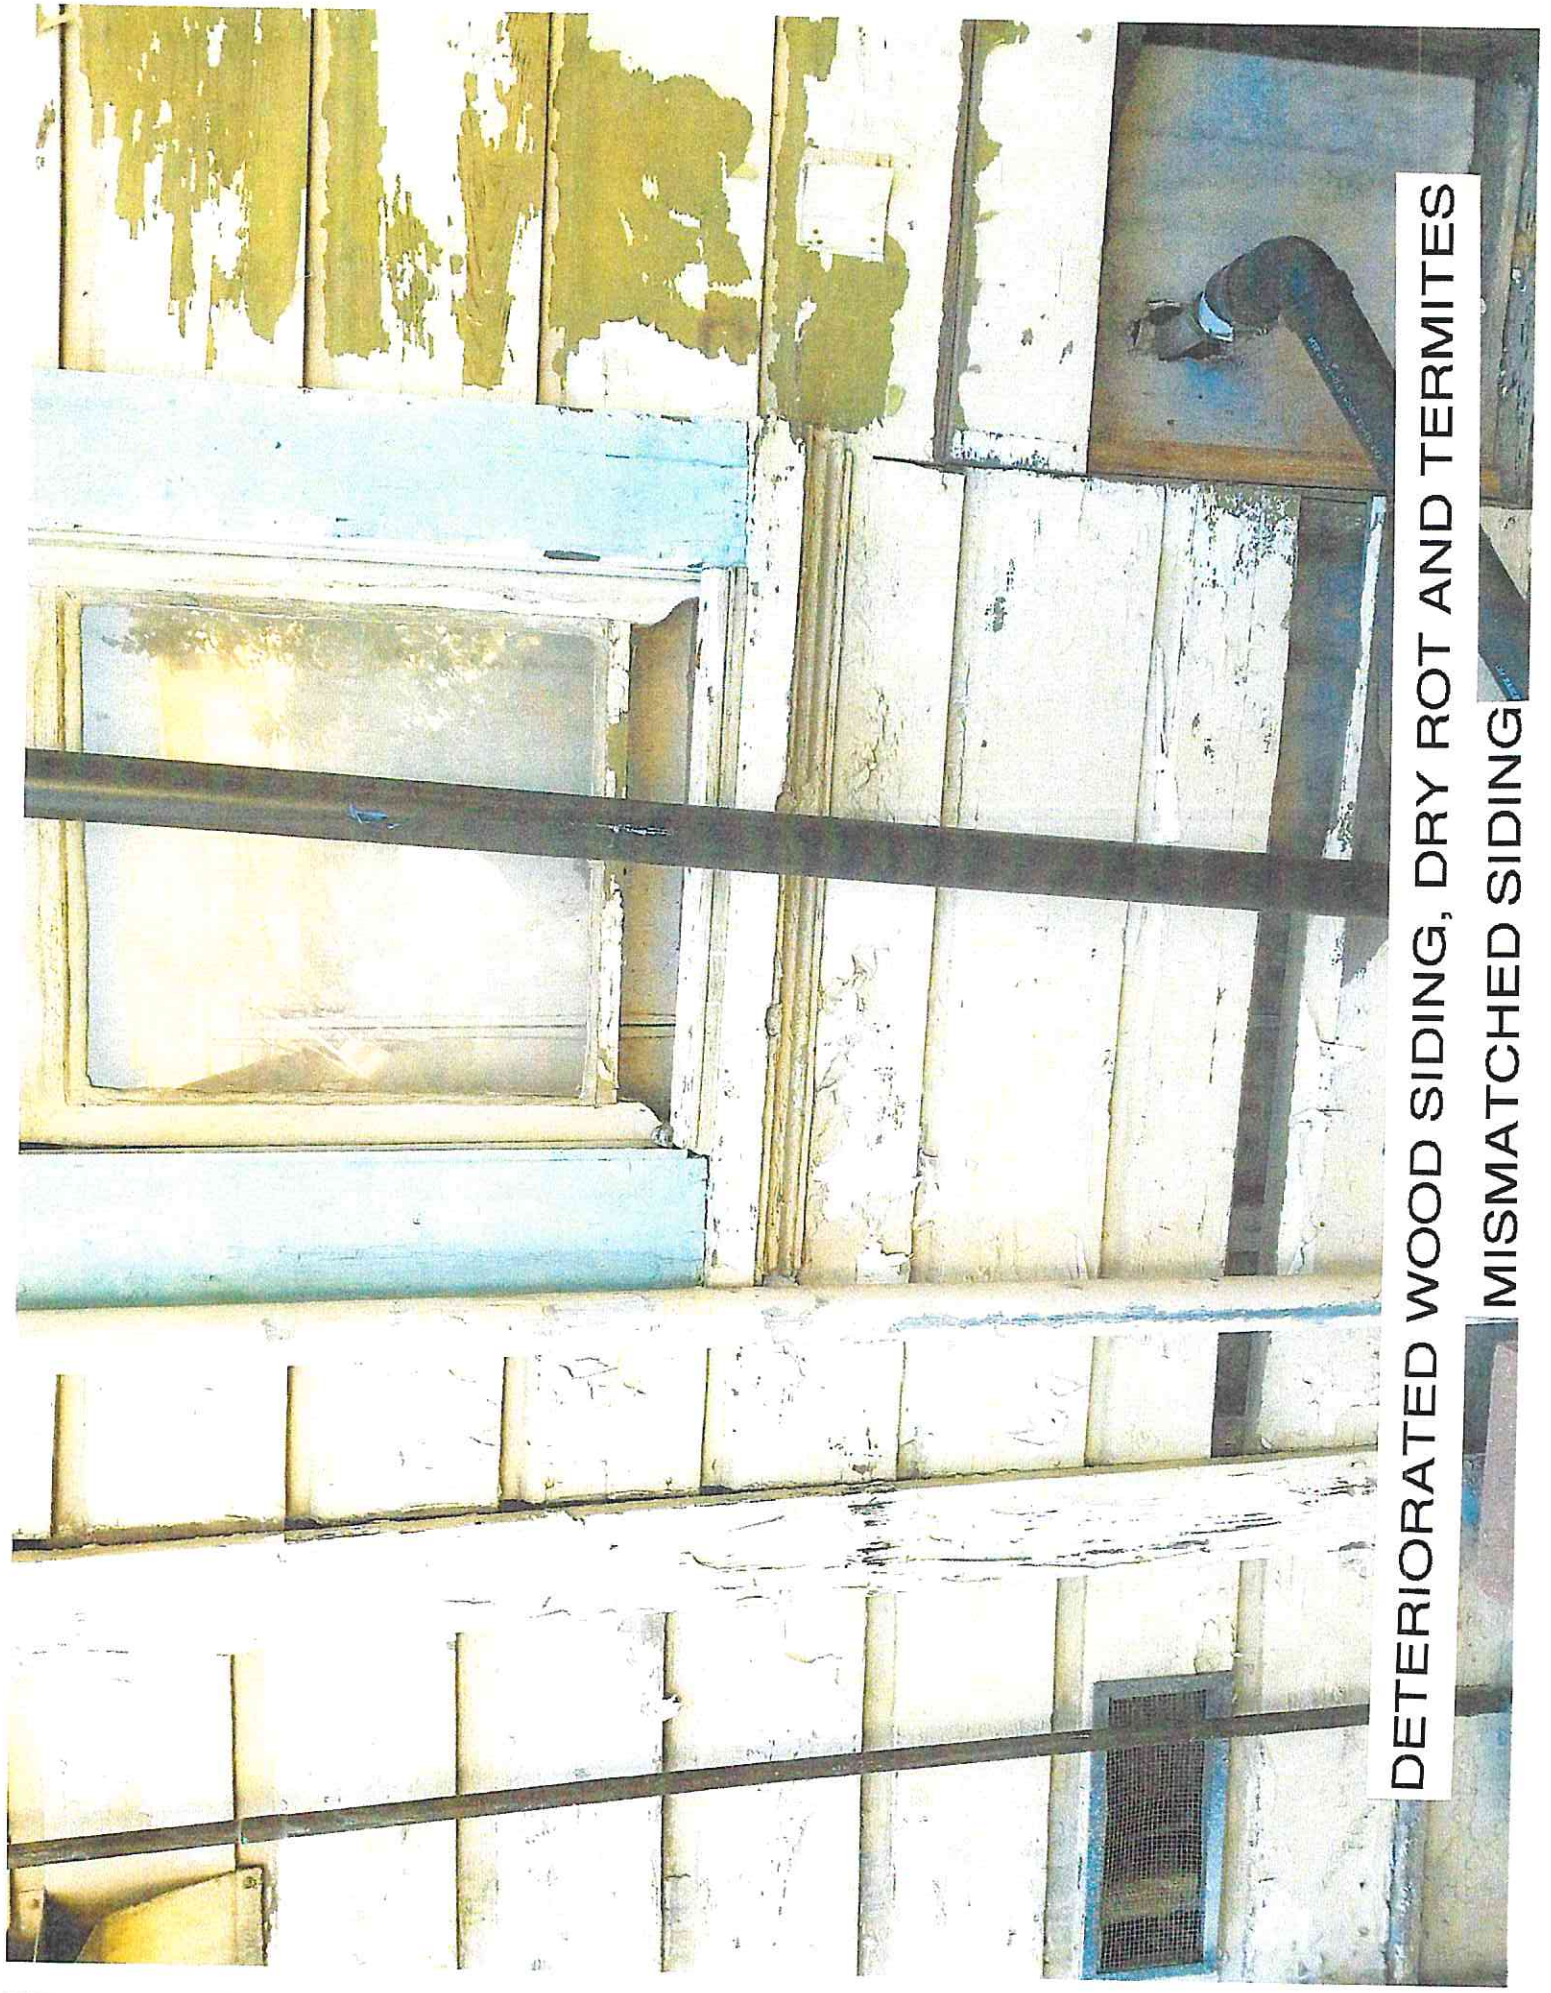
DETERIORATED WOOD SIDING, DRY ROT AND TERMITES
MISMATCHED SIDING
