Project Proposal
1411 Lewis Street and 1444 Madison Street
Santa Clara, California

MADISON AND LEWIS STREET PROJECT DESCRIPTION

Location: 1411 Lewis Street and 1444 Madison Street

March 5, 2018

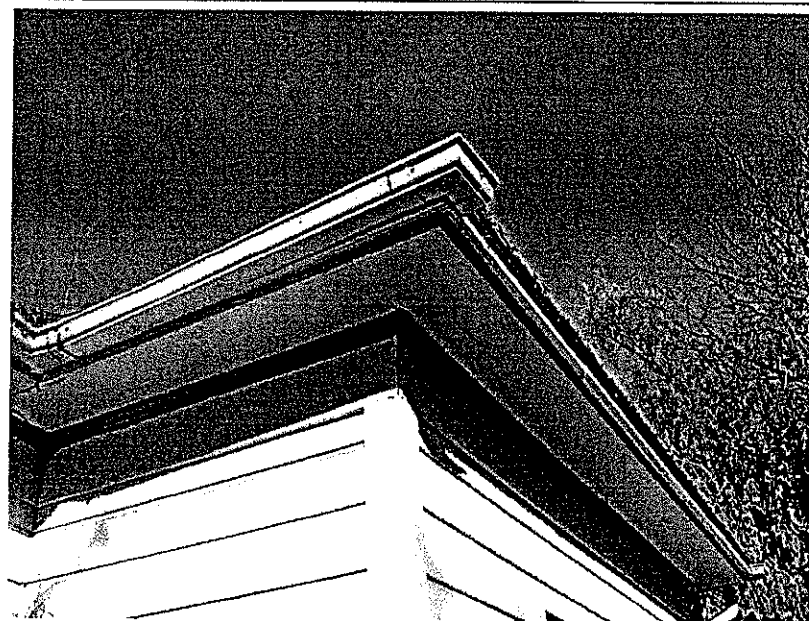
Photo 6: Detail of eaves showing deterioration.

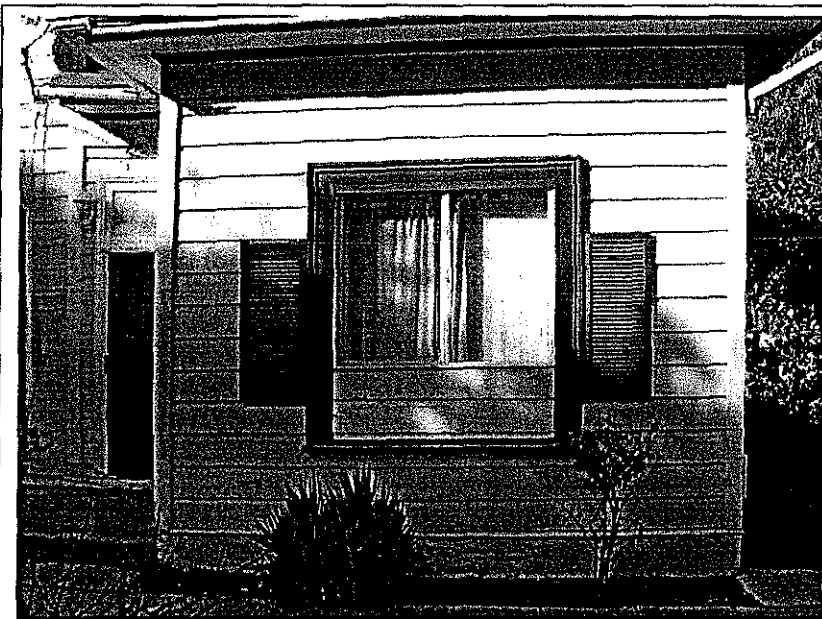
Photo 7: Detail of windows resized and replace with vinyl.

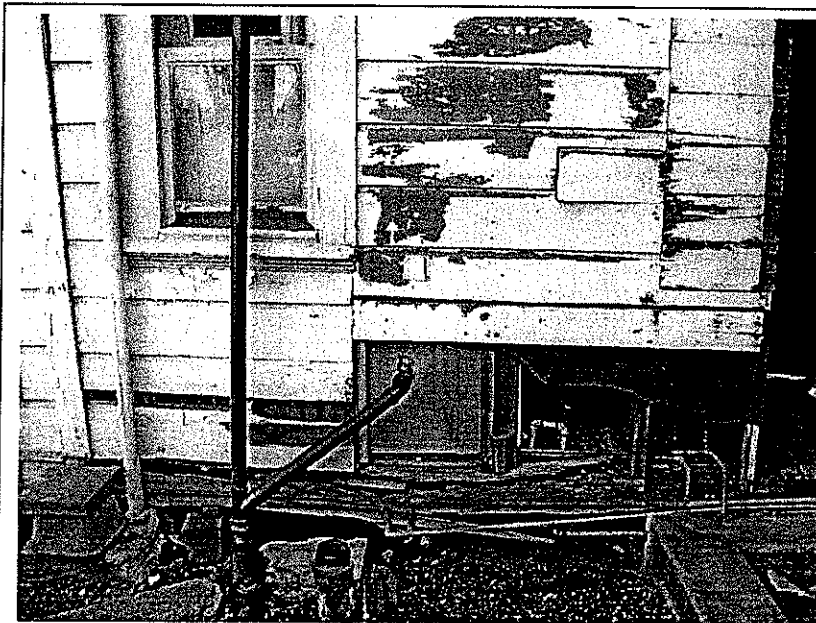
Photo 13: Detail of extensive damage and deterioration on addition.

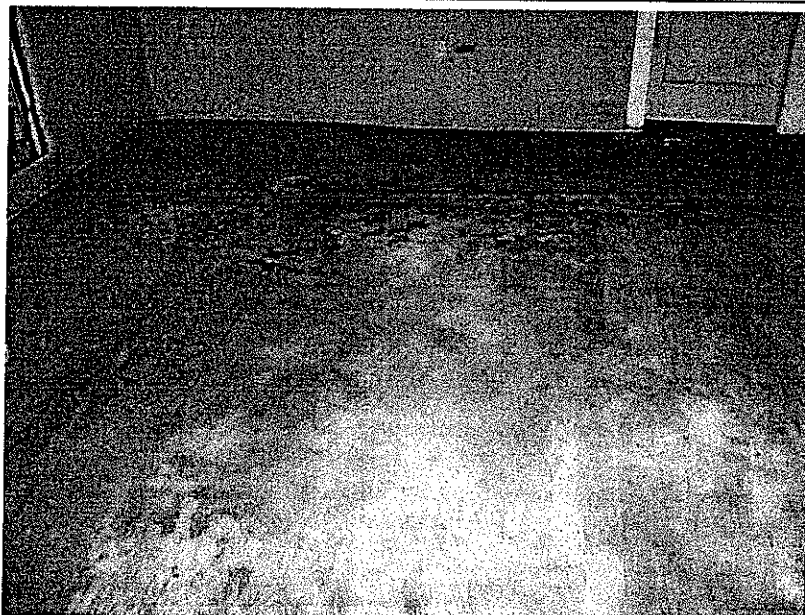
Photo 18: Detail of the stripped and damage flooring in the living room.

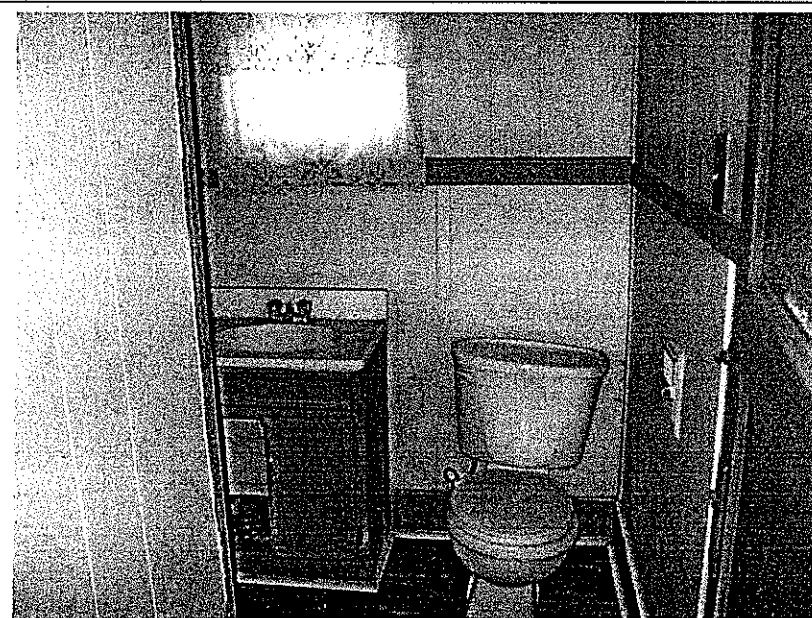
Photo 22: View of the bathroom, note non-original fixtures.

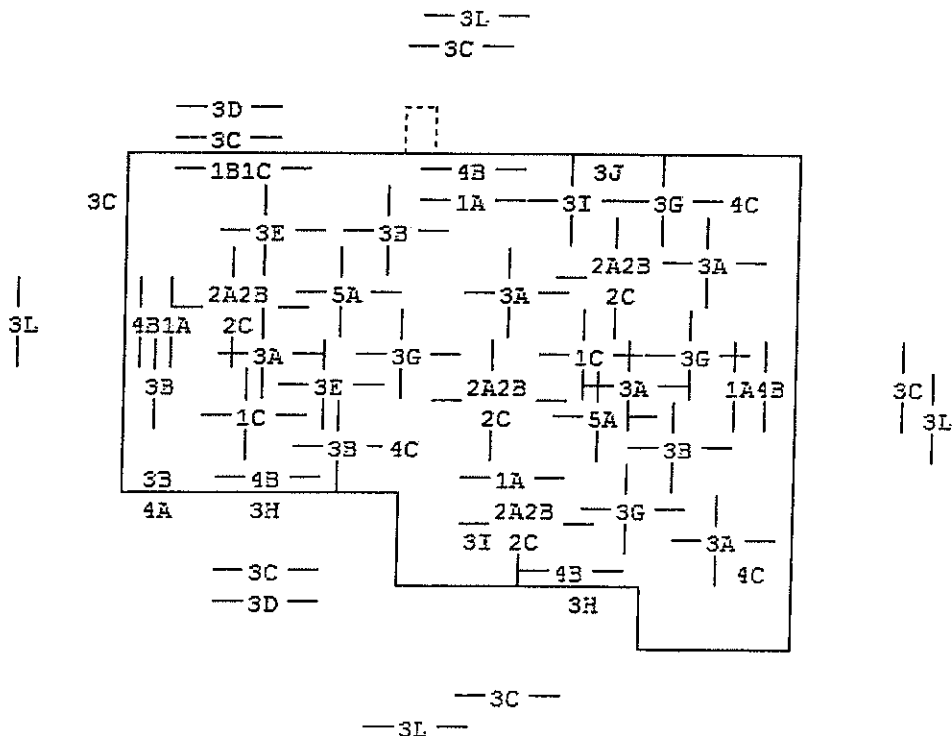
1A. FINDING: Evidence of subterranean termite infestation was observed in one or more locations at the structure, noted as 1A on the diagram.

1B. FINDING: Evidence in the form of shelter tubes for subterranean termites was observed and noted as 1B on the diagram.

1C. FINDING: Subterranean termite damage was observed at the mud sills, girders and joists throughout, noted as 1C on the diagram.

2A. FINDING: Evidence of drywood termites was observed at the areas noted as 2A on the diagram.

2B. FINDING: Evidence of drywood termites, in the form of drywood pellets, was observed, noted as 2B on the diagram.

2C. FINDING: Subterranean termite damage was observed at the framing, subfloor and floors throughout, noted as 2C on the diagram.

3A. FINDING: Fungus damage was observed at the roof framing and sheathing throughout, noted as 3A on the diagram.

3B. FINDING: Fungus damage was observed at the mud sill, joists and framing throughout, noted as 3B on the diagram.

3C. FINDING: Fungus damage was observed at the siding, trim and framing throughout, noted as 3C on the diagram.

3D. FINDING: Fungus damage was observed at the fascia board(s) throughout, noted as 3D on the diagram.

RECOMMENDATION: Perform a guaranteed soil treatment around the entire foundation for the control of subterranean termites using a registered termiticide. (Section I Item)

RECOMMENDATION: Remove all shelter tubes. (Section I)
(SECTION I ITEM)

RECOMMENDATION: Remove and replace damaged wood members. (Section I)

RECOMMENDATION: Tarp, seal, and fumigate with lethal gas, Vikane or other similar chemical. (Section I)

RECOMMENDATION: Mask and/or remove all pellets that are accessible. (Section I) (SECTION I ITEM)

RECOMMENDATION: Remove and replace damaged wood members. If possible, we will chisel or cut out the damage and fill with a plastic or wood filler. (Section I)

RECOMMENDATION: Remove and replace damaged wood members. If possible, we will chisel or cut out the damage and fill with a plastic or wood filler. Primer paint only. (Section I)

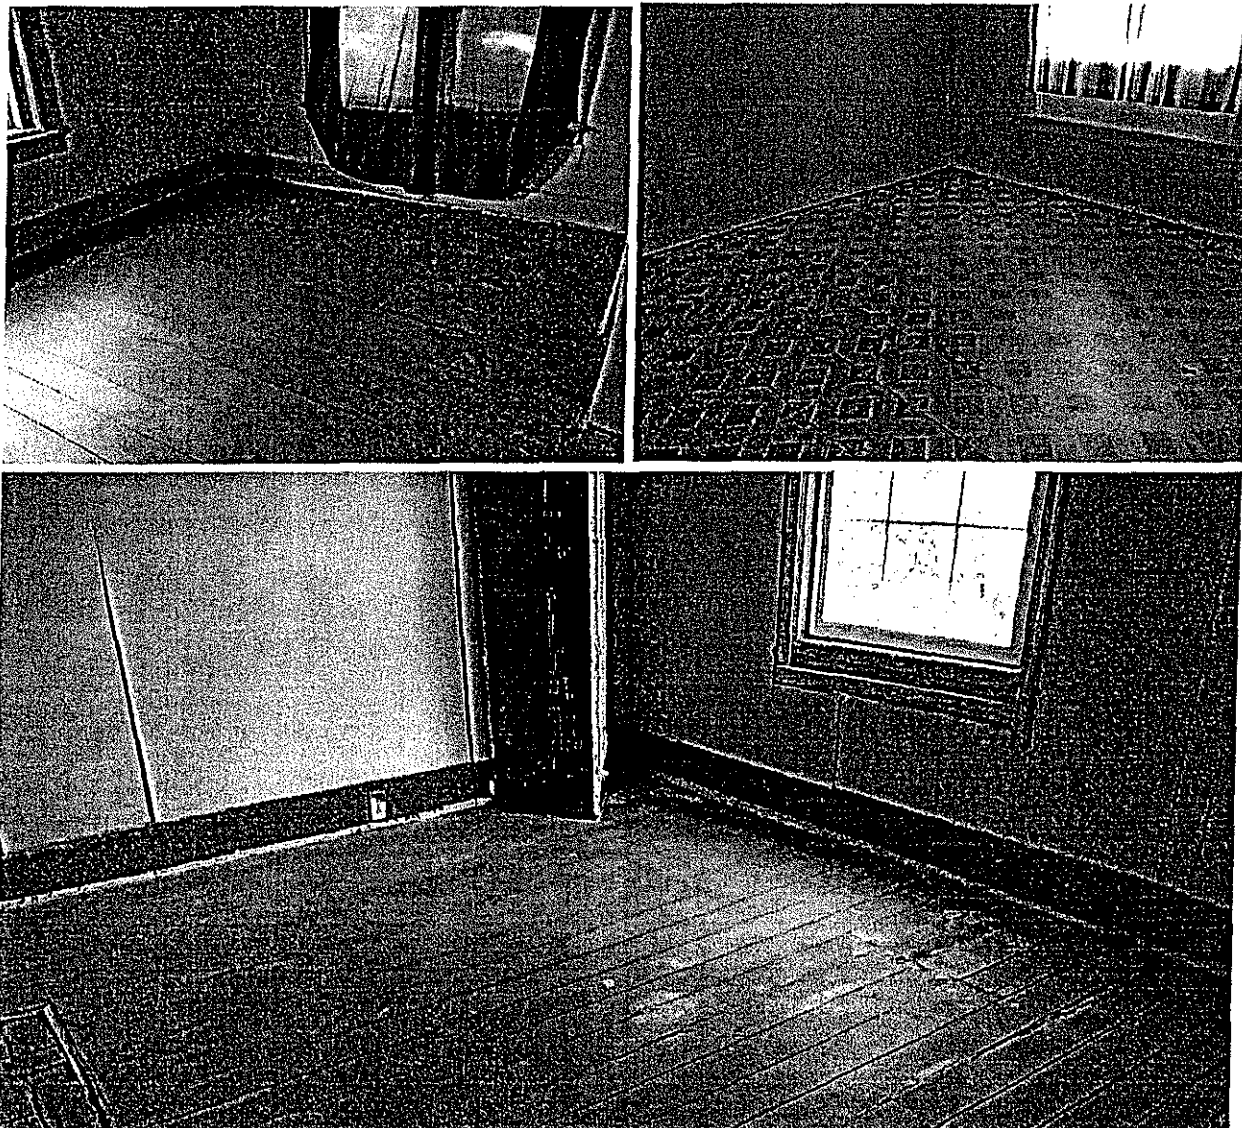
Typical of every room in the house, there is a readily observable slope in the floor towards the exterior walls. It is our opinion that the lack of a concrete foundation had allowed the wood supporting posts to subside into the soil. Since posts along the exterior of the structure are exposed to a soil that tends to have more moisture than that found near the interior of the house, we would expect those post to subside at a faster rate. We also observed significantly sagging in the floor near the pocket door at the common wall at the addition to the left of the structure.

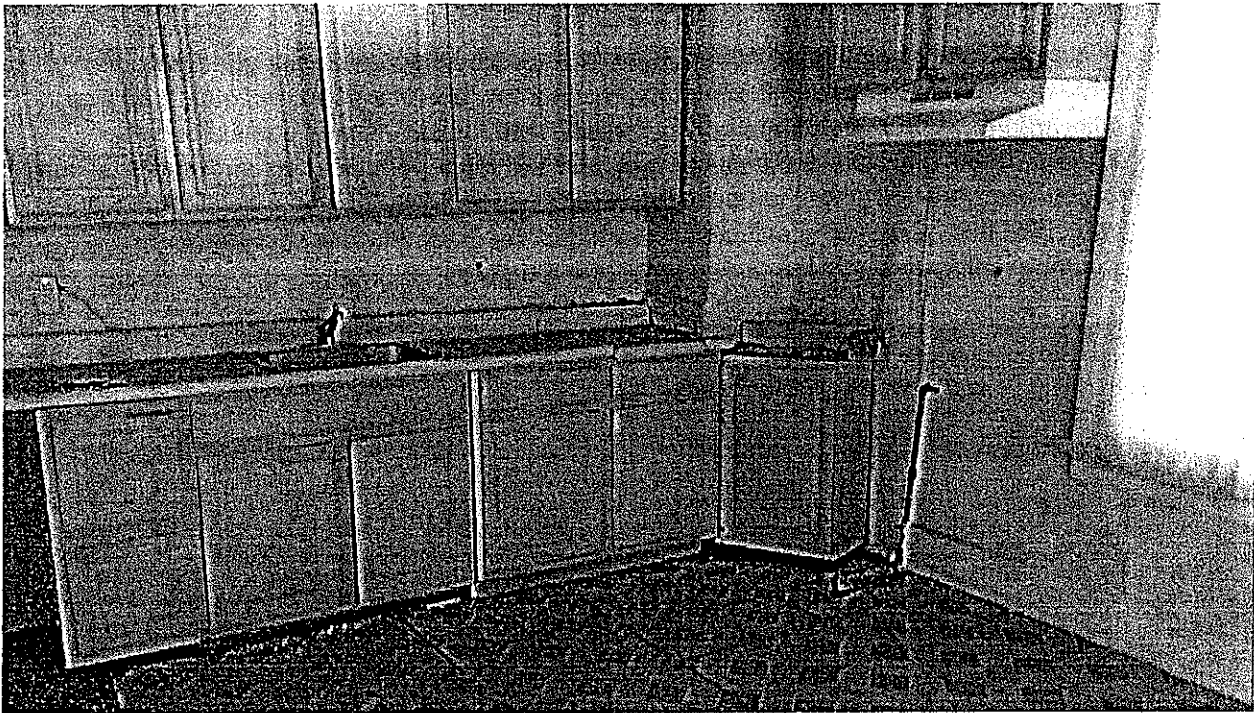
The wall and floor of the kitchen near the chimney have sagged several inches. It is our opinion that the chimney had been poorly founded and has subsided considerable thus dragging the adjacent floor and wall down with it. Interestingly, the exterior of the house near the same chimney is not experiencing the same distress, which suggests the chimney might not be positively connected to the exterior wall.

Figure 4: Kitchen looking toward chimney.

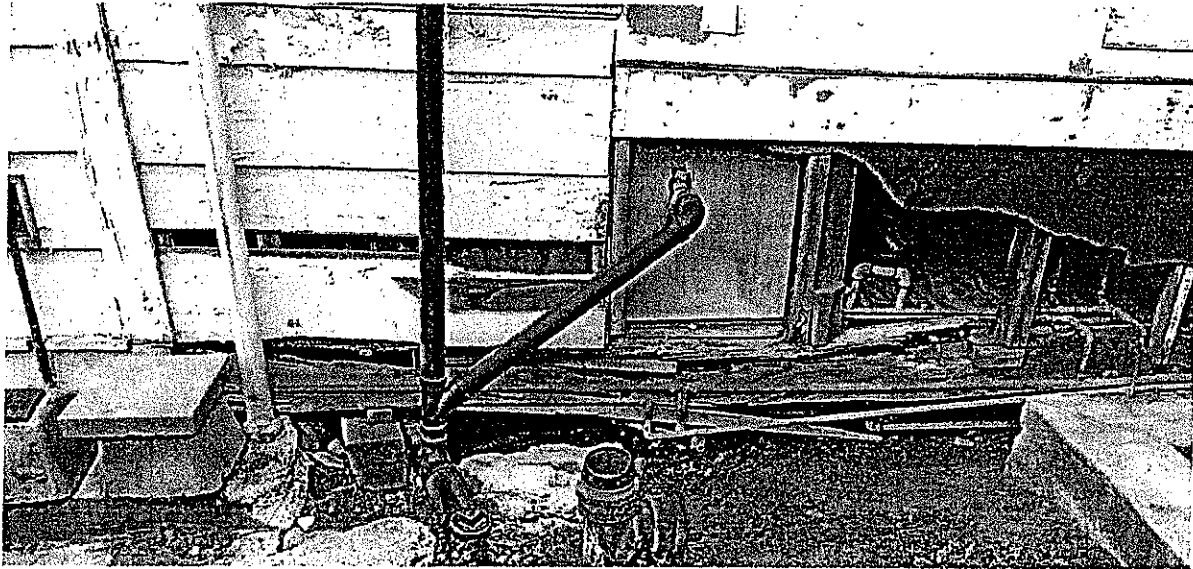
A large portion of the rear foundation are of the structure was open due to missing siding along the rear of the house at the ground level. Severe termite damage was apparent on all of the wood framing members at the edge of the floor.

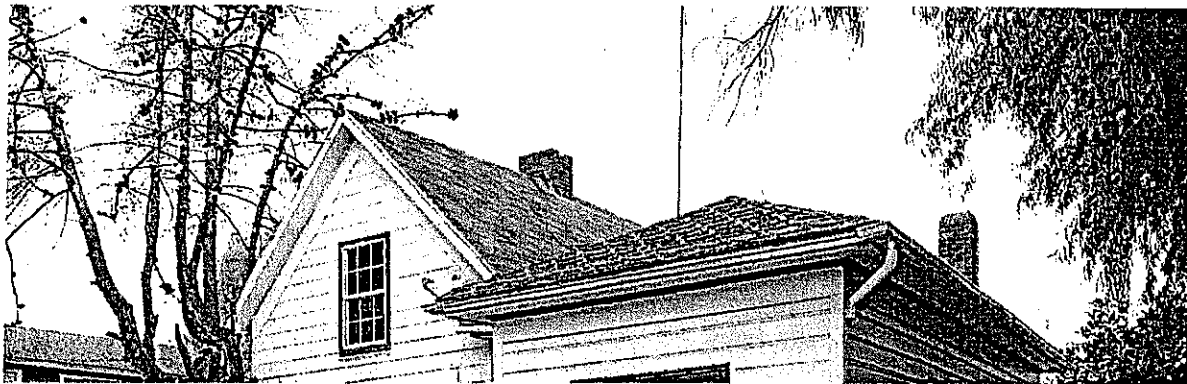
The roof has several layers of composite shingles. The edges look quite weathered and perhaps even attacked by mold. Despite the deterioration at the edges, the roof lines still appear straight which indicates that the framing underneath is likely sound. We did not observe any sagging in the roof with is an obvious sign of persistent water penetration.

Figure 5: Main roof and kitchen addition.

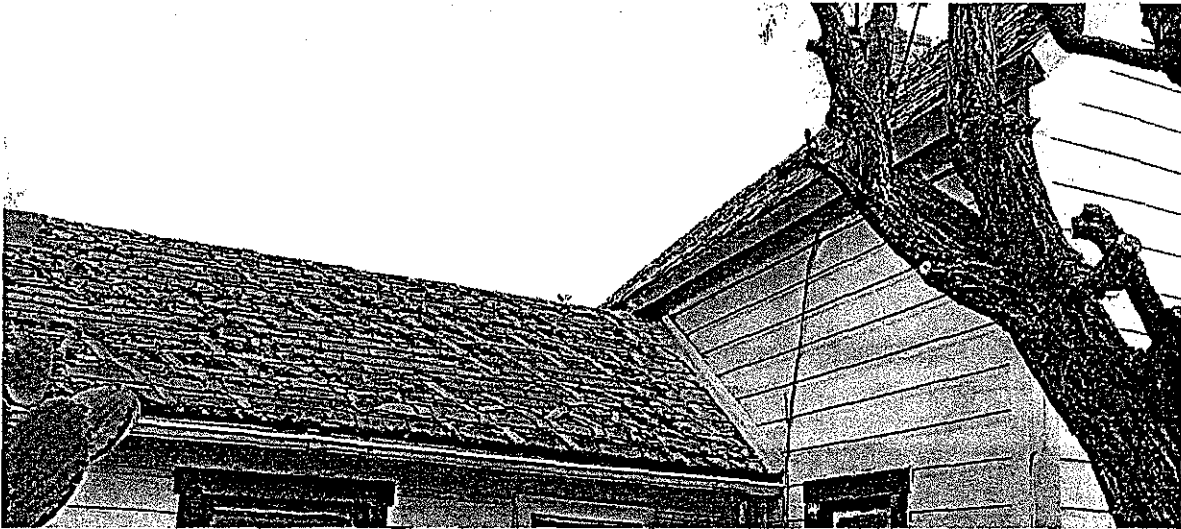
Figure 6: Roof at left side of structure

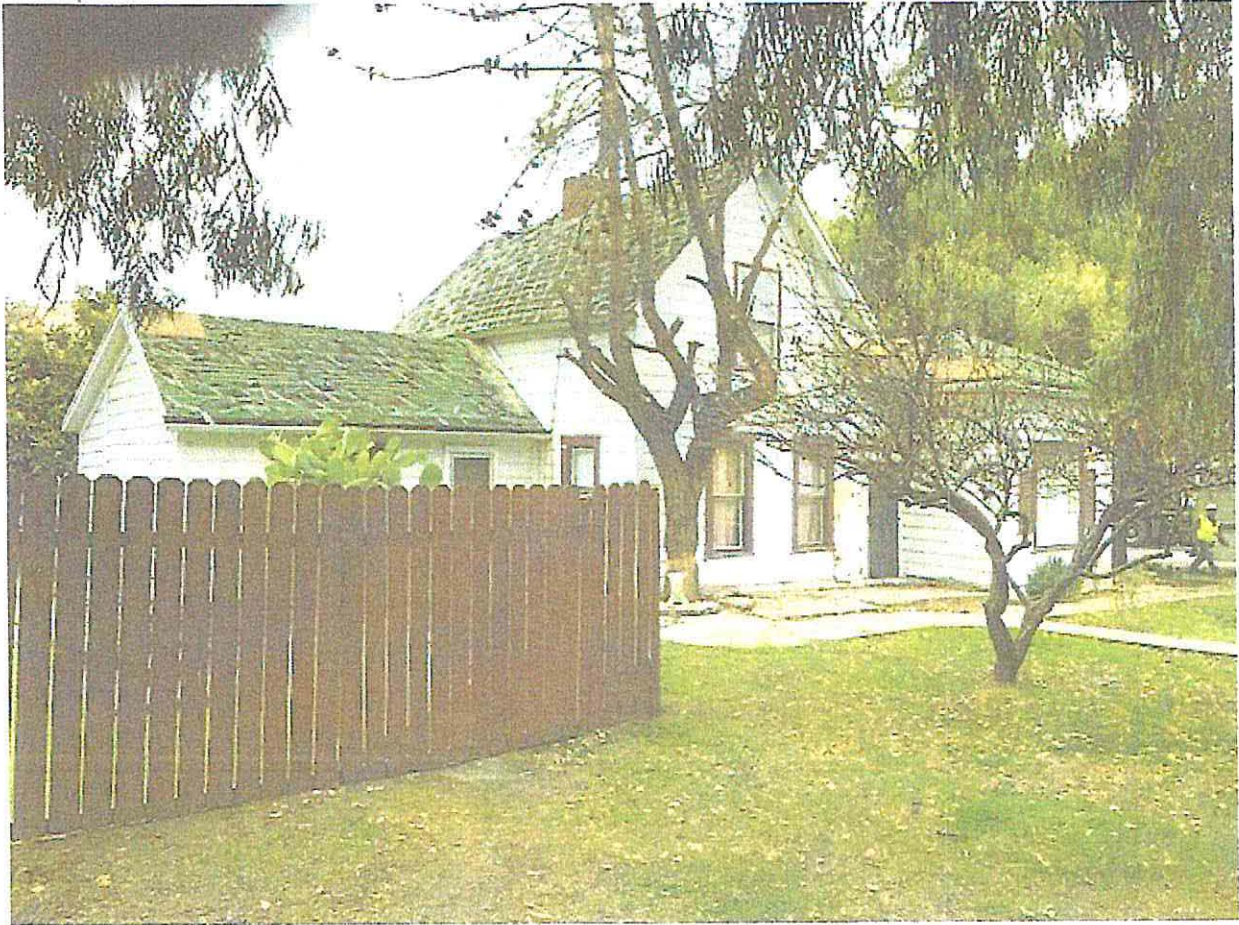
EXISTING UNINHABITABLE HOME ON 1411 LEWIS STREET

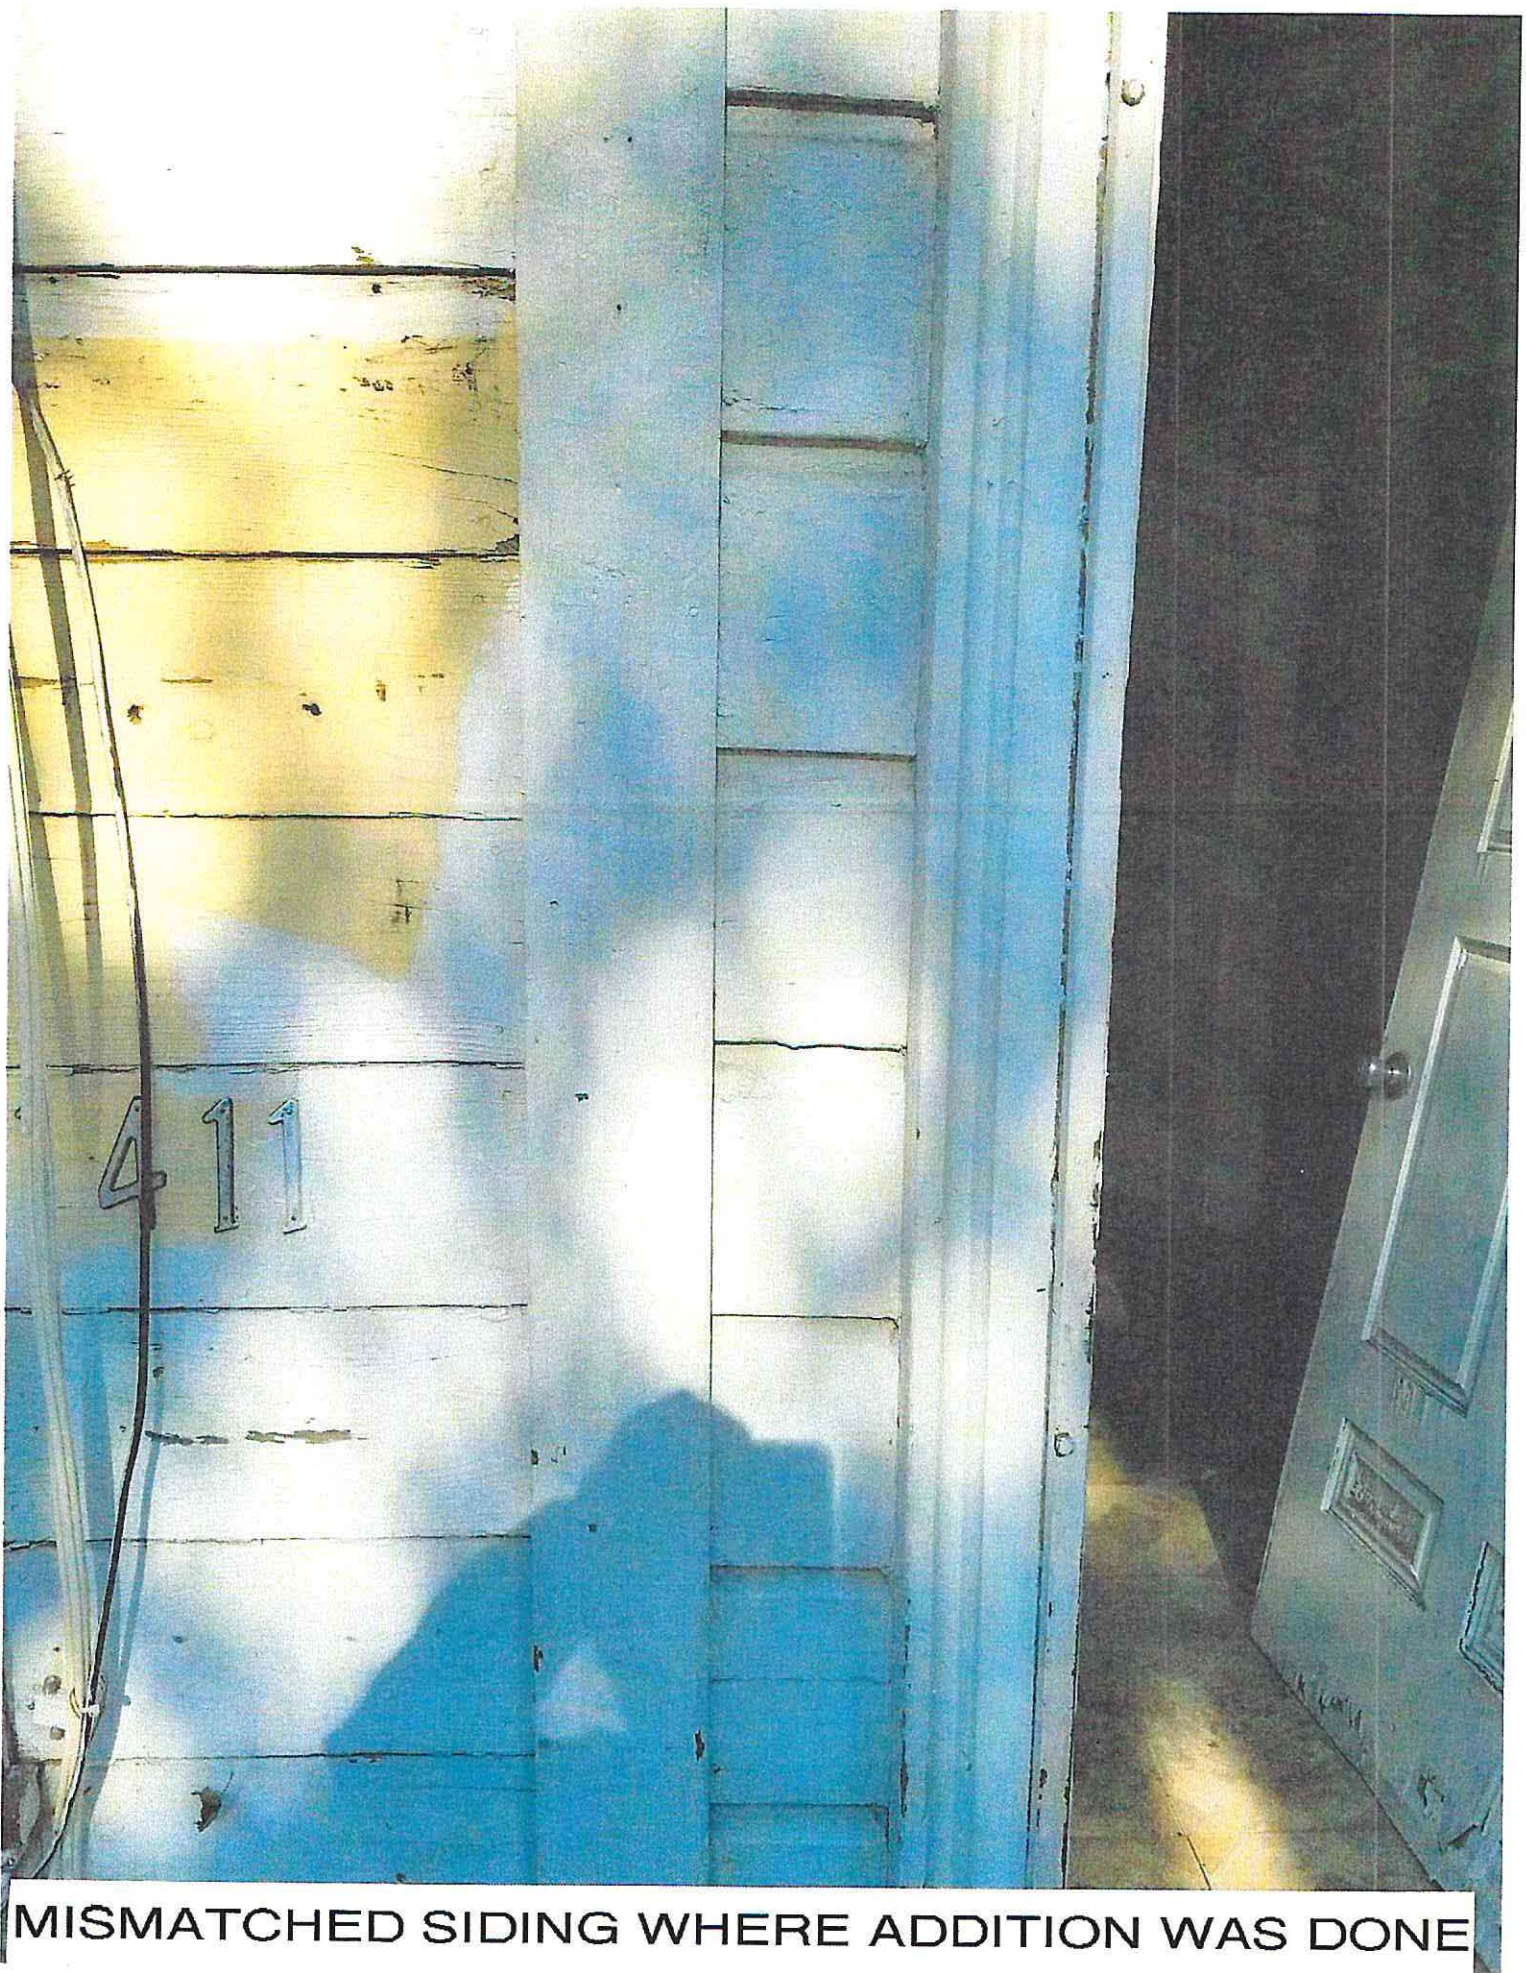
MISMATCHED SIDING WHERE ADDITION WAS DONE

PLUMBING ADDED

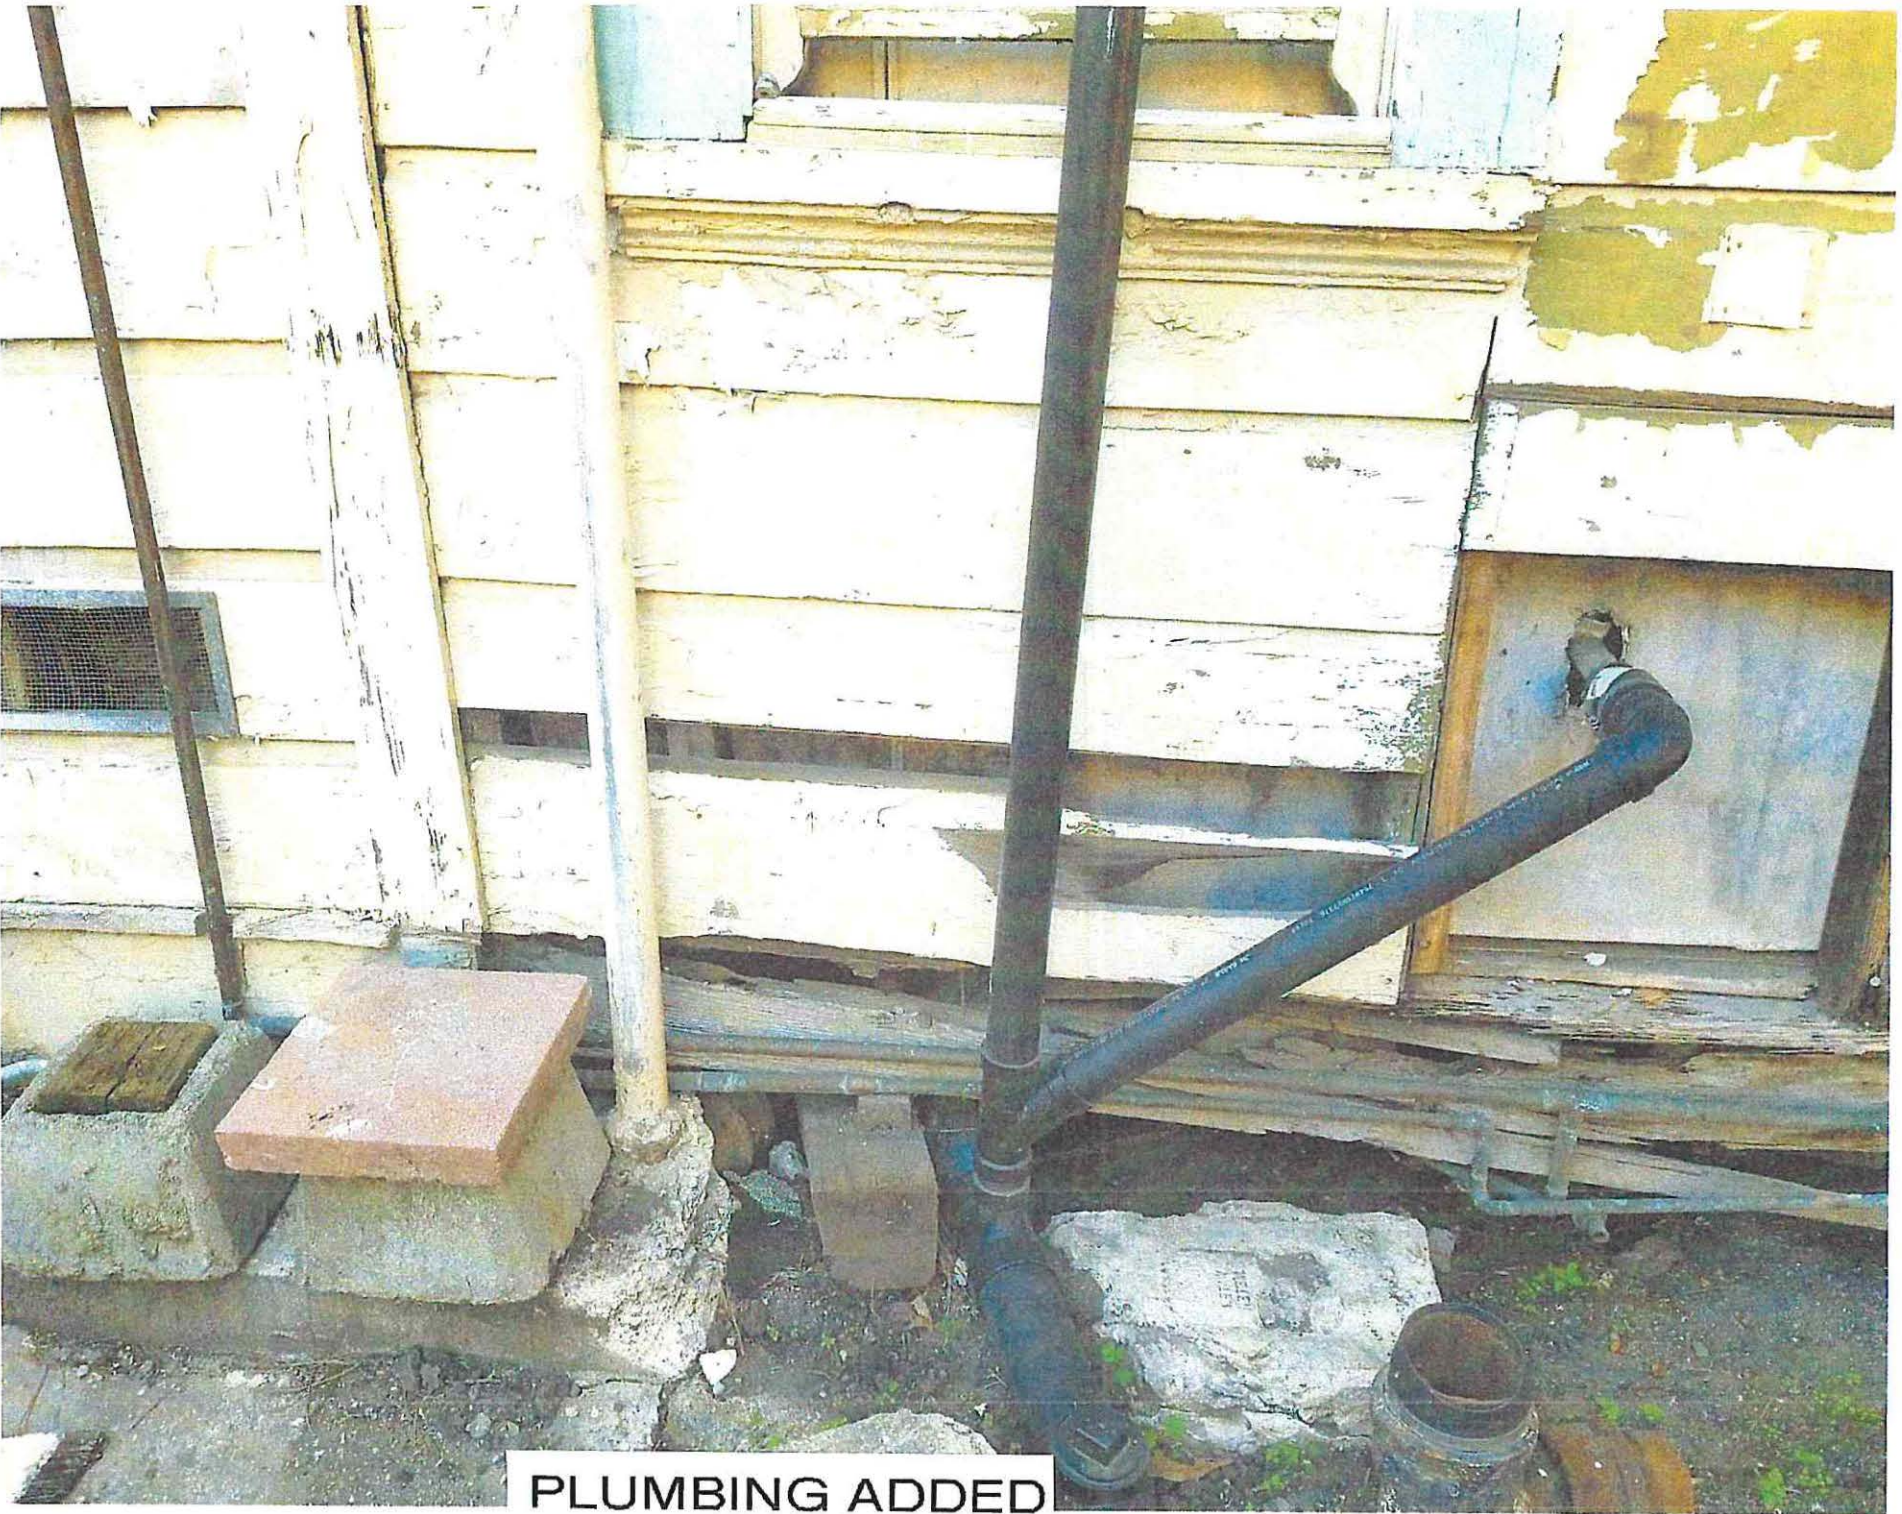
DETERIORATED FRAMING, SIDING AND FOUNDATION

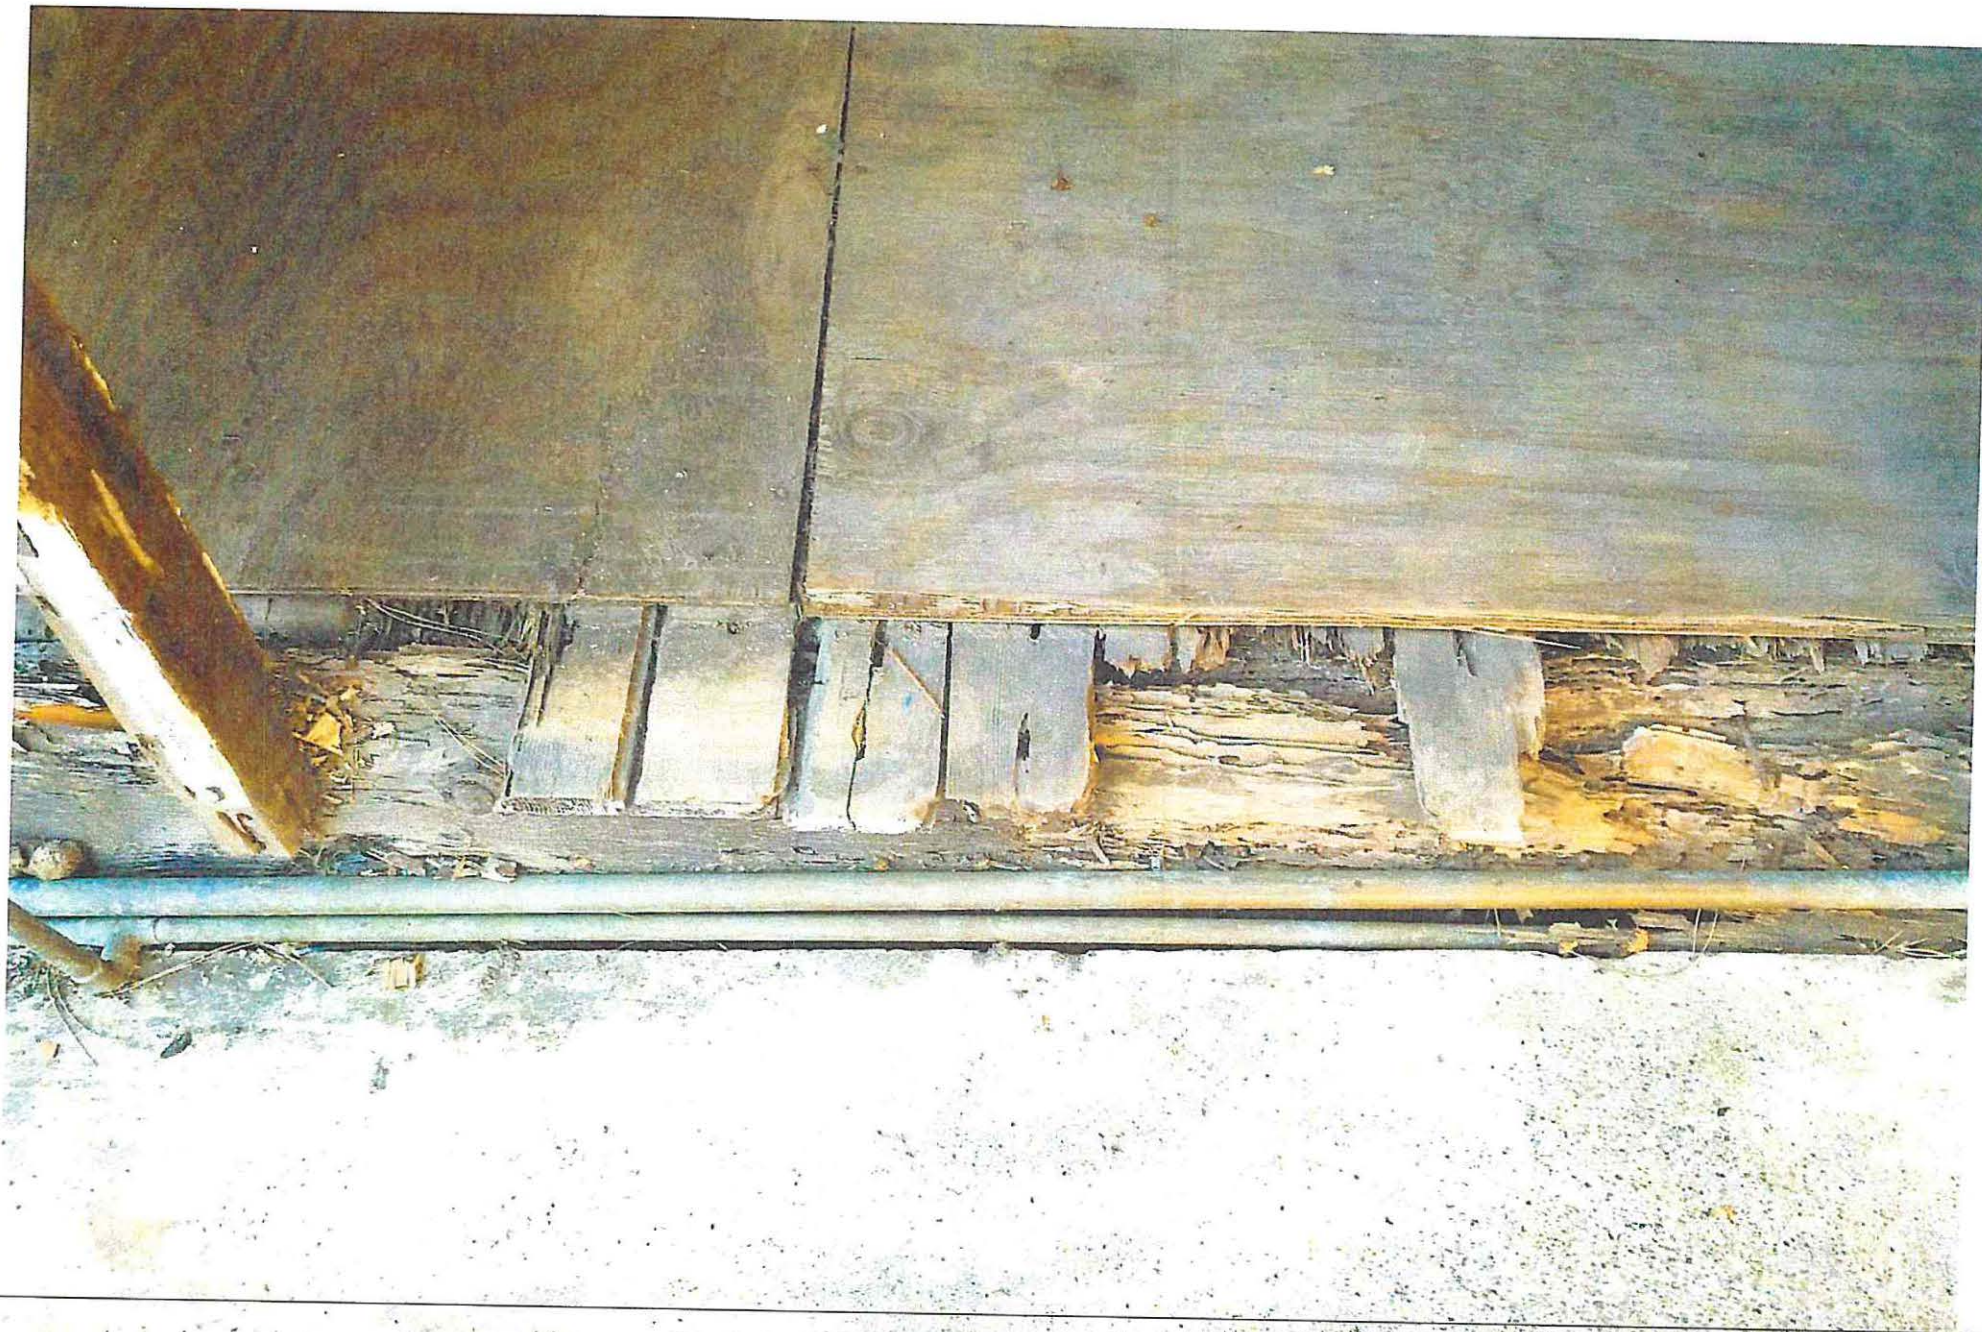
DETERIORATED WOOD FLOOR, FOUNDATION AND FRAMING

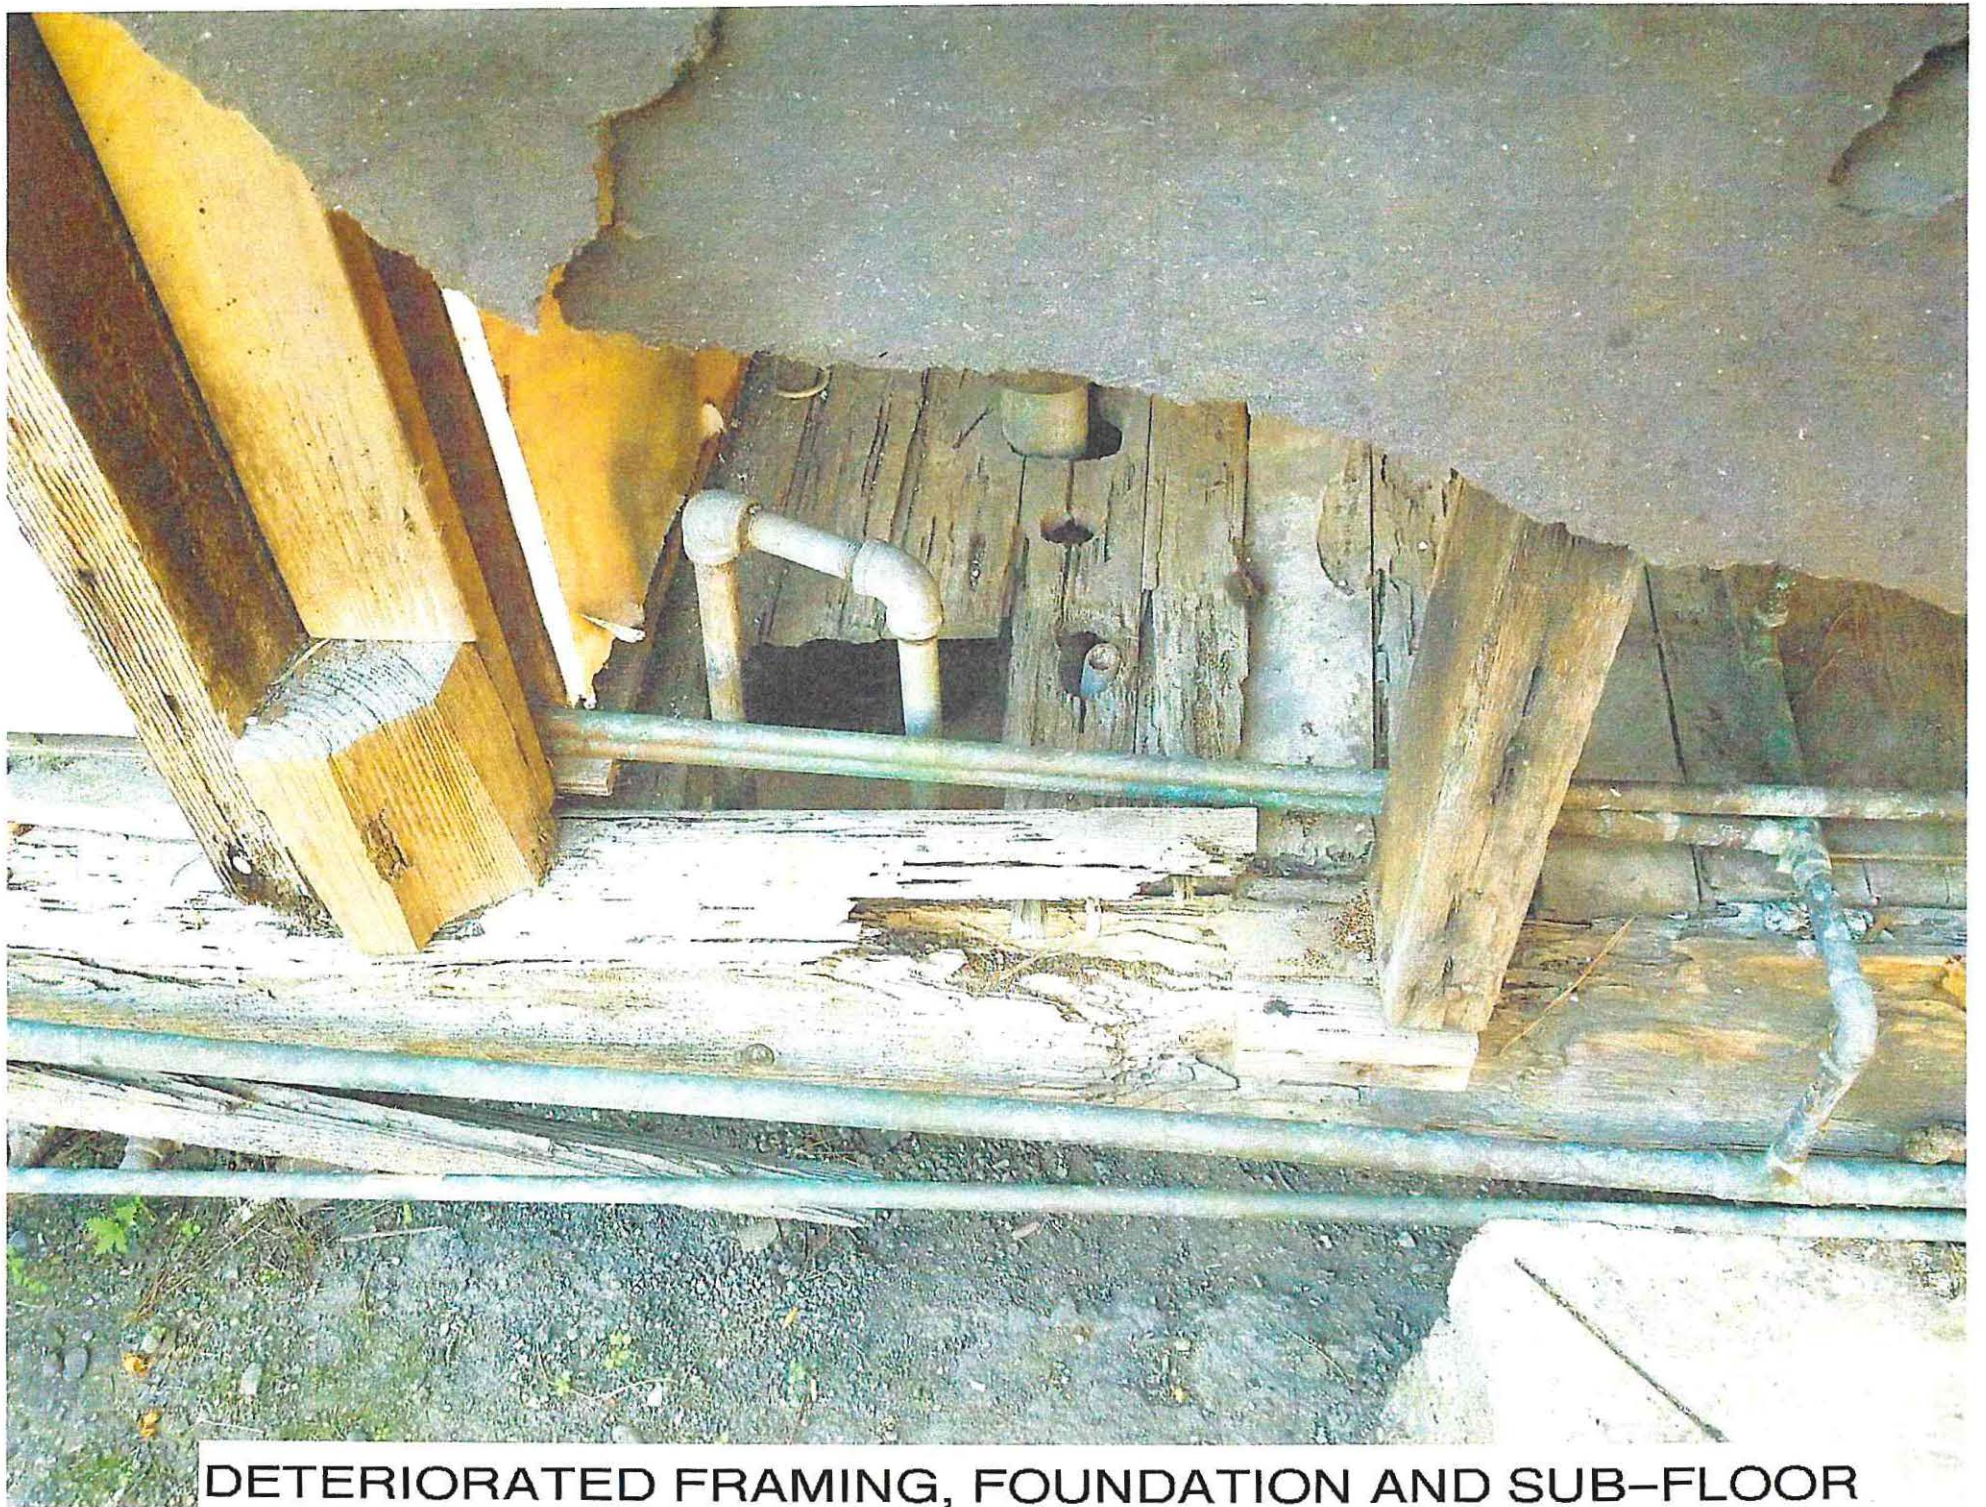
DETERIORATED FRAMING, FOUNDATION AND SUB-FLOOR
