Project Proposal
1411 Lewis Street and 1444 Madison Street
Santa Clara, California

MADISON AND LEWIS STREET PROJECT DESCRIPTION

Location: 1411 Lewis Street and 1444 Madison Street

March 5, 2018

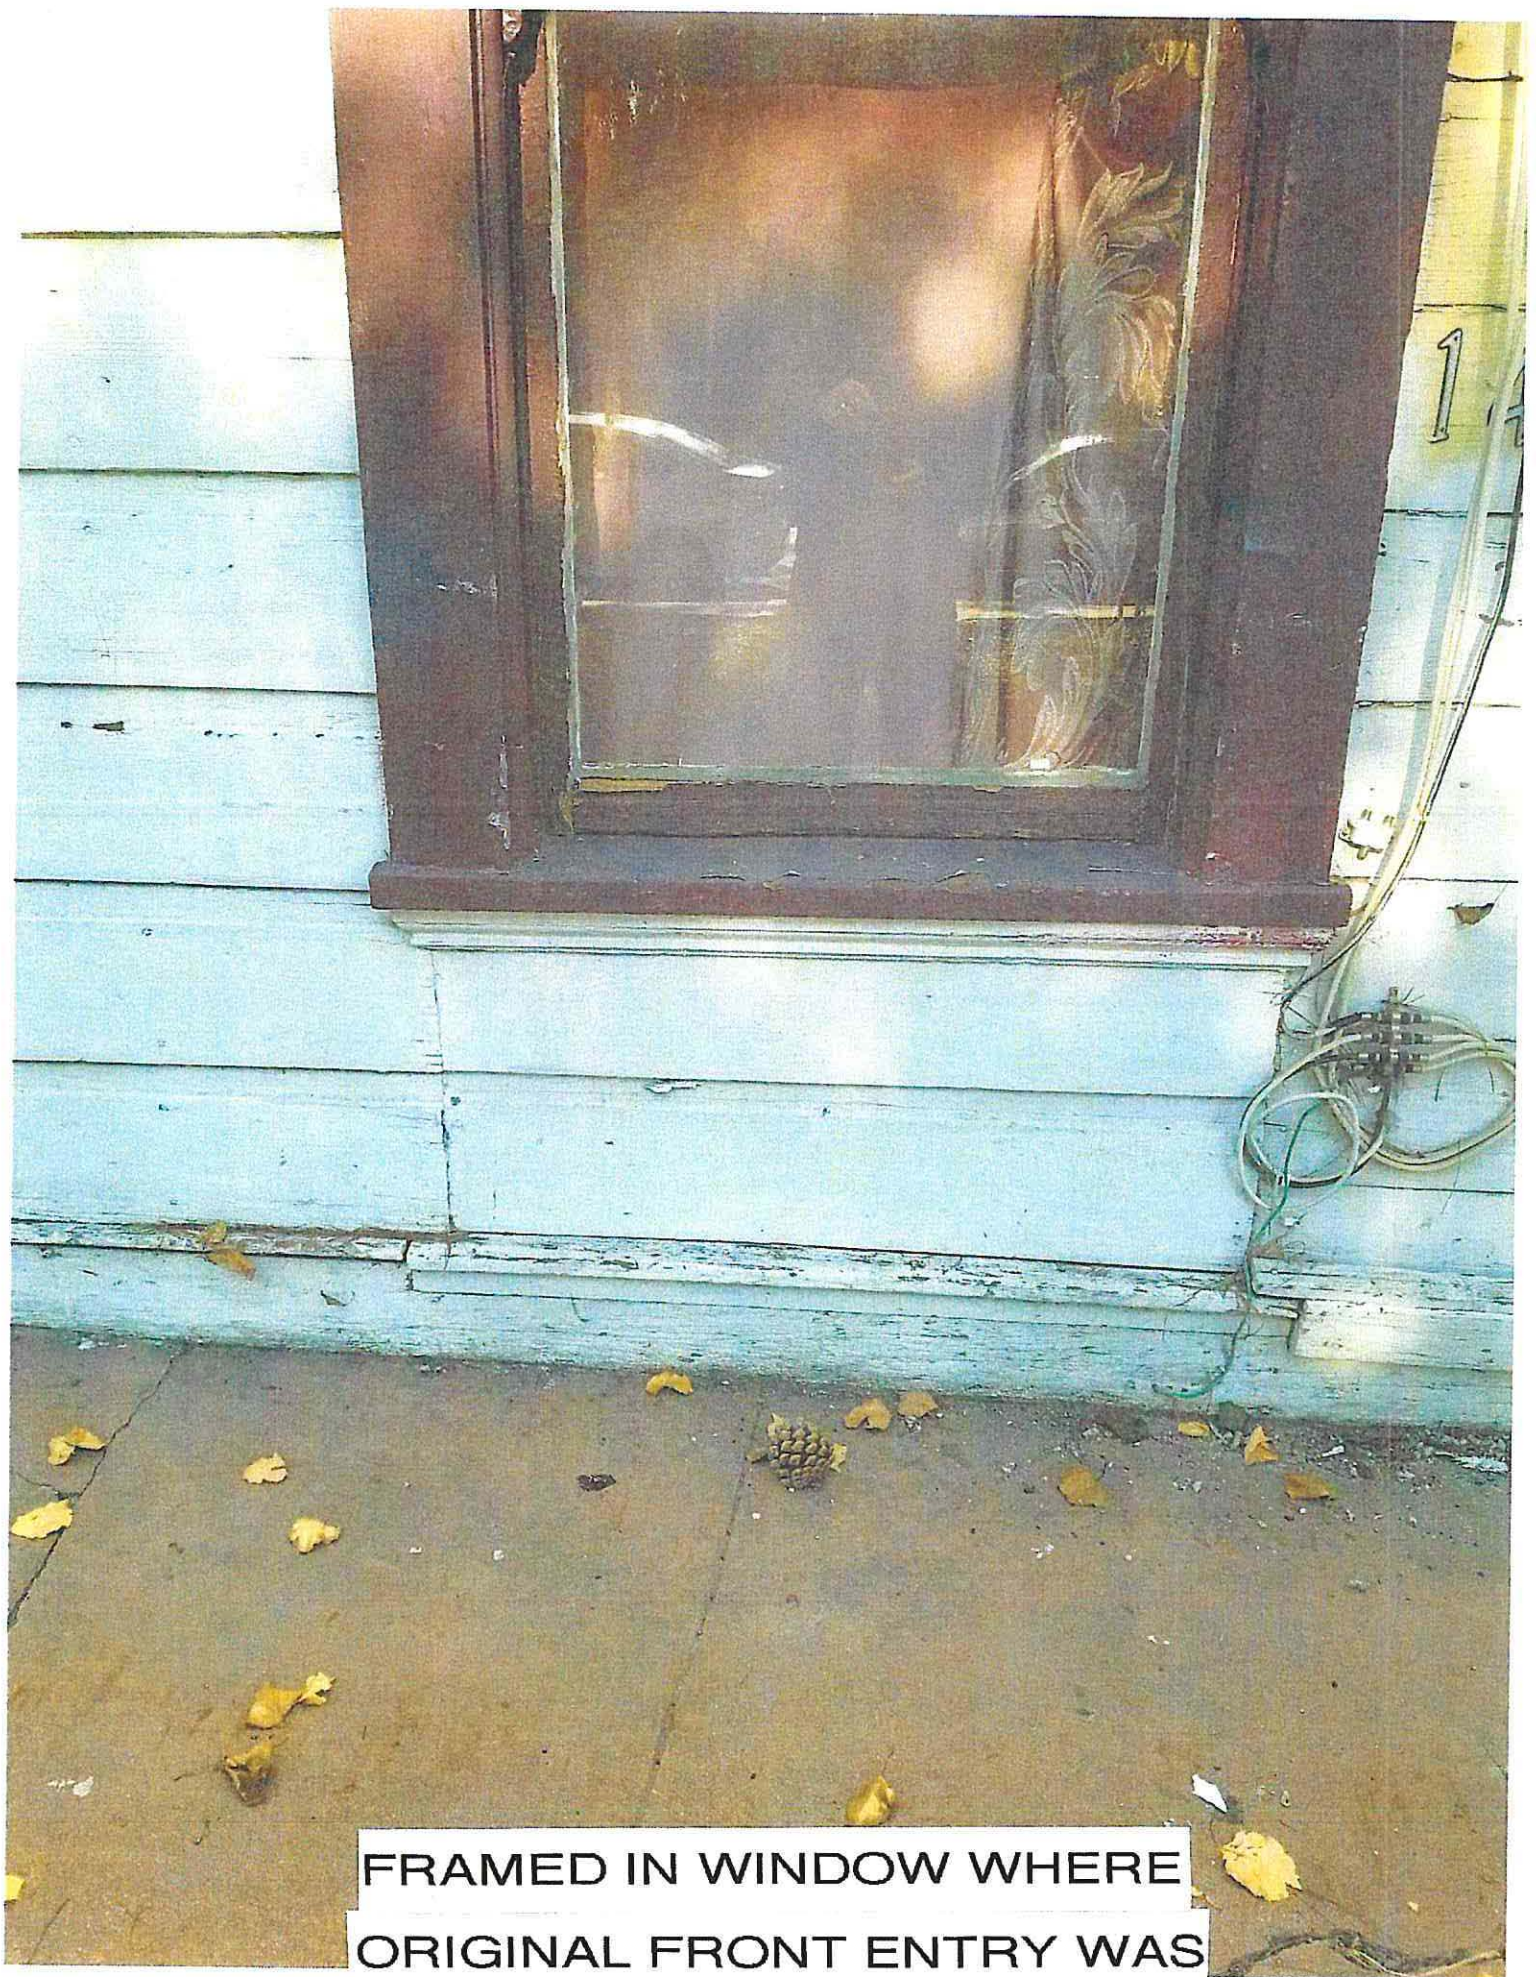
FRAMED IN WINDOW WHERE
ORIGINAL FRONT ENTRY WAS

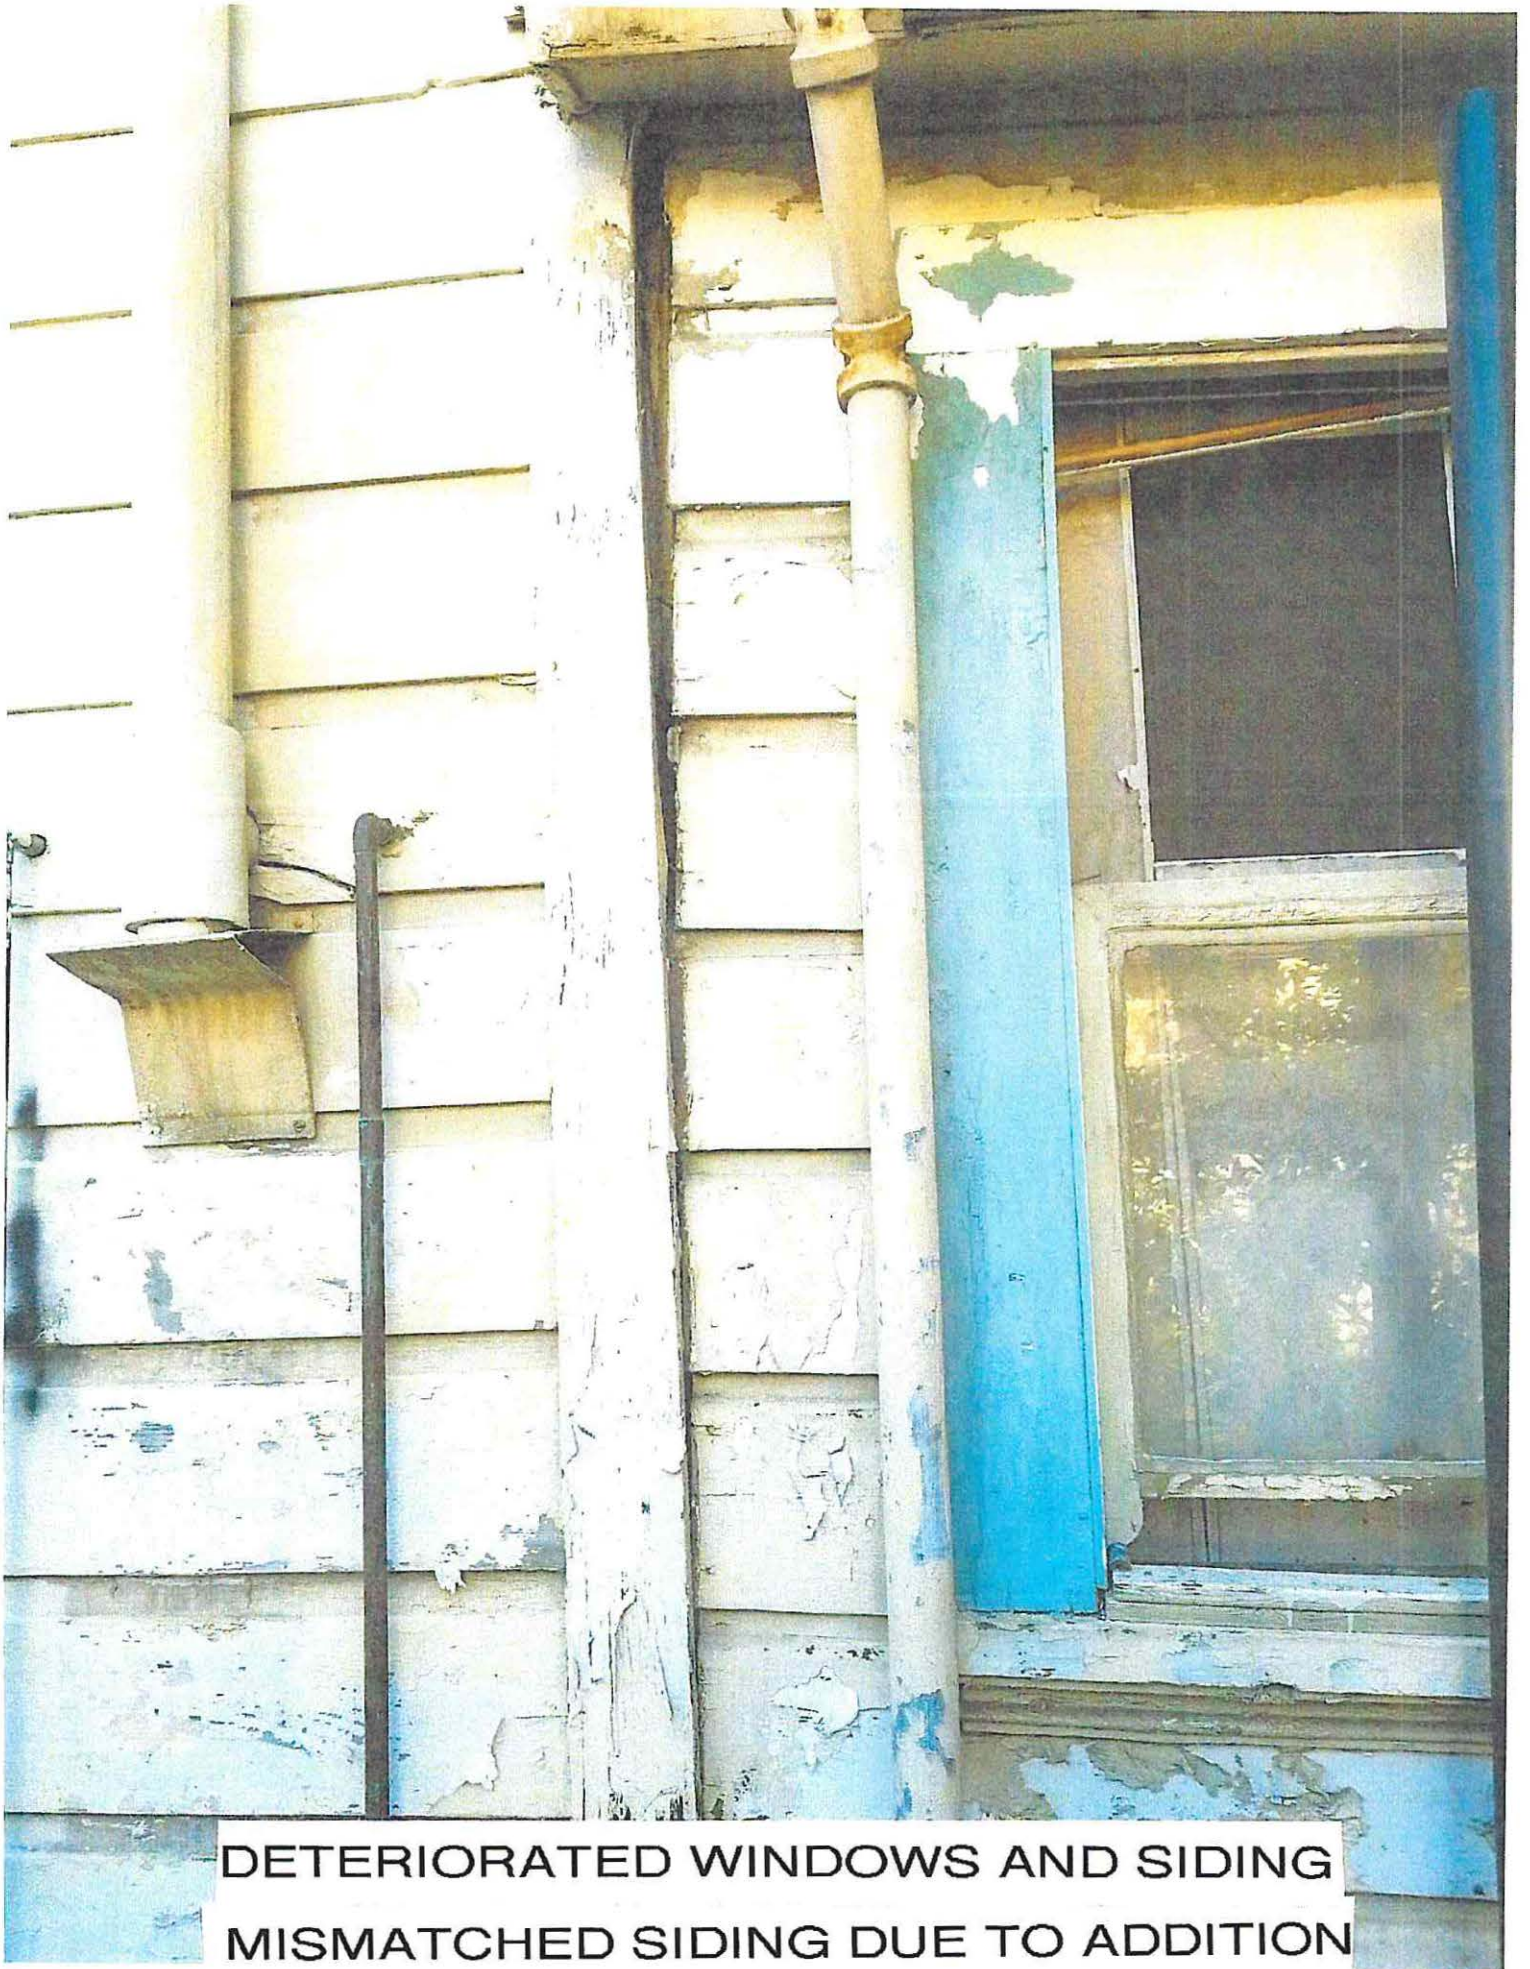
DETERIORATED WINDOWS AND SIDING
MISMATCHED SIDING DUE TO ADDITION

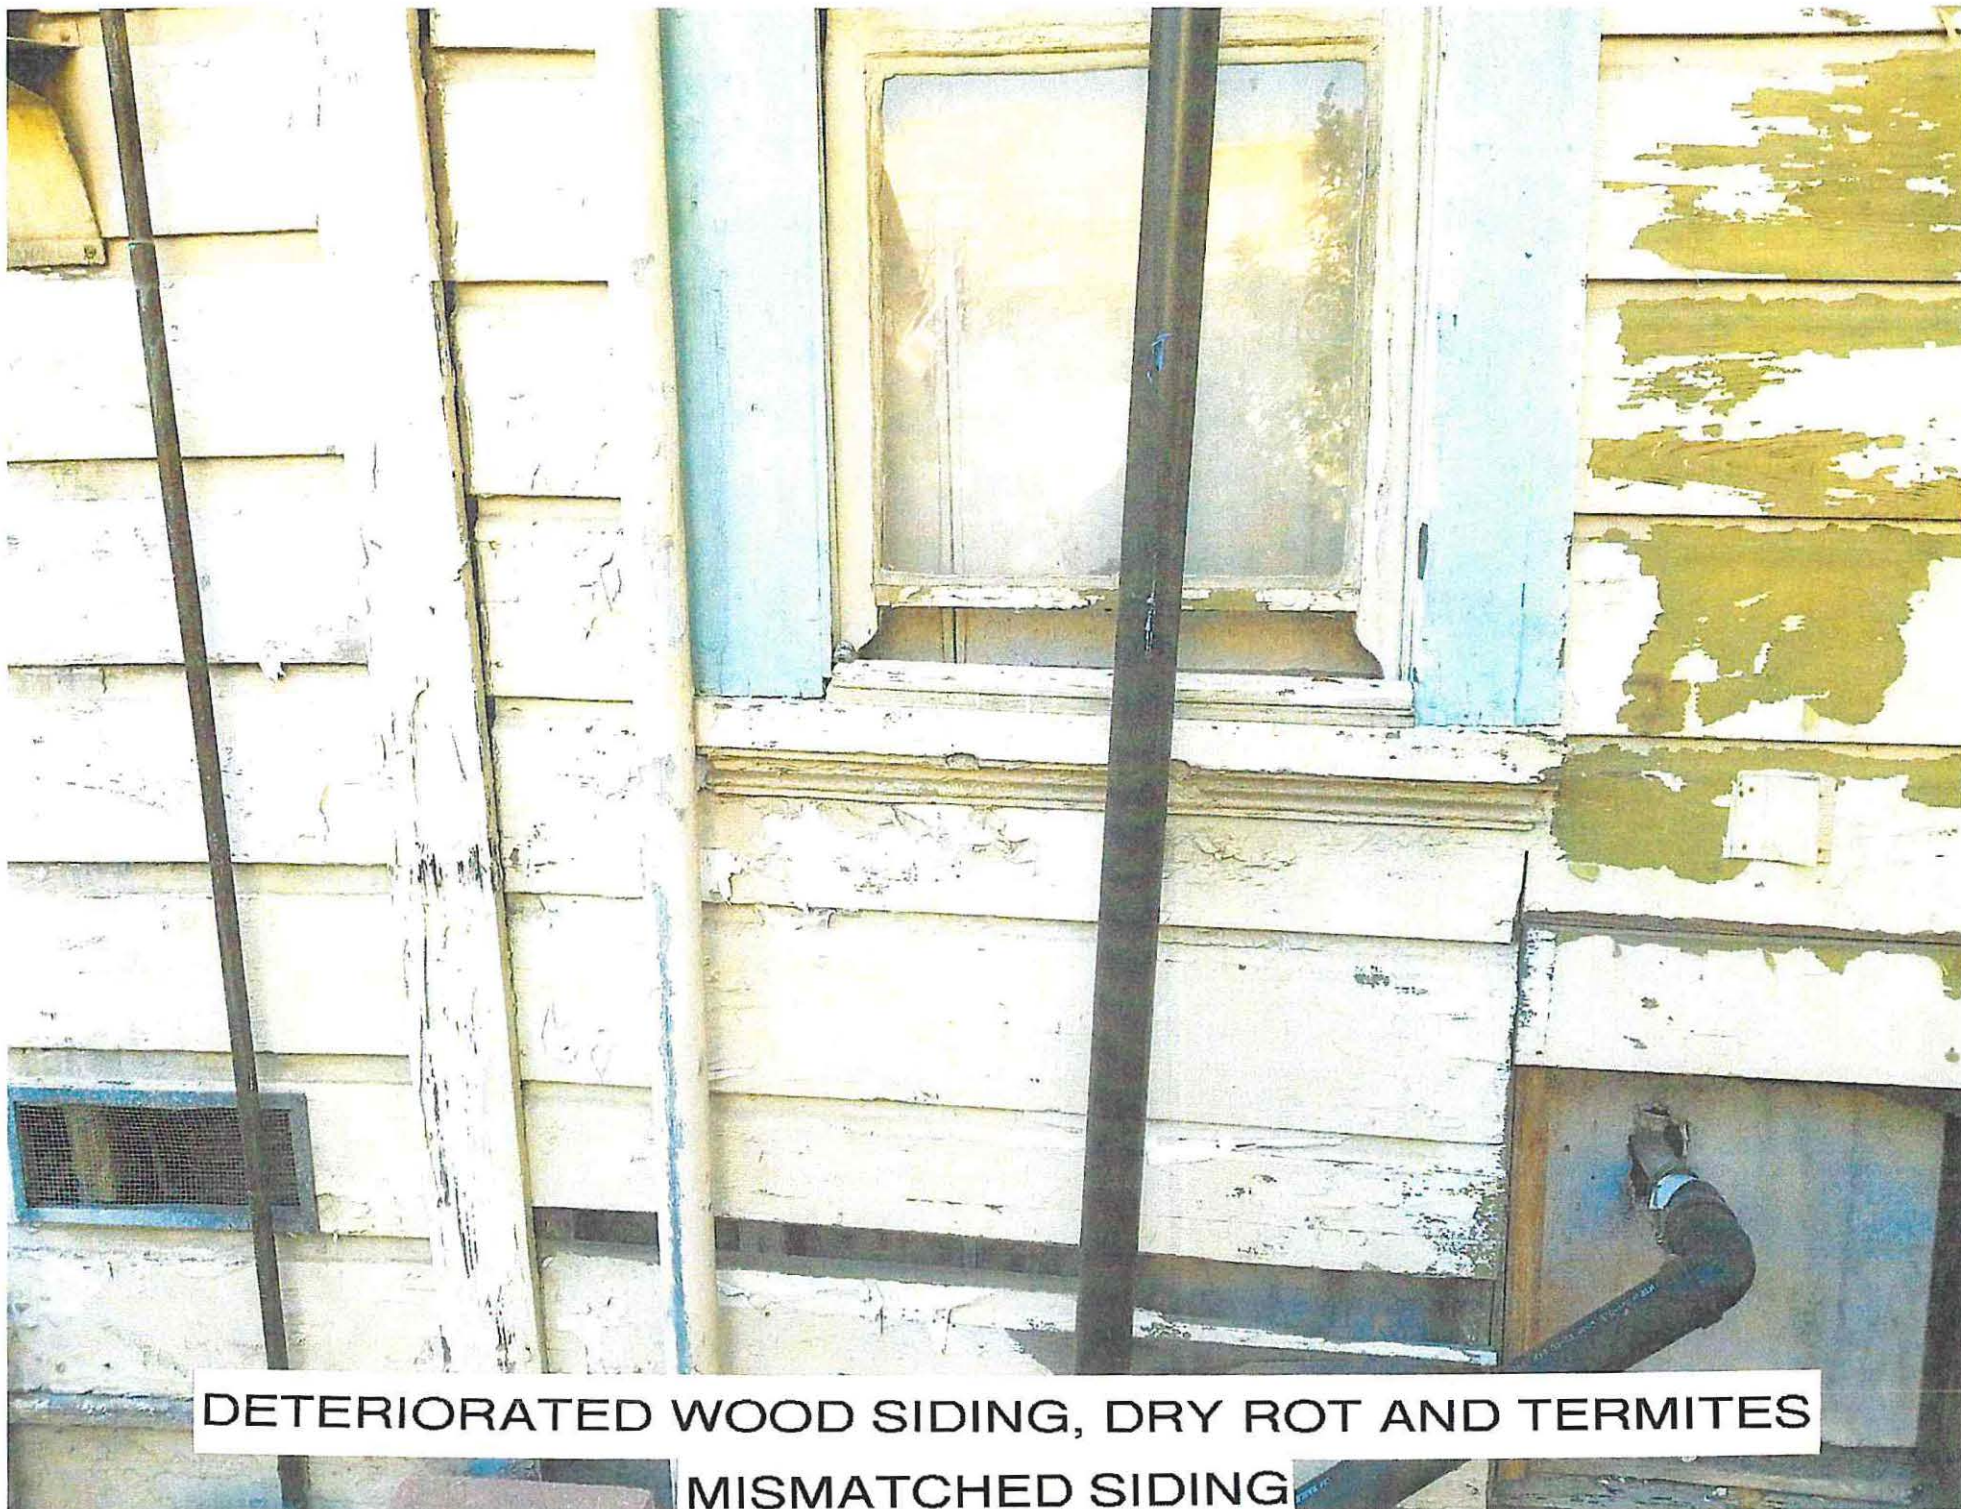
DETERIORATED WOOD SIDING, DRY ROT AND TERMITES
MISMATCHED SIDING
