MAIN RESIDENCE PRESERVATION PLAN

1393 SANTA CLARA STREET

HISTORIC PERSERVATION PLAN EXTERIOR PHOTOS

HP-1

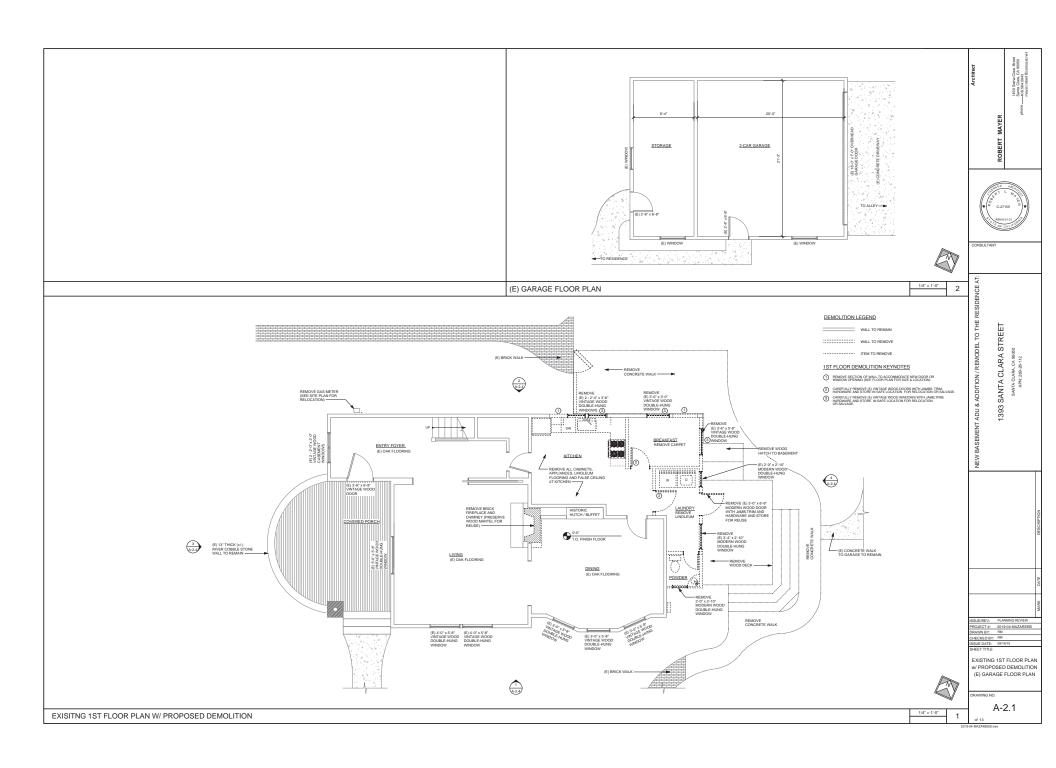
EXTERIOR MATER	IALS	
FEATURE	DESCRIPTION AND CONDITION	TREATMENT
STONE VENEER BELOW 1ST FLOOR WALLS	THE RIVER COBBLE STONE VENEER SET WITH MORTAR AT THE FRONT AND LEFT LEVATIONS ARE A CHARACTER-DEFINING FEATURE IN GOOD CONDITION. HOWEVER, THE BRICK FOUNDATION WALL THAT HELPS SUPPORT THIS STONE IS BADLY DETERIORATED AND MUST BE REPLACED TO PRESERVE THE STRUCTURE AS NOTED IN THE 10-YEAR PLAN OF THE MILES ACT CONTRACT.	THE STONE YENGER WILL BE CAREFULLY REMOVED AND STORED MA SAFE LOCATION AND THEN BE REINSTALLED TO MATCH EXISTING AFTER THE NEW FOUNDATIONS ARE INSTALLED WHICH IS THE TOP PRIORITY IN THE 10-YEAR PLANFOR THE MILLS ACT AND KEY TOT HE LONG-TERM PRESERVATION OF THIS INSTORIC HOME.
STONE PORCH WALL	THE RIVER STONE WALL SET WITH MORTAR AT THE FRONT PORCH IS IN FAIR TO GOOD CONDITION WITH SOME LARGE VERTICAL CRACKS IN THE MORTAR.	THE MORTAR WILL BE PATCHED AFTER THE FOUNDATION WORK IS COMPLETE.

PHOTO OF ORIGINAL RIVER COBBLE STONE VENEER
