Facility Condition Assessment Report

Machado Park

City of Santa Clara, California

FINAL DRAFT
January 31, 2018

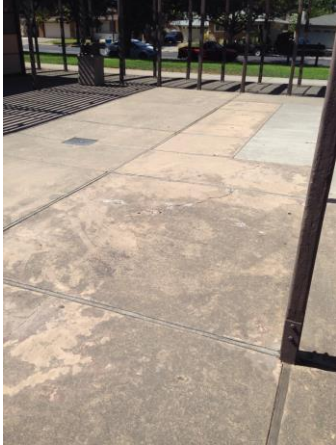
System: G2030.10.008

Asset Assigned Common Name (if applicable): Building 01
Area/Floor (if applicable): Patio / 1
Asset ID: CSC003482
Asset Category (if applicable): Building
Quantity/Unit of Measure: 1600 / SF
Estimate: \$44,242
Priority Year Description: 05 - Address deficiency or Capital Requirement in Year 05
Deficiency Description: Concrete pathway shows evidence of damage.
Description of Work: Replace concrete paving.
Comment:

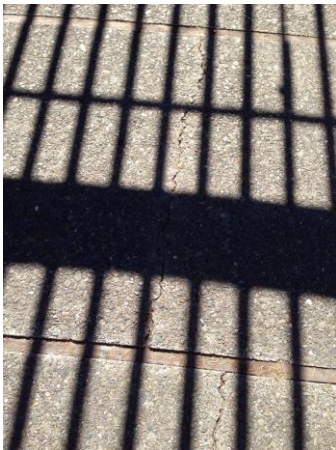
System: G2030.10.008

Asset Assigned Common Name (if applicable): Building 01
Area/Floor (if applicable): Exterior Building Walk / 1
Asset ID: CSC003482
Asset Category (if applicable): Building
Quantity/Unit of Measure: 80 / SF
Estimate: \$2,006
Priority Year Description: 03 - Address deficiency or Capital Requirement in Year 03
Deficiency Description: Concrete pathway shows evidence of damage.
Description of Work: Replace concrete paving.
Comment:

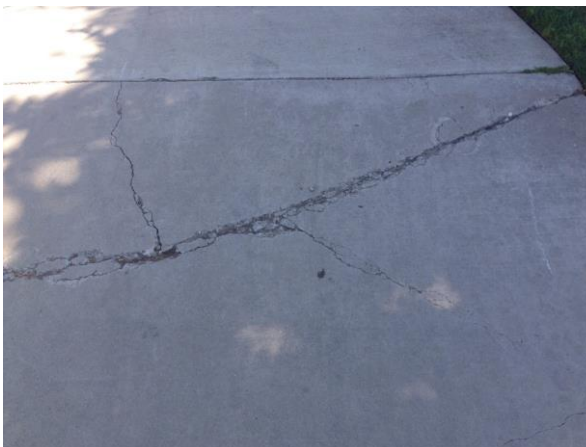
System: G2030.10.009

Asset Assigned Common Name (if applicable): Pathway 01
Area/Floor (if applicable): Grounds
Asset ID: CSC002310
Asset Category (if applicable): Pathways
Quantity/Unit of Measure: 3230 / SF
Estimate: \$82,663
Priority Year Description: 01 - Address deficiency or Capital Requirement in Year 01
Deficiency Description: Concrete pathway shows evidence of damage.
Description of Work: Replace concrete and base to match existing.
Comment:

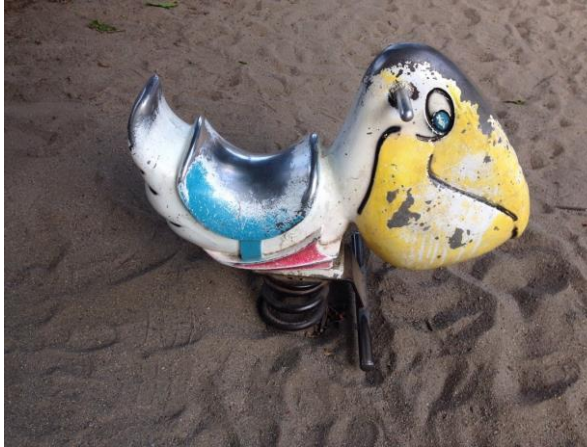
System: G2050.50.003

Asset Assigned Common Name (if applicable):	Play Equip Pt 02
Area/Floor (if applicable):	Grounds
Asset ID:	CSC002321
Asset Category (if applicable):	Playground Equipment
Quantity/Unit of Measure:	1 / EA
Estimate: (Escalated to Priority Year)	\$4,702
Priority Year Description:	03 - Address deficiency or Capital Requirement in Year 03
Deficiency Description:	<i>Playground equipment is approaching the end of its useful life.</i>
Description of Work:	<i>Replace playground equipment.</i>
Comment:

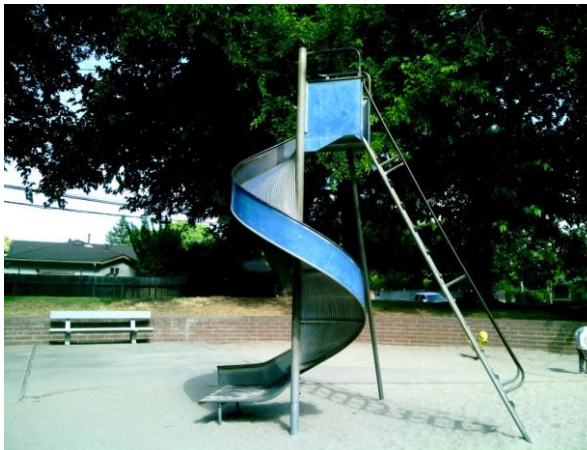
System: G2050.50.005

Asset Assigned Common Name (if applicable):	Play Equip Pt 03
Area/Floor (if applicable):	
Asset ID:	CSC003486
Asset Category (if applicable):	Playground Equipment
Quantity/Unit of Measure:	1 / EA
Estimate: (Escalated to Priority Year)	\$4,389
Priority Year Description:	03 - Address deficiency or Capital Requirement in Year 03
Deficiency Description:	<i>Playground equipment is approaching the end of its useful life.</i>
Description of Work:	<i>Replace playground equipment.</i>
Comment:

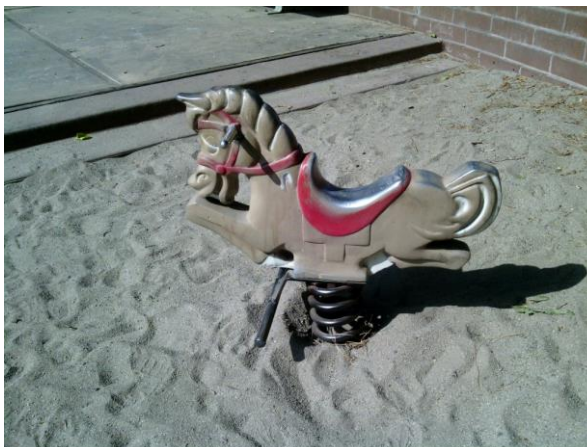
System: G2050.50.003

Asset Assigned Common Name (if applicable):	Play Equip Pt 04
Area/Floor (if applicable):	
Asset ID:	CSC003487
Asset Category (if applicable):	Playground Equipment
Quantity/Unit of Measure:	1 / EA
Estimate: (Escalated to Priority Year)	\$4,702
Priority Year Description:	03 - Address deficiency or Capital Requirement in Year 03
Deficiency Description:	<i>Playground equipment is approaching the end of its useful life.</i>
Description of Work:	<i>Replace playground equipment.</i>
Comment:

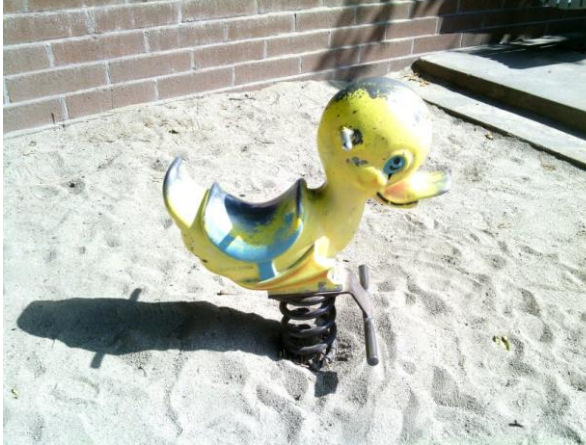
System: G2050.50.003

Asset Assigned Common Name (if applicable):	Play Equip Pt 05
Area/Floor (if applicable):	
Asset ID:	CSC003488
Asset Category (if applicable):	Playground Equipment
Quantity/Unit of Measure:	1 / EA
Estimate: (Escalated to Priority Year)	\$4,702
Priority Year Description:	03 - Address deficiency or Capital Requirement in Year 03
Deficiency Description:	<i>Playground equipment is approaching the end of its useful life.</i>
Description of Work:	<i>Replace playground equipment.</i>
Comment:

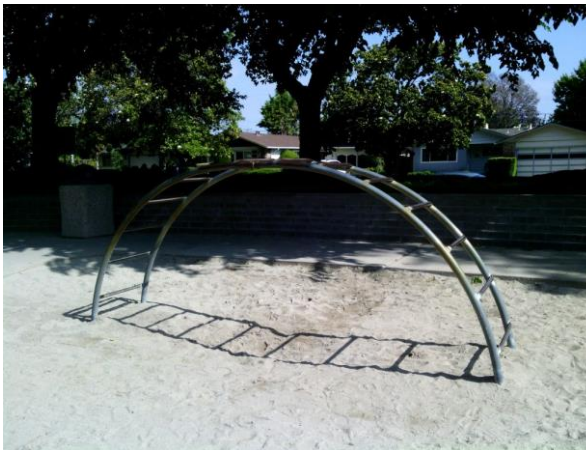
System: G2050.50.005

Asset Assigned Common Name (if applicable):	Play Equip Pt 06
Area/Floor (if applicable):	
Asset ID:	CSC003489
Asset Category (if applicable):	Playground Equipment
Quantity/Unit of Measure:	1 / EA
Estimate: (Escalated to Priority Year)	\$4,389
Priority Year Description:	03 - Address deficiency or Capital Requirement in Year 03
Deficiency Description:	<i>Playground equipment is approaching the end of its useful life.</i>
Description of Work:	<i>Replace playground equipment.</i>
Comment:

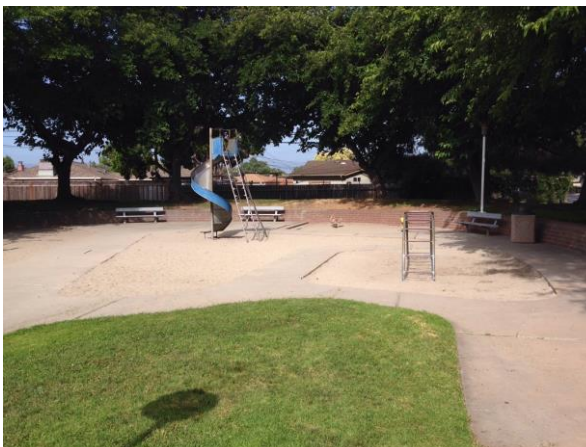
System: G2050.50.033

Asset Assigned Common Name (if applicable):	Playground 01
Area/Floor (if applicable):	Grounds
Asset ID:	CSC002322
Asset Category (if applicable):	Playground Area
Quantity/Unit of Measure:	1 / EA
Estimate: (Escalated to Priority Year)	\$711
Priority Year Description:	01 - Address deficiency or Capital Requirement in Year 01
Deficiency Description:	<i>Playground age-specific sign is missing.</i>
Description of Work:	<i>Install new age-appropriate sign.</i>
Comment:

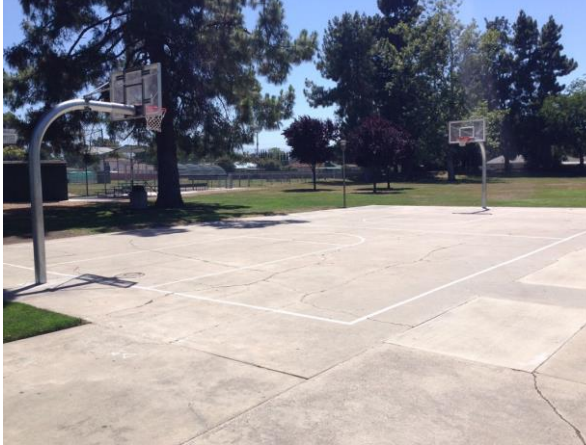
System: G2050.10.008

Asset Assigned Common Name (if applicable): Sports Court 01
Area/Floor (if applicable): Grounds
Asset ID: CSC002312
Asset Category (if applicable): Sports Courts
Quantity/Unit of Measure: 2900 / SF
Estimate: \$72,731
(Escalated to Priority Year)
Priority Year Description: 03 - Address deficiency or Capital Requirement in Year 03
Deficiency Description: Concrete court shows evidence of damage.
Description of Work: Replace concrete court.
Comment:

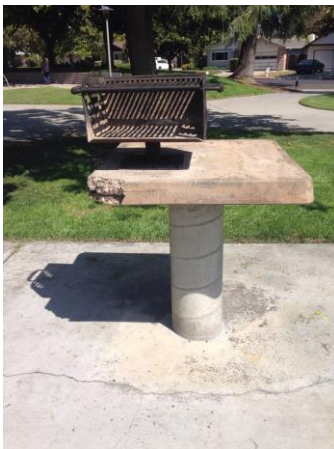
System: G2060.25.038

Asset Assigned Common Name (if applicable): BBQ 01
Area/Floor (if applicable): Grounds
Asset ID: CSC002319
Asset Category (if applicable): BBQs
Quantity/Unit of Measure: 1 / EA
Estimate: \$924
(Escalated to Priority Year)
Priority Year Description: 01 - Address deficiency or Capital Requirement in Year 01
Deficiency Description: Barbeque equipment shows evidence of damage.
Description of Work: Install new barbeque grille.
Comment:

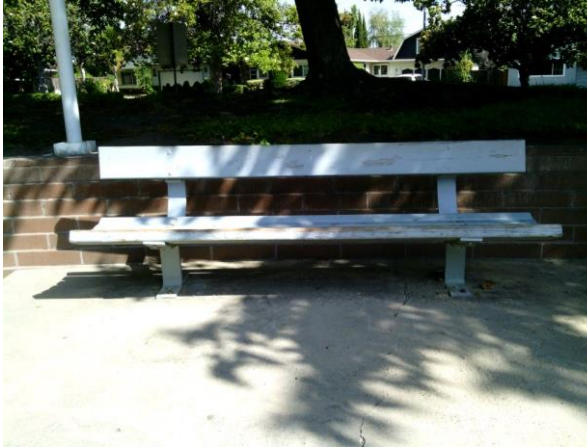
System: G2060.25.026

Asset Assigned Common Name (if applicable): Bench 02
Area/Floor (if applicable):
Asset ID: CSC003450
Asset Category (if applicable): Benches
Quantity/Unit of Measure: 1 / EA
Estimate: (Escalated to Priority Year) \$2,508
Priority Year Description: 03 - Address deficiency or Capital Requirement in Year 03
Deficiency Description: *Bench shows evidence of damage.*
Description of Work: *Replace bench.*
Comment:

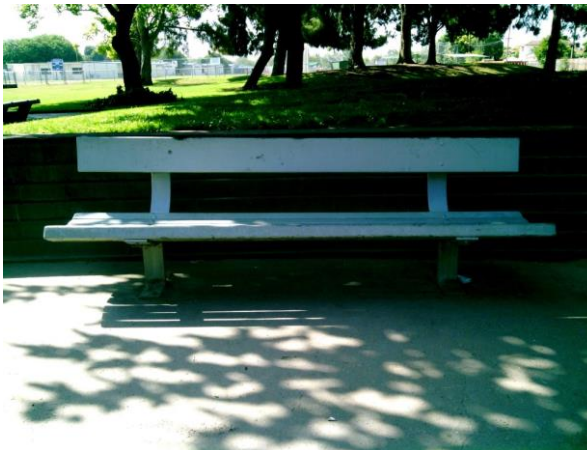
System: G2060.25.026

Asset Assigned Common Name (if applicable): Bench 05
Area/Floor (if applicable):
Asset ID: CSC003453
Asset Category (if applicable): Benches
Quantity/Unit of Measure: 1 / EA
Estimate: (Escalated to Priority Year) \$2,508
Priority Year Description: 03 - Address deficiency or Capital Requirement in Year 03
Deficiency Description: *Bench shows evidence of damage.*
Description of Work: *Replace bench.*
Comment:

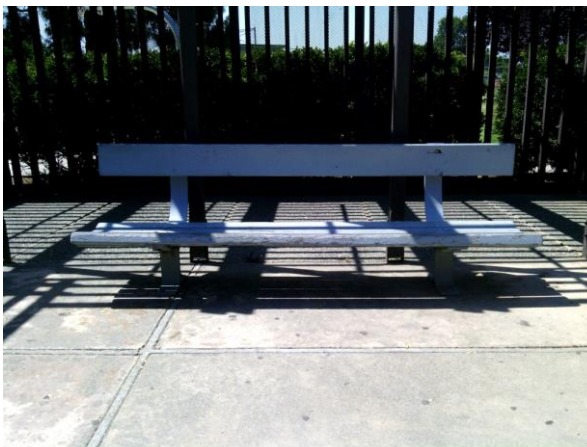
System: G2060.25.026

Asset Assigned Common Name (if applicable): Bench 06
Area/Floor (if applicable):
Asset ID: CSC003454
Asset Category (if applicable): Benches
Quantity/Unit of Measure: 1 / EA
Estimate: (Escalated to Priority Year) \$2,508
Priority Year Description: 03 - Address deficiency or Capital Requirement in Year 03
Deficiency Description: *Bench shows evidence of damage.*
Description of Work: *Replace bench.*
Comment:

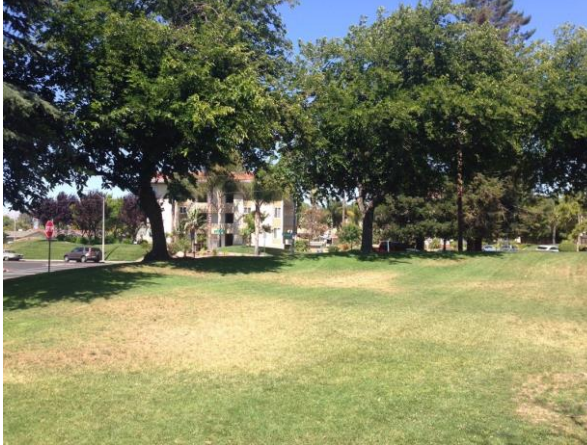
System: G2080.20.003

Asset Assigned Common Name (if applicable): Landscaping 01
Area/Floor (if applicable): Grounds
Asset ID: CSC002311
Asset Category (if applicable): Landscaping
Quantity/Unit of Measure: 1500 / SF
Estimate: \$4,436
(Escalated to Priority Year)
Priority Year Description: 01 - Address deficiency or Capital Requirement in Year 01
Deficiency Description: *Natural turf areas show evidence of damage.*
Description of Work: *Repair natural turf areas.*
Comment:

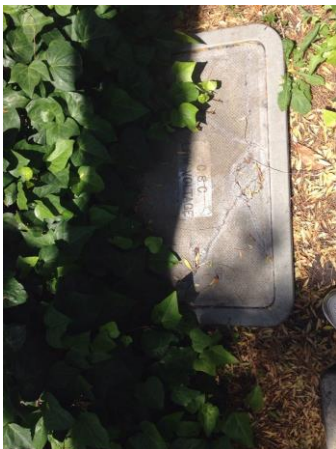
System: G4010.20.005

Asset Assigned Common Name (if applicable): Elec Box 10
Area/Floor (if applicable): Grounds
Asset ID: CSC002315
Asset Category (if applicable): Electrical Boxes
Quantity/Unit of Measure: 1 / EA
Estimate: \$622
(Escalated to Priority Year)
Priority Year Description: 02 - Address deficiency or Capital Requirement in Year 02
Deficiency Description: *Electrical box cover shows evidence of damage.*
Description of Work: *Replace electrical box cover.*
Comment:

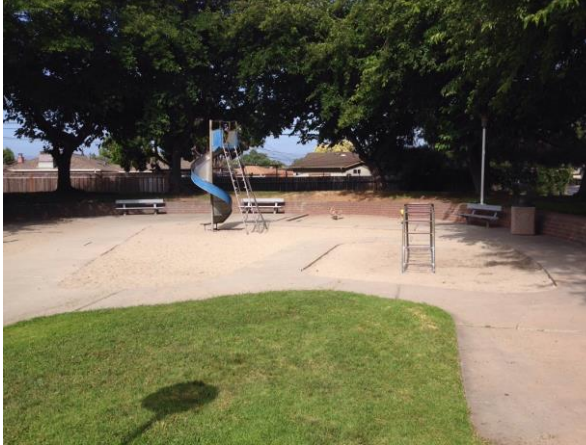
System: B1010.50.011

Asset Assigned Common Name (if applicable): Playground 01
Area/Floor (if applicable): Grounds
Asset ID: CSC002322
Asset Category (if applicable): Playground Area
Quantity/Unit of Measure: 150 / SF
Estimate: \$5,332
(Escalated to Priority Year)
Priority Year Description: 01 - Address deficiency or Capital Requirement in Year 01
Deficiency Description: *No ADA access - add accessible material.*
Description of Work: *Provide improvements for ADA path of travel.*
Comment:

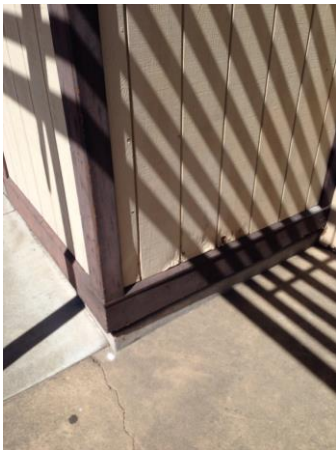
System: B2010.10.007

Asset Assigned Common Name (if applicable): Building 01
Area/Floor (if applicable): Exterior Building / 1
Asset ID: CSC003482
Asset Category (if applicable): Building
Quantity/Unit of Measure: 40 / LF
Estimate: \$1,097
(Escalated to Priority Year)
Priority Year Description: 04 - Address deficiency or Capital Requirement in Year 04
Deficiency Description: *Wood trim is worn.*
Description of Work: *Replace trim and finish to match.*
Comment: Damaged trim.

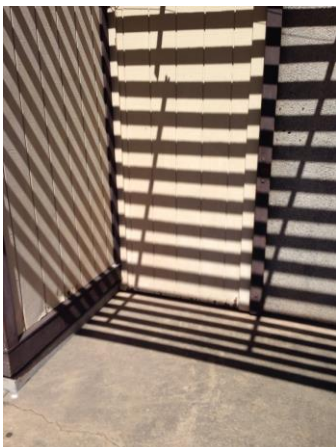
System: B2010.10.003

Asset Assigned Common Name (if applicable): Building 01
Area/Floor (if applicable): Exterior Building / 1
Asset ID: CSC003482
Asset Category (if applicable): Building
Quantity/Unit of Measure: 80 / SF
Estimate: \$1,672
(Escalated to Priority Year)
Priority Year Description: 03 - Address deficiency or Capital Requirement in Year 03
Deficiency Description: *Wood board is in poor condition.*
Description of Work: *Replace or repair existing wood siding. Place new siding over building paper and plywood sheathing.*
Comment: Wood panels.

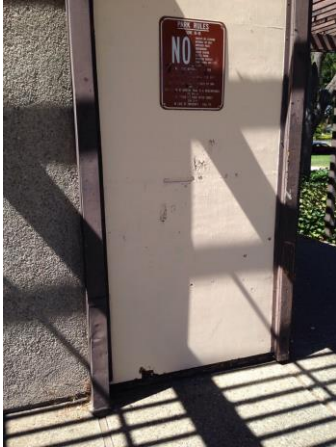
System: B2010.10.003

Asset Assigned Common Name (if applicable): Building 01
Area/Floor (if applicable): Exterior Building / 1
Asset ID: CSC003482
Asset Category (if applicable): Building
Quantity/Unit of Measure: 40 / SF
Estimate: \$836
(Escalated to Priority Year)
Priority Year Description: 03 - Address deficiency or Capital Requirement in Year 03
Deficiency Description: *Wood board is in poor condition.*
Description of Work: *Replace or repair existing wood siding. Place new siding over building paper and plywood sheathing.*
Comment: Wood panels.

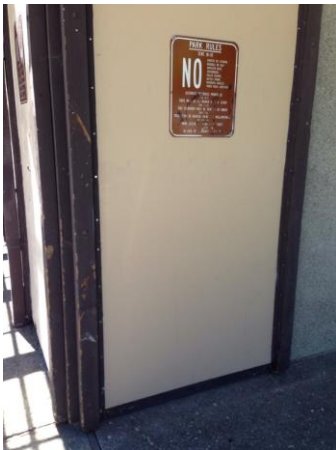
Asset Assigned Common Name (if applicable): Building 01
Area/Floor (if applicable): Exterior Building / 1
Asset ID: CSC003482
Asset Category (if applicable): Building
Quantity/Unit of Measure: 40 / SF
Estimate: \$836
(Escalated to Priority Year)
Priority Year Description: 03 - Address deficiency or Capital Requirement in Year 03
Deficiency Description: *Wood board is in poor condition.*
Description of Work: *Replace or repair existing wood siding. Place new siding over building paper and plywood sheathing.*
Comment: Wood panels.

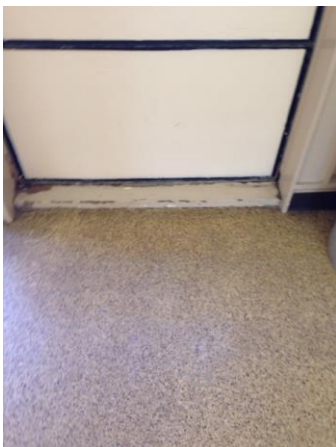
Asset Assigned Common Name (if applicable): Building 01
Area/Floor (if applicable): Classroom / 1
Asset ID: CSC003482
Asset Category (if applicable): Building
Quantity/Unit of Measure: 10 / LF
Estimate: \$144
(Escalated to Priority Year)
Priority Year Description: 05 - Address deficiency or Capital Requirement in Year 05
Deficiency Description: *The paint finish on the window sills is chipped and peeling.*
Description of Work: *Clean and paint window sills.*
Comment: Wood sills.

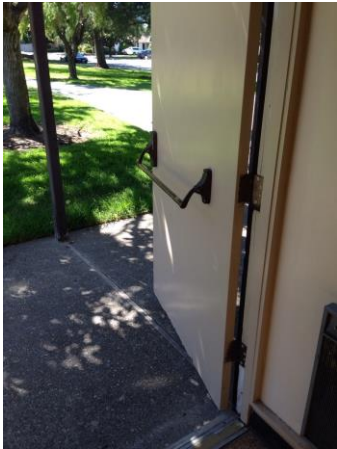
Asset Assigned Common Name (if applicable):	Building 01
Area/Floor (if applicable):	Classroom / 1
Asset ID:	CSC003482
Asset Category (if applicable):	Building
Quantity/Unit of Measure:	2 / EA
Estimate:	\$10,386
(Escalated to Priority Year)	
Priority Year Description:	01 - Address deficiency or Capital Requirement in Year 01
Deficiency Description:	Exterior hollow metal doors: Poor closing and latching, worn out door hardware and missing door seals.
Description of Work:	Replace doors and hardware with new accessible hardware, including door seals and thresholds. Rework concrete to provide level door landing to meet accessibility standards.
Comment:	Exit doors, door landings/thresholds do not meet current accessibility standards.

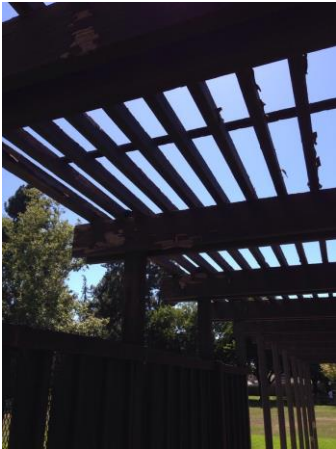
Asset Assigned Common Name (if applicable):	Building 01
Area/Floor (if applicable):	Exterior Trellis / 1
Asset ID:	CSC003482
Asset Category (if applicable):	Building
Quantity/Unit of Measure:	3403 / SF
Estimate: (Escalated to Priority Year)	\$294,055
Priority Year Description:	05 - Address deficiency or Capital Requirement in Year 05
Deficiency Description:	Existing 4x4 wood post and 2x8 beam trellis has deteriorated.
Description of Work:	Demolish existing wood trellis and replace with similar structure.
Comment:	Deteriorating wood trellis.

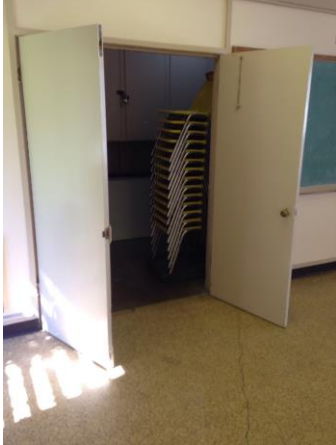
Asset Assigned Common Name (if applicable): Building 01
Area/Floor (if applicable): Classroom / 1
Asset ID: CSC003482
Asset Category (if applicable): Building
Quantity/Unit of Measure: 2 / EA
Estimate: \$12,070
(Escalated to Priority Year)
Priority Year Description: 04 - Address deficiency or Capital Requirement in Year 04
Deficiency Description: *Interior wood or metal door is in poor condition.*
Description of Work: *Refurbish or replace existing door.*
Comment: Classroom storage doors.

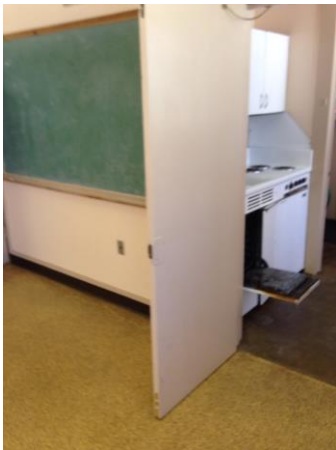
Asset Assigned Common Name (if applicable): Building 01
Area/Floor (if applicable): Classroom / 1
Asset ID: CSC003482
Asset Category (if applicable): Building
Quantity/Unit of Measure: 2 / EA
Estimate: \$11,495
(Escalated to Priority Year)
Priority Year Description: 03 - Address deficiency or Capital Requirement in Year 03
Deficiency Description: *Interior wood or metal door is in poor condition.*
Description of Work: *Refurbish or replace existing door.*
Comment: Classroom storage doors.

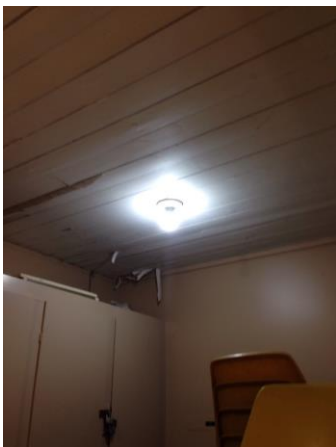
Asset Assigned Common Name (if applicable): Building 01
Area/Floor (if applicable): Classroom - Storage / 1
Asset ID: CSC003482
Asset Category (if applicable): Building
Quantity/Unit of Measure: 90 / SF
Estimate: \$1,543
(Escalated to Priority Year)
Priority Year Description: 04 - Address deficiency or Capital Requirement in Year 04
Deficiency Description: *Ceiling is in poor condition.*
Description of Work: *Remove and replace existing ceiling and replace with new gypsum board. Tape and paint.*
Comment: Classroom storage ceiling.

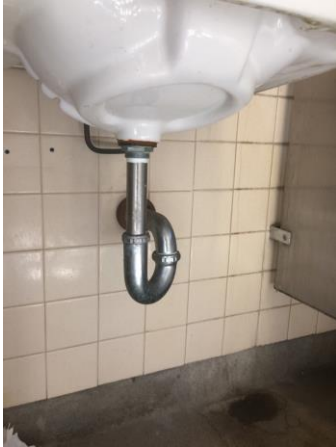
Asset Assigned Common Name (if applicable): LAV - Women's Restroom
Area/Floor (if applicable): Women's Restroom
Asset ID: CSC002224
Asset Category (if applicable): Plumbing Fixtures
Quantity/Unit of Measure: 1 / SF
Estimate: \$29
(Escalated to Priority Year)
Priority Year Description: 01 - Address deficiency or Capital Requirement in Year 01
Deficiency Description: *Insulation missing from sanitary sewer tailpipe for ADA.*
Description of Work: *Cover sanitary sewer pipe with appropriate ADA-approved insulation.*
Comment:

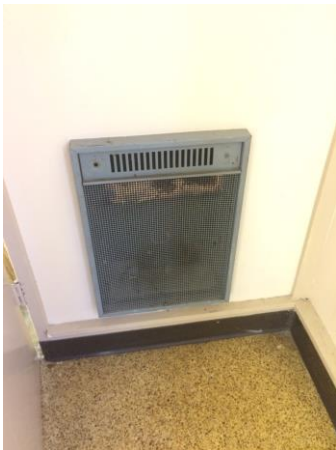
Asset Assigned Common Name (if applicable): EUH-1
Area/Floor (if applicable): Community / Ground
Asset ID: CSC002230
Asset Category (if applicable): Air Conditioning Unit
Quantity/Unit of Measure: 1 / EA
Estimate: \$1,443
(Escalated to Priority Year)
Priority Year Description: 02 - Address deficiency or Capital Requirement in Year 02
Deficiency Description: *Electric unit heater is approaching the end of its useful life.*
Description of Work: *Provide equipment replacement and installation.*
Comment:

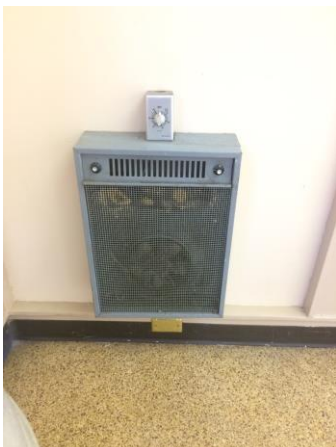
Asset Assigned Common Name (if applicable): EUH-2
Area/Floor (if applicable): Community / Ground
Asset ID: CSC002229
Asset Category (if applicable): Air Conditioning Unit
Quantity/Unit of Measure: 1 / EA
Estimate: \$1,443
(Escalated to Priority Year)
Priority Year Description: 02 - Address deficiency or Capital Requirement in Year 02
Deficiency Description: *Electric unit heater is approaching the end of its useful life.*
Description of Work: *Provide equipment replacement and installation.*
Comment: Equipment appears to be not in use.

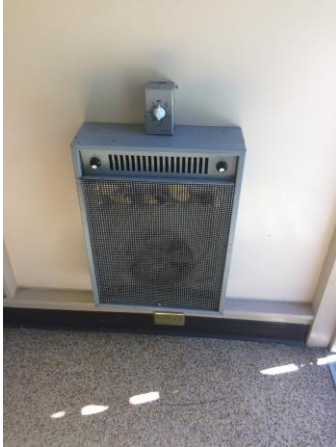
Asset Assigned Common Name (if applicable): EUH-3
Area/Floor (if applicable): Community / Ground
Asset ID: CSC002228
Asset Category (if applicable): Air Conditioning Unit
Quantity/Unit of Measure: 1 / EA
Estimate: \$1,443
(Escalated to Priority Year)
Priority Year Description: 02 - Address deficiency or Capital Requirement in Year 02
Deficiency Description: *Electric unit heater is approaching the end of its useful life.*
Description of Work: *Provide equipment replacement and installation.*
Comment: Equipment appears to be not in use.

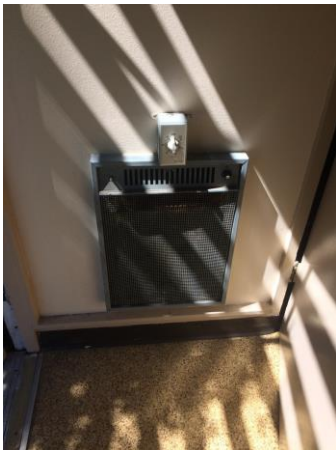
Asset Assigned Common Name (if applicable): EUH-4
Area/Floor (if applicable): Community / Ground
Asset ID: CSC002232
Asset Category (if applicable): Air Conditioning Unit
Quantity/Unit of Measure: 1 / EA
Estimate: \$1,443
(Escalated to Priority Year)
Priority Year Description: 02 - Address deficiency or Capital Requirement in Year 02
Deficiency Description: *Electric unit heater is approaching the end of its useful life.*
Description of Work: *Provide equipment replacement and installation.*
Comment: Equipment appears to be not in use.

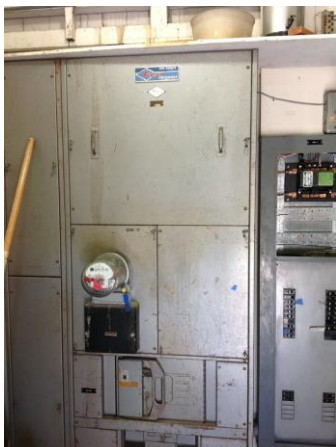
Asset Assigned Common Name (if applicable): Metered Main Switchboard
Area/Floor (if applicable): Restroom - Storage / 1
Asset ID: CSC002292
Asset Category (if applicable): Main Switchgear
Quantity/Unit of Measure: 1 / EA
Estimate: \$13,080
(Escalated to Priority Year)
Priority Year Description: 01 - Address deficiency or Capital Requirement in Year 01
Deficiency Description: *400A Metered main switchboard (3P, 120/208) is approaching the end of its expected useful life.*
Description of Work: *Replace the metered main switchboard.*
Comment: Switchboard is beyond its useful life. Additionally, Zinsco switchboards are known for their chance of catastrophic failure.

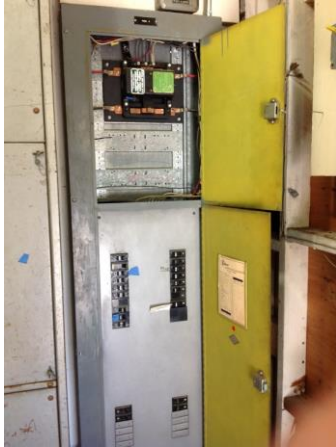
Asset Assigned Common Name (if applicable):	Panel A
Area/Floor (if applicable):	Restroom - Storage / 1
Asset ID:	CSC002291
Asset Category (if applicable):	Panel
Quantity/Unit of Measure:	1 / EA
Estimate:	\$13,694
(Escalated to Priority Year)	
Priority Year Description:	01 - Address deficiency or Capital Requirement in Year 01
Deficiency Description:	225A (42 ckts, 120/208, 3P) Panelboard is approaching the end of its expected useful life.
Description of Work:	Replace the panelboard.
Comment:	Panelboard is beyond its useful life. Additionally, Zinsco panelboards are known for their chance of catastrophic failure.

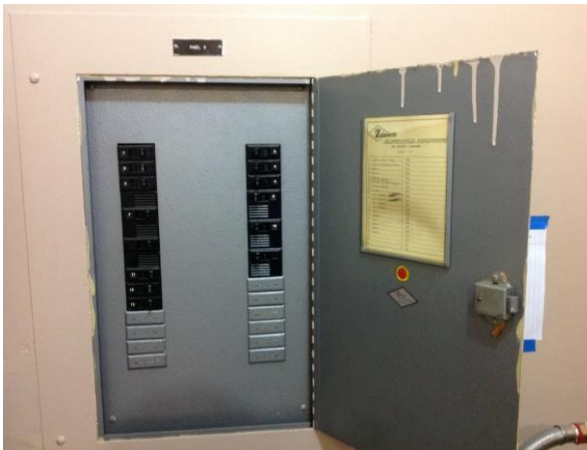
Asset Assigned Common Name (if applicable):	Panel B
Area/Floor (if applicable):	Classroom - Storage / 1
Asset ID:	CSC002288
Asset Category (if applicable):	Panel
Quantity/Unit of Measure:	1 / EA
Estimate:	\$13,694
(Escalated to Priority Year)	
Priority Year Description:	01 - Address deficiency or Capital Requirement in Year 01
Deficiency Description:	225A (42 ckts, 120/208, 3P) Panelboard is approaching the end of its expected useful life.
Description of Work:	Replace the panelboard.
Comment:	Panelboard is beyond its useful life. Additionally, Zinsco panelboards are known for their chance of catastrophic failure.

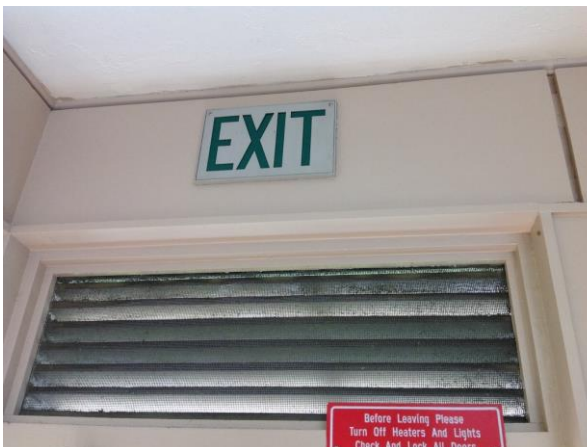
Asset Assigned Common Name (if applicable):	Exit Sign
Area/Floor (if applicable):	Classroom / 1
Asset ID:	CSC002285
Asset Category (if applicable):	Exit Lighting
Quantity/Unit of Measure:	2 / EA
Estimate:	\$2,725
(Escalated to Priority Year)	
Priority Year Description:	01 - Address deficiency or Capital Requirement in Year 01
Deficiency Description:	Public areas do not have code required illuminated exit lights.
Description of Work:	Add battery backed up illuminated exit lights including circuiting.
Comment:	Exit light fixtures are not illuminated.

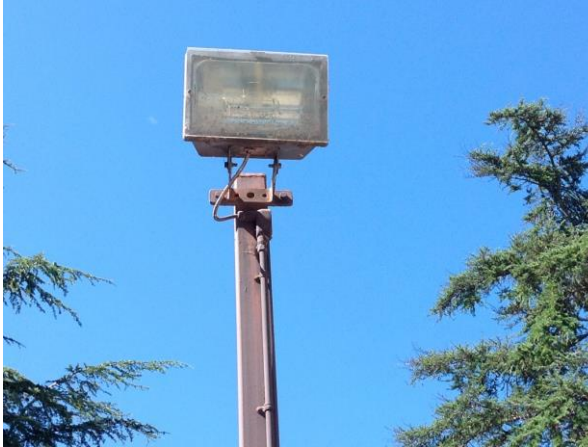
Asset Assigned Common Name (if applicable):	Exterior Lighting
Area/Floor (if applicable):	Exterior Courtyard / 1
Asset ID:	CSC002282
Asset Category (if applicable):	Exterior Lighting
Quantity/Unit of Measure:	1 / EA
Estimate:	\$143
(Escalated to Priority Year)	
Priority Year Description:	02 - Address deficiency or Capital Requirement in Year 02
Deficiency Description:	<i>Exterior lighting fixture lens is yellowing or is in poor condition.</i>
Description of Work:	<i>Replace the lighting fixture lens.</i>
Comment:	Cracked lens on floodlight fixture.

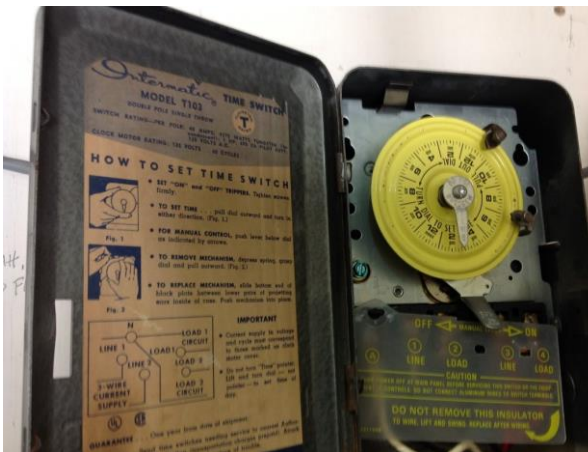
Asset Assigned Common Name (if applicable):	Time Clock 1
Area/Floor (if applicable):	Restroom - Storage / 1
Asset ID:	CSC002290
Asset Category (if applicable):	Time Clock
Quantity/Unit of Measure:	1 / EA
Estimate:	\$662
(Escalated to Priority Year)	
Priority Year Description:	05 - Address deficiency or Capital Requirement in Year 05
Deficiency Description:	<i>Time clock is approaching the end of its expected useful life.</i>
Description of Work:	<i>Replace the time clock.</i>
Comment:

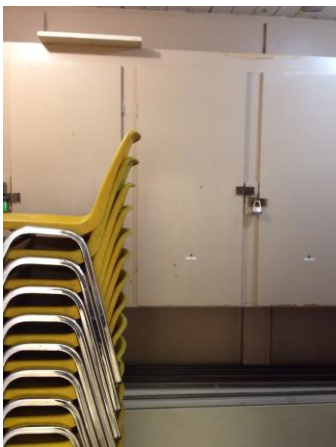
Asset Assigned Common Name (if applicable):	Building 01
Area/Floor (if applicable):	Classroom / 1
Asset ID:	CSC003482
Asset Category (if applicable):	Building
Quantity/Unit of Measure:	20 / LF
Estimate:	\$23,512
(Escalated to Priority Year)	
Priority Year Description:	03 - Address deficiency or Capital Requirement in Year 03
Deficiency Description:	<i>Original casework and shelving is worn and damaged.</i>
Description of Work:	<i>Refinish or replace original cabinets and countertops.</i>
Comment:	Classroom storage cabinets.
