**City Council Meeting**

Item 5, RTC 24-120

**Action & Direction on the Re-Opening of the George F. Haines International Swim Center (ISC) for Temporary Use with a Maximum Occupancy of 200 People**

**June 25, 2024**

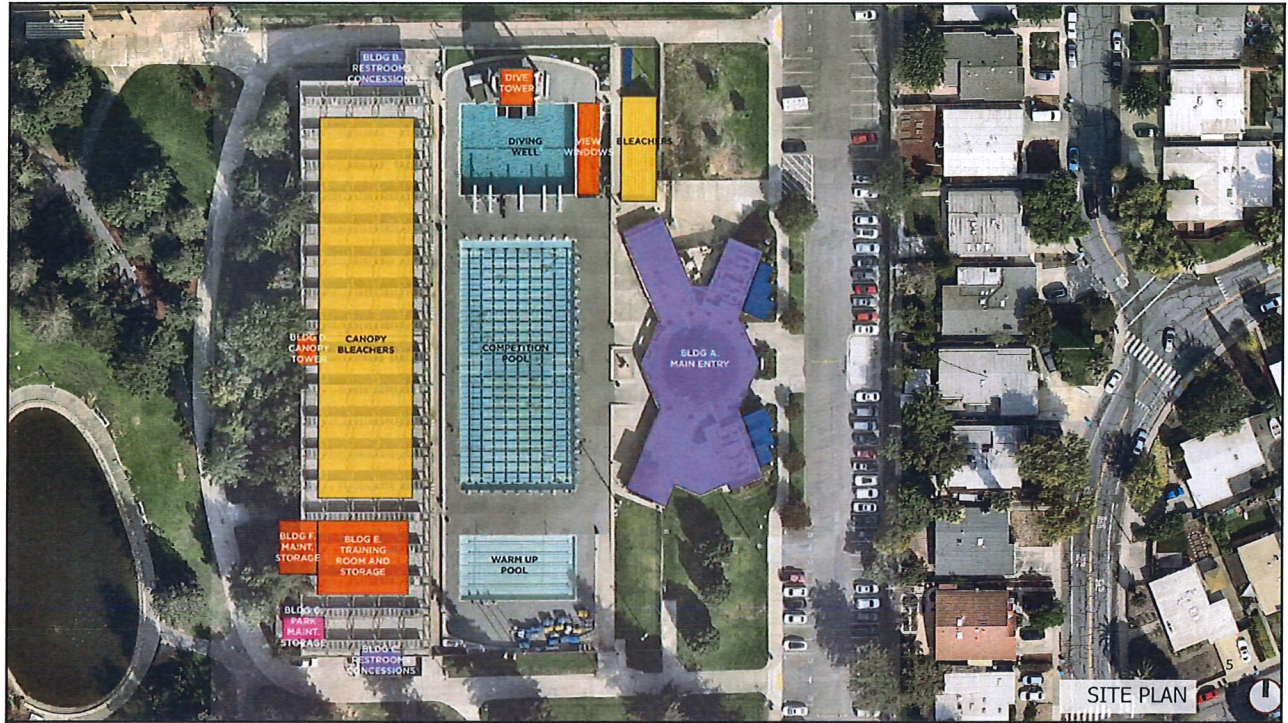
5

Building A - Building supporting walls are structurally unsound and have extensive wood decay and corrosion of metal components, requiring replacement.

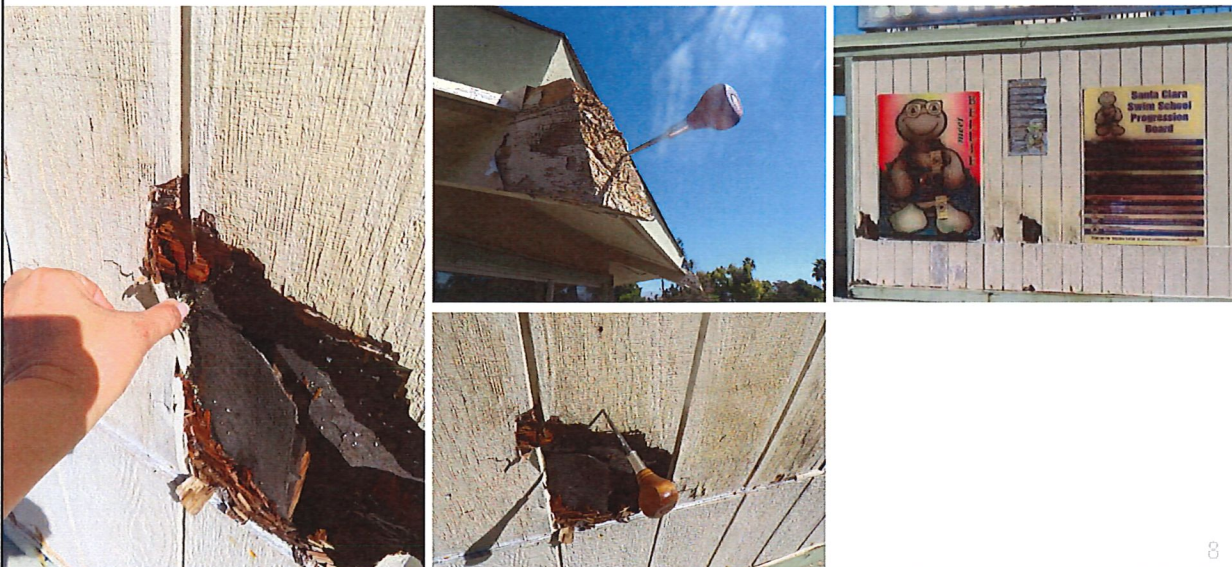
Building A - Compromised wall structure with decayed wood and flaking paint. Inspectors were able to push the awl into the trim with relative ease.

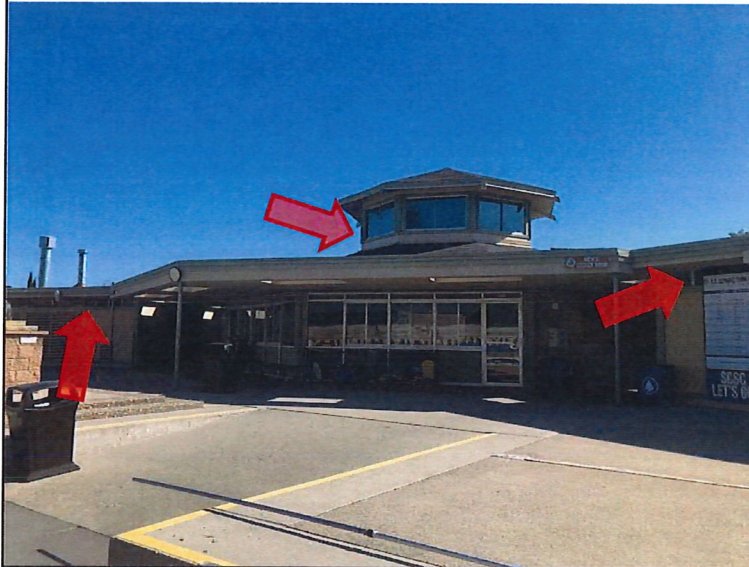
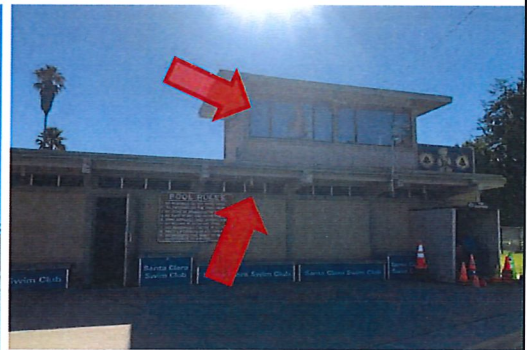
Building A – The building is structurally unsound due to the large clerestory windows which prevent adequate lateral structural support throughout. These windows need to be removed and infilled to transfer shear loads.

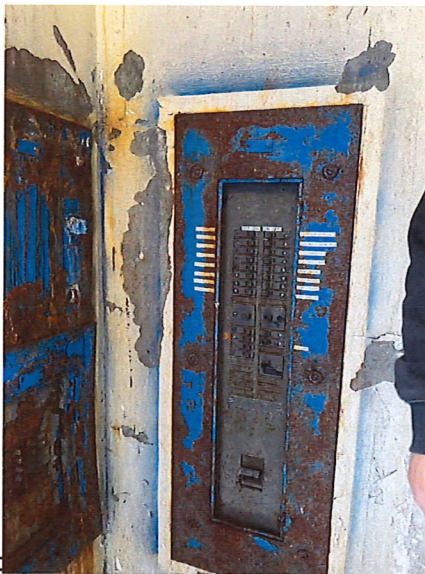
Diving Tower – Significant concerns with the electrical system and corrosion were observed.

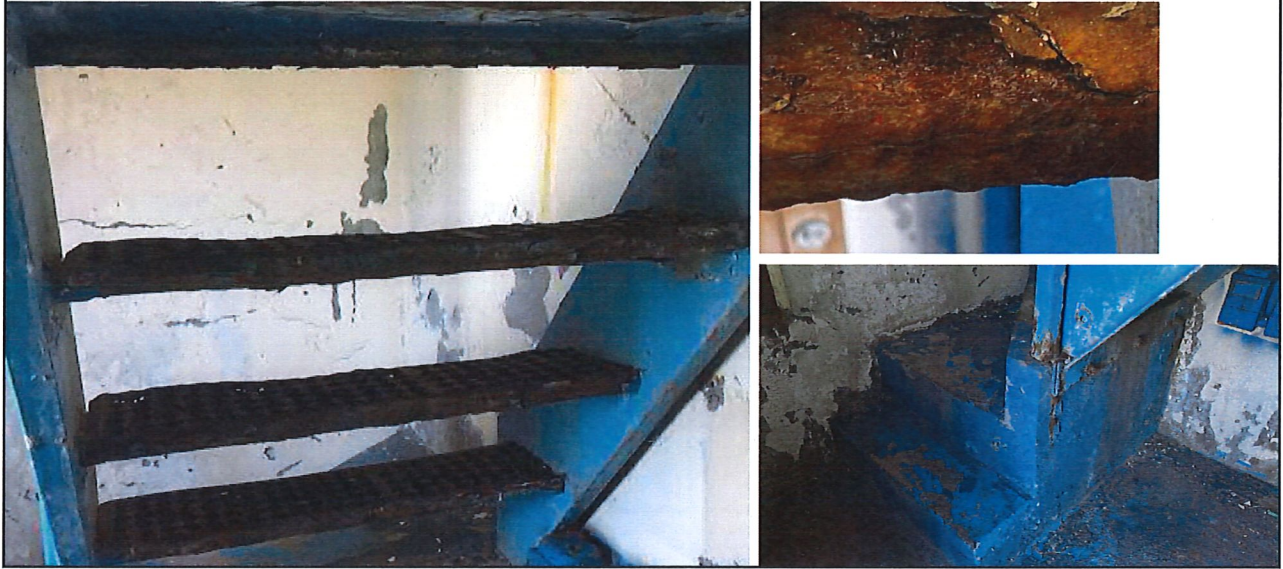
Dive Tower - Staircase is unsafe with extensive corrosion, particularly on flat surfaces and crevices. Welds are also corroded.

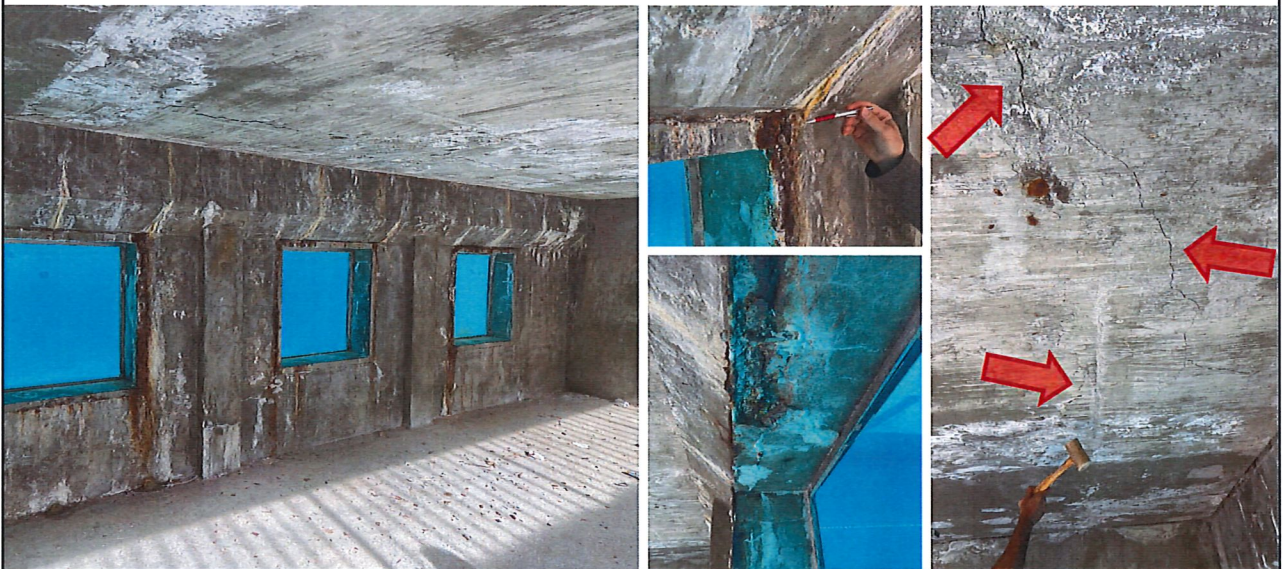
Pool - The viewing area under the deck at the dive pool and the deck above show signs of structural instability and significant deterioration. This portion of deck and viewing area (in addition to other areas) should not be utilized in any manner.

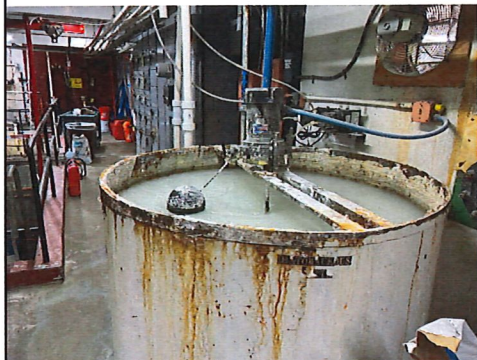
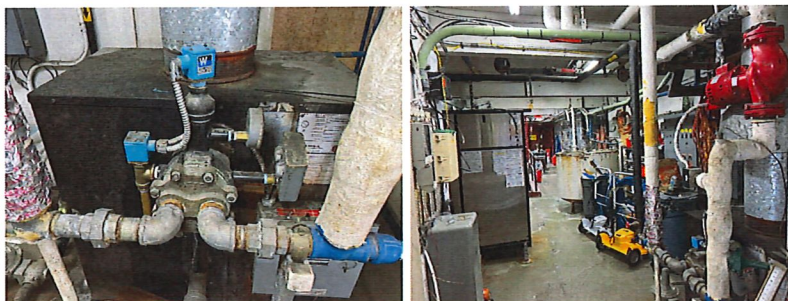
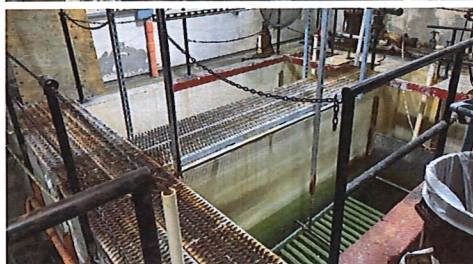
Pool Mechanicals – The pools mechanical systems do not meet current code. The bodies of water are comingled, do not meet turnover requirements and are in need of replacement. The systems are most likely “grandfathered” for operations and may need to be addressed if any improvements are made.

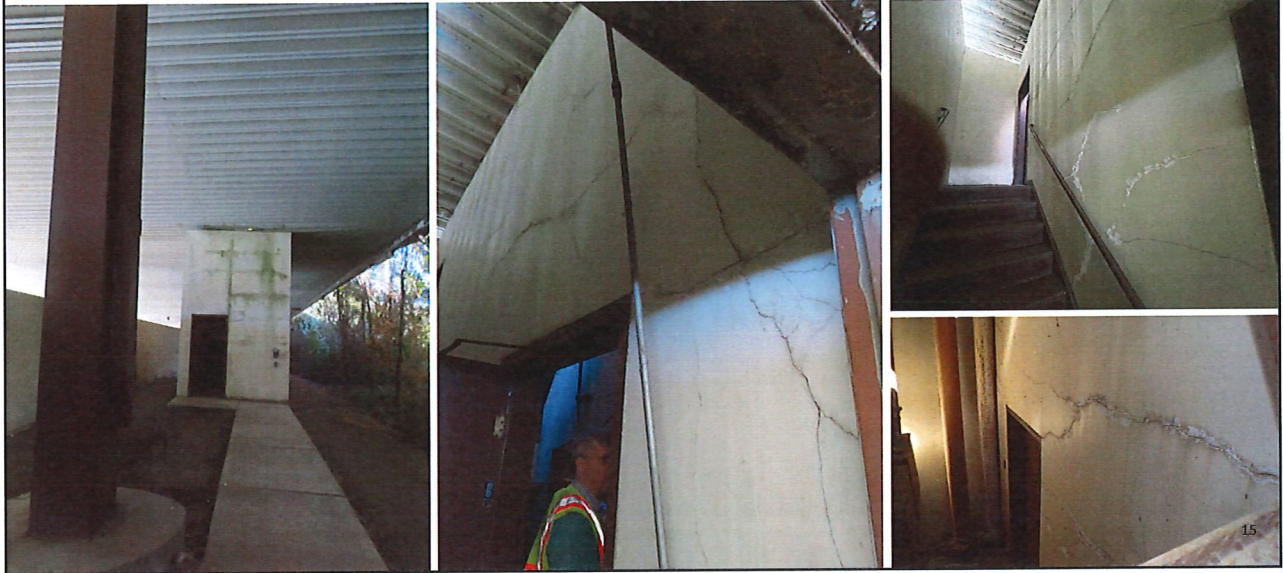
Canopy - The canopy access structure that houses the access ladder to the top of the roof deck is badly damaged. This is a stand-alone structure without connection to the roof structure. It is unsafe to be inside the structure.

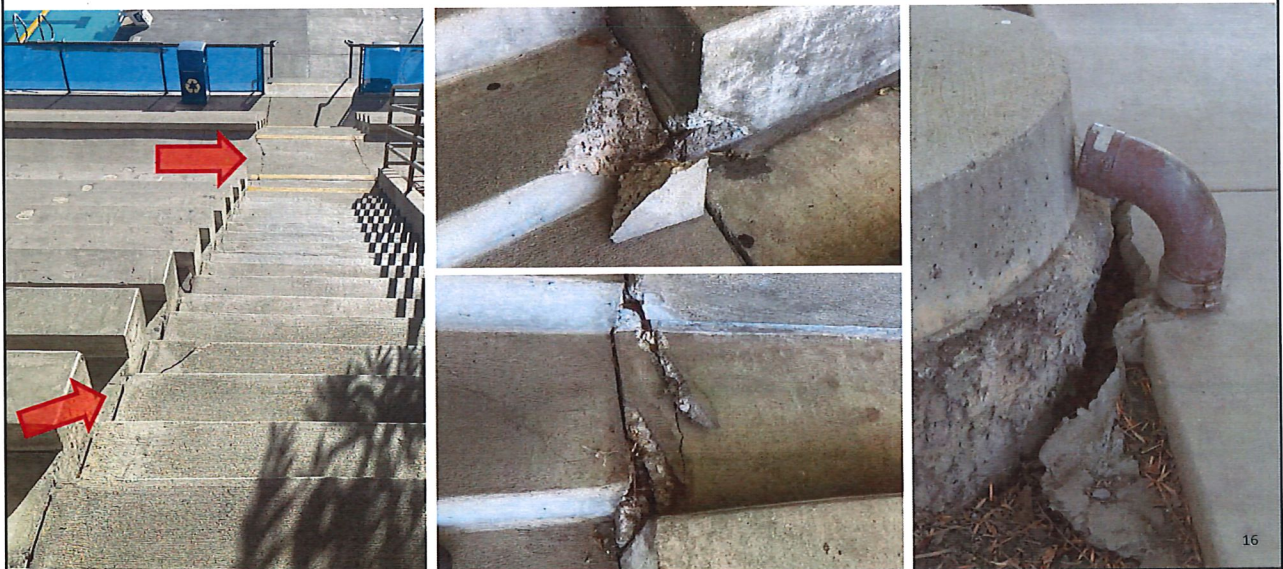
Canopy - Bleachers show signs of settlement and separation and undermining of the footings.

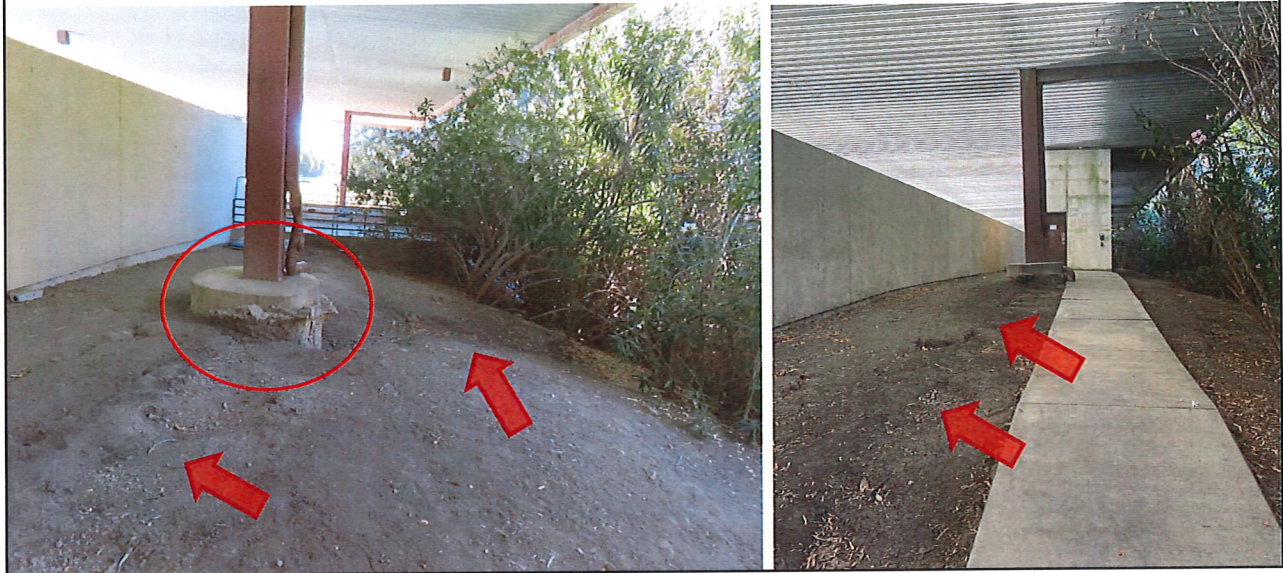
Canopy - Bleachers show signs of settlement and separation and undermining of the footings.
