9.4.5. Construction Considerations

TETRA TECH 21700 Copley Drive, Suite 200, Diamond Bar, CA 91765 TEL 909.860.7777 www.tetratech.com	2655 THE ALAMEDA PROPOSED DEVELOPMENT - SANTA CLARA, CA	JOB NO. TET 22-235E
	<h2>SITE LOCATION MAP</h2>	DATE MAY 2022
		DRAWN BY SCM
		CHECKED BY MS

PRELIMINARY DEVELOPMENT PLAN

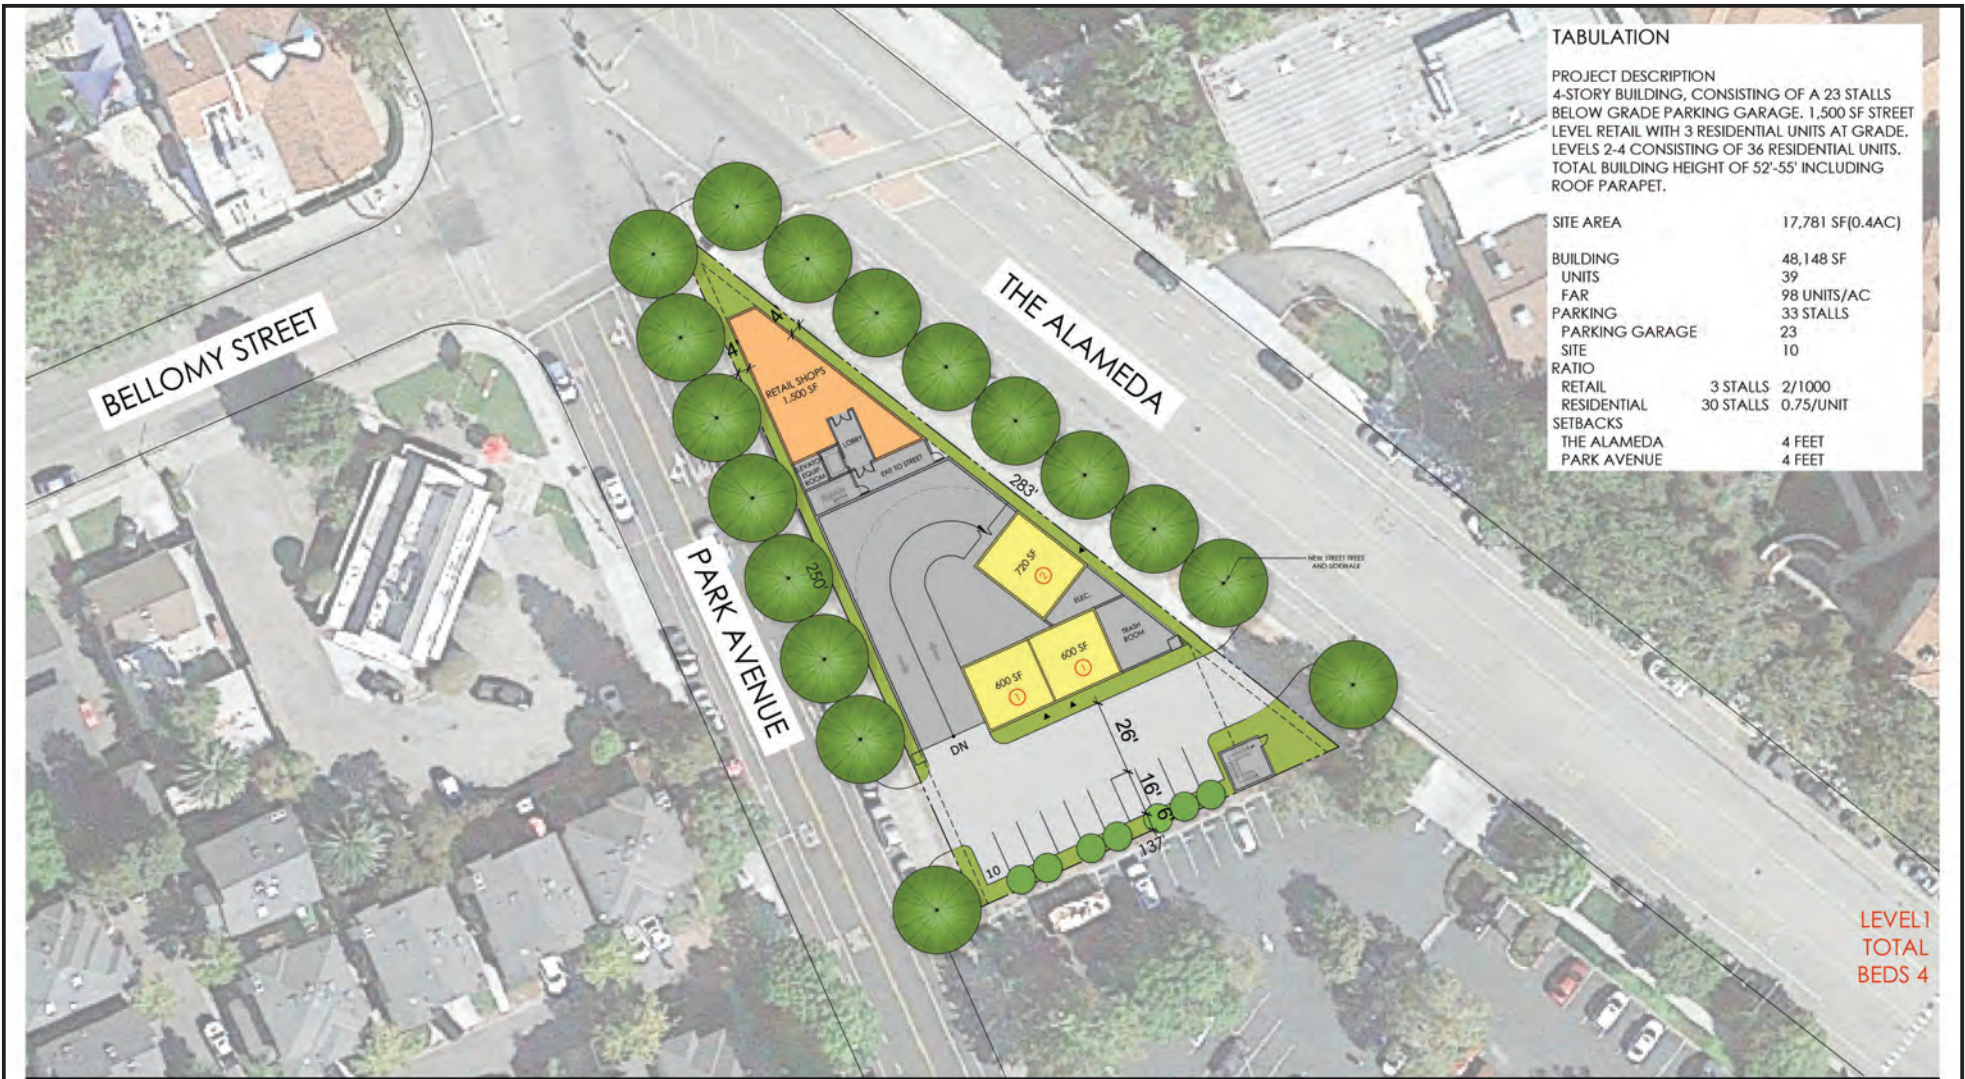
TABULATION	
PROJECT DESCRIPTION	
4-STORY BUILDING, CONSISTING OF A 23 STALLS BELOW GRADE PARKING GARAGE, 1,500 SF STREET LEVEL RETAIL WITH 3 RESIDENTIAL UNITS AT GRADE, LEVELS 2-4 CONSISTING OF 36 RESIDENTIAL UNITS, TOTAL BUILDING HEIGHT OF 52'-55' INCLUDING ROOF PARAPET.	
SITE AREA	17,781 SF(0.4AC)
BUILDING	48,148 SF
UNITS	39
FAR	98 UNITS/AC
PARKING	33 STALLS
PARKING GARAGE	23
SITE	10
RATIO	
RETAIL	3 STALLS 2/1000
RESIDENTIAL	30 STALLS 0.75/UNIT
SETBACKS	
THE ALAMEDA	4 FEET
PARK AVENUE	4 FEET

LEVEL 1
TOTAL
BEDS 4

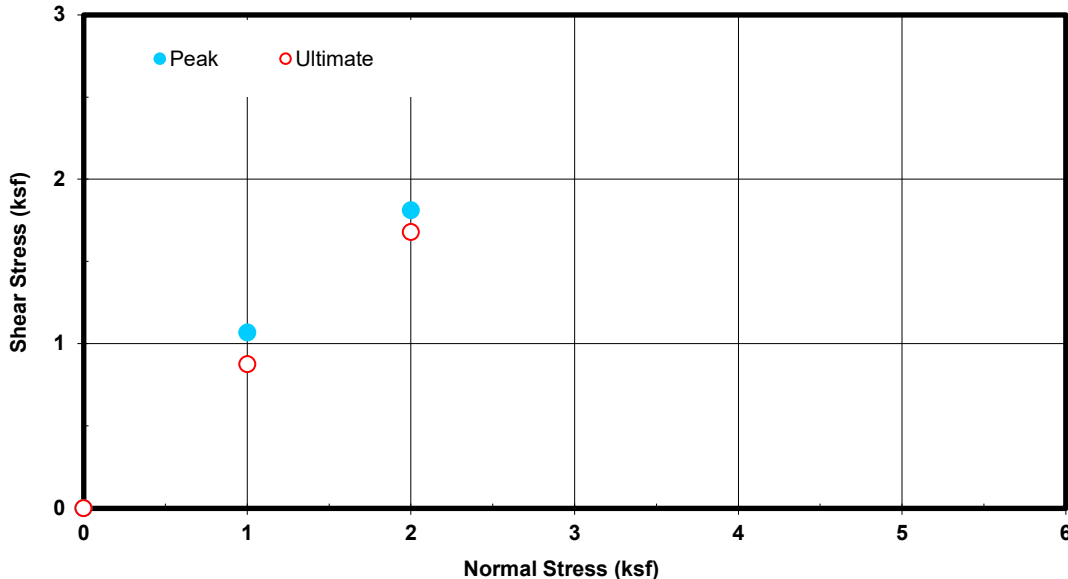
DIRECT SHEAR TEST RESULTS
ASTM D 3080

Wet Unit Weight (pcf)	Dry Unit Weight (pcf)	Initial Moisture Content (%)	Final Moisture Content (%)	Initial Degree Saturation (%)	Final Degree Saturation (%)	Normal Stress (ksf)	Peak Shear Stress (ksf)	Ultimate Shear Stress (ksf)
137.8	125.9	9.4	12.3	75	98	1	1.068	0.876
						2	1.812	1.680

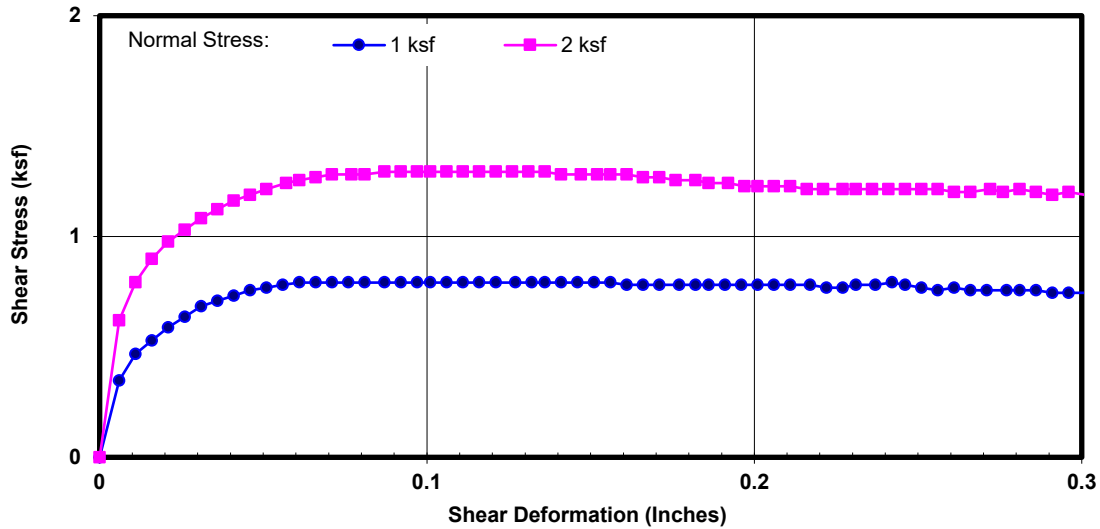
DIRECT SHEAR TEST RESULTS
ASTM D 3080

Wet Unit Weight (pcf)	Dry Unit Weight (pcf)	Initial Moisture Content (%)	Final Moisture Content (%)	Initial Degree Saturation (%)	Final Degree Saturation (%)	Normal Stress (ksf)	Peak Shear Stress (ksf)	Ultimate Shear Stress (ksf)
114.8	83.9	36.9	37.6	99	100	1	0.792	0.744
						2	1.294	1.188

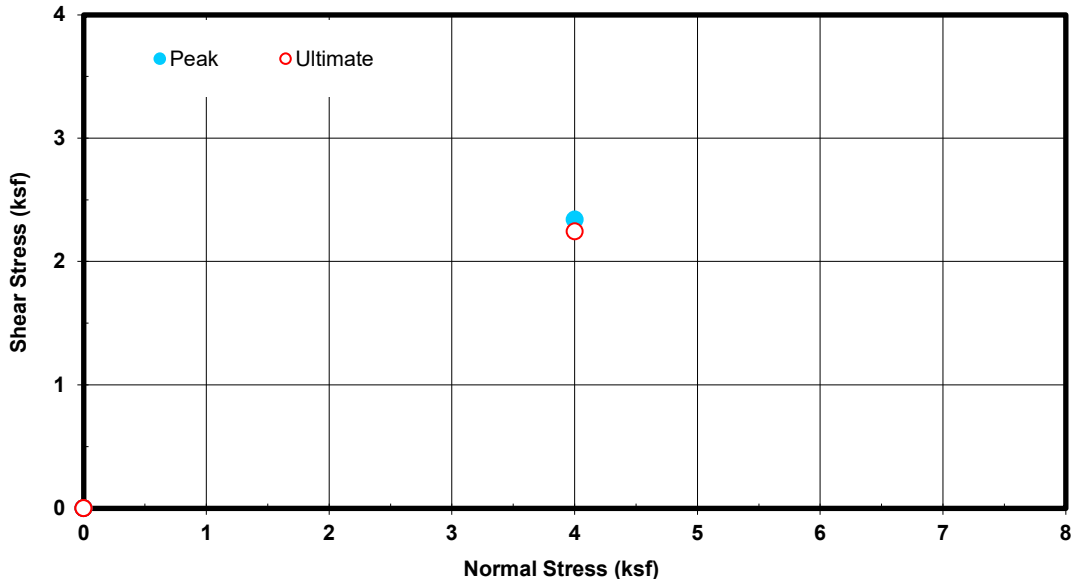
DIRECT SHEAR TEST RESULTS
ASTM D 3080

Wet Unit Weight (pcf)	Dry Unit Weight (pcf)	Initial Moisture Content (%)	Final Moisture Content (%)	Initial Degree Saturation (%)	Final Degree Saturation (%)	Normal Stress (ksf)	Peak Shear Stress (ksf)	Ultimate Shear Stress (ksf)
123.7	100.5	23.0	25.0	92	100	4	2.340	2.246

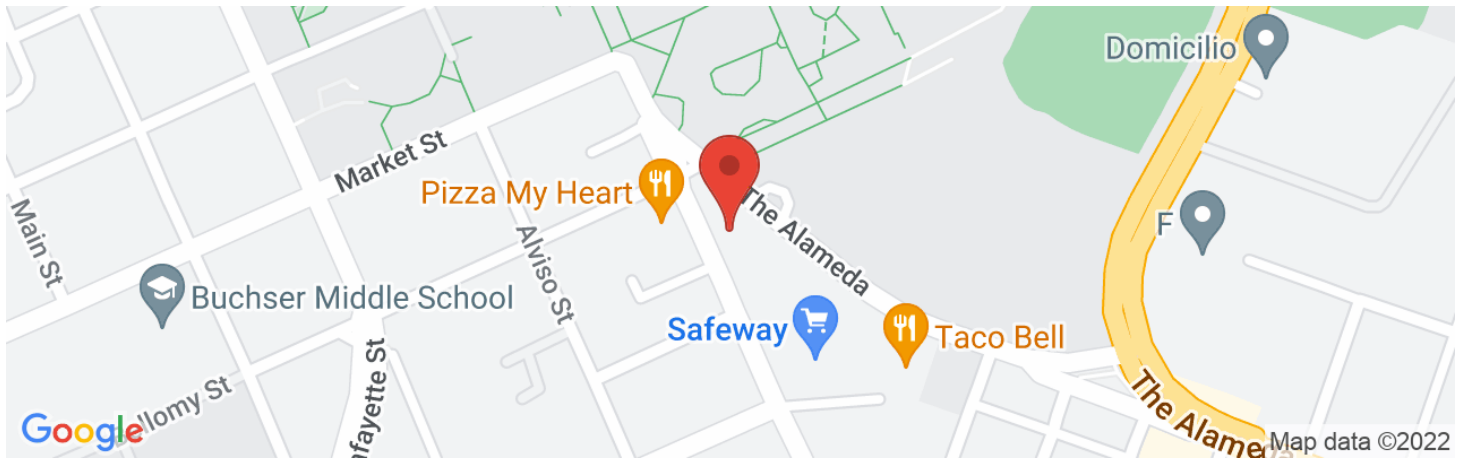
Date	5/5/2022, 5:13:42 PM
Design Code Reference Document	ASCE7-16
Risk Category	II
Site Class	E - Soft Clay Soil

Type	Value	Description
S_S	1.5	MCE_R ground motion. (for 0.2 second period)
S_1	0.6	MCE_R ground motion. (for 1.0s period)
S_{MS}	null -See Section 11.4.8	Site-modified spectral acceleration value
S_{M1}	null -See Section 11.4.8	Site-modified spectral acceleration value
S_{DS}	null -See Section 11.4.8	Numeric seismic design value at 0.2 second SA
S_{D1}	null -See Section 11.4.8	Numeric seismic design value at 1.0 second SA

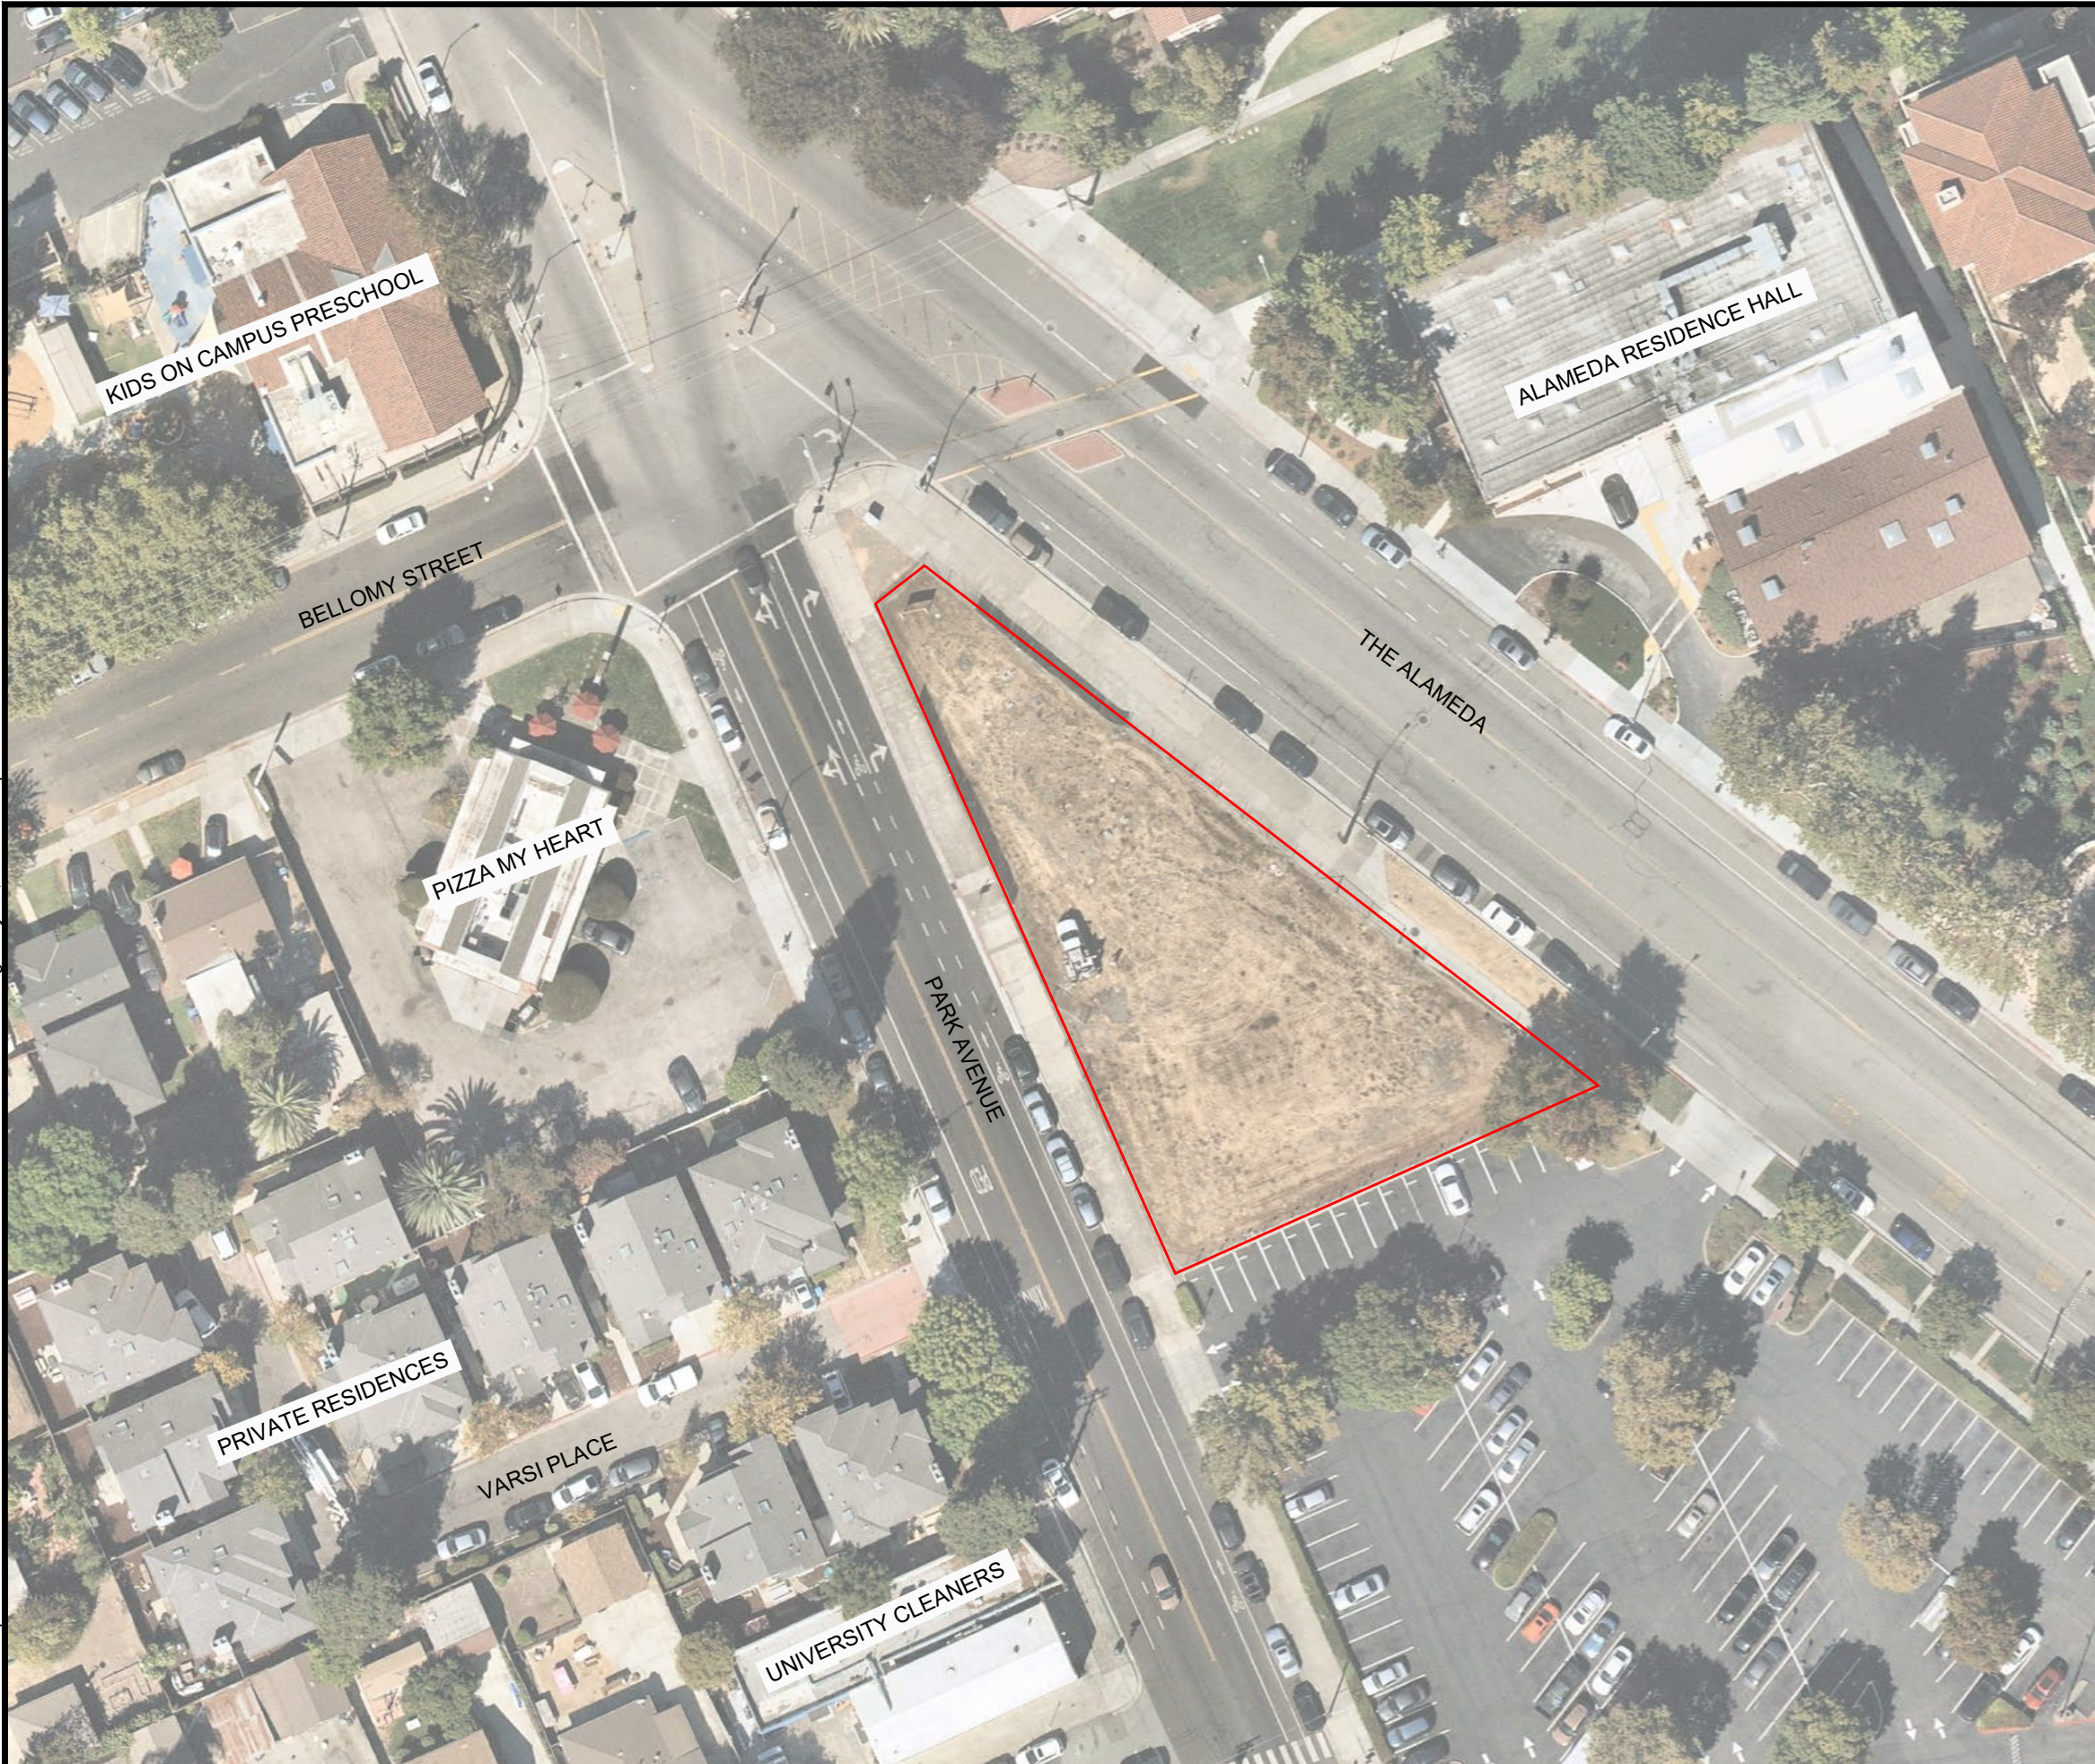
PROJECT NUMBER	APPROVED BY	DRAWN BY	DATE	FIGURE
194-1347-0001	CL	KG	FEB 2022	2

The Subject Property is located at 2665 The Alameda and consists of a triangular parcel of fenced, vacant land in the city of Santa Clara and is identified by the Assessor Parcel Number 230-12-012 (Figure 1). The Subject Property is bordered by The Alameda to the northeast, Park Avenue to the west, Bellomy Street to the northwest, and a Safeway parking lot to the south. Adjacent properties of note include various residence halls of Santa Clara University located to the east and northeast of the Property; a preschool and childcare center, Kids on Campus, to the northwest; University Cleaners to the southwest; and Pizza My Heart to the west (Figure 2).

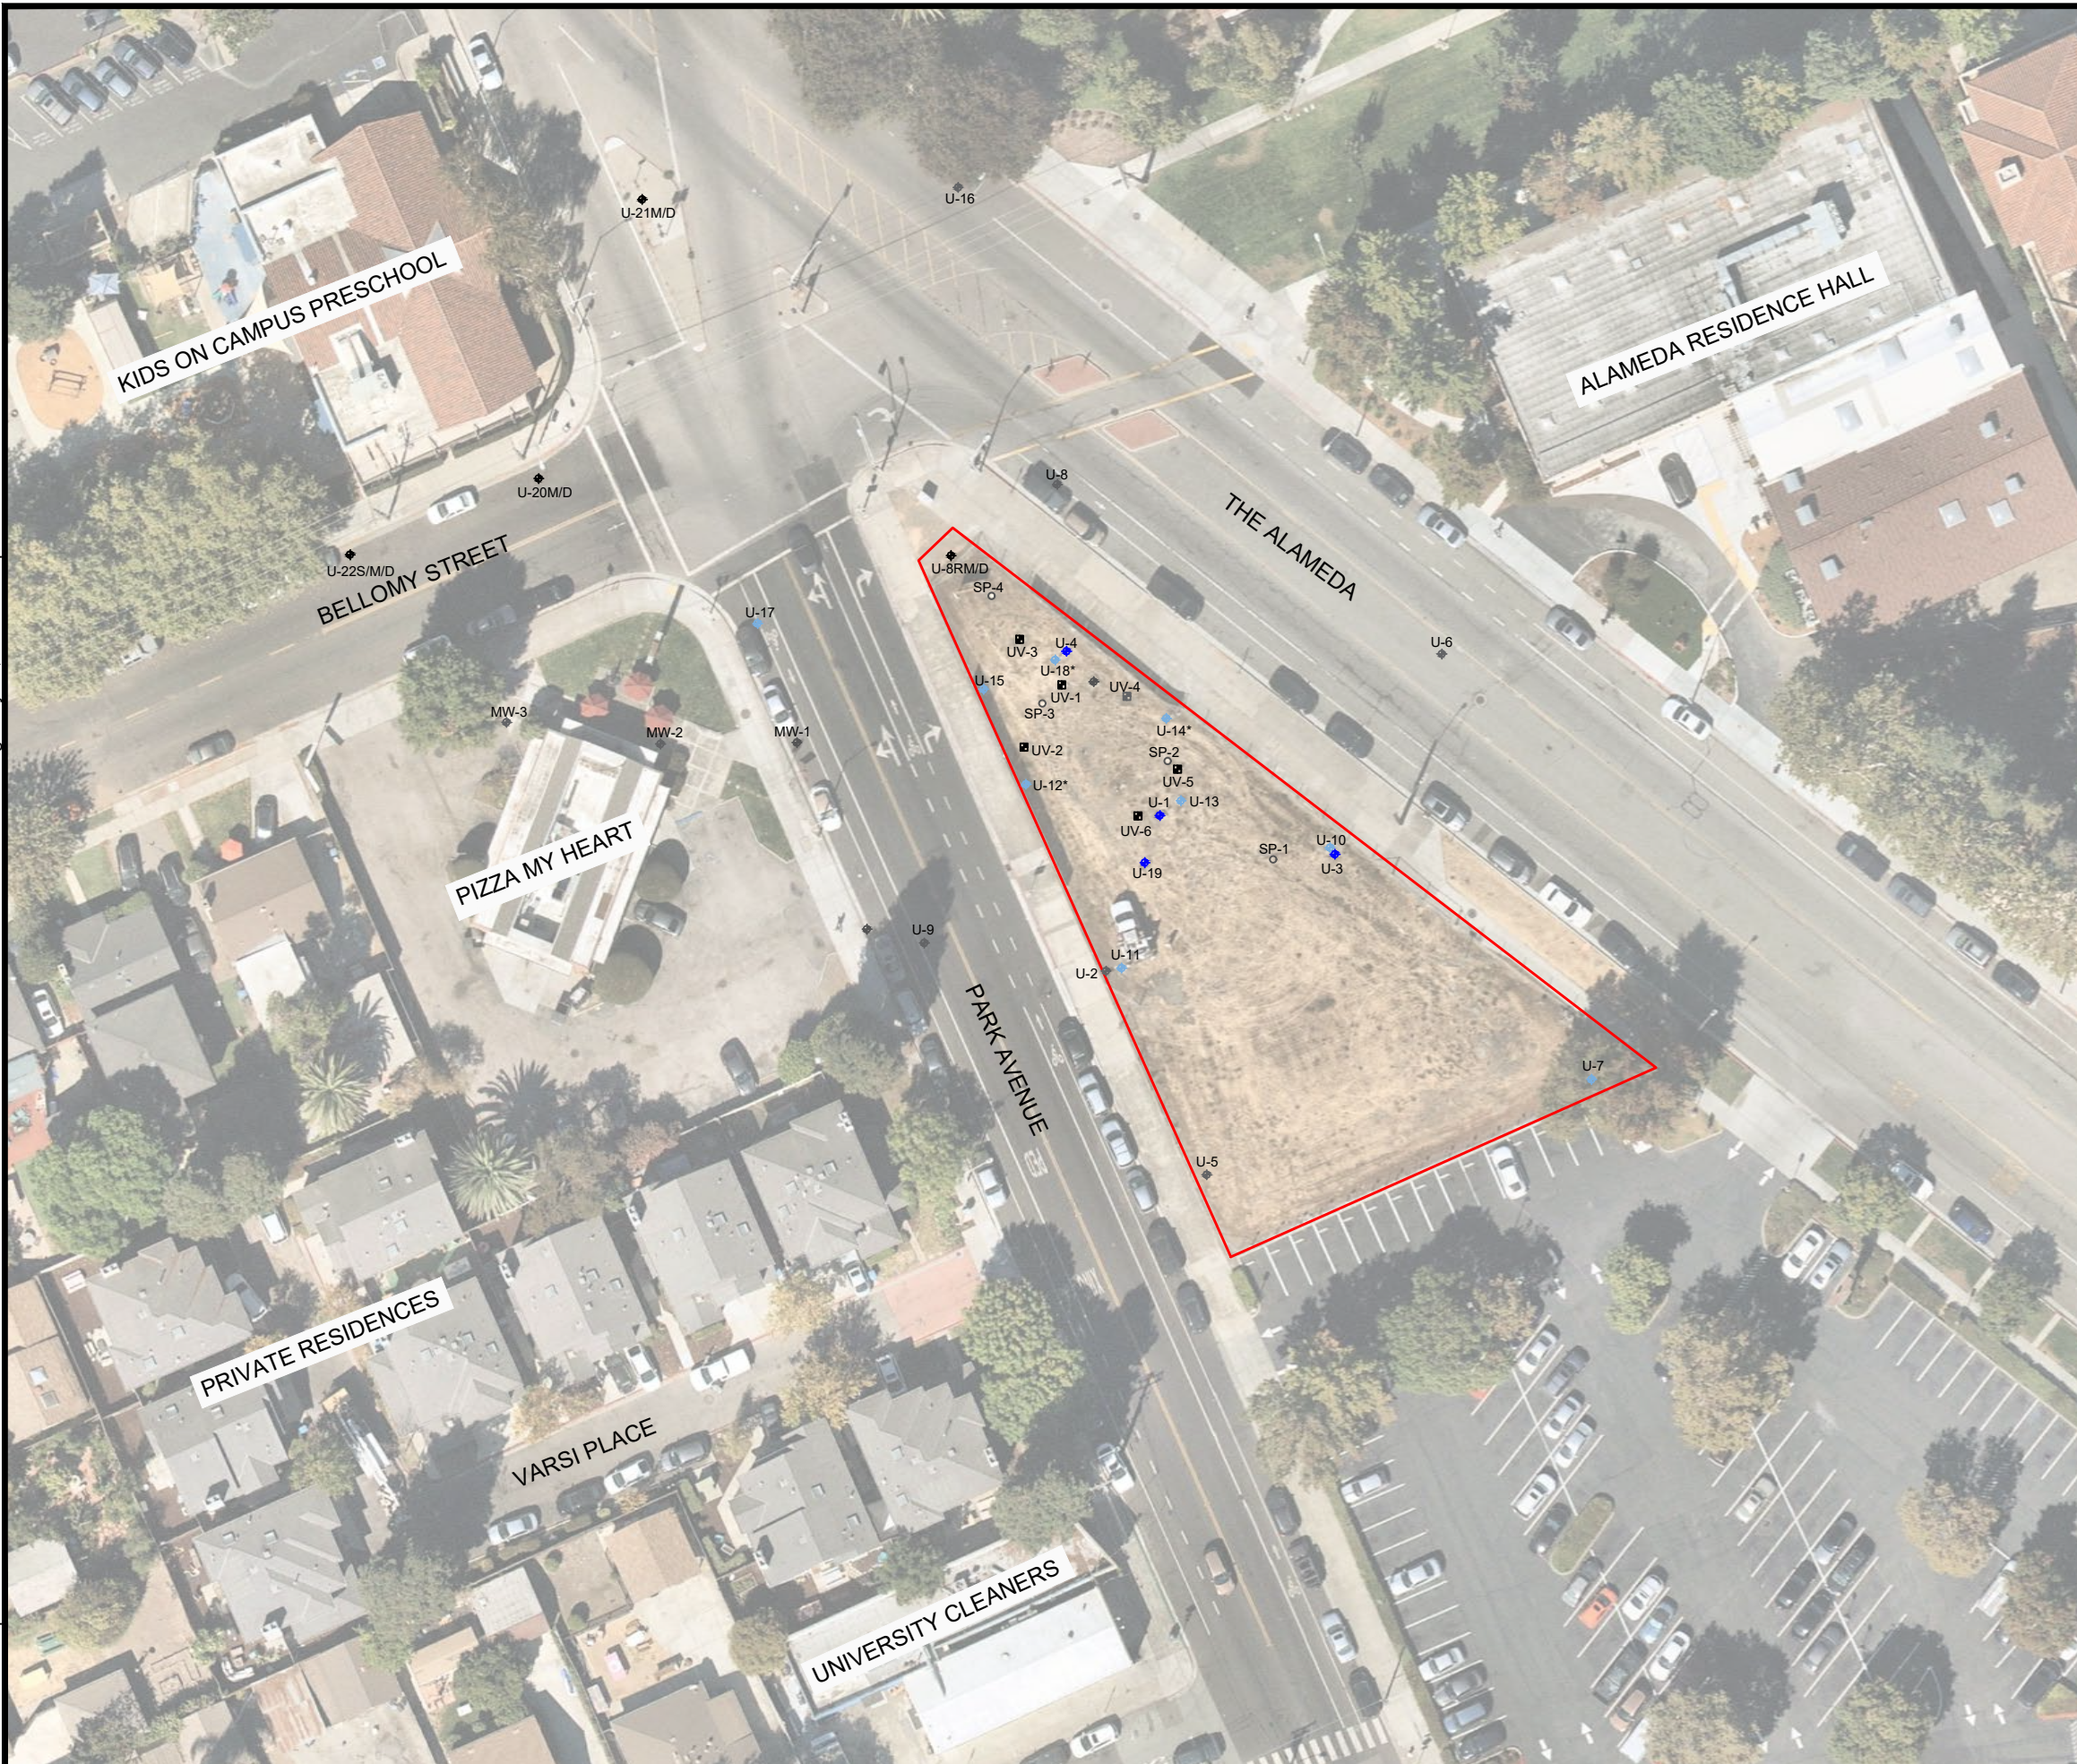
SITE PLAN WITH WELL NETWORK				
2655 THE ALAMEDA		SANTA CLARA, CA		
	PREPARED BY: TETRA TECH, INC.			
	17885 VON KARMAN AVENUE, SUITE 500 IRVINE, CA 92614-6213 Phone (949) 809-5000 Fax (949) 809-5010			
PROJECT NUMBER	APPROVED BY	DRAWN BY	DATE	FIGURE
194-1347-0001	CL	KG	APR 2022	3

- LEGEND**
- SITE BOUNDARY
 - VAPOR EXTRACTION WELL
 - GROUNDWATER MONITORING WELL (MID)
 - GROUNDWATER MONITORING WELL (DEEP)
 - NESTED GROUNDWATER MONITORING WELL
 - ABANDONED MONITORING WELL
 - ABANDONED VAPOR EXTRACTION WELL
 - OZONE SPARGE POINT
 - U-18* PETROLEUM ODOR OBSERVED WHEN OPENED
