City Council

**Item #5: Work at Gianera
Generating Station**

RTC 21-597

May 4, 2021

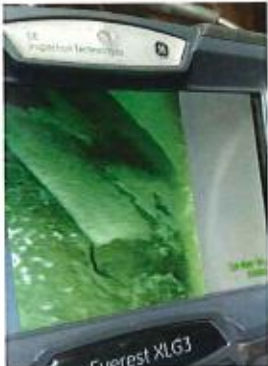
Shroud Blocks Erosion

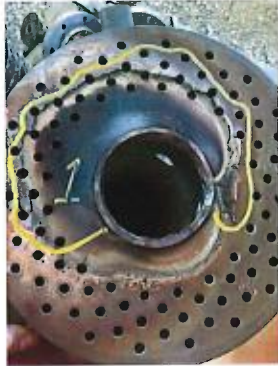
Shroud Blocks Cracking

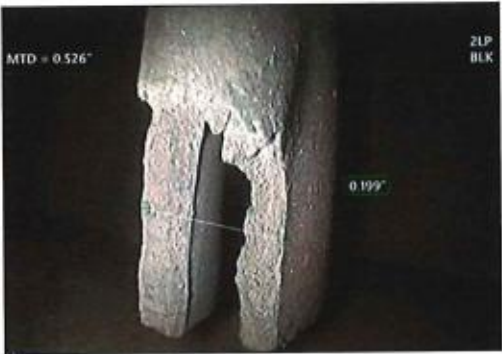
Damaged Turbine Tip
