Agenda Report

Consideration of a Mills Act Contract and Major Significant Property Alteration Permit at 1365 Main Street.

SECRETARY OF THE INTERIOR'S STANDARDS
COMPLIANCE REVIEW

CONDITION ASSESSMENT AND TREATMENT PLAN

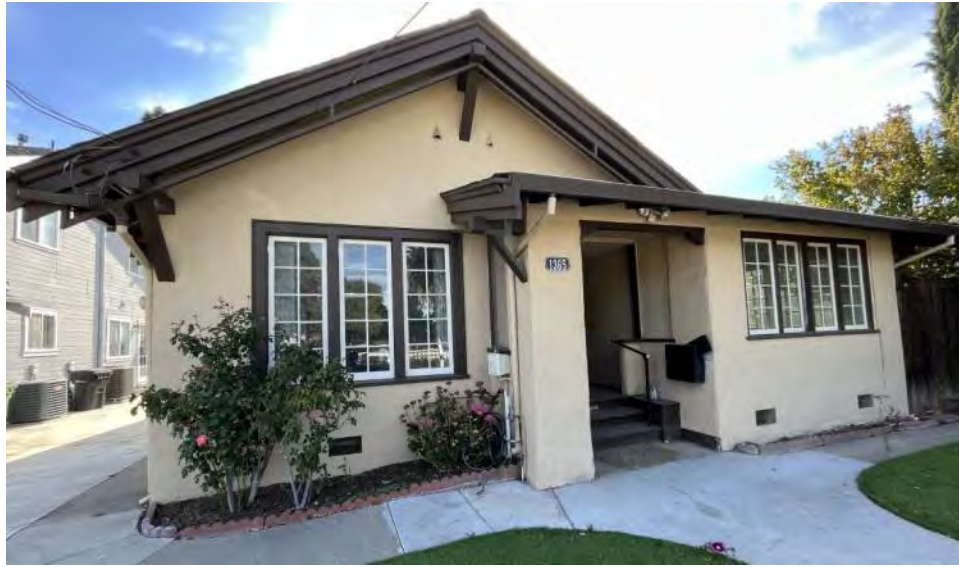
Figure 3. The west (front) facade of 1365 Main Street.

On the west (front) façade, the original windows at the north end would be preserved. The group of four casement windows will be reduced to a group of three with the removal of one window. The remaining three will be recentered on the wall. While one of the windows is removed, the windows remain a group, and this alteration will minimally impact the character of the building. Additionally, these four windows are not original to the house and were installed in the 1960s. The existing door under the covered porch would be replaced with a new one. The enclosed front porch is a later alteration and is not original to the initial

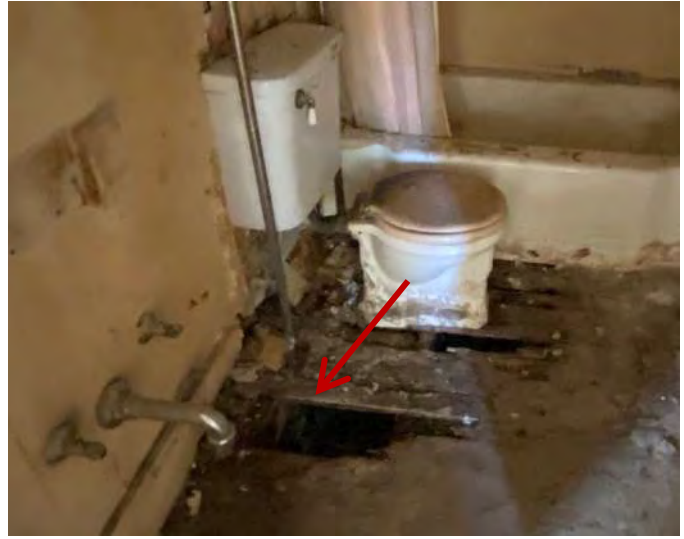
Comments: Structural floor sheathing is failing in some location. During demolition, material and locations should be evaluated for decay.

Decayed or failing 1 x 6 sheathing to be removed between joists and replaced with an equivalent thickness exterior grade plywood with an appropriate span rating. Structural engineer should provide a detail.

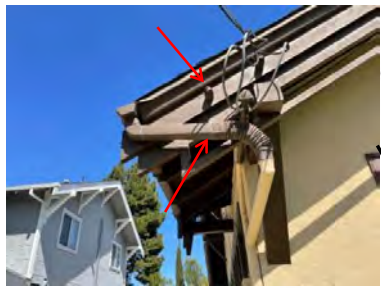
Phase: Construction
Comments: Downspouts should not extend past bargeboard. Run downspouts inside of bargeboard. Remove excess electrical equipment.

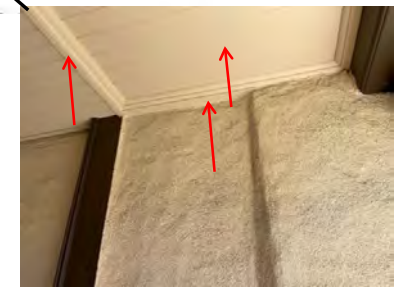
Phase: Pre-construction
Comments: The porch ceiling height and trim varies. During construction, evaluate structure and conditions. Retain the bead board and crown at front of porch.

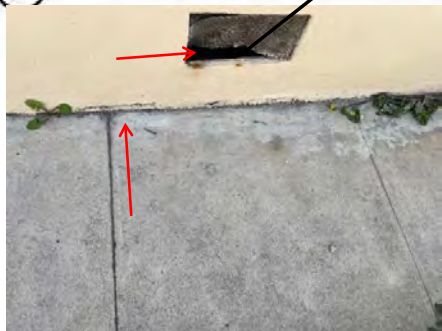
Phase: Design/Construction
 Comments: Add note. Replace/repair vent screen as needed. This prevents rodent intrusion. Unless screens can be repaired. Stucco needs to be removed, a matching vent installed, and the stucco patched at multiple locations. Stucco is delaminating due to moisture. Either patch stucco, or remove stucco, add a weep screed to prevent moisture wicking/entrapment

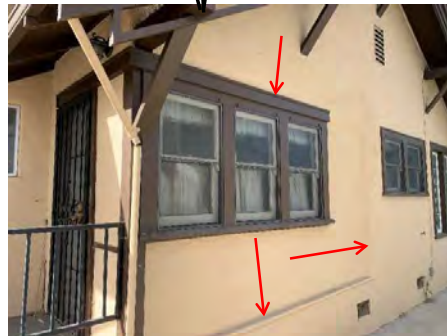
Phase: Design/Construction
 Comments: Add note. The wall finish jogs and an old porch ledge is exposed. Remove ledge, fur wall, and adjust windows. New window trim should match addition to differentiate between old and new.

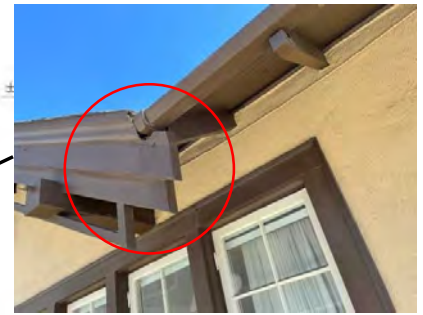
Phase: Design/Construction
 Comments: The gutter passes the barge. Develop repair detail. Bargeboard end needs restoration. Extend bargeboard and crown to original location.

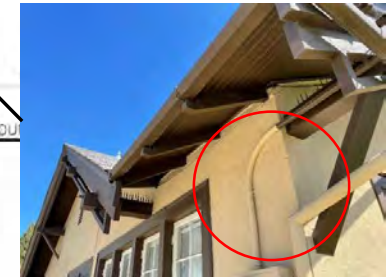
Phase: Design/Construction
 Comments: Add/Note. Conduit is exposed on the building. Reroute conduit to inside wall. Note electrical panel requires an upgrade.

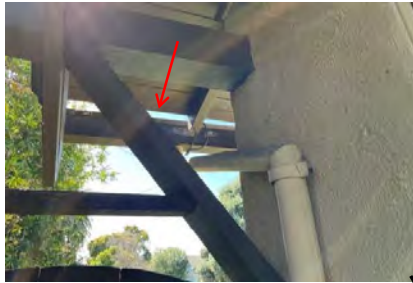
Phase: Construction
 Comments: Gutters and downspouts are loose and in poor condition in multiple locations. Replace system.

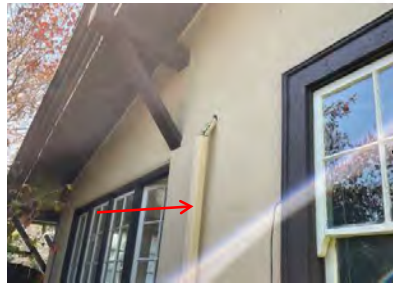
Phase: Design/Construction
 Comments: Add note. Exterior conduit to be removed. Patch stucco as required.

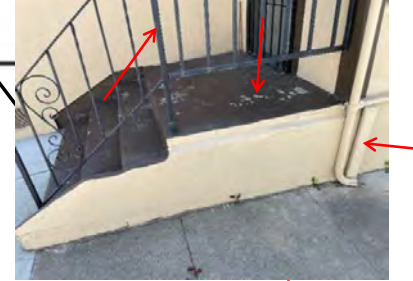
Phase: Design/Construction
 Comments: The stairs and the porch enclosure were part of an addition and will be removed and replaced with a compatible stair and railing.

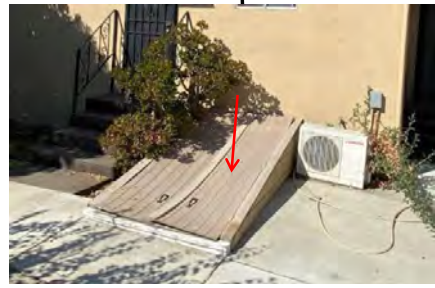
Phase: Design/Construction
 Comments: Adjust note. Replace existing basement access doors.
