CITY OF SANTA CLARA GEORGE F. HAINES INTERNATIONAL SWIM CENTER VISUAL OBSERVATION ASSESSMENTS REPORT

01/24/2024
LPA Job No. 31047

VISUAL OBSERVATION ASSESSMENTS REPORT

PREPARED BY
LPA, Inc.
& Aquatic Design Group, Inc.
& Simpson Gumpertz & Heger

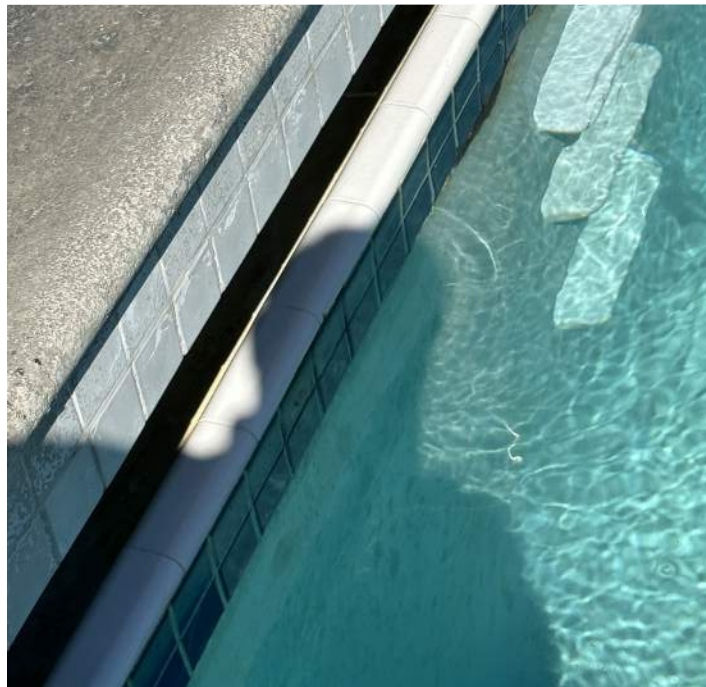
Image 8: Instructional Pool Gutter

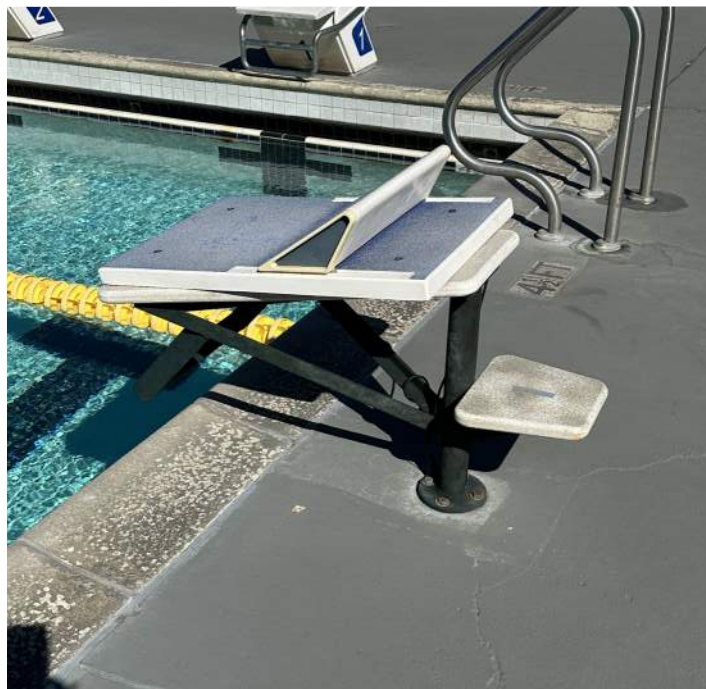
3110B.5. No diving markers. For pool water depths 6 feet or less no diving markers with the universal symbol of no diving...

Image 10: Starting Platform in 4'-6" Depth of Water

The starting platforms should be removed from all locations where the water is 6' deep or less to enhance safety and comply with code. Staff can remove the starting platforms from the deck.

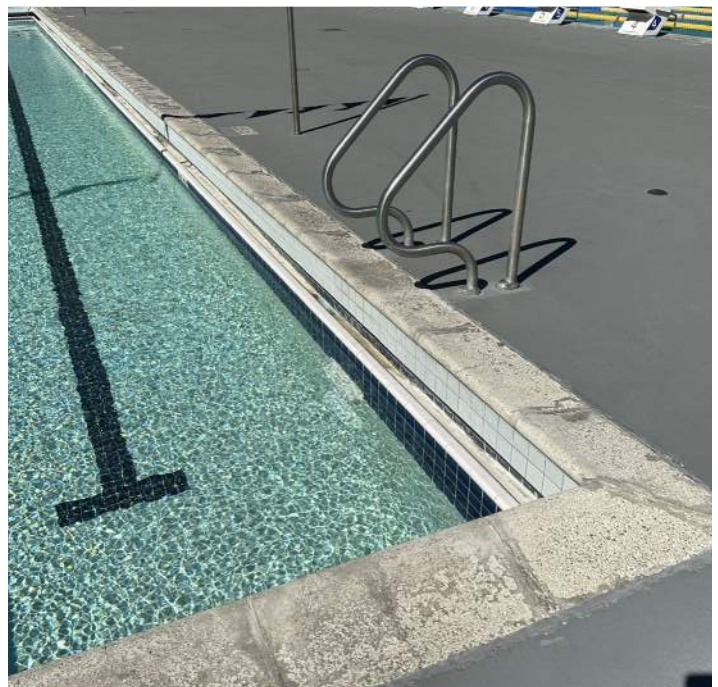
Image 12: Instructional Pool Coping Stones

The coping stones should be replaced. The following estimate is for replacement coping stones (this item is included in the project scope on page 23).

(Estimated Cost- \$50,000.00)

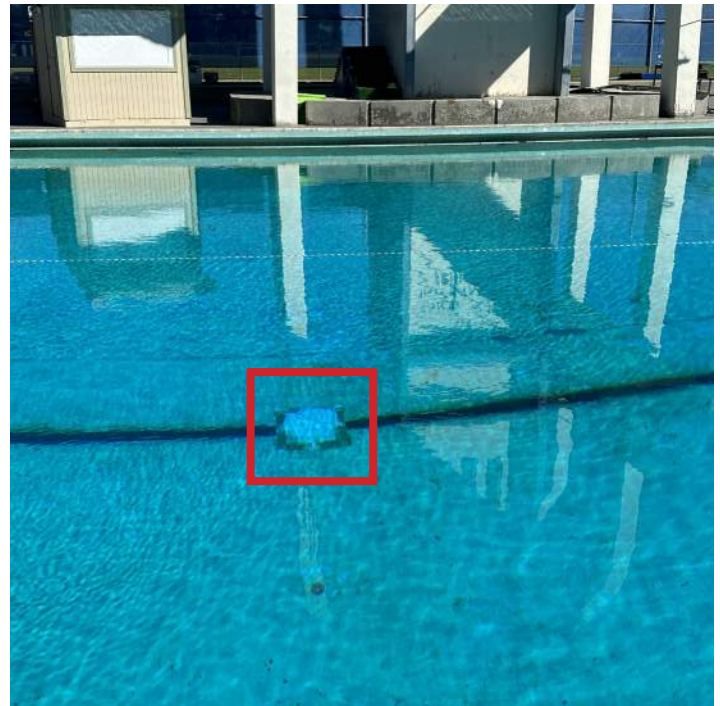
Image 13: Diving Pool Main Drain

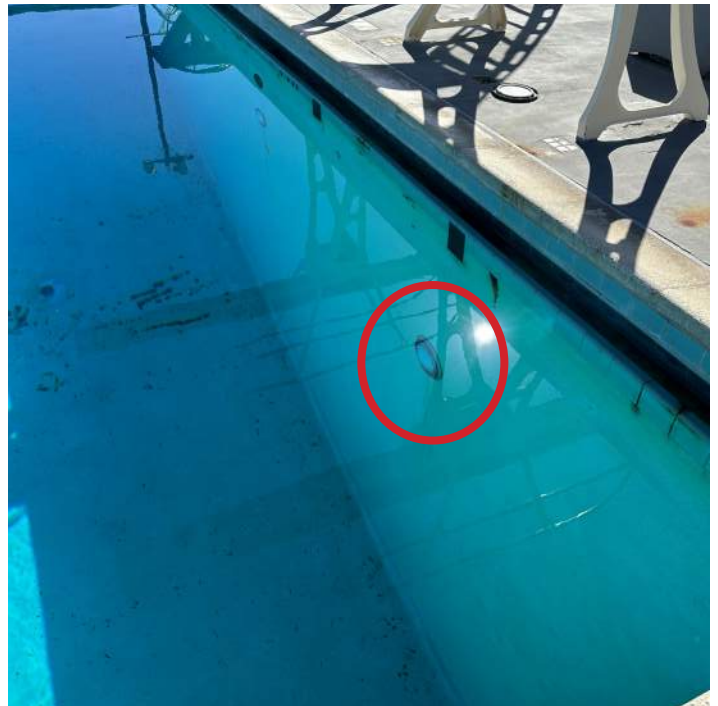
Image 15: Underwater Light in Diving Pool

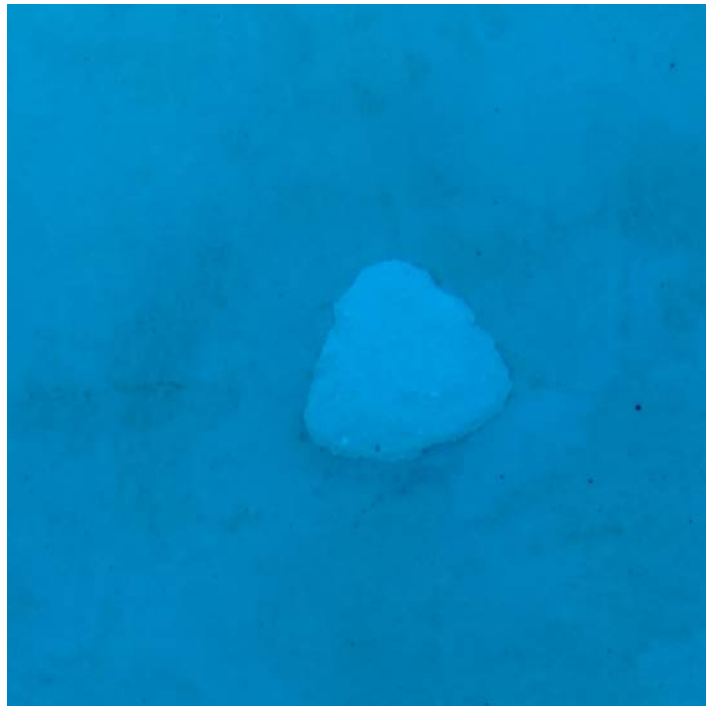
Image 16: Delaminating Plaster in Diving Pool

(Estimated Cost- \$337,500.00)

Alternative pool finishes to plaster and tile include fiberglass, liners and Myrtha's RenovAction system. If the City is interested in information for alternative finishes ADG can be consulted for details, including costs.

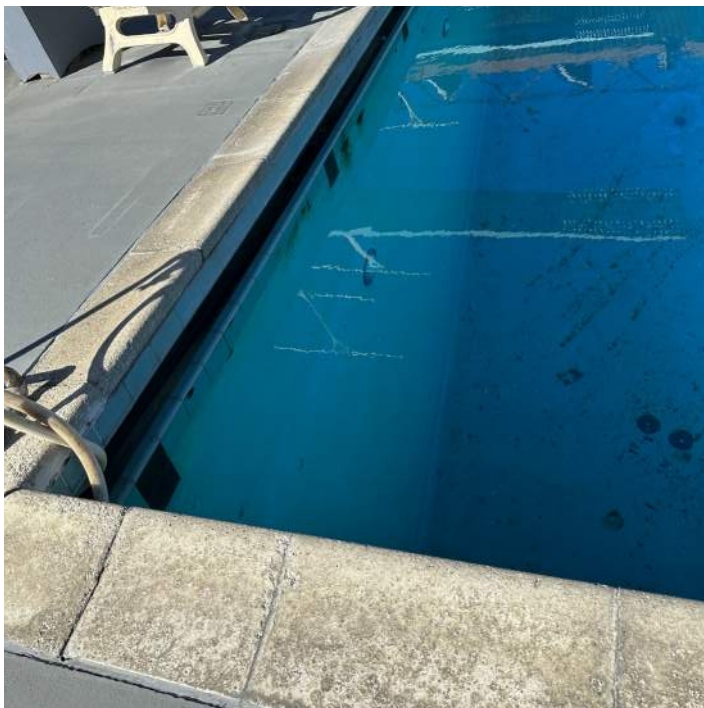
Image 17: Diving Pool Coping Stones

The coping stones should be replaced. The following estimate is for replacement coping stones (this item is included in the project scope on page 24).

(Estimated Cost- \$60,000.00)

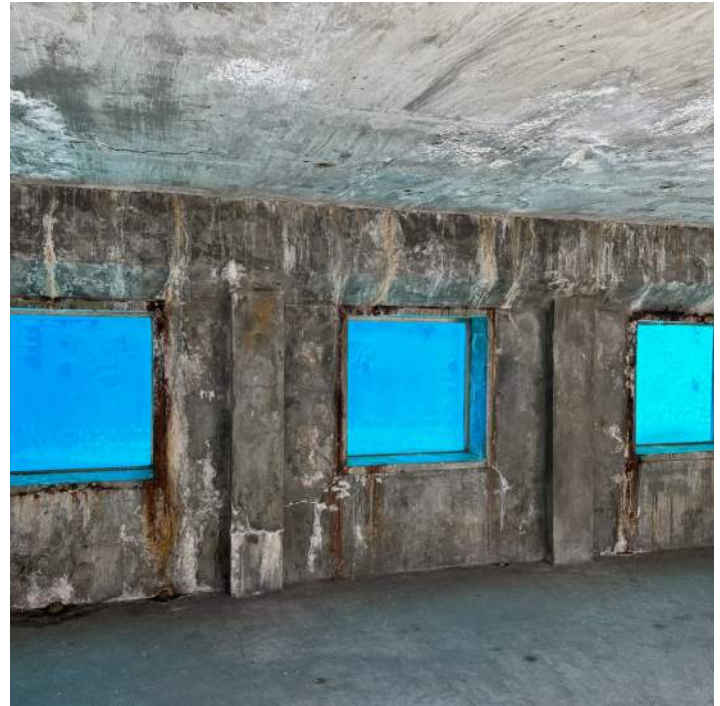
Image 24: Diving Pool Underwater Windows

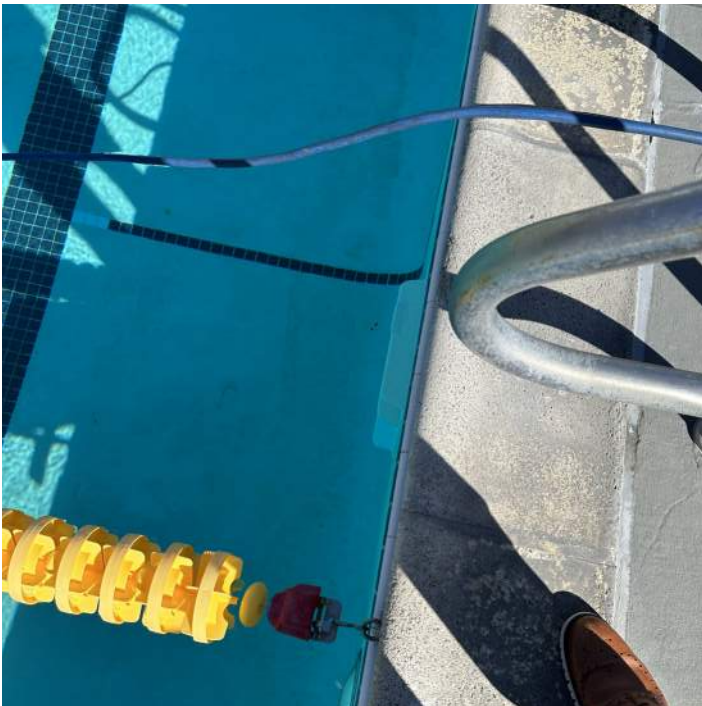
Image 25: Recessed Steps in 50-Meter Pool

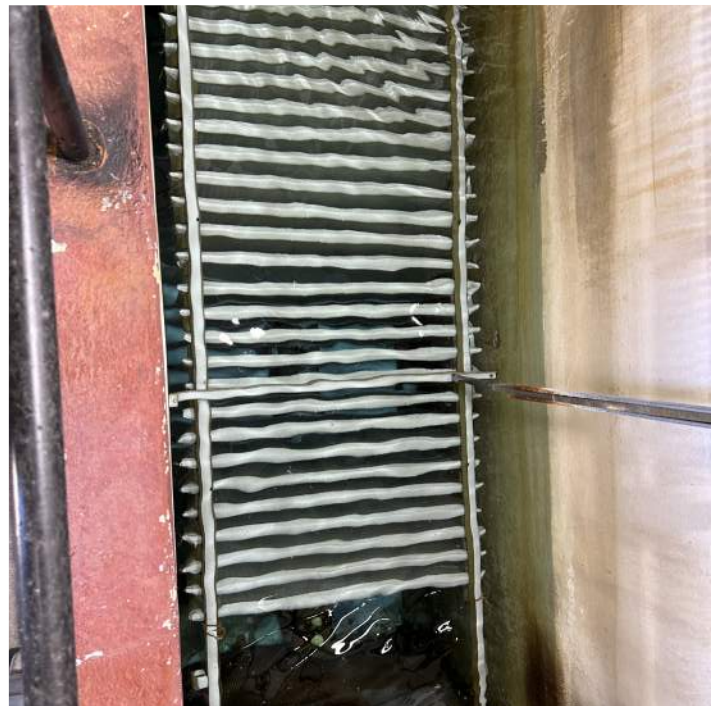
Staff report that they must drain and clean the diatomaceous earth filter systems every other week or 26 times per year. To accomplish this the staff must close the 50-Meter and Instructional Pools every other Tuesday from 6AM to 3PM and the Diving Pool every other Wednesday from 6AM to 3PM to clean the filter systems. New fully automatic high-rate sand filters would eliminate this requirement for staff labor and pool program closure. The following estimate is for new high-rate sand filter systems for each pool (this item is included in the project scopes on pages 23 and 24).

Image 26: DE Filter

(Estimated Cost- \$1,050,000.00)

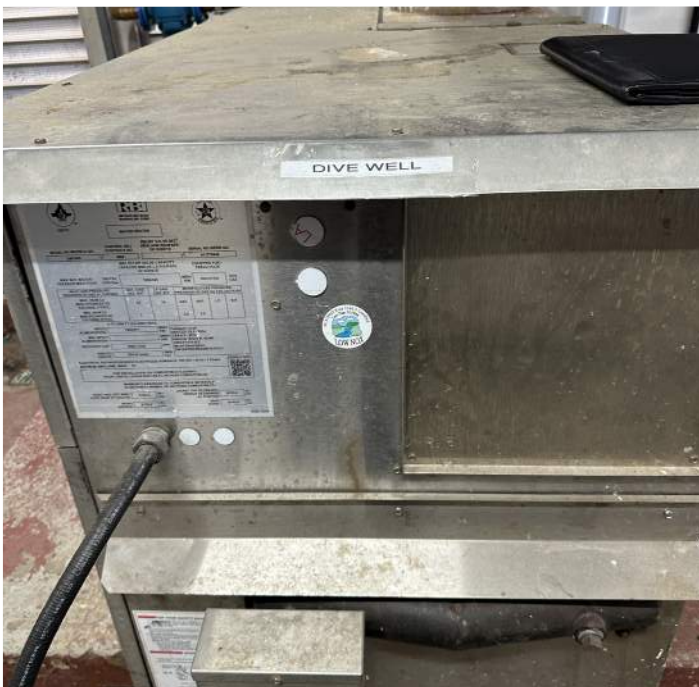
Image 27: Diving Pool Heater

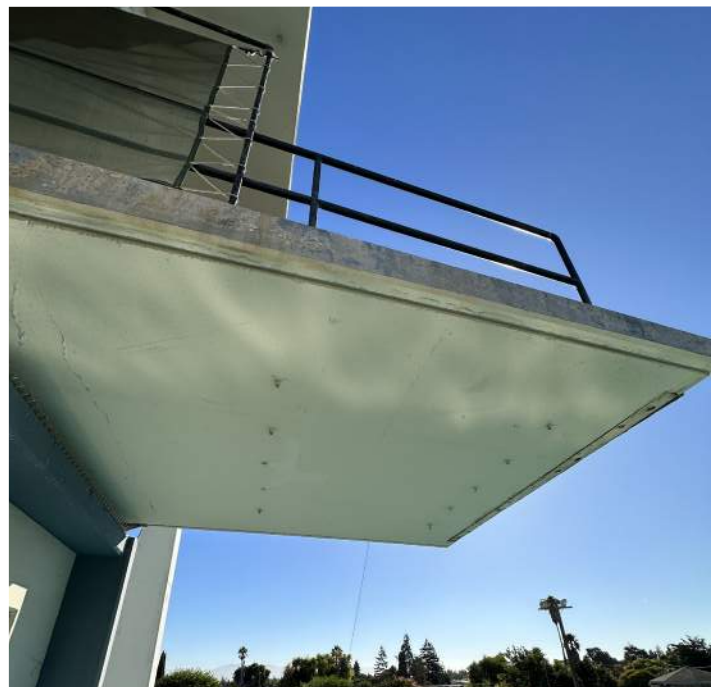
The dive tower has been deteriorating for some time. The structural viability of this tower will be addressed by others. In the meantime it should be noted that the existing dive tower is constructed with 5-meter, 6.5-meter and 10-meter platforms. Current dive regulations require dive platforms of 5-meters, 7.5-meters and 10-meters.

Image 28: Diving Platform in Tower

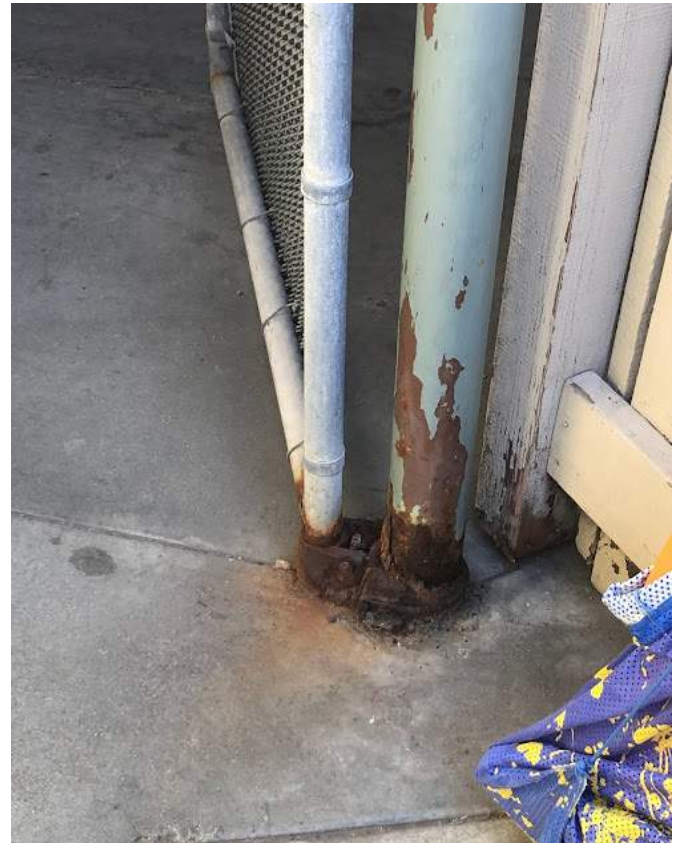
1. Building A - Administration Building
 - a. The center Rotunda requires lateral load resisting system. Existing corner wood posts are not sufficient as lateral load resisting system.

- b. Along the 4 wings of the building, continuous clerestory windows occur along all perimeter walls. As the result, the shear walls are discontinued from the roof framing. Wood posts cantilever over wall panels to resist lateral loads from the roof. This type of lateral load resisting system is not permitted in current code. Further review required to retrofit the lateral load resisting system.
 - c. Some exposed steel posts are badly rusted at the base and shall be replaced.

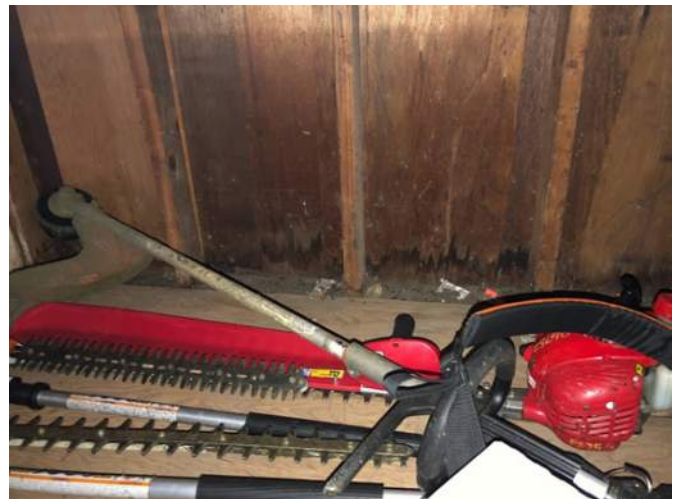
- 6. Building E - Training Room and Storage
 - a. This one-story building constructed of wood roof framing and reinforced concrete masonry wall around perimeter is in generally good condition.
- 7. Building F - Maintenance Storage
 - a. Similar construction as Building E with wood roof framing and concrete masonry walls, the building is in generally good condition.
- 8. Building G - Park Maintenance Storage
 - a. This one-story building constructed of wood roof framing over plywood shear walls on all side of the building. A continuous clerestory window along the north and south wall of the structure. The shear wall are discontinuous between roof and top wall. Wood posts connect the roof to the shear wall. This system do not meet the current code requirement.
 - b. Evidence of water damage observed at the plywood shear wall near the sill plate.

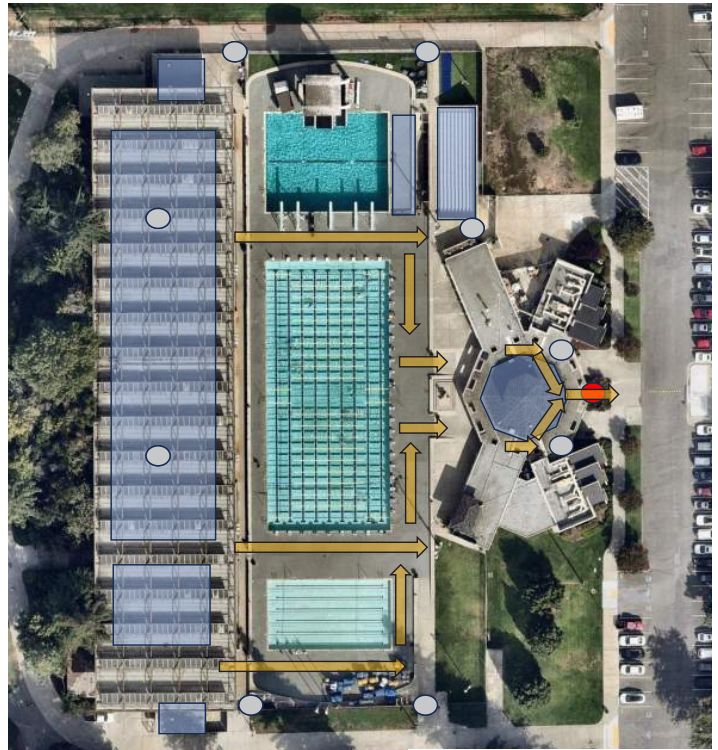
CURRENT EGRESS PLAN

Observation of the current conditions shows that the facility has a total combined exit width of roughly 45 linear feet, which is nearly half of the requirements needed for an event. Of the 45 feet only (2) gates of approximately 8 feet in width have code-compliant egress gate and hardware for pedestrians. However, two gates with proper hardware are locked by chains and padlocks at all times making them non code-compliant. The remaining exits are not pedestrian gates and are currently used like maintenance gates that are not valid exits when closed.

Based on how the facility currently operates, the main exit path is not in compliance with California Building Code for safe emergency egress. All users are required to enter and exit through a single entry within the main entry building. In an emergency, the main path of egress divides into two directions, only to funnel the two paths back into the buildings in one main exit path. This is not

compliant with code and a life safety hazard during an emergency.

Our findings show that it is needed to have additional exit lengths to total 87 feet and a minimum of four exits with panic hardware, per the 2022 California Building Code.

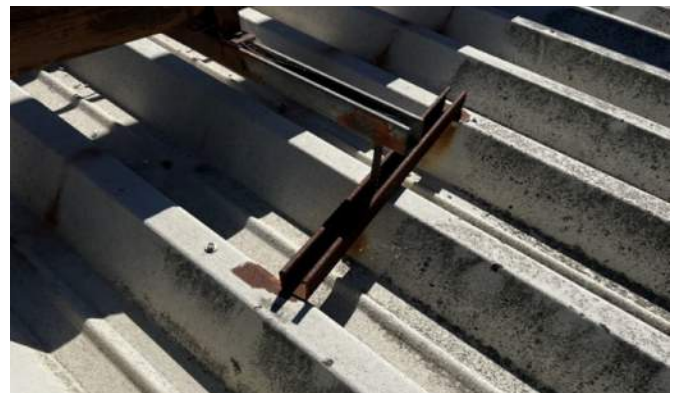
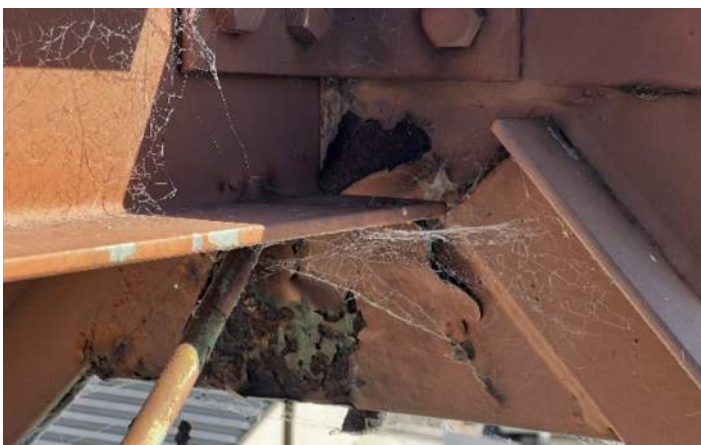
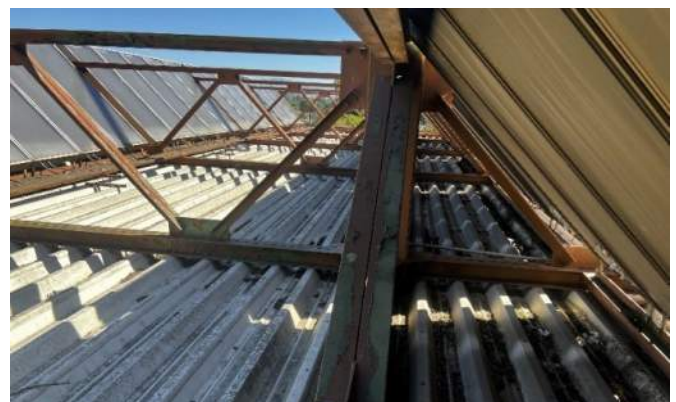
- The canopy support truss structure generally appears to be in good condition. The base coating is well adhered to the steel, but the top coating is delaminating.
- We did not observe any significant corrosion (section loss) in the structural steel or fasteners in the areas we inspected.

The canopy support columns and canopy support truss structure appear to be in good condition. We recommend stripping the current coating and recoating them with a two-part epoxy coating. We did not detect lead in our coating analysis at these locations. The localized corrosion on the canopy panels is likely due to original local coating defects rather than debris accumulation and ponding water. These local areas could be cut out and replaced, with the remaining panels stripped and recoated. However, it might be more cost-effective to replace these panels. The canopy gutters are corroded past their useful life and should be replaced with a non-metallic gutter system. The canopy tower appears to be in good condition and no work is required on the stairs or railings. The corroded door and frames should be replaced with components that are designed for external exposure. The solar heating pipe risers should be removed, and the local deformation of the roof panels repaired.

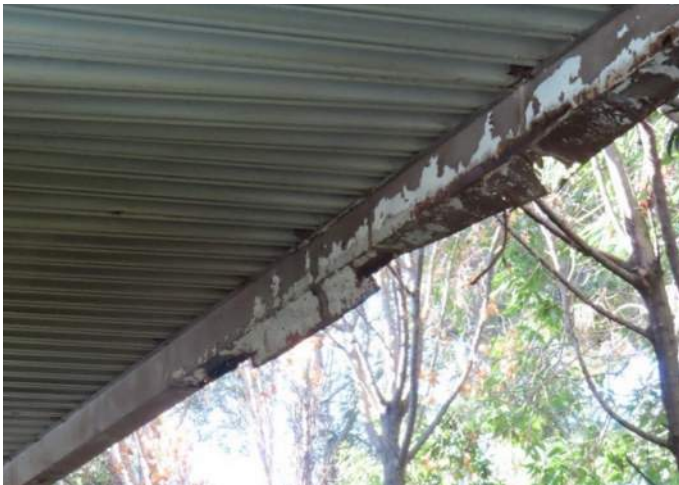
- Infrequent and discrete locations in the trough of the panels with through-thickness corrosion occur. Leaves and other debris have accumulated throughout the troughs of the roof panels, but there did not appear to be a correlation between debris accumulation and corroded areas. The corrosion is highly localized (less than 12 in.) with the coating immediately adjacent to these locations in relatively good condition.
- The gutters along both edges of the roof are completely corroded with cross-sectional loss at multiple sections.

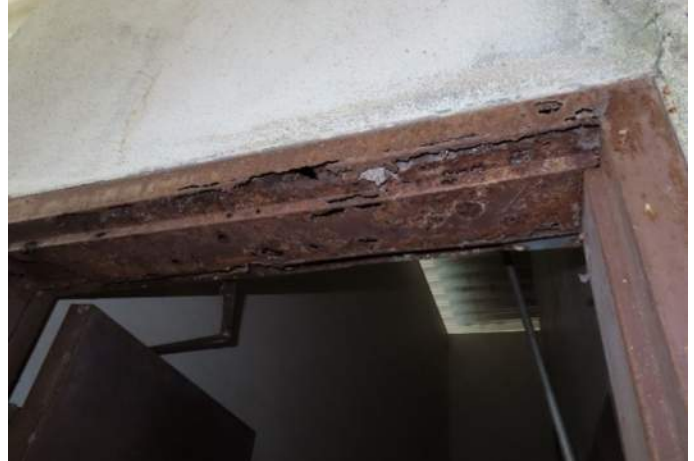
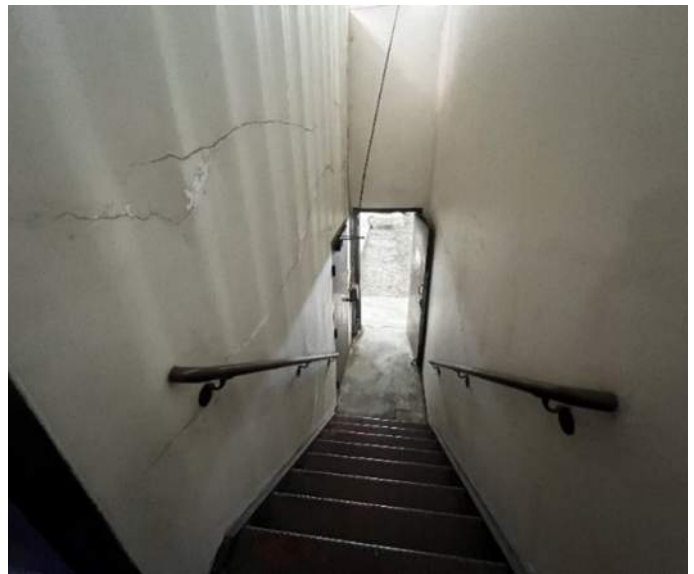
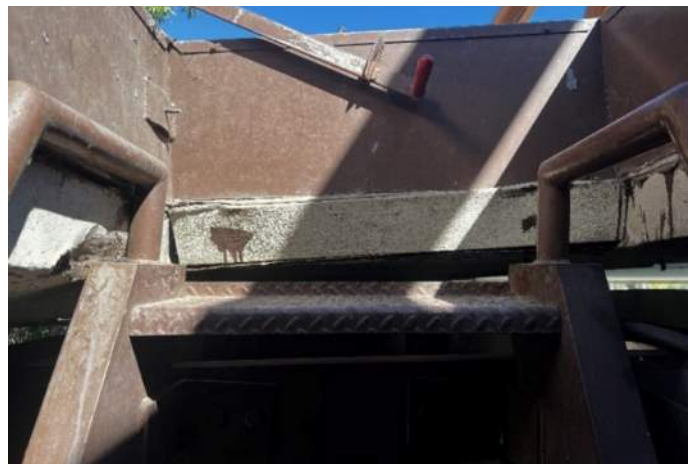
Canopy Tower

The canopy tower (Building D) contains metal components such as the staircase, railings, pipe risers, doors, and frames. We noted the following:

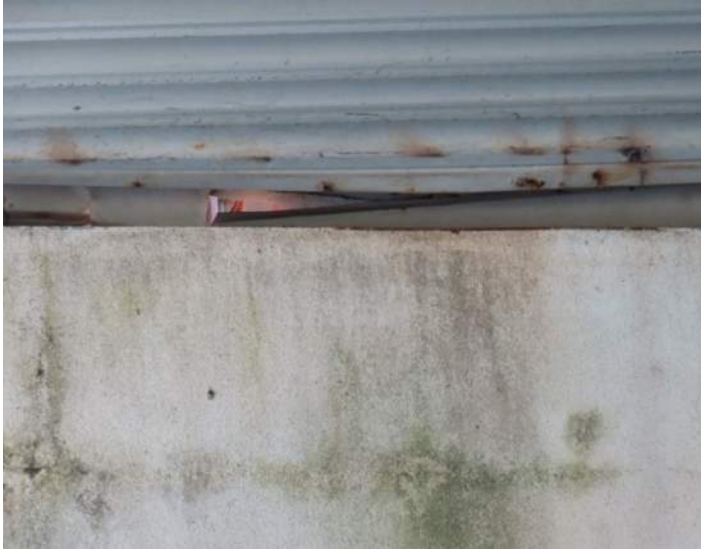
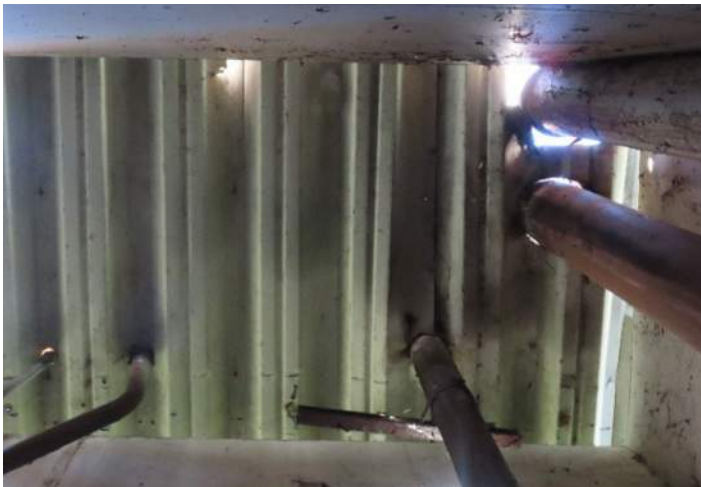
- The two riser pipes for the redundant solar heating system appear to have subsided into the ground. These have, in turn, pulled down adjacent pipe supports on the roof, resulting in deformation of the roof panel connected to these supports.

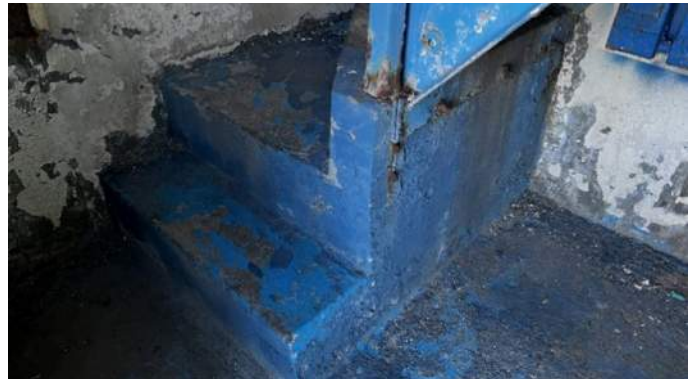
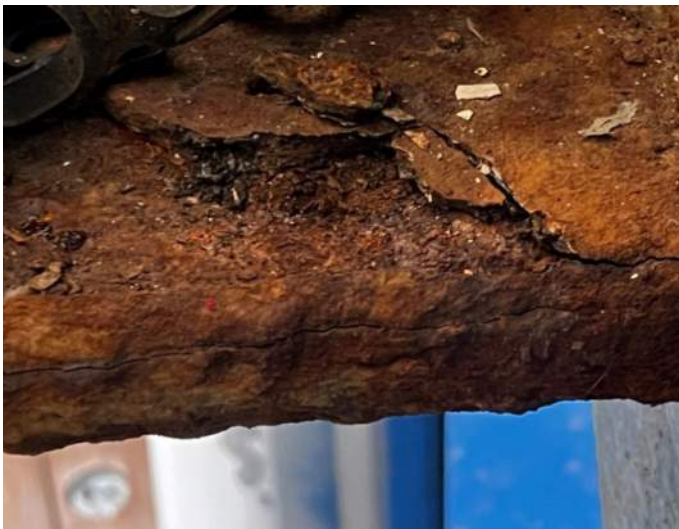
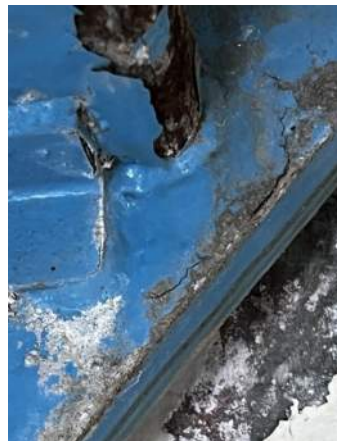
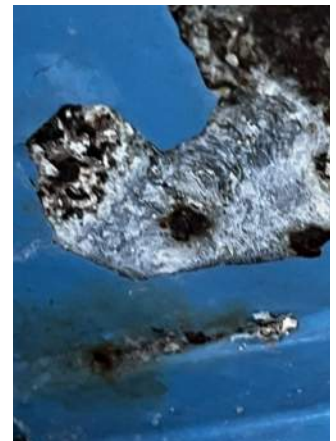
Dive Tower Staircase

- The dive tower staircase is in poor condition with extensive corrosion, particularly on flat surfaces and crevices. Welds are also corroded with the lower section more heavily corroded than the upper section.
- Many of the original coatings have completely delaminated, resulting in a significant accumulation of corrosion products.
- Areas of white corrosion products exist underneath delaminated sections of coating.

The dive tower staircase is heavily corroded and should be replaced. The white corrosion products that we observed suggest that underneath the coating, the metal substrate is galvanized, which is not a suitable coating for structures such as these which are frequently wet and enclosed in a humid environment. We recommend removing and replacing it with a code-compliant structure fabricated from a corrosion-resistant alloy, such as 316 stainless steel.

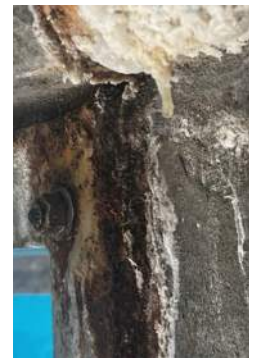
Dive Tower Viewing Windows

- The window frames are not coated and appear to be galvanized steel.
- The adjacent concrete is cracked with evidence of water seepage and a small, active leak at one location.
- The top and side elements of the galvanized frames are heavily corroded.

The galvanized window frames at the viewing area are heavily corroded due to water infiltration through the concrete. We recommend that once the concrete has been repaired and waterproofed, these frames are replaced with frames fabricated from a corrosion-resistant alloy such as 316 stainless steel.

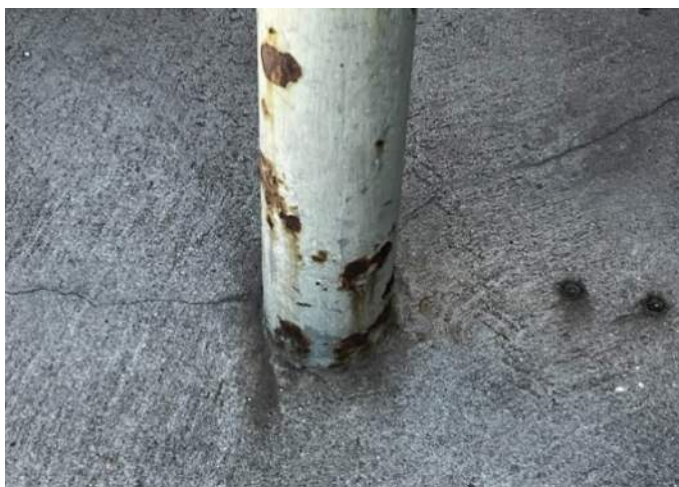
- The posts, particularly at deck level, exhibit coating failure and localized corrosion of up to 50%.

The Building A canopy supporting poles have corroded at several locations, especially at their base, with thickness loss of up to 50%. We recommend that these poles be replaced with carbon steel posts coated with a 2-part epoxy system.

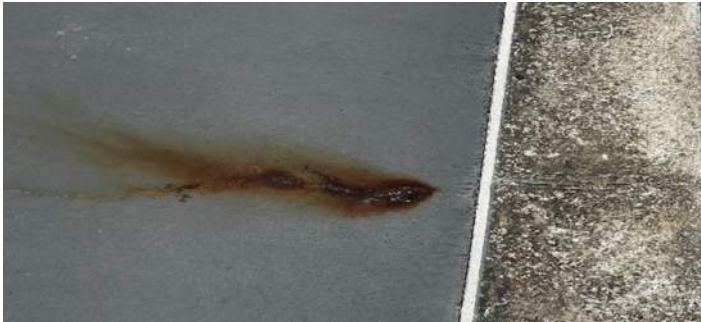
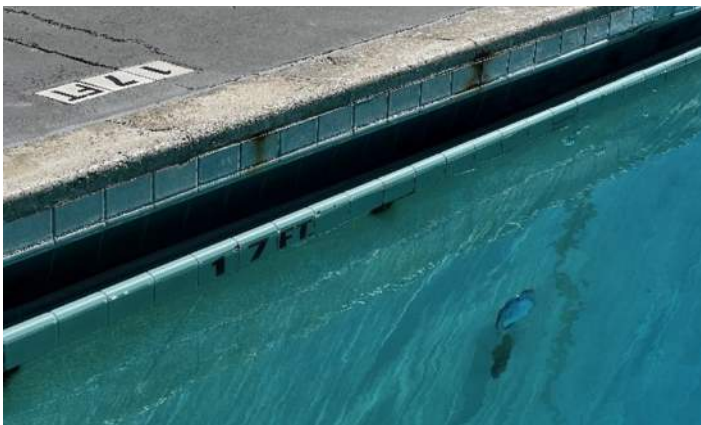
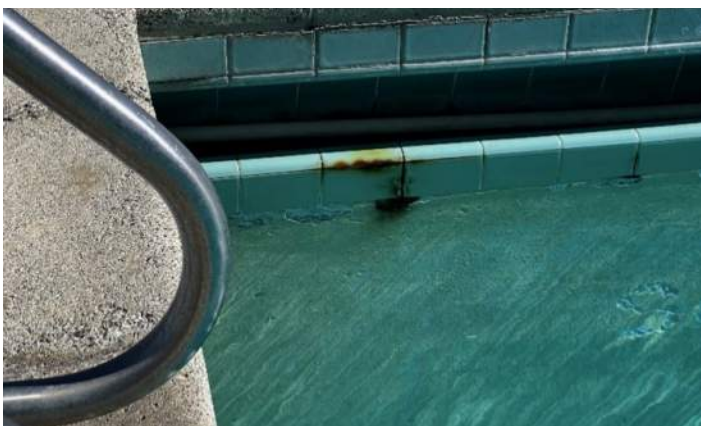
- The concrete deck is cracked with occasional corrosion staining.
- The pool tiles at the waterline are corroded.

We observed localized corrosion staining around the pool deck at crack locations, suggesting that localized rebar corrosion is occurring. Local concrete repairs and waterproofing the deck should eliminate this corrosion.

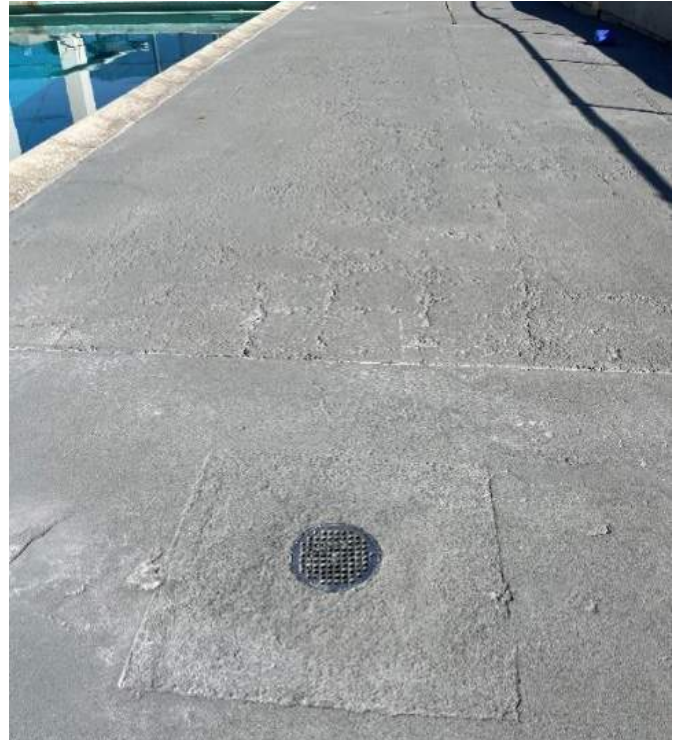
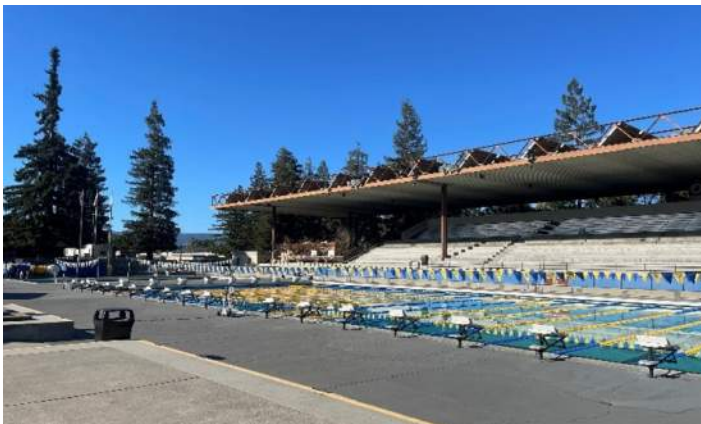
- The typical pool deck slab on grade has significant cracking uniformly. These cracks are likely due to several reasons including soil compaction and settlement cracking, drying shrinkage cracking due to the wide spacing between control joints. These cracks do not represent a life-safety hazard but could present serviceability issues.

- The topside of the elevated deck slab above the viewing room has patching mortar applied. SGH detected delamination of the patch material when performing a chain drag.

The concrete pool decks at this Facility exhibit signs of distress and deterioration. While the cracking and settlement of the slabs on grade do not present a life safety hazard, they may pose serviceability issues. The current condition of the elevated Viewing Room represents an unsafe condition. Access to the Viewing Room below or walking on top of the elevated slab should be restricted. Given the condition of the elevated deck, we recommend locally removing and replacing the elevated slab and beam at the earliest.

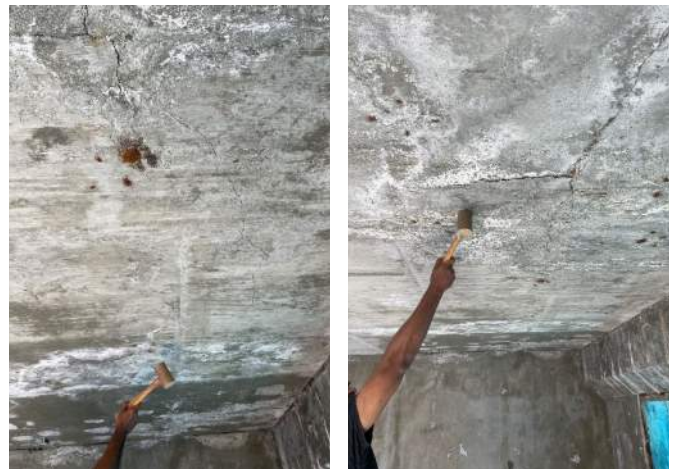
- The underside of the viewing room elevated slab has a large crack running longitudinally along the slab. The crack is beginning to initiate spalls, representing a safety hazard. Outside of the spalled region, the underside of the slab appeared in sound condition when we hit it with a sounding hammer.

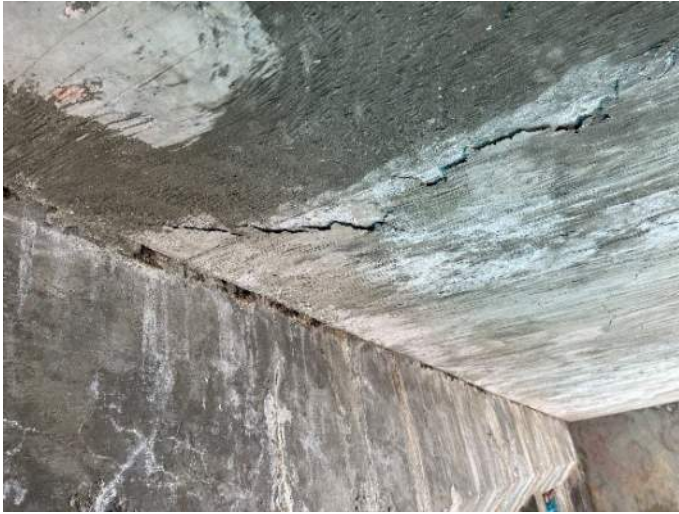
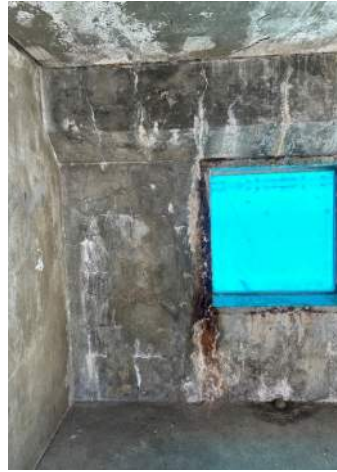
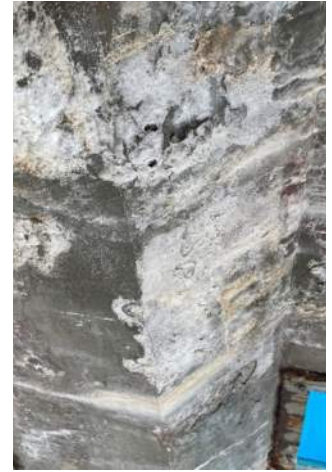
- Significant efflorescence and/or chemical leaching is evident on the underside of the slab.
- The exterior face (viewing room side) of the pool walls and the top bond beam both have moderate cracks exhibiting signs of efflorescence and or chemical leaching. The observed cracks align with reinforcement locations, as determined by our GPR survey. This indicates that moisture is likely reaching the reinforcement, and corrosion of the rebar is probable.

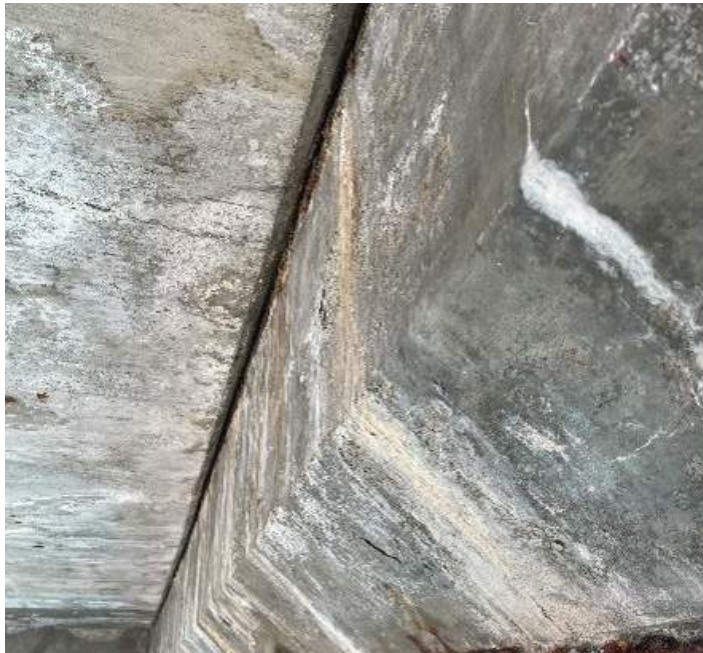
- The cold joint between the elevated slab and the bond beam appears moderately deteriorated with signs of water intrusion between the concrete joint.
- The metal frames for the windows inset into the viewing room pool room are exhibiting signs of severe corrosion.
- The underside of the viewing room elevated slab has a large crack running longitudinally along the edge beam to the east. The crack is beginning to initiate spalls. Significant efflorescence and or chemical leaching is evident on the underside of the slab.

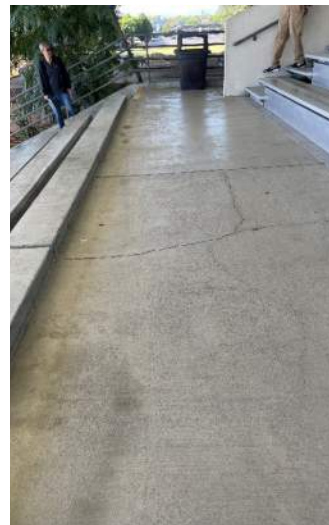
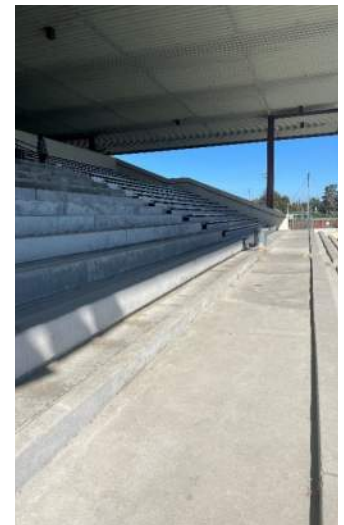
- The concrete slab and steps appear in fair condition, with moderate settlement cracking observed.

The construction of the stadium bleachers appears to be in fair condition structurally. However, we note that architecturally, there may be some concerns. The settlement of the concrete stair elements may constitute a trip hazard. If the hazard is deemed significant, the concrete steps and slabs should be removed, soil compacted, and replaced in kind.

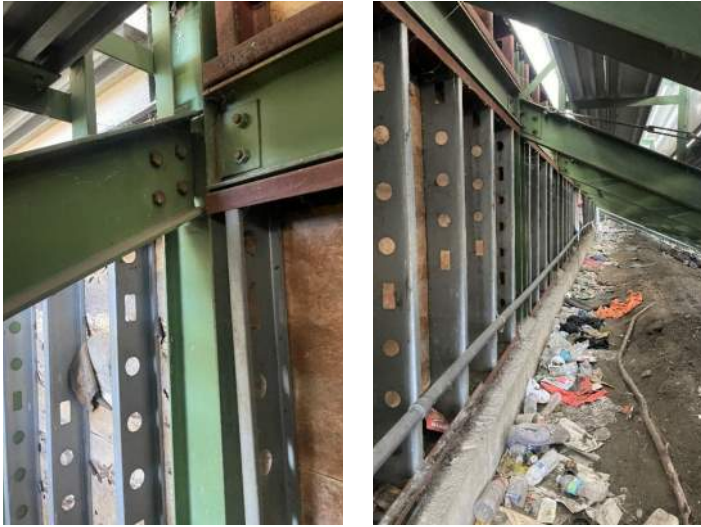
- The steel beam stringers, posts, and seat support elements are painted and appear to be in sound condition with no visible signs of corrosion.

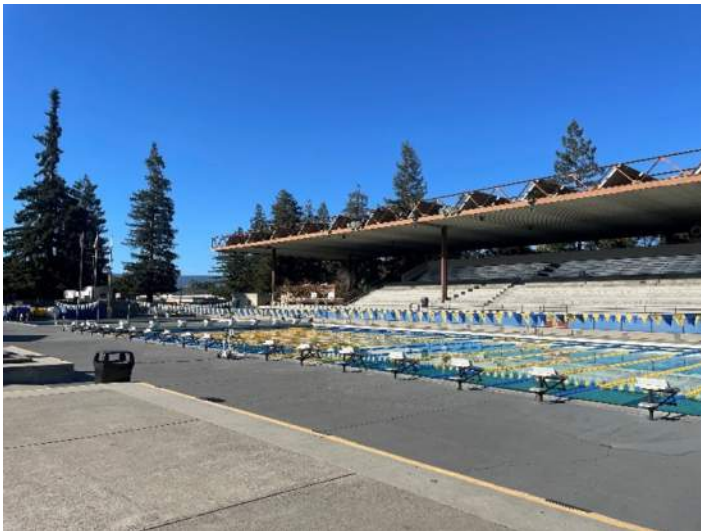
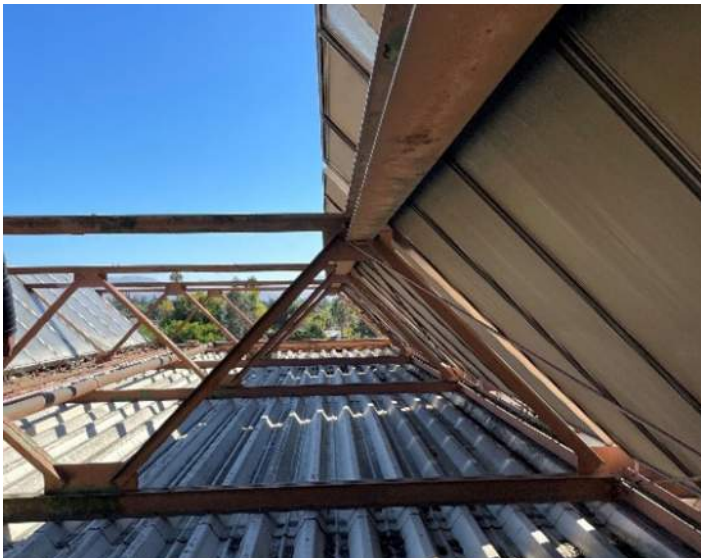
- The structural steel members appear to be in fair condition with minimal signs of local corrosion.

Annual visual observations of the structural steel elements should be performed to inspect for signs of corrosion or deterioration.

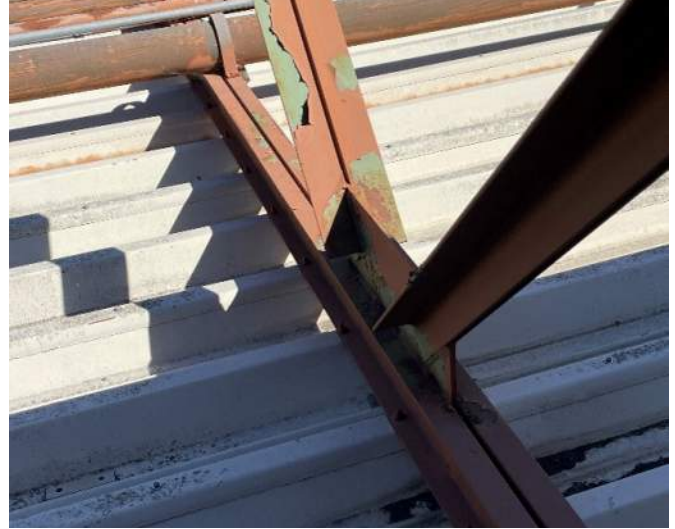
- The paint of the structural steel trusses is spalling at locations, however, we observed no corrosion of steel members observed.

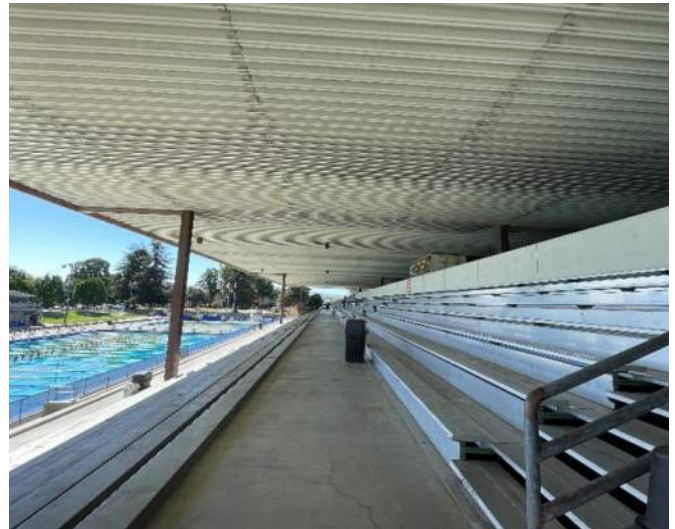
- The metal deck appears to be in fair condition.

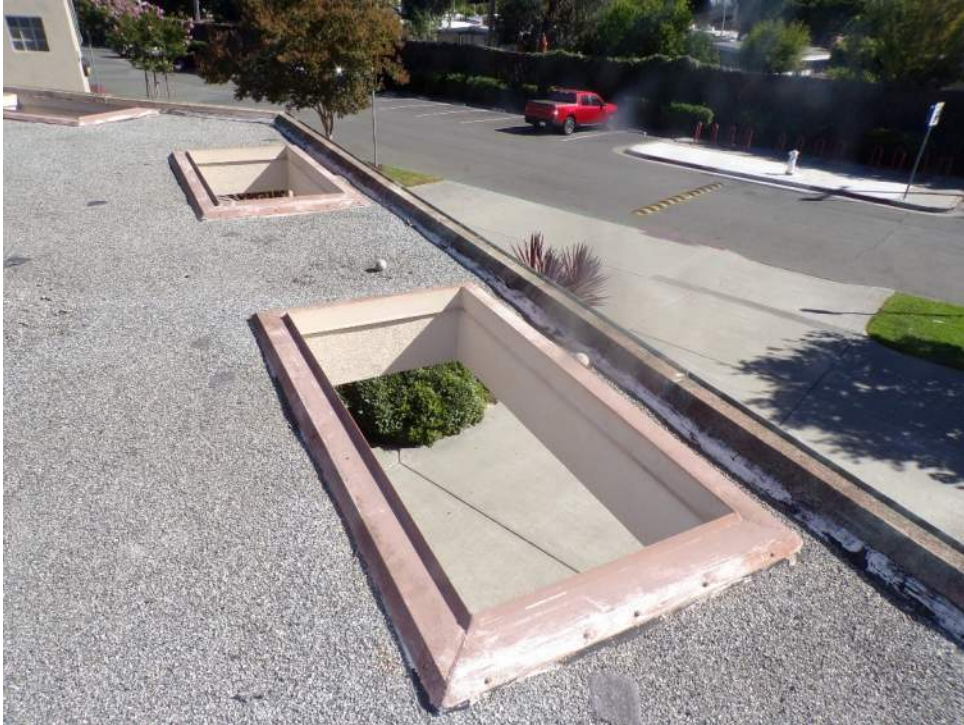
Photo 1

- The low-slope roof at Building A has 16 “skylight” openings with no cover, safety barrier, or safety markings. These unprotected roof openings pose a potential fall hazard to the ground level below (Appendix A, Photo 1) and violate the current Code: Section 3212 of the California Code of Regulations (CCR), Title 8 requires roof openings to be guarded by a cover or a guardrail on all sides of the roof opening. This safety hazard is exacerbated by the ease of roof-level access, where a single flight of stairs leads directly to the roof (Appendix A, Photo 2). There are no locked gates or restrictions to the roof level.

Unprotected roof openings pose a potential fall hazard to the ground level below.

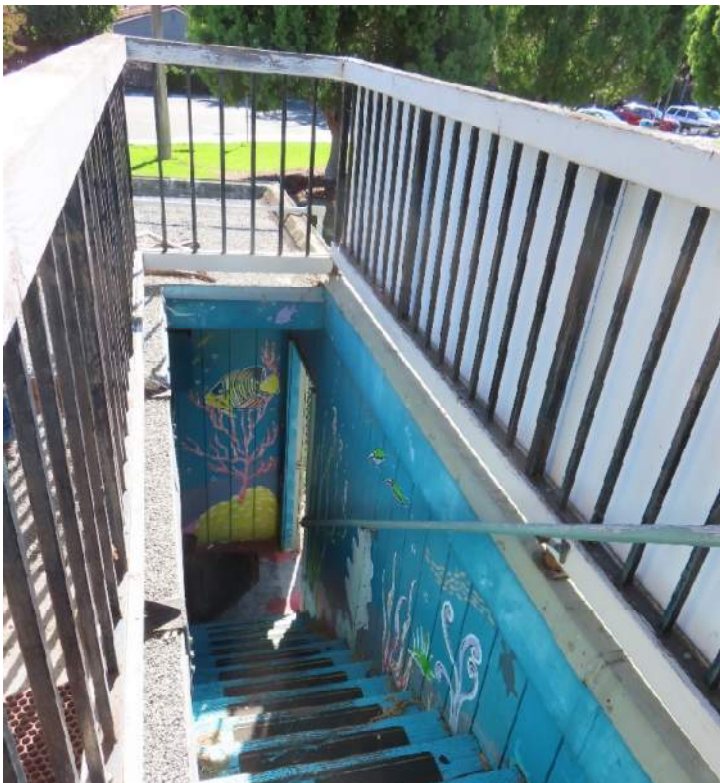
Photo 2

Single flight of wood stairs leads directly to the roof with no locked gates or restrictions to the roof level.

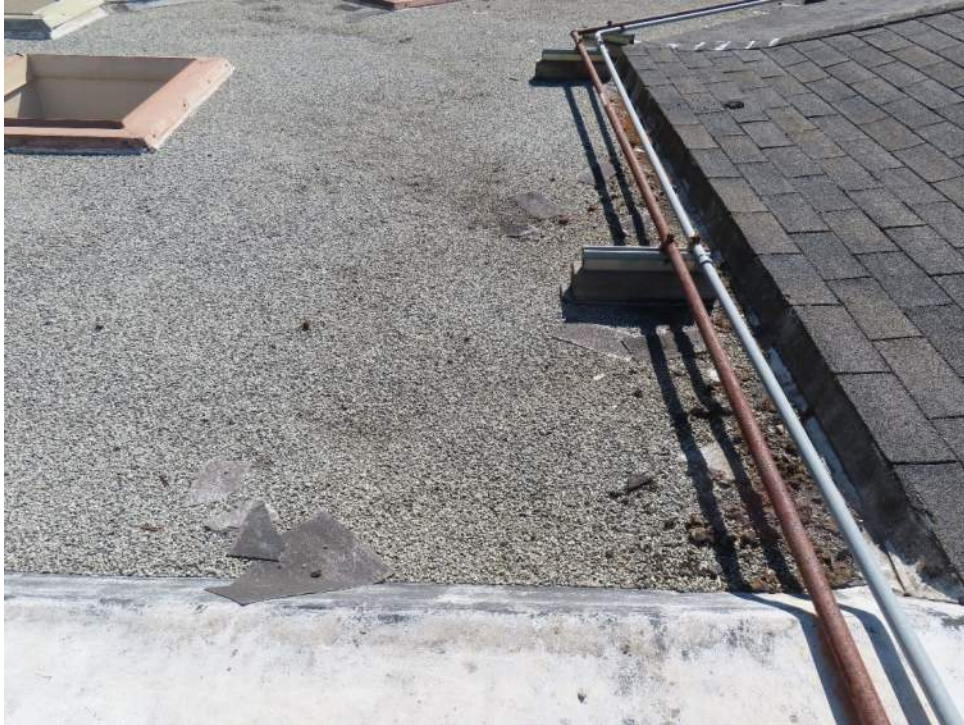
Photo 3

- Approximately 40% of the built-up roof exhibits signs of distress and inadequate drainage, such as bar spots and cracked plies and asphalt.
- Debris (e.g., dislodged asphalt shingles, swimming attire, wood crates) exists on the roof (Appendix A, Photo 3).

Debris (e.g., dislodged asphalt shingles, swimming attire, wood crates) exist on the roof.
