CITY OF SANTA CLARA GEORGE F. HAINES INTERNATIONAL SWIM CENTER VISUAL OBSERVATION ASSESSMENTS REPORT

01/24/2024
LPA Job No. 31047

VISUAL OBSERVATION ASSESSMENTS REPORT

PREPARED BY
LPA, Inc.
& Aquatic Design Group, Inc.
& Simpson Gumpertz & Heger

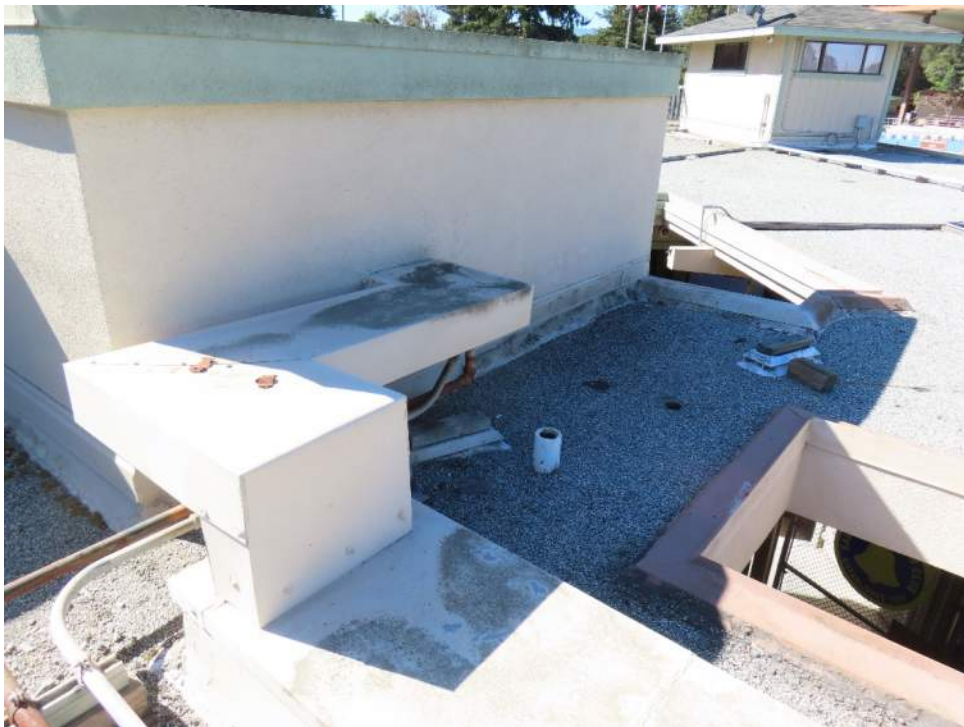
Photo 4

- Wide parapet caps and rooftop mechanical chutes exhibited oil canning (i.e., visible, wavy distortion that affects cold-rolled metal products) (Appendix A, Photo 4).

Rooftop mechanical ducts exhibit oil canning and stains from potential ponding water.

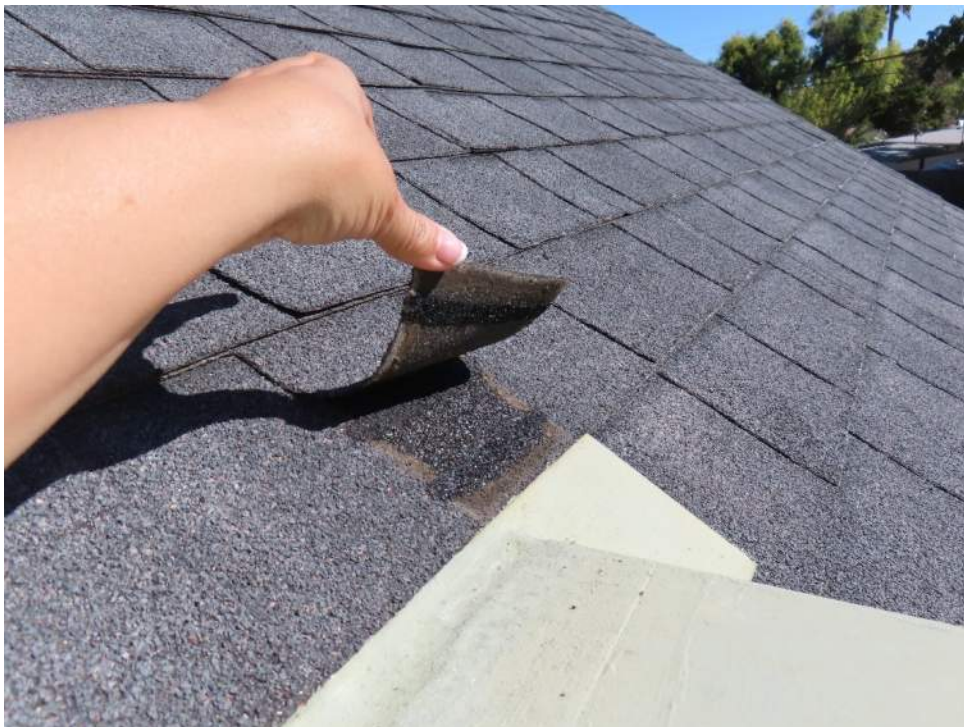
Photo 6

- Approximately 60-70% of the composite, asphalt shingles at the saw-tooth roofs are inadequately adhered and could be lifted with relative ease. These poorly adhered shingles occur along the rake edge and within the field of the roof (Appendix A, Photos 5 & 6). Algae growth exists on the downslope edges of asphalt shingles (Appendix A, Photos 7 & 8).

Poorly adhered shingles occur along the rake edge and within the field of the roof.

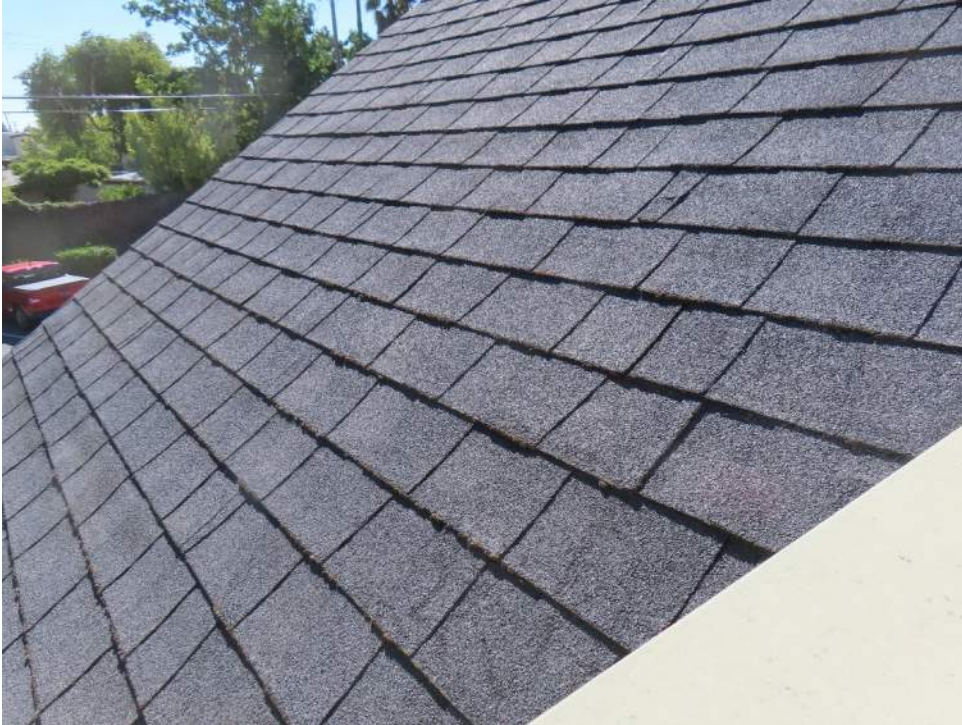
Photo 7

Organic growth exists on the downslope edges of asphalt shingles - see Photo 8 for close up.

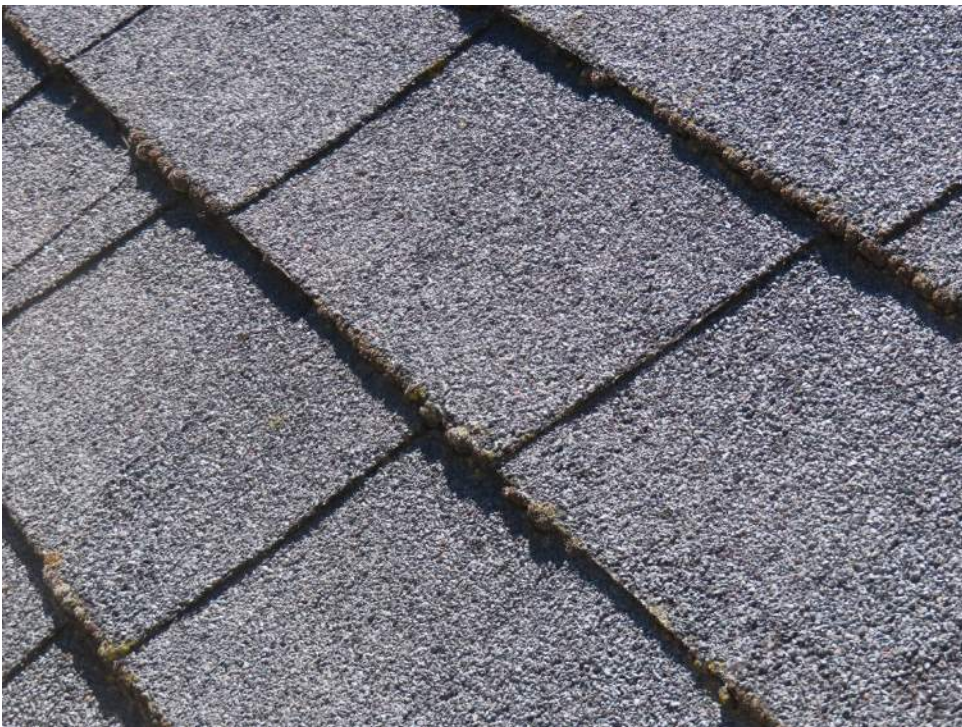
Photo 8

Algae growth exists on the downslope edges of asphalt shingles.

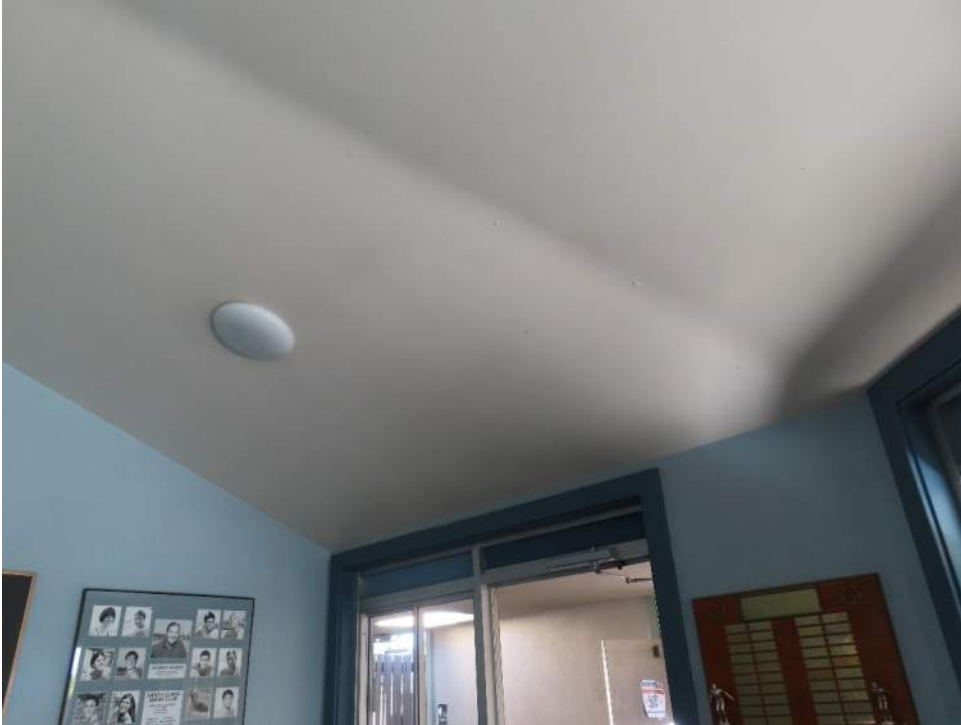
Photo 9

- Approximately 70% of the asphalt shingles we checked at the octagonal, steep slope roof are dislodged or inadequately adhered. Most of the asphalt shingles on the hips are dislodged, missing, or have significant granular and • The missing shingles on the hips align with the ceiling cracks, nail pops, and bubbling in the gypsum wallboard below (Appendix A, Photos 9 & 10).

Missing shingles on the roof hips align with the ceiling crack, nail pops, and bubbling in the gypsum wallboard.

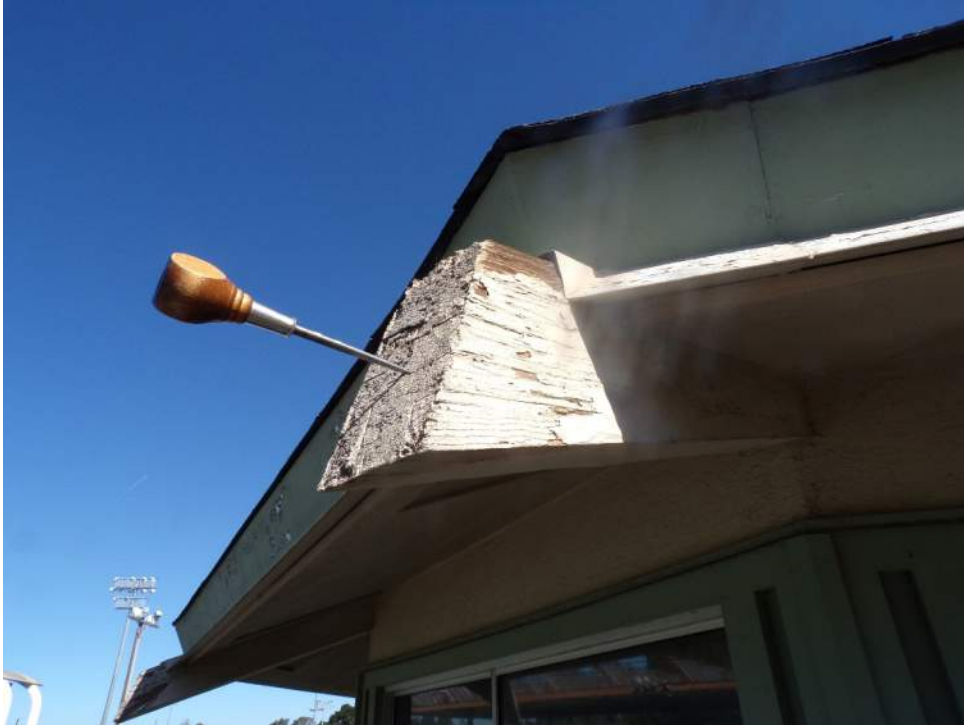
Photo 15

Significant wood decay at the exposed ends of common and hip rafters.

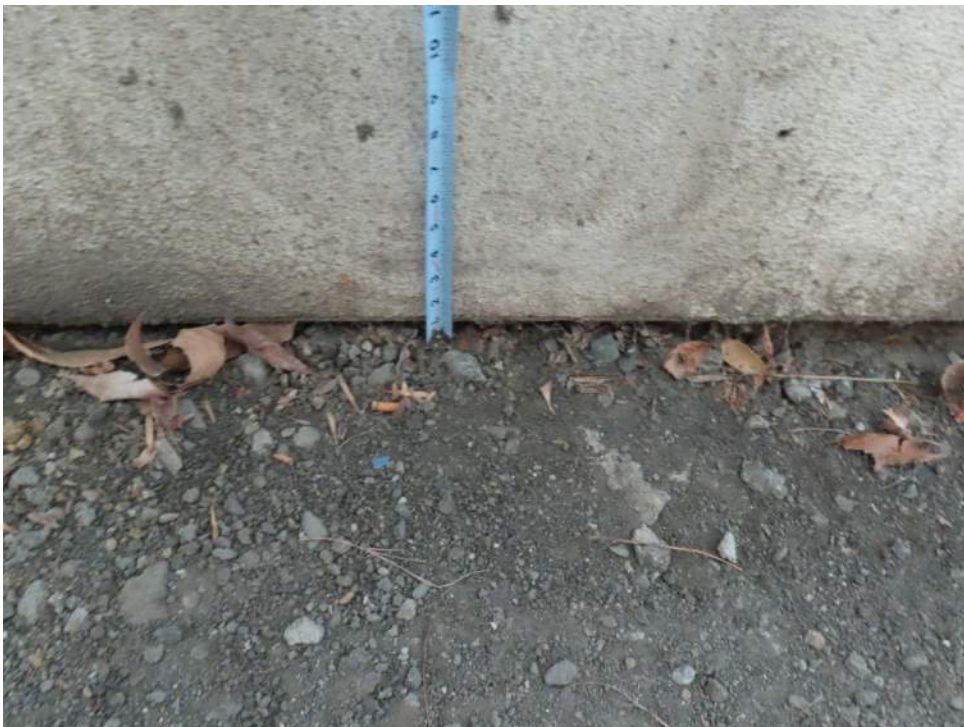
Photo 26

The stucco wall weep screed is less than 1 in. above grade.

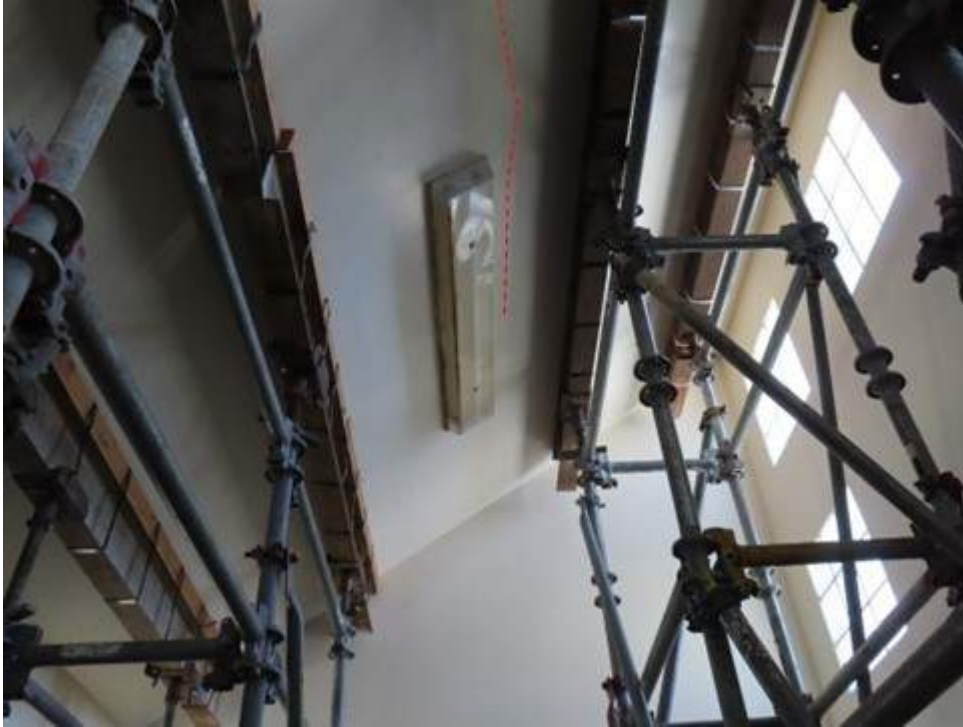
Photo 27

- Sizeable cracks in the ceiling and wall finishes (Appendix A, Photos 27 & 28) and cracks and gaps within the tile assembly particularly at inside wall corners and at tile ledges (Appendix A, Photo 29). The location and pattern of cracking indicate wall movement.
- Water stains and chipped paint exist on the non-

Sizeable cracks exist in the plaster ceiling and wall finishes. The location and pattern of cracking indicate wall movement.

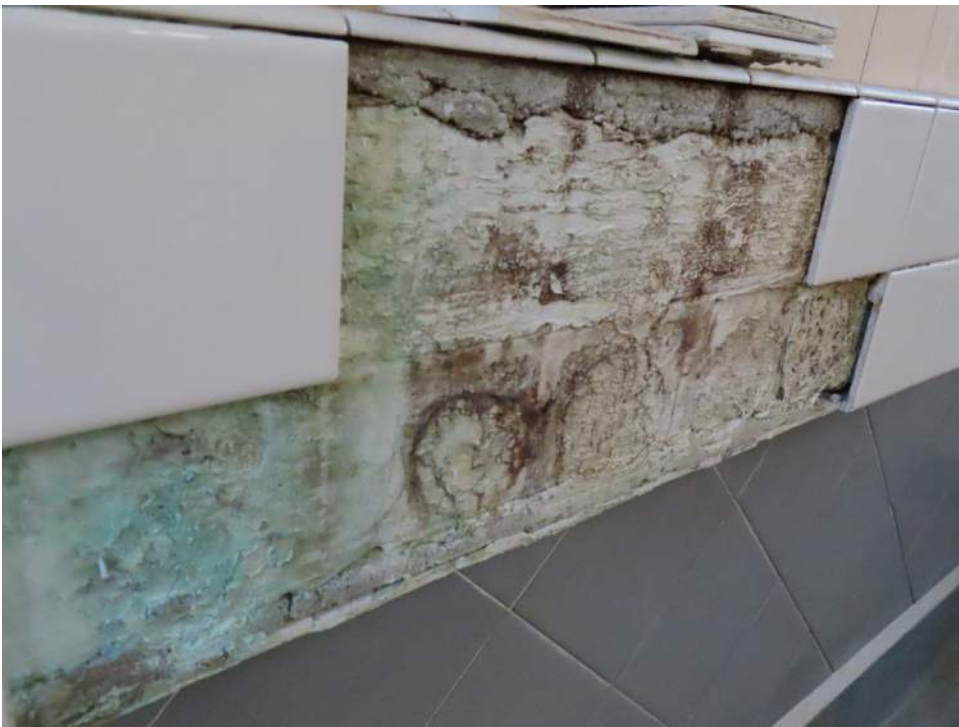
Photo 34

Debonded ceramic tiles expose the underlying discolored and discontinuous mortar bed.
