# CITY OF SANTA CLARA GEORGE F. HAINES INTERNATIONAL SWIM CENTER VISUAL OBSERVATION ASSESSMENTS REPORT

01/24/2024  
LPA Job No. 31047

**PREPARED BY**  
LPA, Inc.  
& Aquatic Design Group, Inc.  
& Simpson Gumpertz & Heger

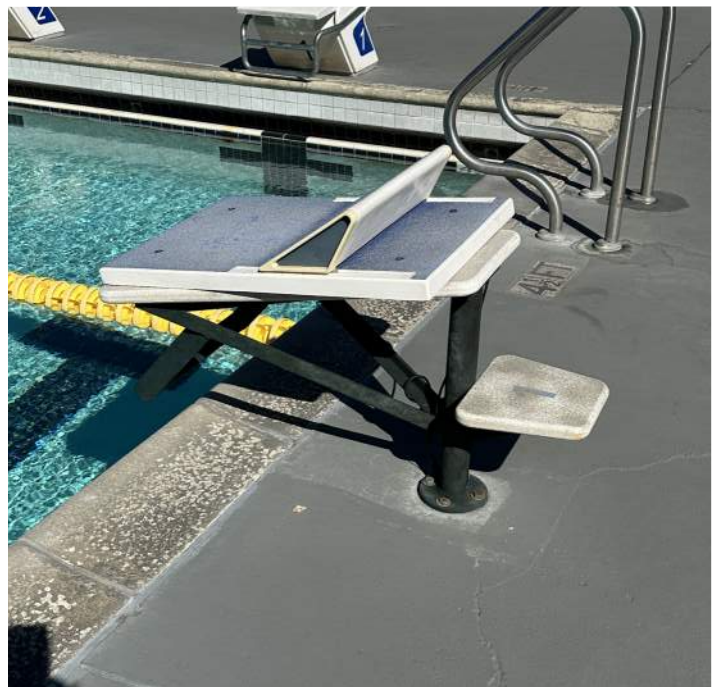
Image 10: Starting Platform in 4'-6" Depth of Water

The starting platforms should be removed from all locations where the water is 6' deep or less to enhance safety and comply with code. Staff can remove the starting platforms from the deck.

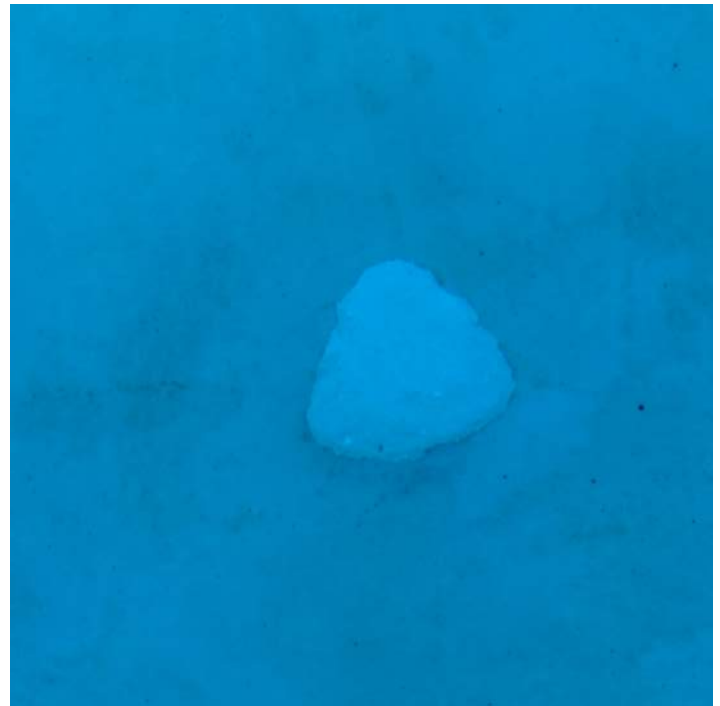
Image 16: Delaminating Plaster in Diving Pool

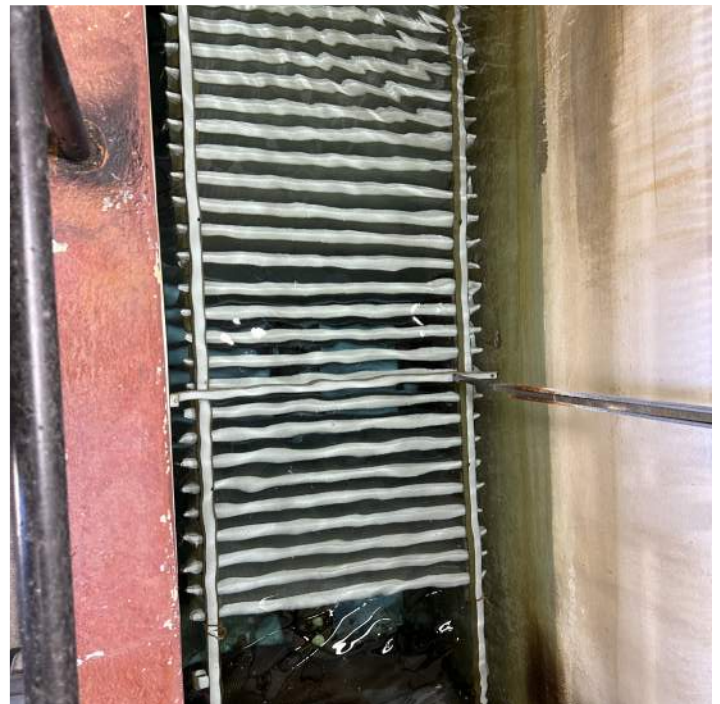
Image 26: DE Filter

Staff report that they must drain and clean the diatomaceous earth filter systems every other week or 26 times per year. To accomplish this the staff must close the 50-Meter and Instructional Pools every other Tuesday from 6AM to 3PM and the Diving Pool every other Wednesday from 6AM to 3PM to clean the filter systems. New fully automatic high-rate sand filters would eliminate this requirement for staff labor and pool program closure. The following estimate is for new high-rate sand filter systems for each pool (this item is included in the project scopes on pages 23 and 24).

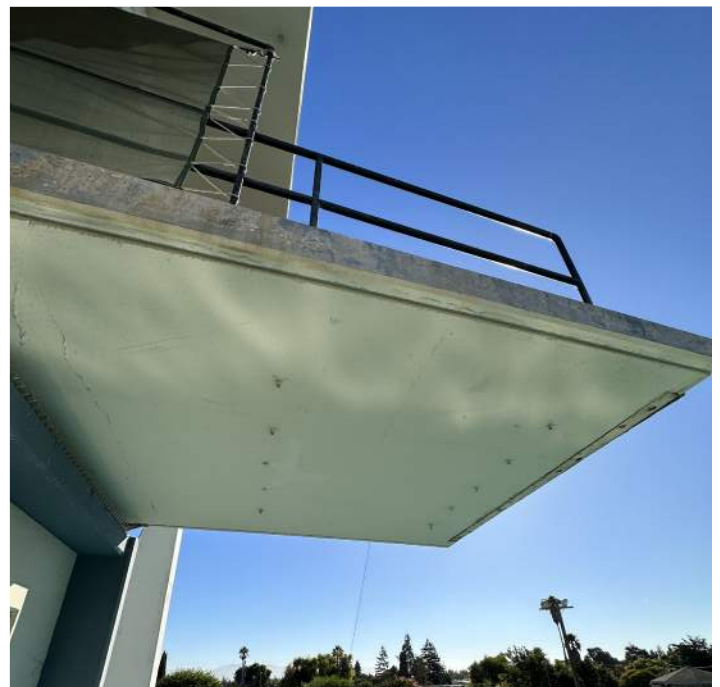
Image 28: Diving Platform in Tower

The dive tower has been deteriorating for some time. The structural viability of this tower will be addressed by others. In the meantime it should be noted that the existing dive tower is constructed with 5-meter, 6.5-meter and 10-meter platforms. Current dive regulations require dive platforms of 5-meters, 7.5-meters and 10-meters.

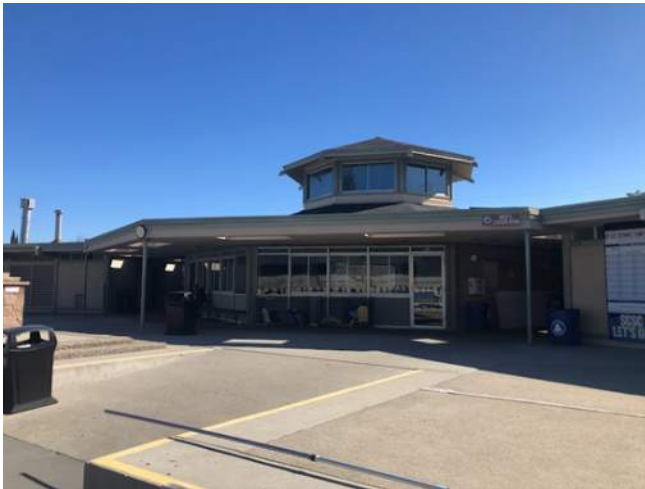
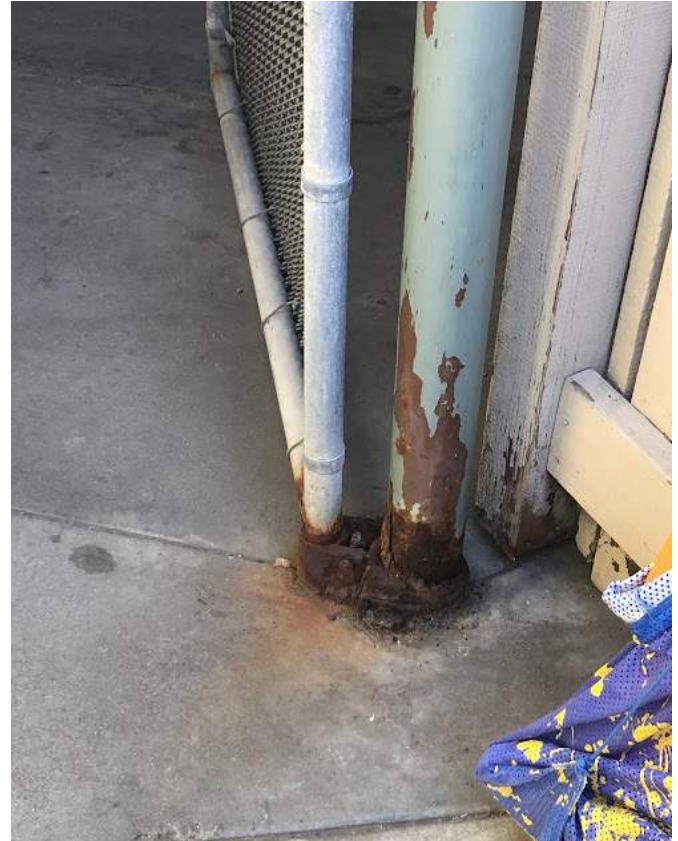
1. Building A – Administration Building
  - a. The center Rotunda requires lateral load resisting system. Existing corner wood posts are not sufficient as lateral load resisting system.

- b. Along the 4 wings of the building, continuous clerestory windows occur along all perimeter walls. As the result, the shear walls are discontinued from the roof framing. Wood posts cantilever over wall panels to resist lateral loads from the roof. This type of lateral load resisting system is not permitted in current code. Further review required to retrofit the lateral load resisting system.
    - c. Some exposed steel posts are badly rusted at the base and shall be replaced.

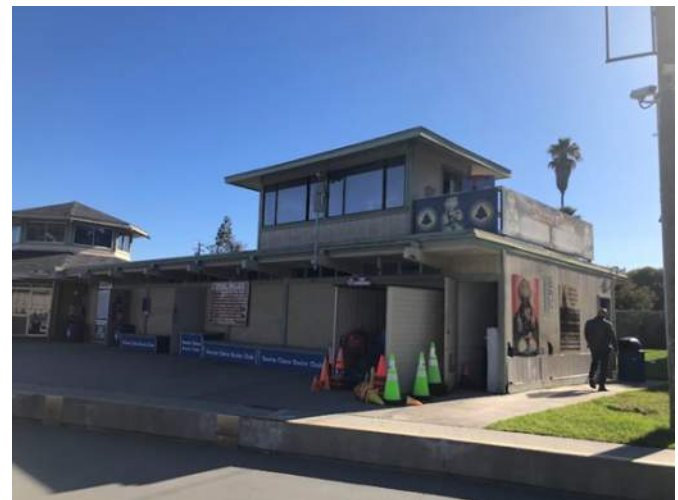
- d. Press box structure above the club office wing does not have defined lateral load resisting system on 4 sides of walls.

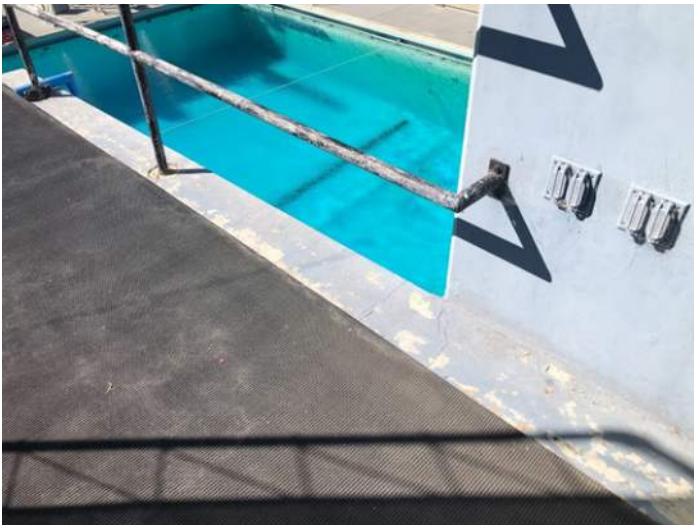
- a. Steel stair inside the dive tower is severely rusted and some connections are damaged. Stair is unsafe to use.
- b. Concrete curb adjacent to the stair opening is cracked and exposed rebar is severely rusted.
- c. Diving platforms at the start of the cantilevers have observed cracks on the top surface concrete structural slab. Concern that water will get into these cracks and cause rusting to the rebars. Recommend removing the floor cover to further evaluate the existing condition.

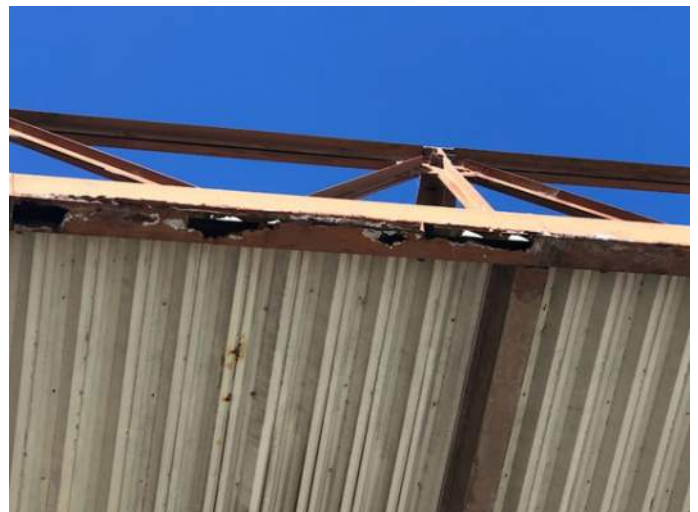
- a. Severe rusting is found on the roof drain gutter along the perimeter of the canopy roof. These roof drain gutter are made of light gauge sheet metal. Some damaged gutters poses falling hazards to the building or walkway below.

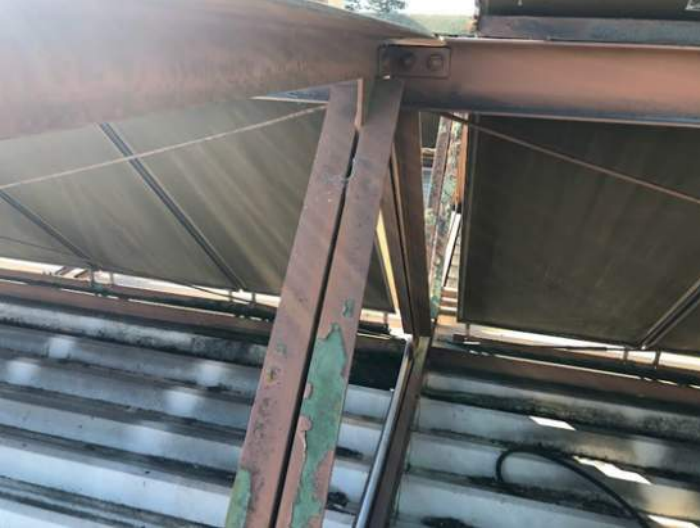
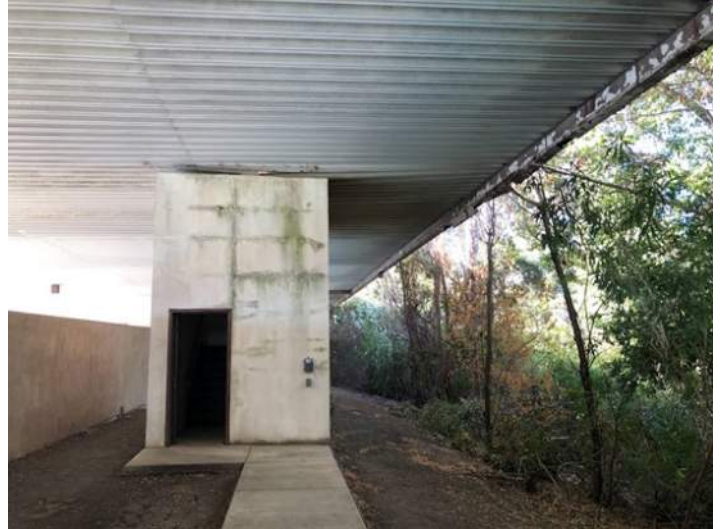
- b. Roof trusses of the canopy roof appear in reasonably sound condition. Some of the cover coating has been worn off and exposed the base primer. The original primer appears to be in reasonable shape with minor rusting observed.

- c. The canopy tower access structure that houses the access ladder to the top of roof deck is badly damaged. Severe water damage and drywall cracks are observed on all walls of the structure. Rusting of metal stud bottom tracks are observed. Metal stud walls enclosed by the gypsum wall board are anticipated to be badly rusted as well. This is a stand-alone structure without connection to the roof structure. The gravity and lateral load resisting system is primarily metal studs and drywall. With the severity of the damage observed, most of the lateral load resisting system have been compromised, it is unsafe to be inside the structure.

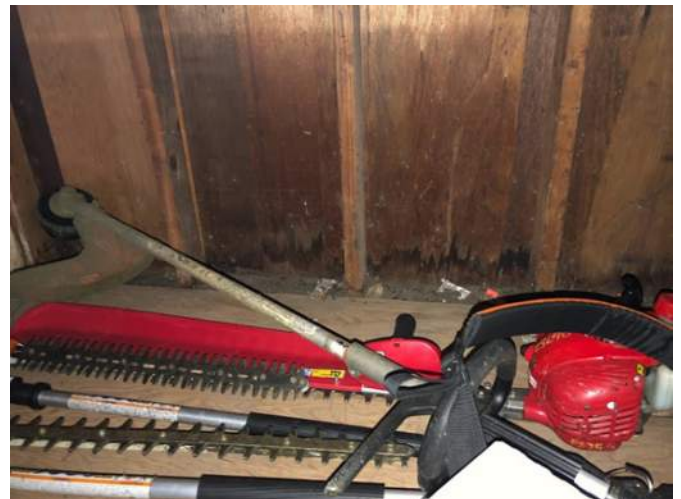
8. Building G – Park Maintenance Storage
  - a. This one-story building constructed of wood roof framing over plywood shear walls on all side of the building. A continuous clerestory window along the north and south wall of the structure. The shear wall are discontinuous between roof and top wall. Wood posts connect the roof to the shear wall. This system do not meet the current code requirement.

- b. Evidence of water damage observed at the plywood shear wall near the sill plate.

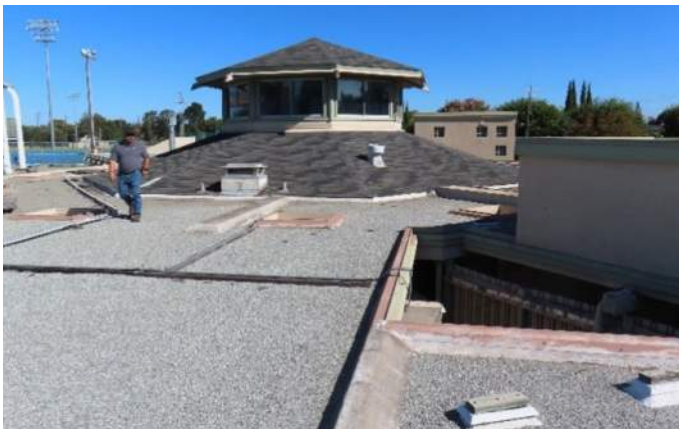
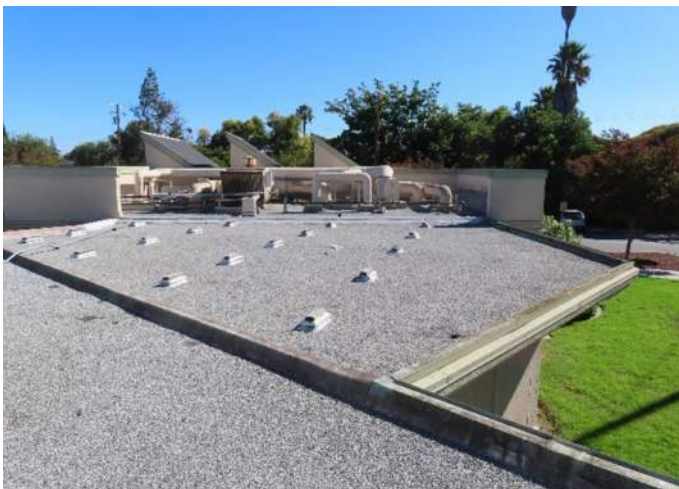
- The low-slope roof at Building A has 16 "skylight" openings with no cover, safety barrier, or safety markings. These unprotected roof openings pose a potential fall hazard to the ground level below (Appendix A, Photo 1) and violate the current Code: Section 3212 of the California Code of Regulations (CCR), Title 8 requires roof openings to be guarded by a cover or a guardrail on all sides of the roof opening. This safety hazard is exacerbated by the ease of roof-level access, where a single flight of stairs leads directly to the roof (Appendix A, Photo 2). There are no locked gates or restrictions to the roof level.

- The perimeter of the low-slope roof has no safety barriers, tie-offs, or edge delineation. This condition poses a fall hazard, especially given the unrestricted, roof-level access. This condition also violates the current code: Section 3210 of CCR, Title 8 requires guardrails along roof edges more than 30 inches above the ground. Alternatively, a zone along the roof edge can be marked to discourage anyone from walking within that zone, but zone marking alone is not code-compliant.

The roofs at this Facility exhibit significant distress and deterioration. Further, the roofs are beyond their useful service life, particularly the low-slope, built-up roofs. Lastly, the layout and configuration of the low-slope roofs near openings and along the perimeter fail to comply with current safety codes and standards. Given the current condition and configuration of the roofs and roof accessories, we recommend wholesale removal and replacement with code-compliant roofs.

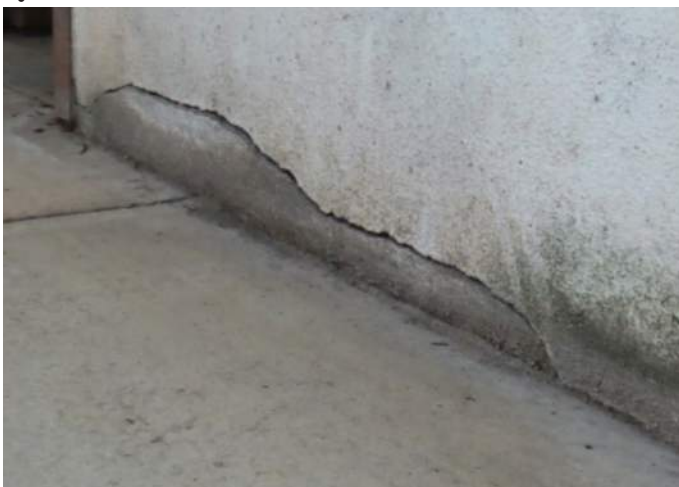
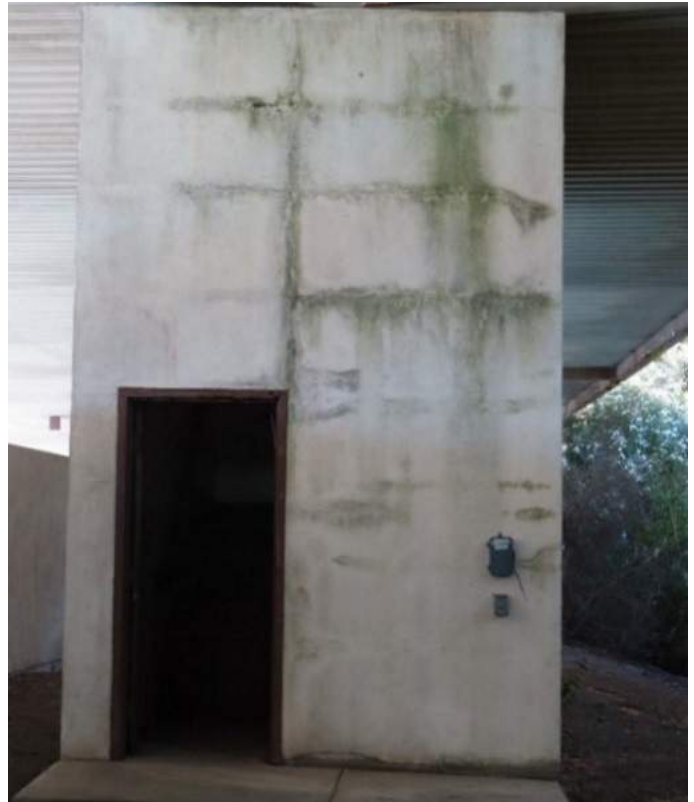
- Extensive cracks throughout the stucco wall forming a checkerboard pattern (Appendix A, Photo 21). We also noticed pronounced buckling of the walls and large stucco spalls, most likely from soil settlement in this general vicinity (Appendix A, Photo 22).

While stucco can provide as a serviceable cladding for over 50 years if design and maintained properly, the stucco walls at the Facility are exhibiting signs of water damage, such as cracking, spalling, staining, and mildew growth. We also did not observe any water-resistive barrier in the destructive opening through the stucco assembly. If the other stucco-clad walls at Building A have no water-resistive barrier, then all stucco-clad walls will need to be removed and rebuilt.

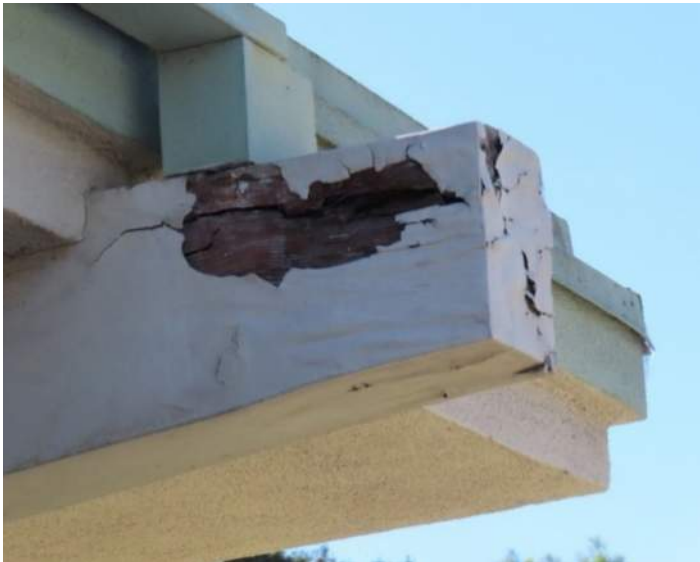
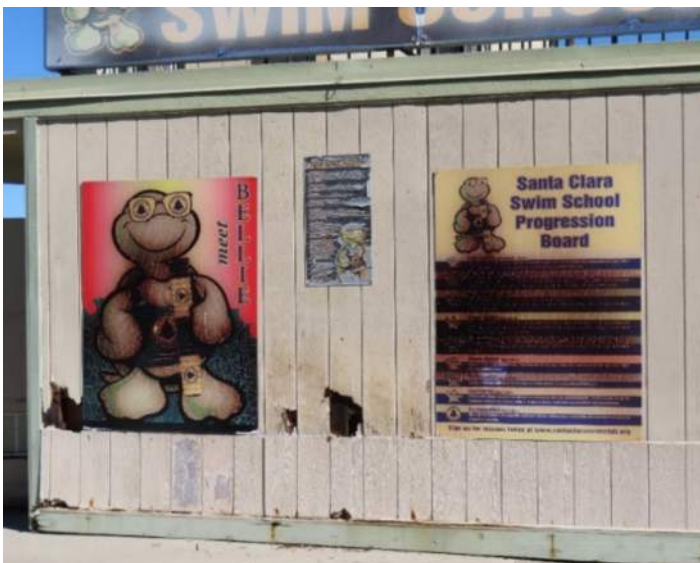
- The Clubhouse and multi-purpose wing walls exhibited significant wood decay forming large holes in T1-11 siding. The holes in the T1-11 siding expose a single layer of Type B building paper over an open wood stud cavity.
- The wood trim throughout the complex, particularly the T1-11 siding, which is significantly decayed and covered with flaking paint. We were able to push the awl into the trim with relative ease.

The typical lifespan for T1-11 plywood siding ranges from 20 to 30 years, assuming it is painted every 10 years. The T1-11 siding at the ISC Facility is well beyond its useful life, as evidenced by the significant decay and cross-sectional loss described above. All T1-11 clad walls need to be removed and replaced, along with any decayed wood framing members within the wall cavity.

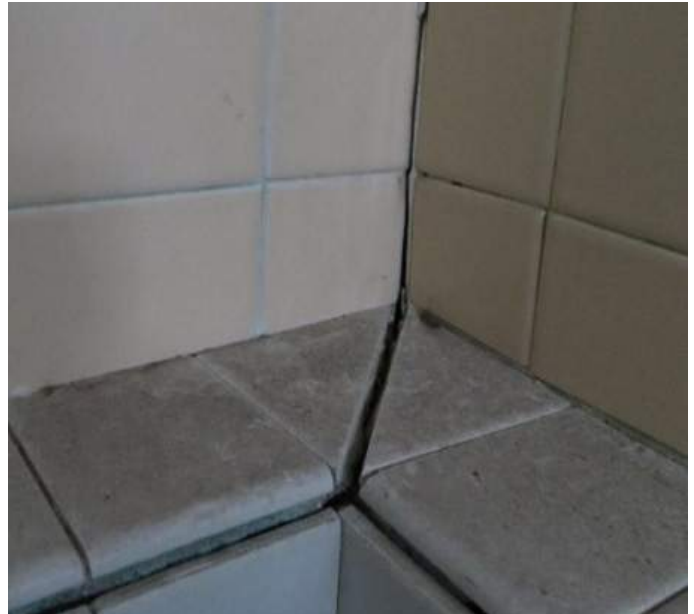
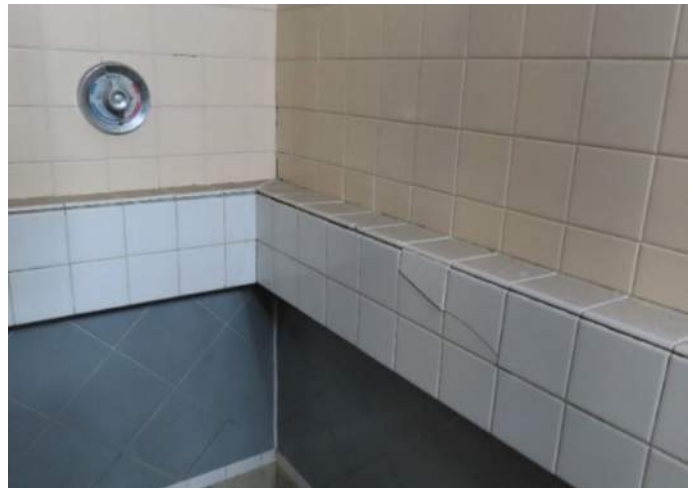
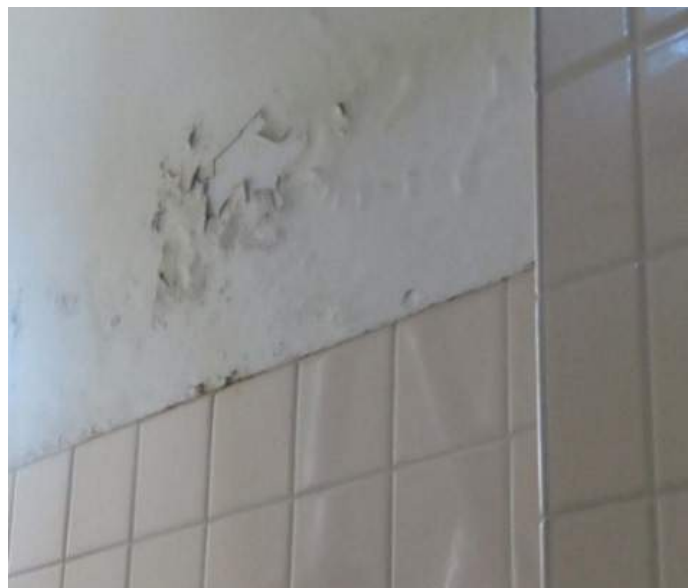
- Sizeable cracks in the ceiling and wall finishes (Appendix A, Photos 27 & 28) and cracks and gaps within the tile assembly particularly at inside wall corners and at tile ledges (Appendix A, Photo 29). The location and pattern of cracking indicate wall movement.
- Water stains and chipped paint exist on the non-

tiled portion of the shower enclosures, indicative of water damage (Appendix A, Photos 30, 31 & 32).

The Men's and Women's showers in Building A exhibit significant structural distress and water damage. Further, the exterior and interior wall assemblies fail to comply with current building code and standards. Given the current condition of these showers, we recommend wholesale demolition and reconstruction of these spaces with code-compliant showers and perimeter wall assemblies.

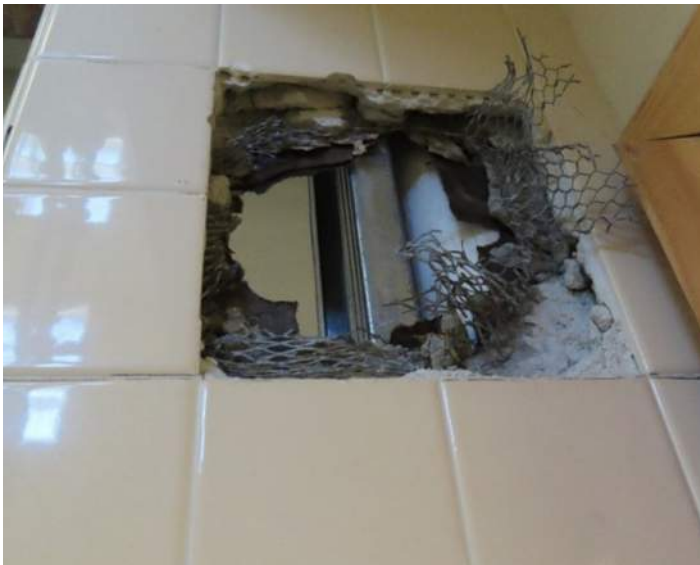
- Debonded ceramic tiles expose a discolored and discontinuous mortar bed (Appendix A, Photos 33 & 34)
- Pronounced efflorescence and discolored residue exist along the base of the tile walls, around shower escutcheon plates, and at tile grout lines (Appendix A, Photos 35, 36 & 37) indicative of water leakage through the tile assembly.
- At an interior wall opening, we observed ceramic tile over a mortar bed over expanded wire lath over 2 layers of grade D building paper. It appears that these two layers of building paper were installed as the shower membrane. Current shower wall standards require a waterproofing membrane inside the shower area extending the full height of the tile assembly and water vapor management.

Two layers of building paper fail to meet this requirement.

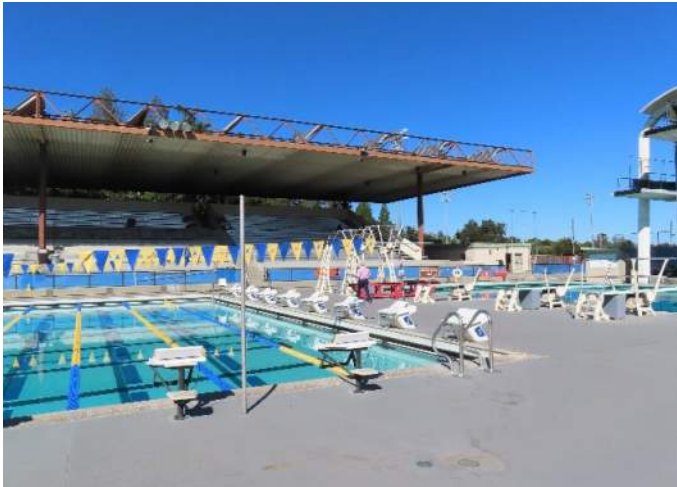
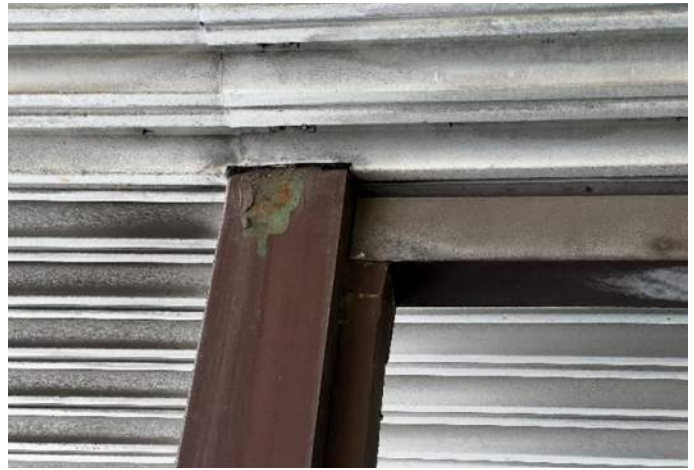
- The eight columns supporting the canopy truss structure appear to be in good condition. The base coating of these columns is well adhered to the steel substrate, but the top coating is delaminating in discrete, localized areas. We did not observe any significant corrosion of the steel substrate, even at the low point where the columns intersect the concrete bleacher steps.

- UT measurements taken at the base of the eight columns (1 in. to 6 ft above the bleacher steps) show no significant variations in the steel thickness with height or between the columns. Refer to these UT measurements in Table 1. These consistent thickness measurements indicate little to no corrosion of the inner surface of the tubular columns.

The canopy support columns and canopy support truss structure appear to be in good condition. We recommend stripping the current coating and recoating them with a two-part epoxy coating. We did not detect lead in our coating analysis at these locations. The localized corrosion on the canopy panels is likely due to original local coating defects rather than debris accumulation and ponding water. These local areas could be cut out and replaced, with the remaining panels stripped and recoated. However, it might be more cost-effective to replace these panels. The canopy gutters are corroded past their useful life and should be replaced with a non-metallic gutter system. The canopy tower appears to be in good condition and no work is required on the stairs or railings. The corroded door and frames should be replaced with components that are designed for external exposure. The solar heating pipe risers should be removed, and the local deformation of the roof panels repaired.

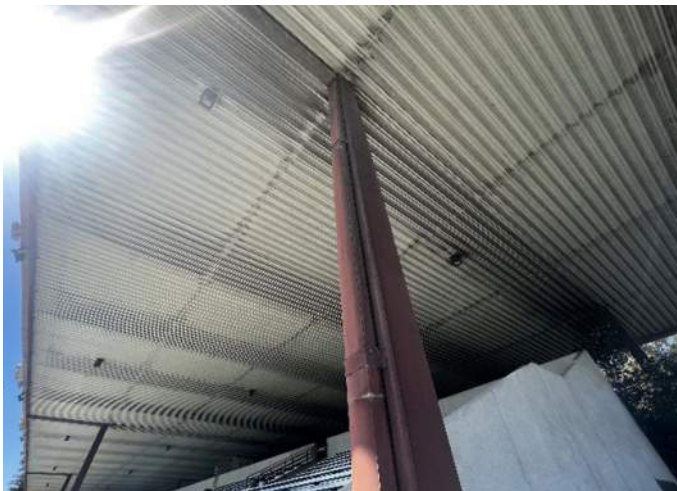
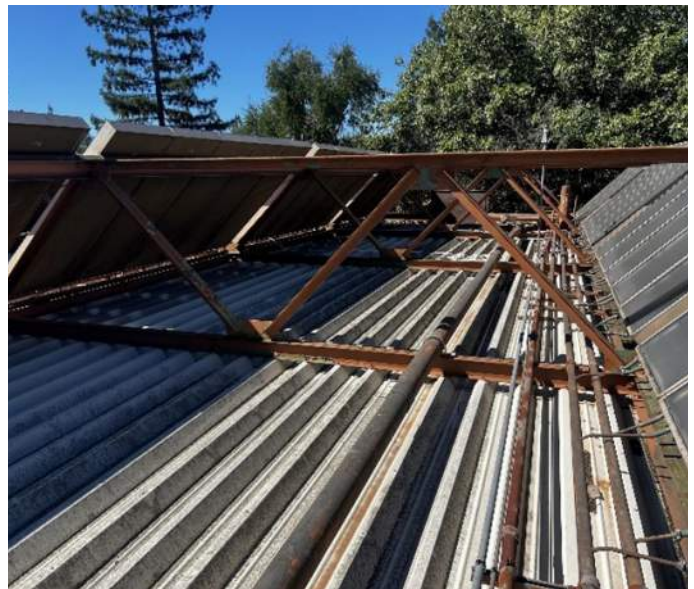
- A truss structure supports canopy panels and the now obsolete solar heating panels and tubing. The truss structure consists of steel I-beams and channels with welded and bolted connections.

- The canopy support truss structure generally appears to be in good condition. The base coating is well adhered to the steel, but the top coating is delaminating.
- We did not observe any significant corrosion (section loss) in the structural steel or fasteners in the areas we inspected.

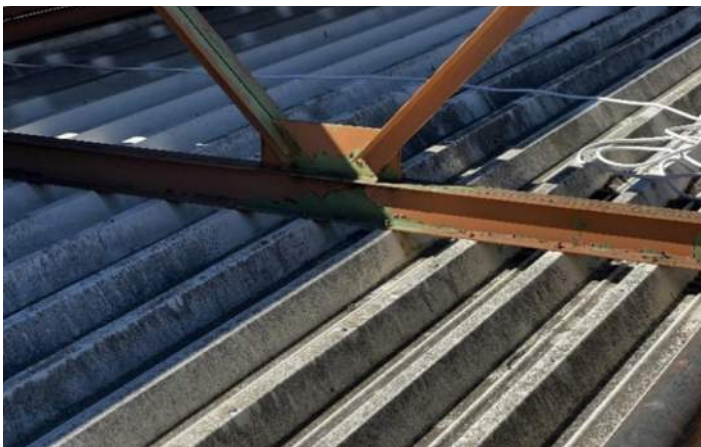
- The canopy panels appear to be in relatively good condition with the original coating on the top surface of the panels intact and no crevice corrosion between the fasteners and roof panels.

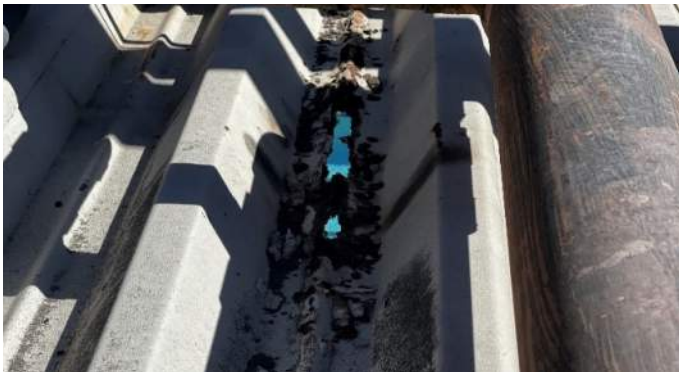
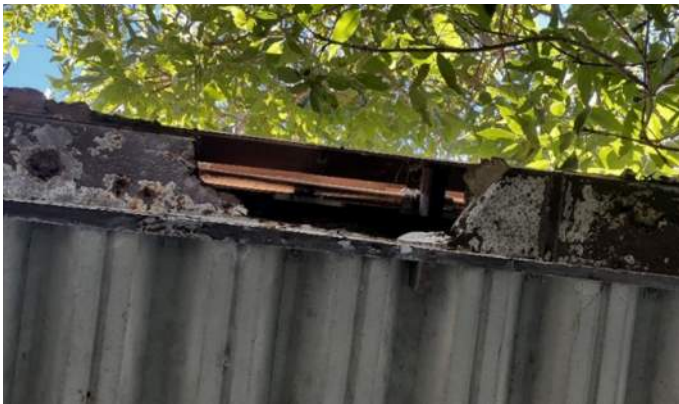
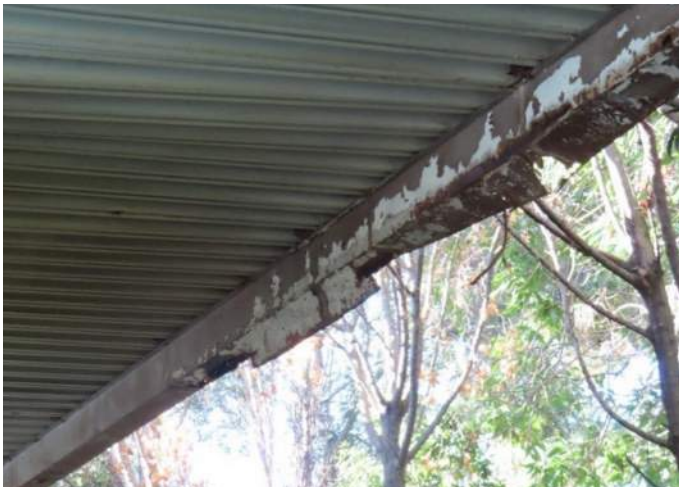
- Infrequent and discrete locations in the trough of the panels with through-thickness corrosion occur. Leaves and other debris have accumulated throughout the troughs of the roof panels, but there did not appear to be a correlation between debris accumulation and corroded areas. The corrosion is highly localized (less than 12 in.) with the coating immediately adjacent to these locations in relatively good condition.
- The gutters along both edges of the roof are completely corroded with cross-sectional loss at multiple sections.

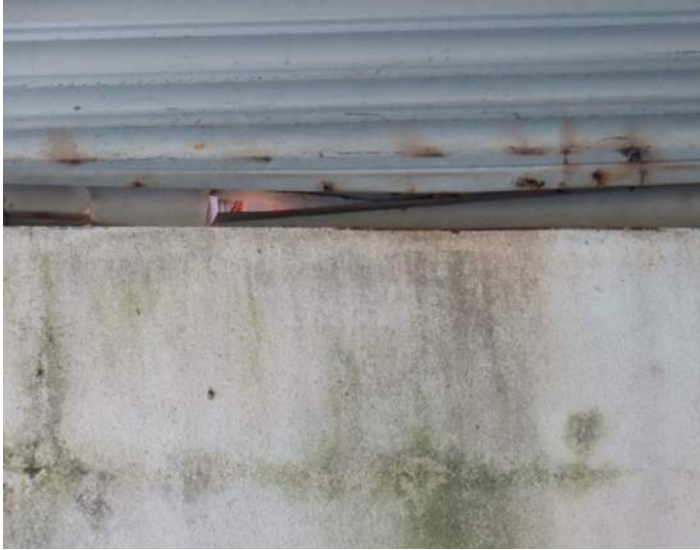
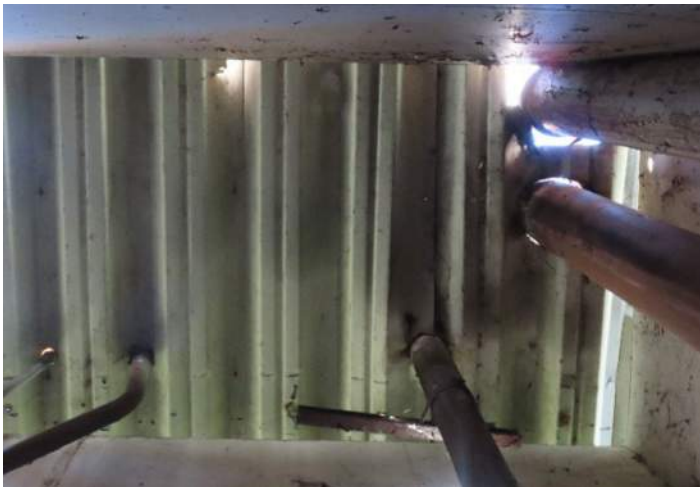
- The two riser pipes for the redundant solar heating system appear to have subsided into the ground. These have, in turn, pulled down adjacent pipe supports on the roof, resulting in deformation of the roof panel connected to these supports.

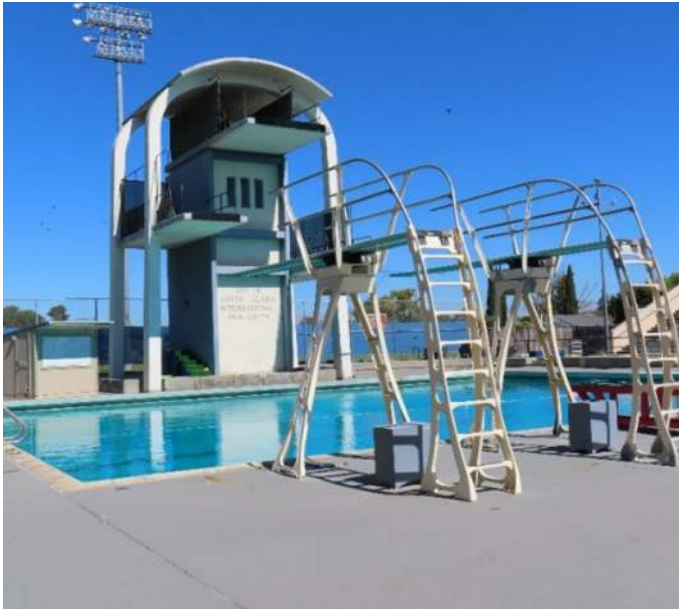
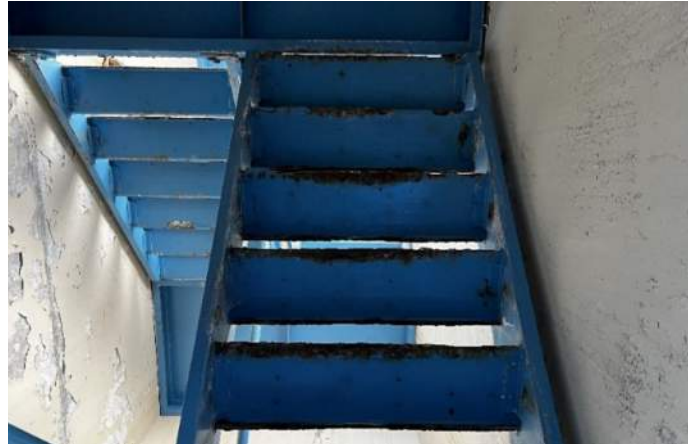
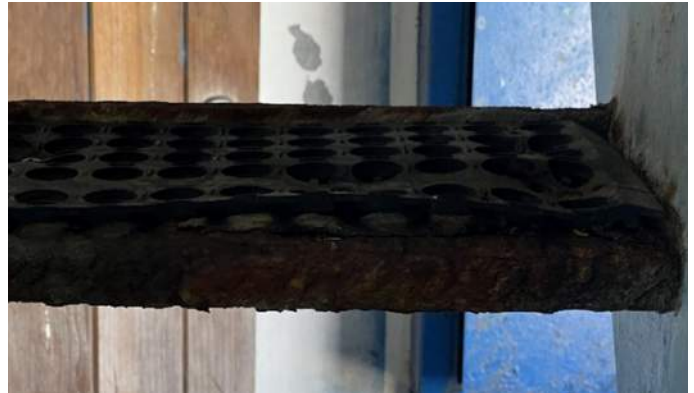
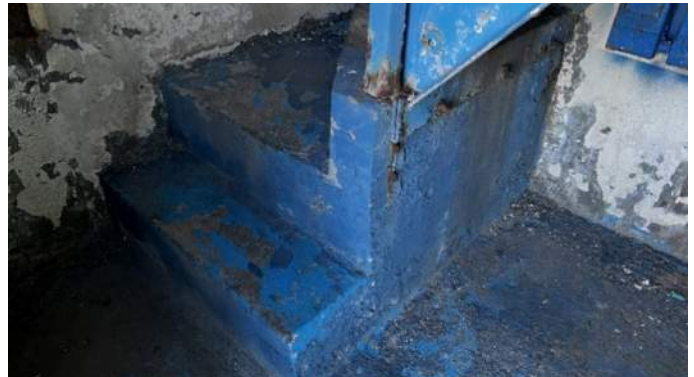
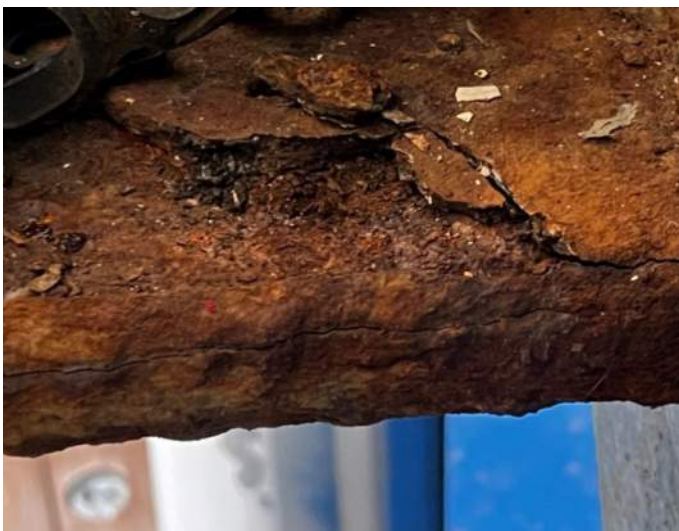
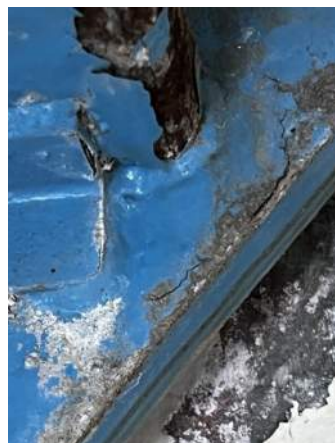
- The dive tower staircase is in poor condition with extensive corrosion, particularly on flat surfaces and crevices. Welds are also corroded with the lower section more heavily corroded than the upper section.
- Many of the original coatings have completely delaminated, resulting in a significant accumulation of corrosion products.
- Areas of white corrosion products exist underneath delaminated sections of coating.

The dive tower staircase is heavily corroded and should be replaced. The white corrosion products that we observed suggest that underneath the coating, the metal substrate is galvanized, which is not a suitable coating for structures such as these which are frequently wet and enclosed in a humid environment. We recommend removing and replacing it with a code-compliant structure fabricated from a corrosion-resistant alloy, such as 316 stainless steel.

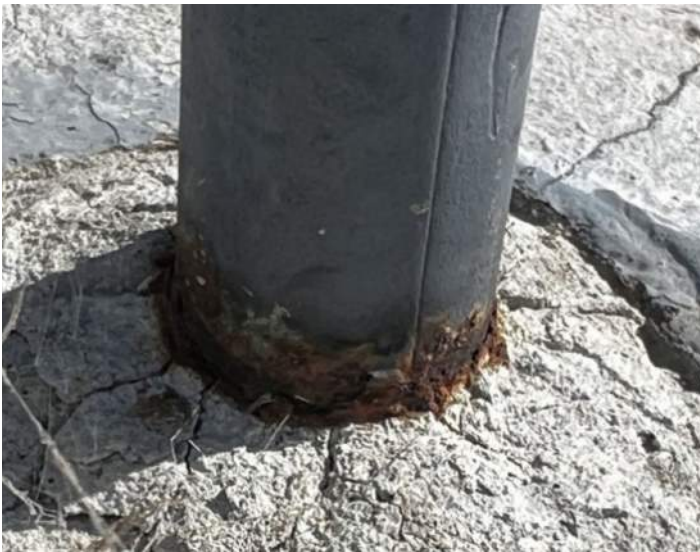
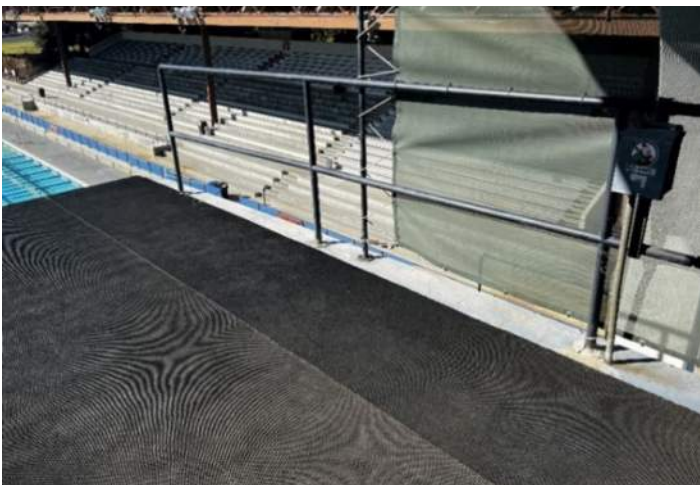
- The railings along the edge of the dive tower platforms appear to be in good condition with intact coatings and no visible corrosion. However, we observed coating loss and corrosion at the base of the railings at the plane of the pool deck.
- We were unable to conduct UT measurements at these locations, but using a knife to remove corrosion products we measured corrosion loss of at least 1/8 in.

The railings on the dive tower platforms are corroded at their base, which has likely affected their structural integrity. The railings should also be replaced with a code-compliant structure fabricated from a corrosion-resistant alloy.

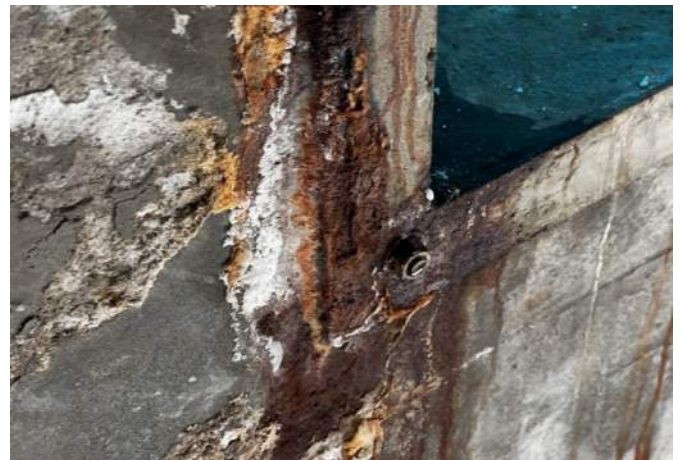
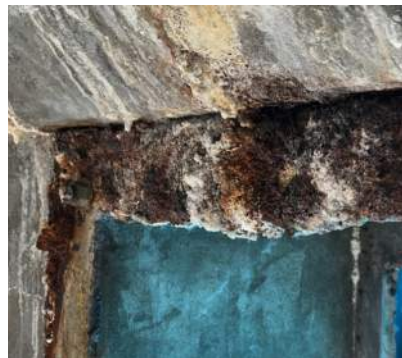
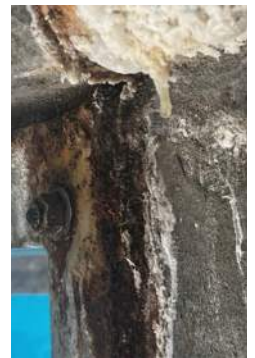
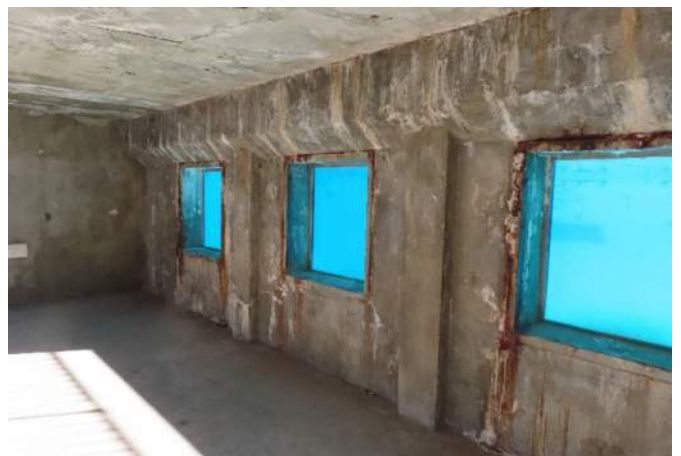
- The window frames are not coated and appear to be galvanized steel.
- The adjacent concrete is cracked with evidence of water seepage and a small, active leak at one location.
- The top and side elements of the galvanized frames are heavily corroded.

The galvanized window frames at the viewing area are heavily corroded due to water infiltration through the concrete. We recommend that once the concrete has been repaired and waterproofed, these frames are replaced with frames fabricated from a corrosion-resistant alloy such as 316 stainless steel.

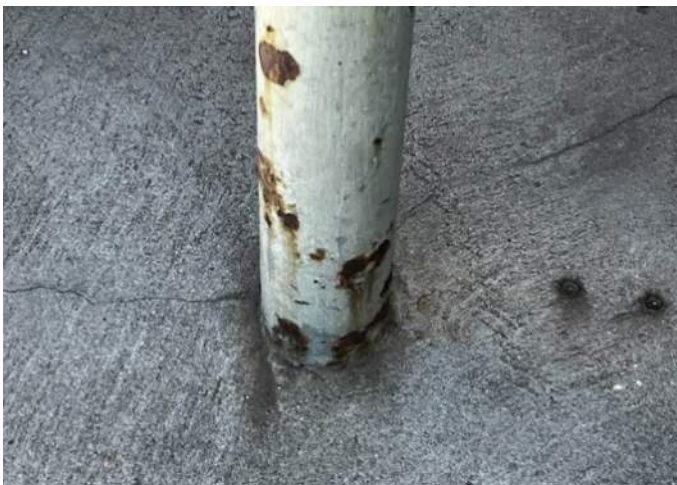
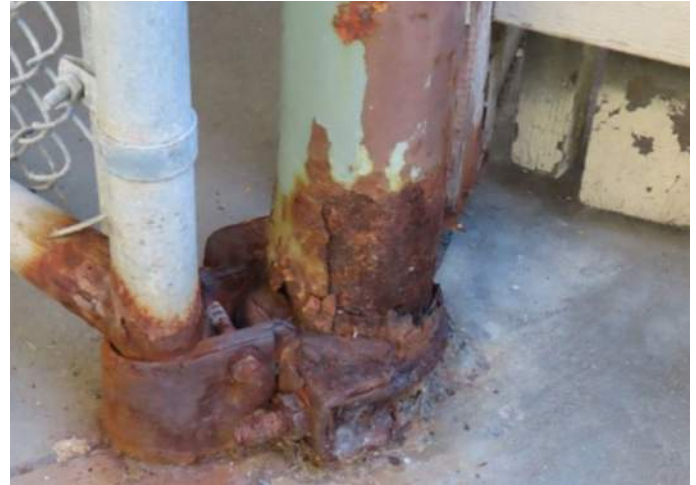
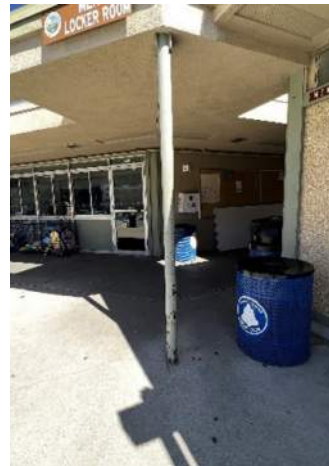
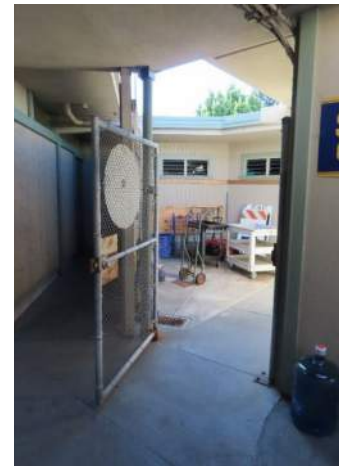
- The posts, particularly at deck level, exhibit coating failure and localized corrosion of up to 50%.

The Building A canopy supporting poles have corroded at several locations, especially at their base, with thickness loss of up to 50%. We recommend that these poles be replaced with carbon steel posts coated with a 2-part epoxy system.

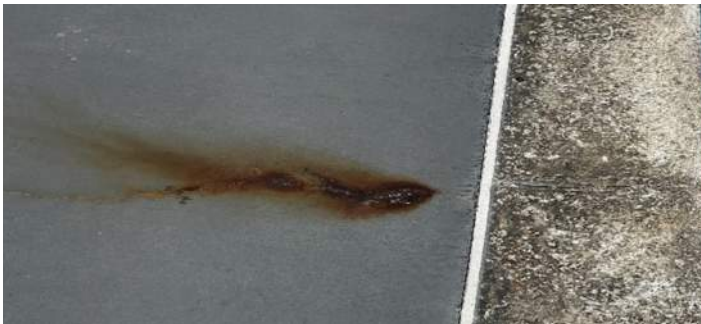
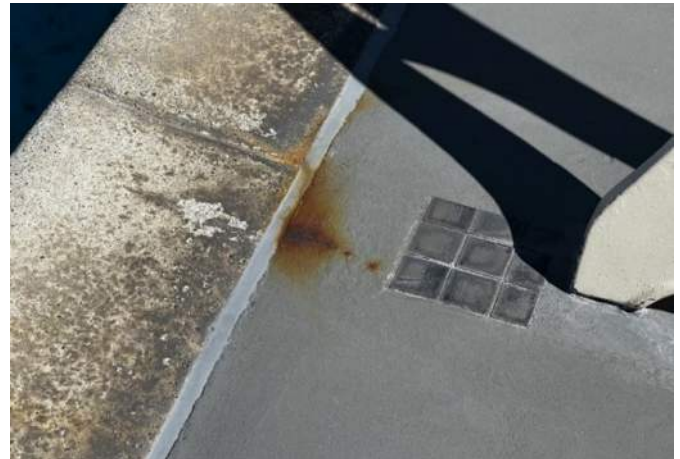
- The concrete deck is cracked with occasional corrosion staining.
- The pool tiles at the waterline are corroded.

We observed localized corrosion staining around the pool deck at crack locations, suggesting that localized rebar corrosion is occurring. Local concrete repairs and waterproofing the deck should eliminate this corrosion.

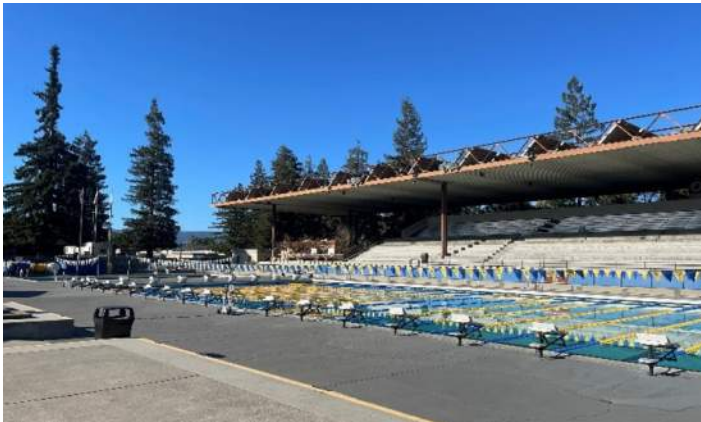
- The typical pool deck slab on grade has significant cracking uniformly. These cracks are likely due to several reasons including soil compaction and settlement cracking, drying shrinkage cracking due to the wide spacing between control joints. These cracks do not represent a life-safety hazard but could present serviceability issues.

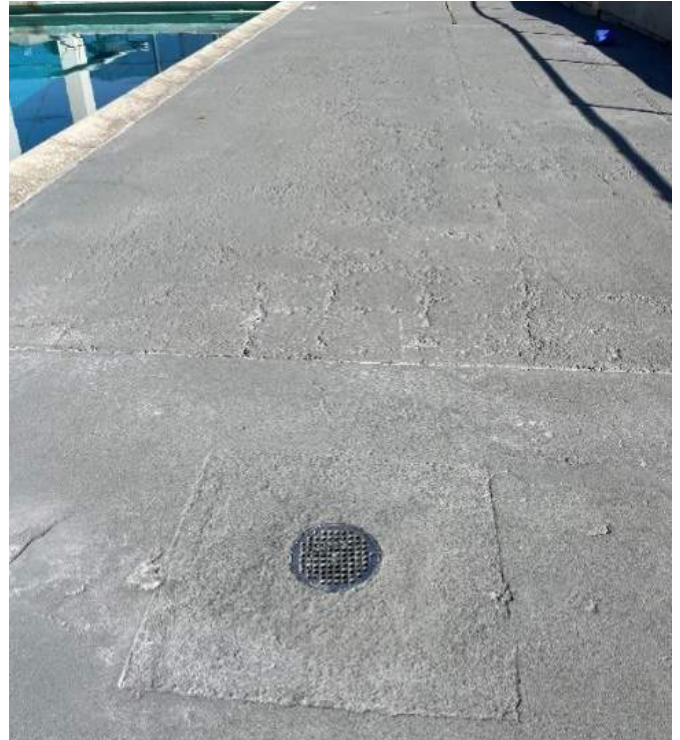
- The topside of the elevated deck slab above the viewing room has patching mortar applied. SGH detected delamination of the patch material when performing a chain drag.

The concrete pool decks at this Facility exhibit signs of distress and deterioration. While the cracking and settlement of the slabs on grade do not present a life safety hazard, they may pose serviceability issues. The current condition of the elevated Viewing Room represents an unsafe condition. Access to the Viewing Room below or walking on top of the elevated slab should be restricted. Given the condition of the elevated deck, we recommend locally removing and replacing the elevated slab and beam at the earliest.

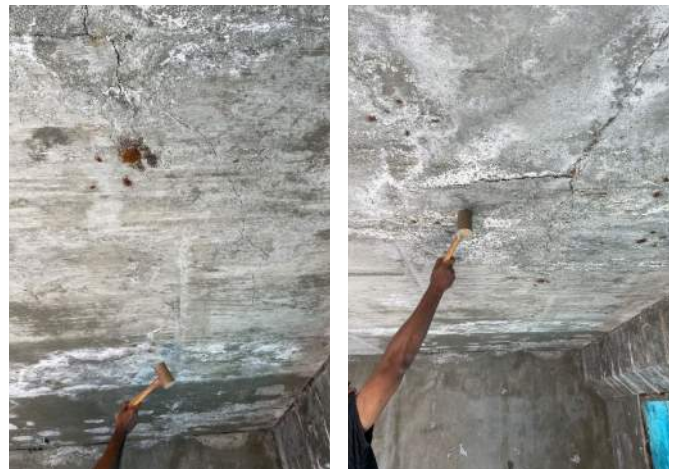
- The underside of the viewing room elevated slab has a large crack running longitudinally along the slab. The crack is beginning to initiate spalls, representing a safety hazard. Outside of the spalled region, the underside of the slab appeared in sound condition when we hit it with a sounding hammer.
