# CITY OF SANTA CLARA GEORGE F. HAINES INTERNATIONAL SWIM CENTER VISUAL OBSERVATION ASSESSMENTS REPORT

01/24/2024  
LPA Job No. 31047

**PREPARED BY**  
LPA, Inc.  
& Aquatic Design Group, Inc.  
& Simpson Gumpertz & Heger

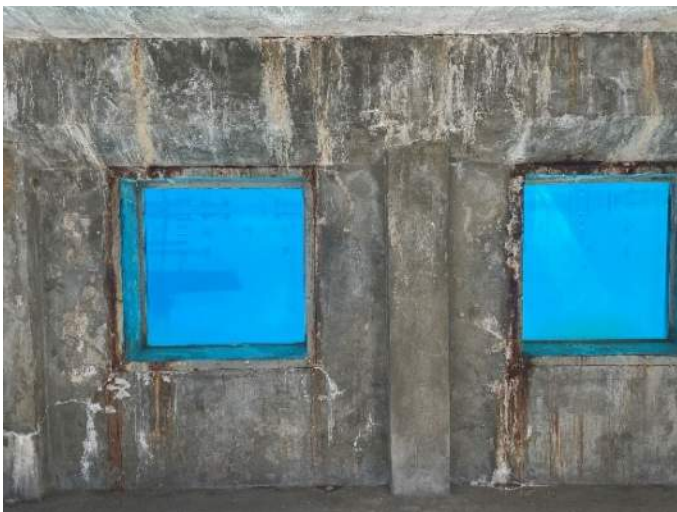
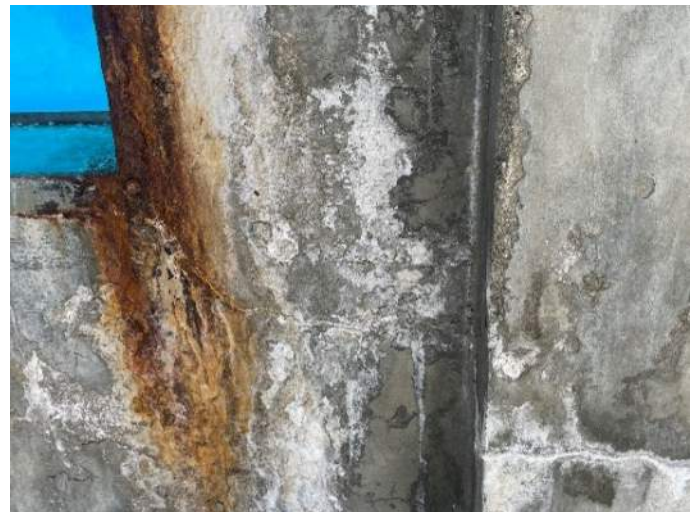
- Significant efflorescence and/or chemical leaching is evident on the underside of the slab.
- The exterior face (viewing room side) of the pool walls and the top bond beam both have moderate cracks exhibiting signs of efflorescence and or chemical leaching. The observed cracks align with reinforcement locations, as determined by our GPR survey. This indicates that moisture is likely reaching the reinforcement, and corrosion of the rebar is probable.

The concrete pool decks at this Facility exhibit signs of distress and deterioration. While the cracking and settlement of the slabs on grade do not present a life safety hazard, they may pose serviceability issues. The current condition of the elevated Viewing Room represents an unsafe condition. Access to the Viewing Room below or walking on top of the elevated slab should be restricted. Given the condition of the elevated deck, we recommend locally removing and replacing the elevated slab and beam at the earliest.

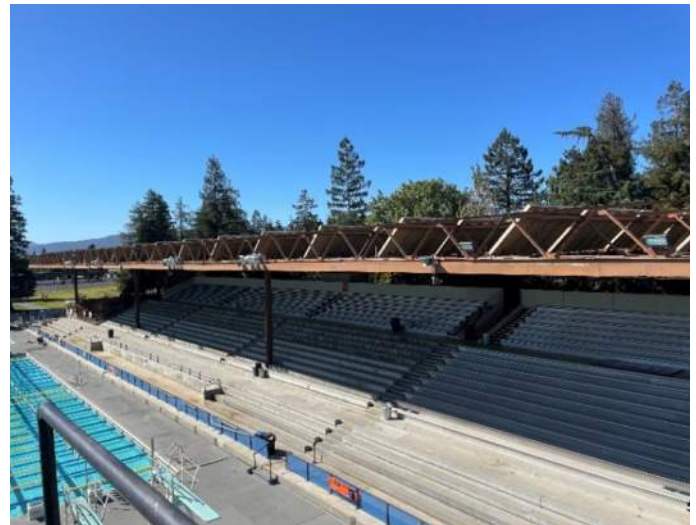
- Both concrete and metal stadium seats are present.

- The concrete slab and steps appear in fair condition, with moderate settlement cracking observed.

The construction of the stadium bleachers appears to be in fair condition structurally. However, we note that architecturally, there may be some concerns. The settlement of the concrete stair elements may constitute a trip hazard. If the hazard is deemed significant, the concrete steps and slabs should be removed, soil compacted, and replaced in kind.

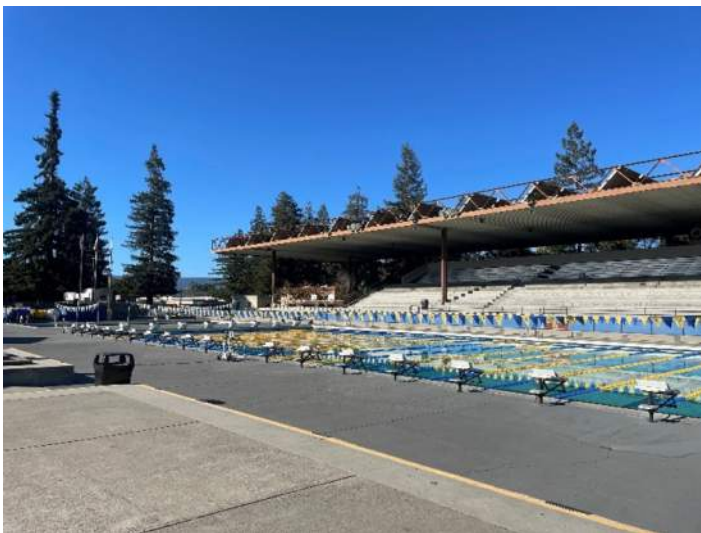
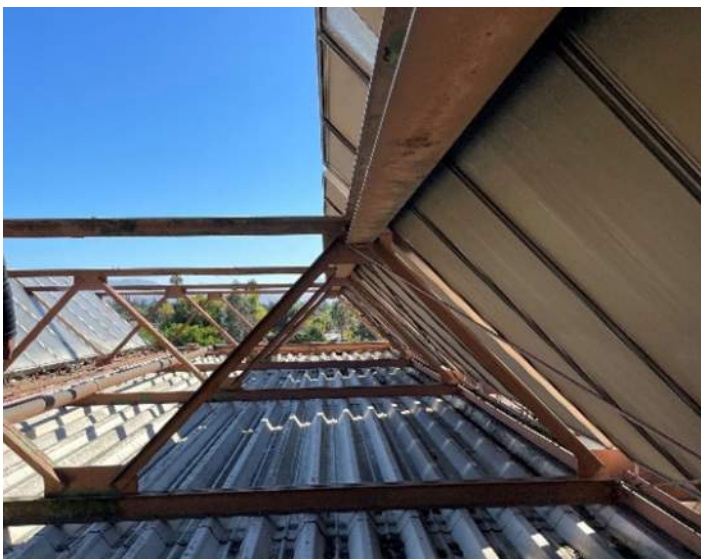
- The structural steel members appear to be in fair condition with minimal signs of local corrosion.

Annual visual observations of the structural steel elements should be performed to inspect for signs of corrosion or deterioration.

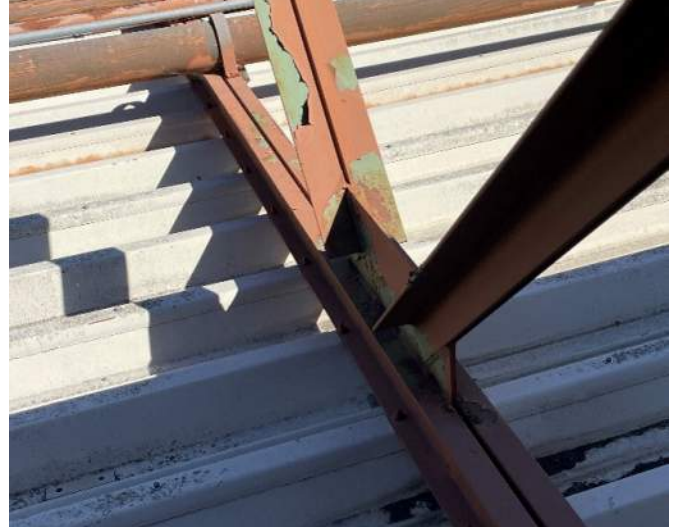
- The paint of the structural steel trusses is spalling at locations, however, we observed no corrosion of steel members observed.

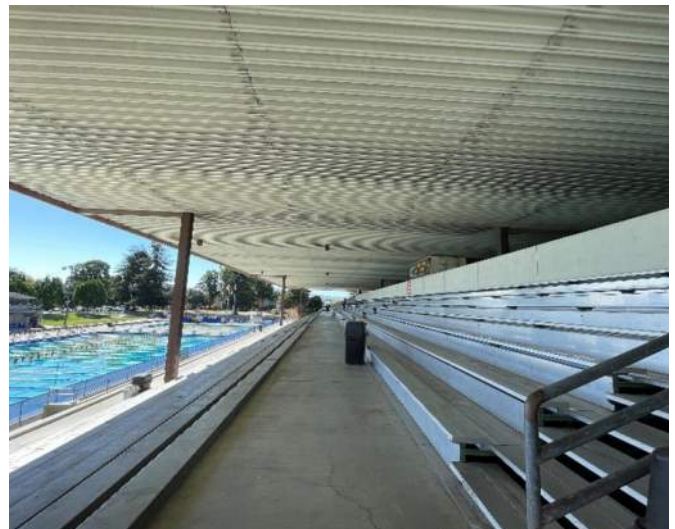
- The metal deck appears to be in fair condition.

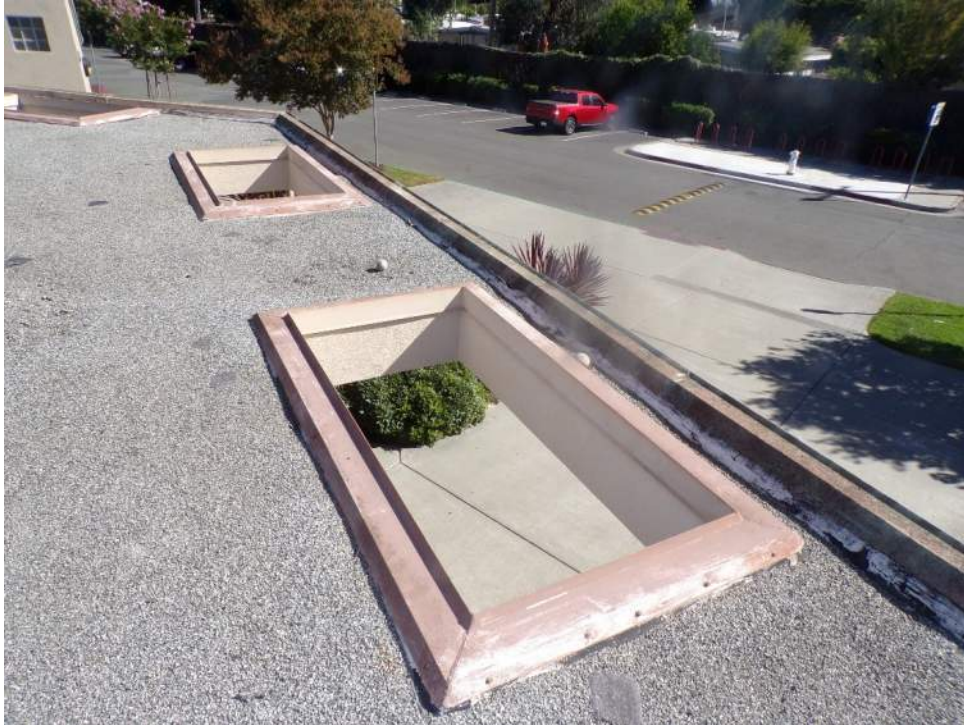
**Photo 1**

- The low-slope roof at Building A has 16 "skylight" openings with no cover, safety barrier, or safety markings. These unprotected roof openings pose a potential fall hazard to the ground level below (Appendix A, Photo 1) and violate the current Code: Section 3212 of the California Code of Regulations (CCR), Title 8 requires roof openings to be guarded by a cover or a guardrail on all sides of the roof opening. This safety hazard is exacerbated by the ease of roof-level access, where a single flight of stairs leads directly to the roof (Appendix A, Photo 2). There are no locked gates or restrictions to the roof level.

Unprotected roof openings pose a potential fall hazard to the ground level below.

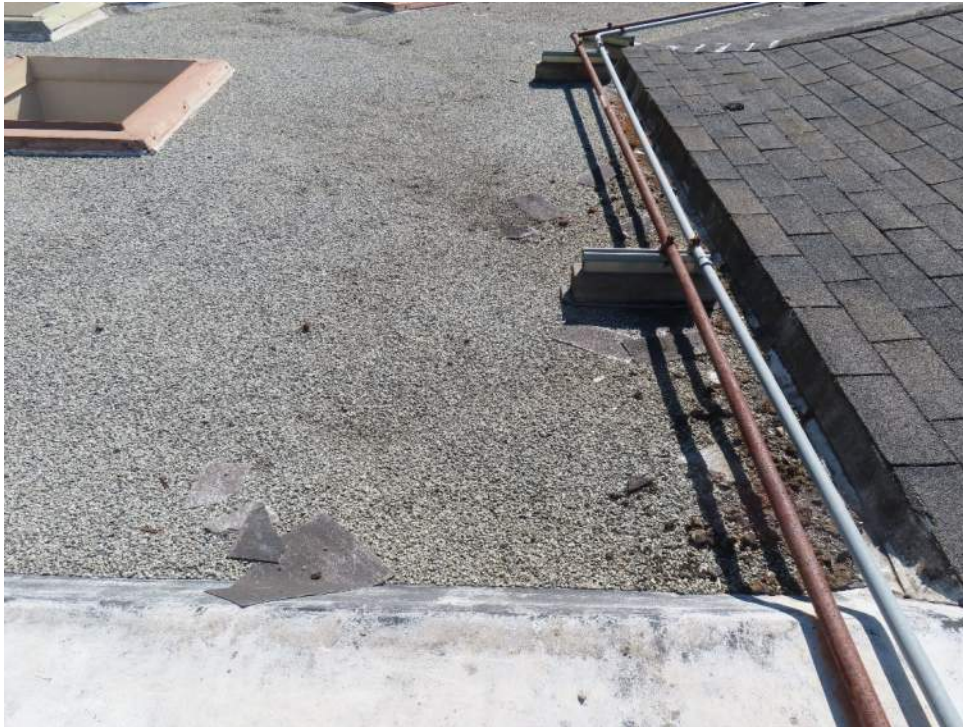
**Photo 3**

- Approximately 40% of the built-up roof exhibits signs of distress and inadequate drainage, such as bar spots and cracked plies and asphalt.
- Debris (e.g., dislodged asphalt shingles, swimming attire, wood crates) exists on the roof (Appendix A, Photo 3).

Building A  
Low slope roof

Debris (e.g., dislodged asphalt shingles, swimming attire, wood crates) exist on the roof.

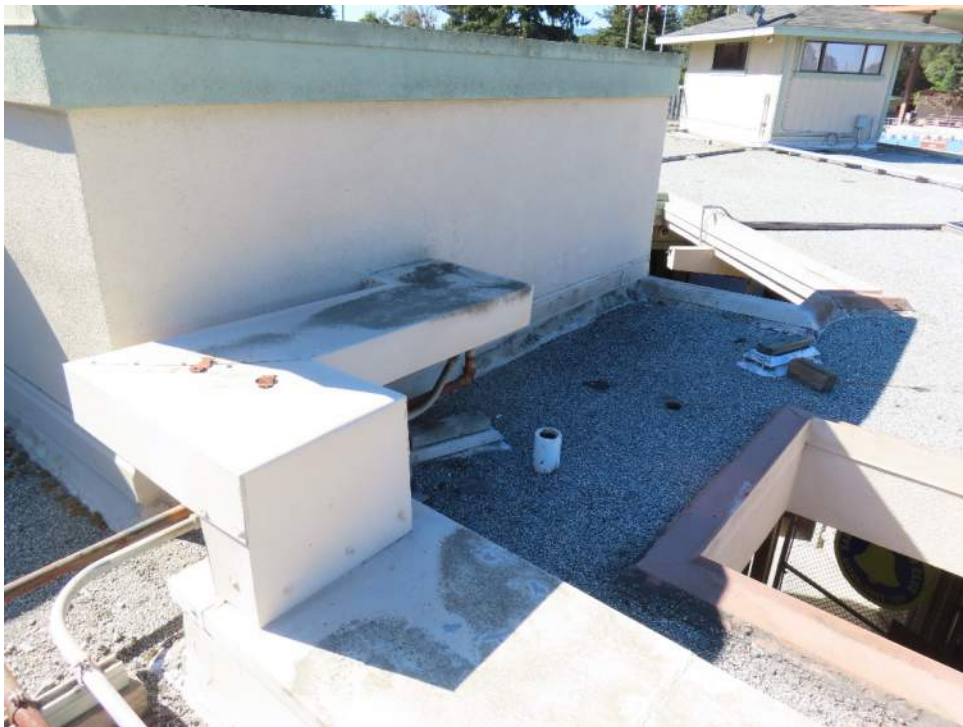
**Photo 4**

- Wide parapet caps and rooftop mechanical chutes exhibited oil canning (i.e., visible, wavy distortion that affects cold-rolled metal products) (Appendix A, Photo 4).

Rooftop mechanical ducts exhibit oil canning and stains from potential ponding water.

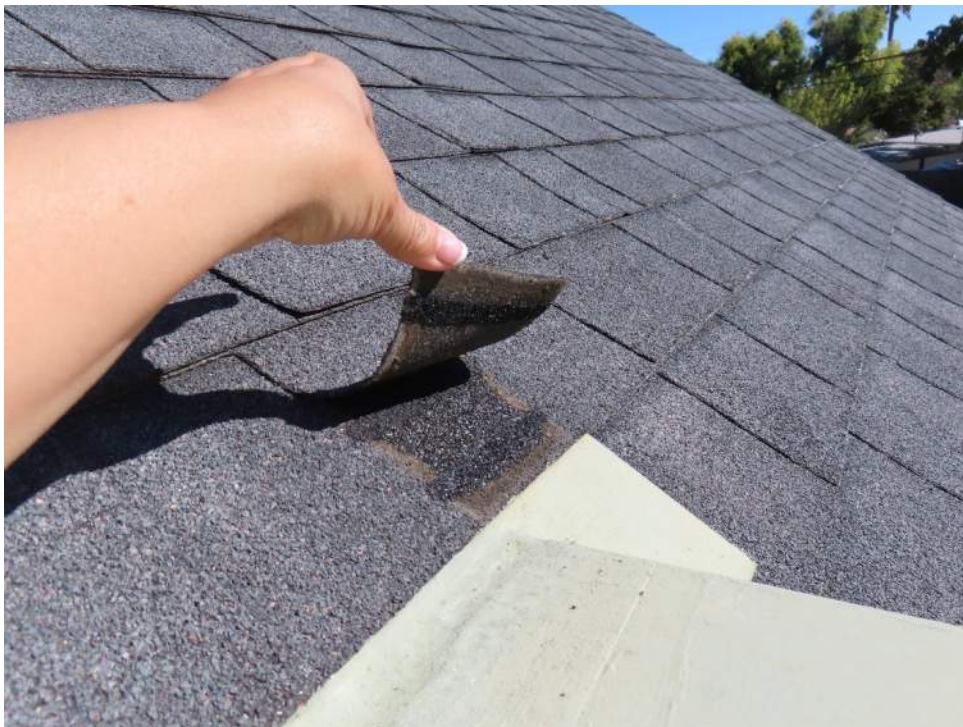
**Photo 6**

- Approximately 60-70% of the composite, asphalt shingles at the saw-tooth roofs are inadequately adhered and could be lifted with relative ease. These poorly adhered shingles occur along the rake edge and within the field of the roof (Appendix A, Photos 5 & 6). Algae growth exists on the downslope edges of asphalt shingles (Appendix A, Photos 7 & 8).

Building A  
Steep-slope roofs

Poorly adhered shingles occur along the rake edge and within the field of the roof.

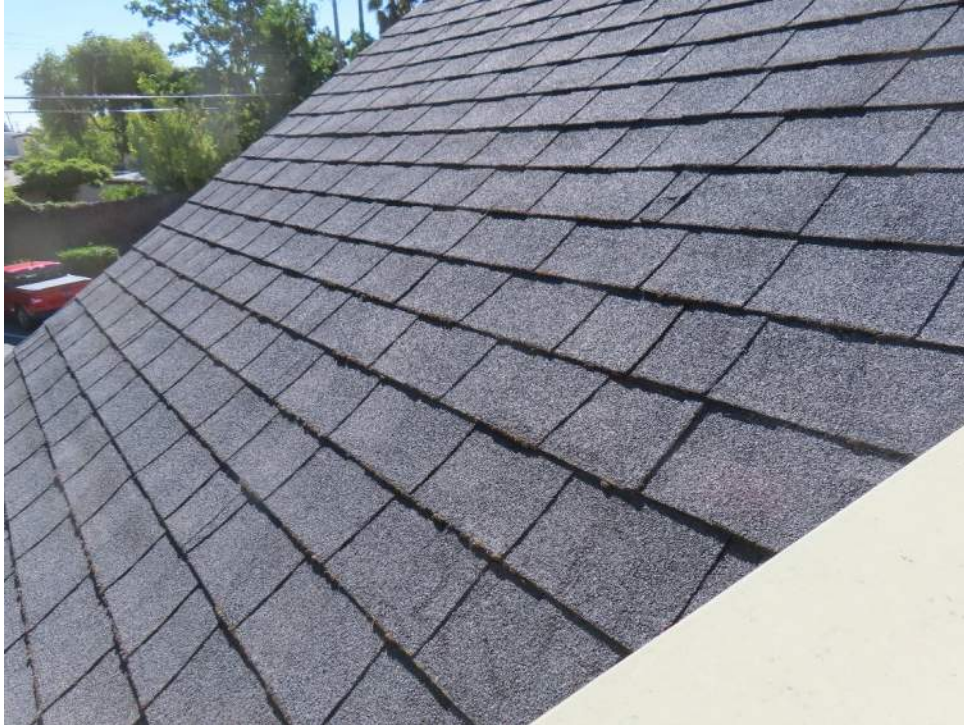
**Photo 7**

Building A  
Steep-slope roofs

Organic growth exists on the downslope edges of asphalt shingles - see Photo 8 for close up.

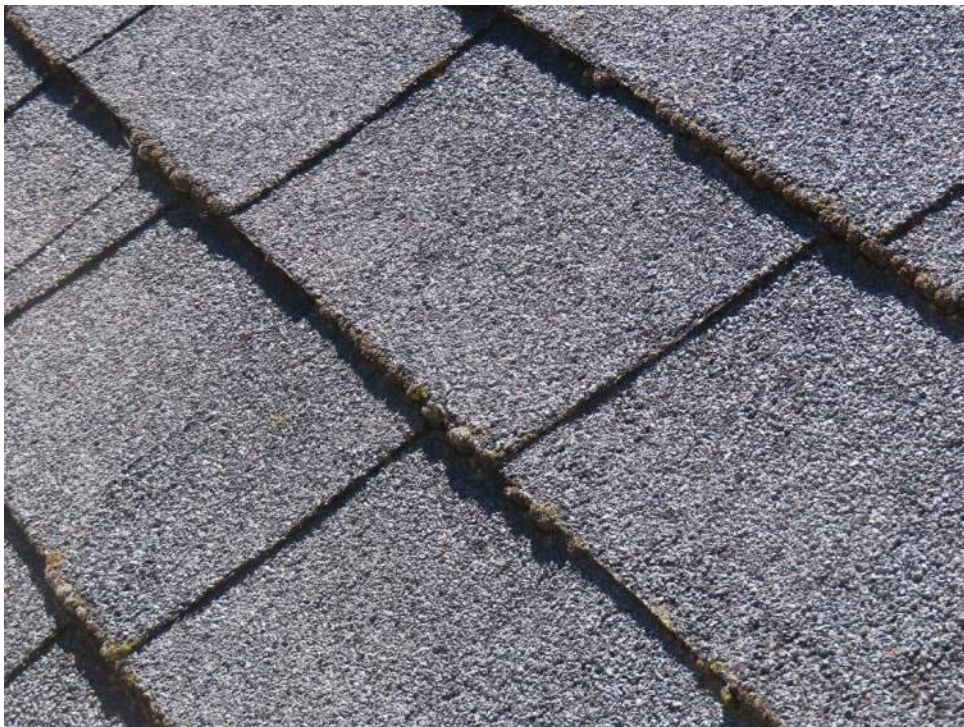
**Photo 8**

Building A  
Steep-slope roofs

Algae growth exists on the downslope edges of asphalt shingles.

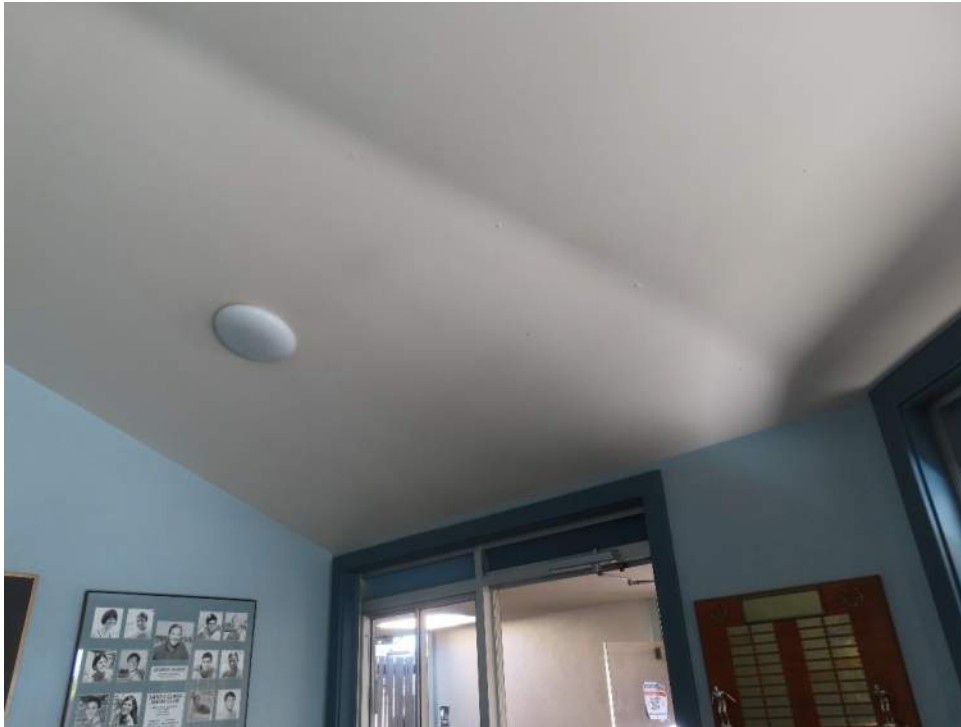
**Photo 9**

- Approximately 70% of the asphalt shingles we checked at the octagonal, steep slope roof are dislodged or inadequately adhered. Most of the asphalt shingles on the hips are dislodged, missing, or have significant granular and • The missing shingles on the hips align with the ceiling cracks, nail pops, and bubbling in the gypsum wallboard below (Appendix A, Photos 9 & 10).

Missing shingles on the roof hips align with the ceiling crack, nail pops, and bubbling in the gypsum wallboard.

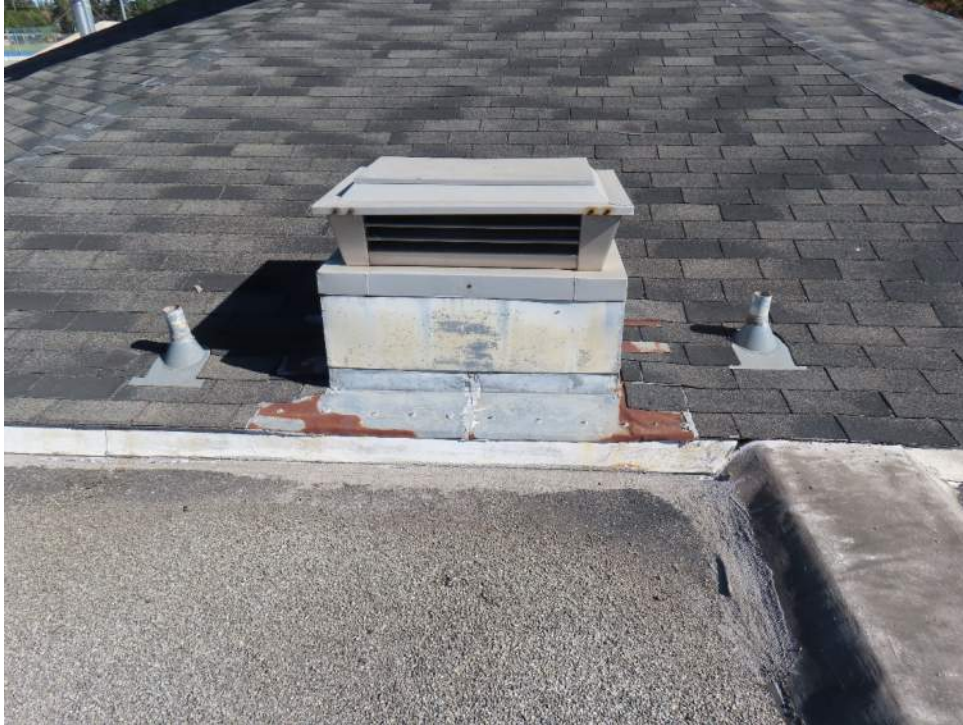
**Photo 11**

Sheet metal flashings, rooftop mechanical equipment, and other metal roof components exhibit moderate to severe corrosion.

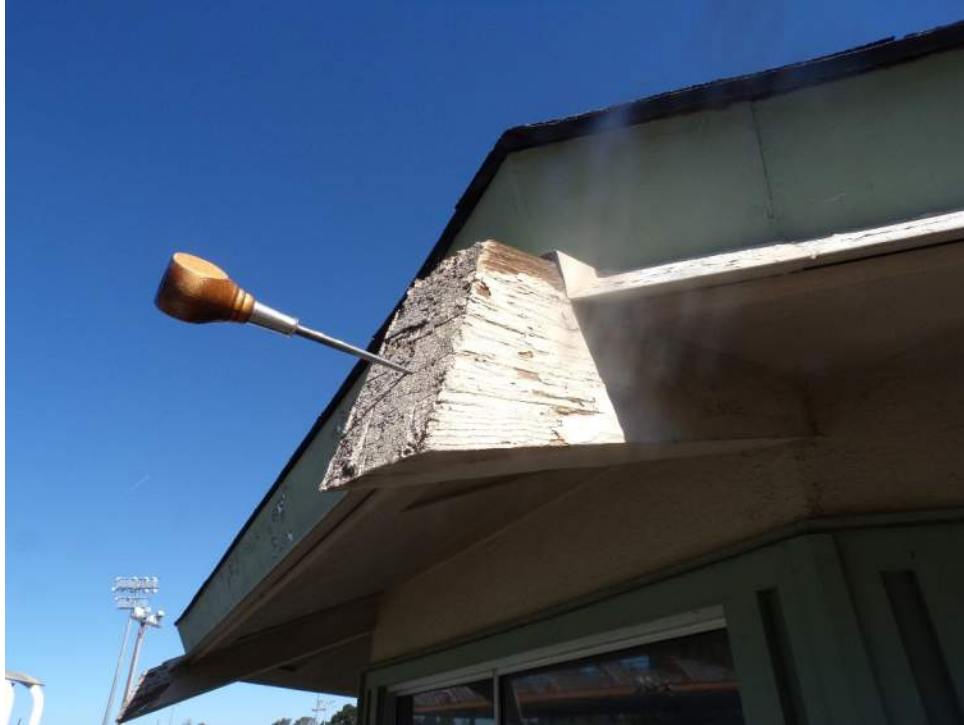
**Photo 15**

Significant wood decay at the exposed ends of common and hip rafters.

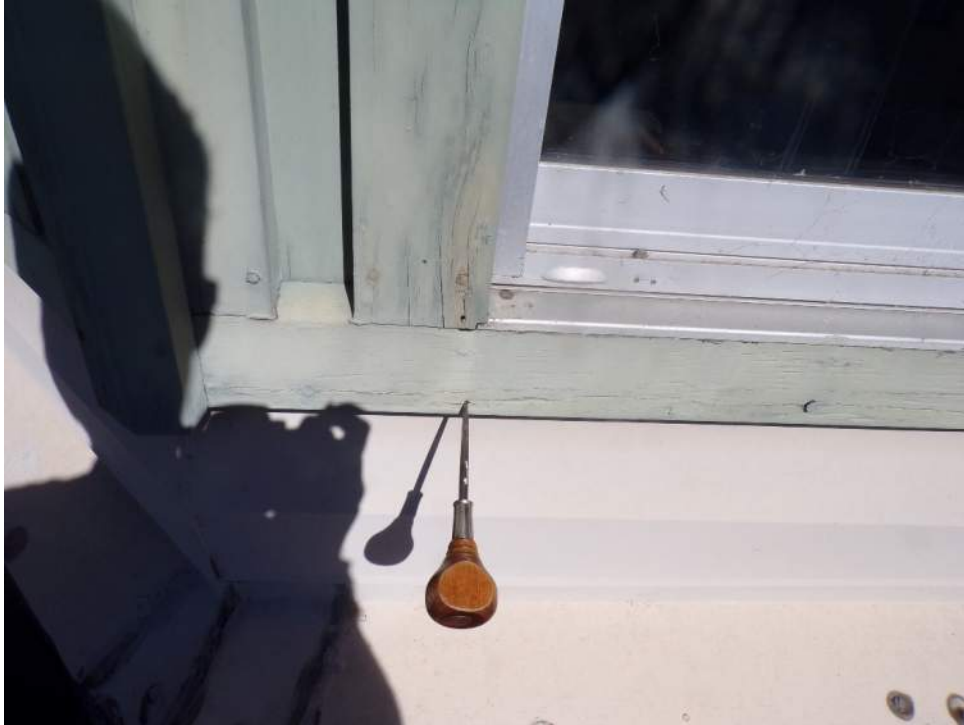
**Photo 19**

Significant wood decay exists at exterior window trim.

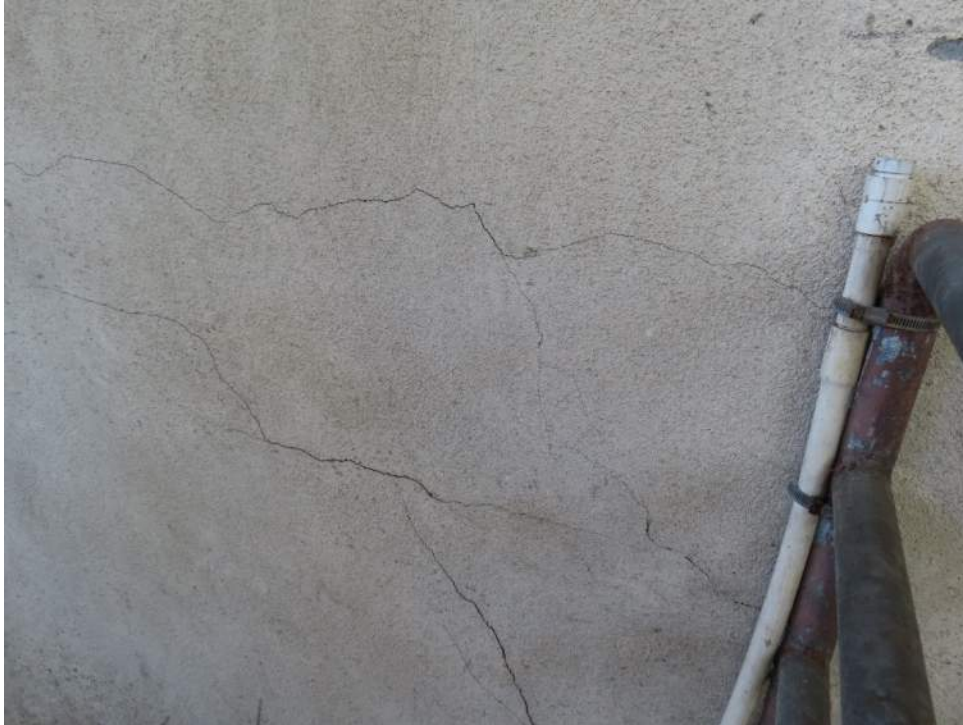
**Photo 23**

- The soil erosion behind the canopy bleachers and around the canopy tower has caused vertical offsets in the concrete walkway, excessive stucco cracks at the canopy bleacher walls (Appendix A, Photo 23) and shifted the walkway and the roof deck downspouts (Appendix A, Photo 24).
- The weep screed abuts the concrete flatwork (Appendix A, Photo 25) or is less than 4 in. from grade (Appendix A, Photo 26). Section 2512.1.2 of the 2022 CBC requires a 2 in. clearance between a weep screed and hardscape and a 4 in. clearance between a weep screed and grade. The current condition violates the code.

Extensive, relatively wide cracks exist in the stucco-clad bleacher walls.

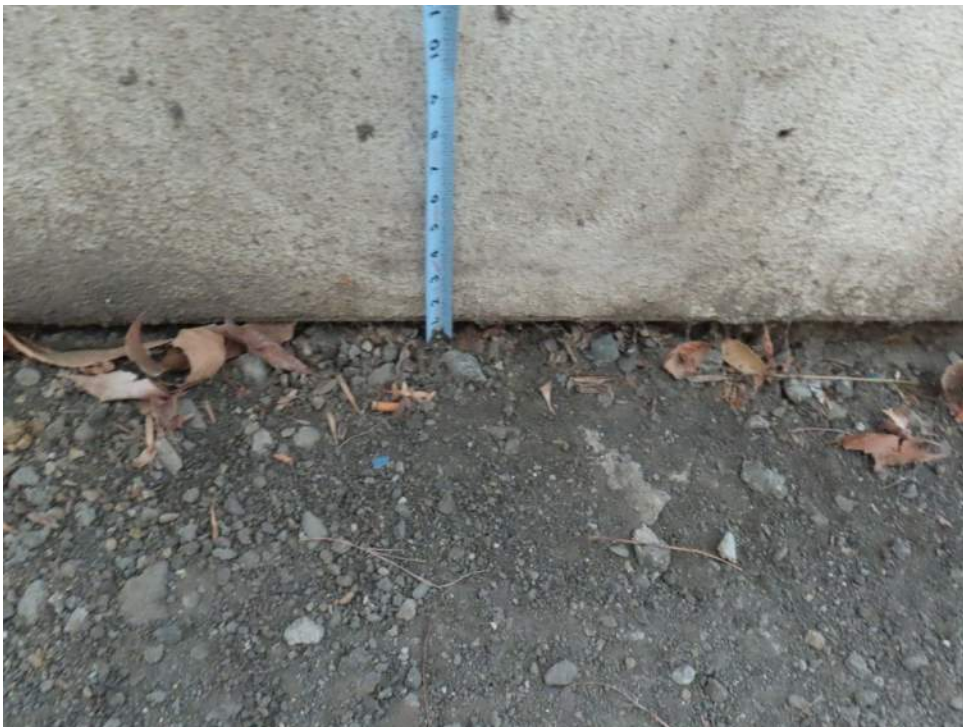
**Photo 26**

**Building D**

The stucco wall weep screed is less than 1 in. above grade.

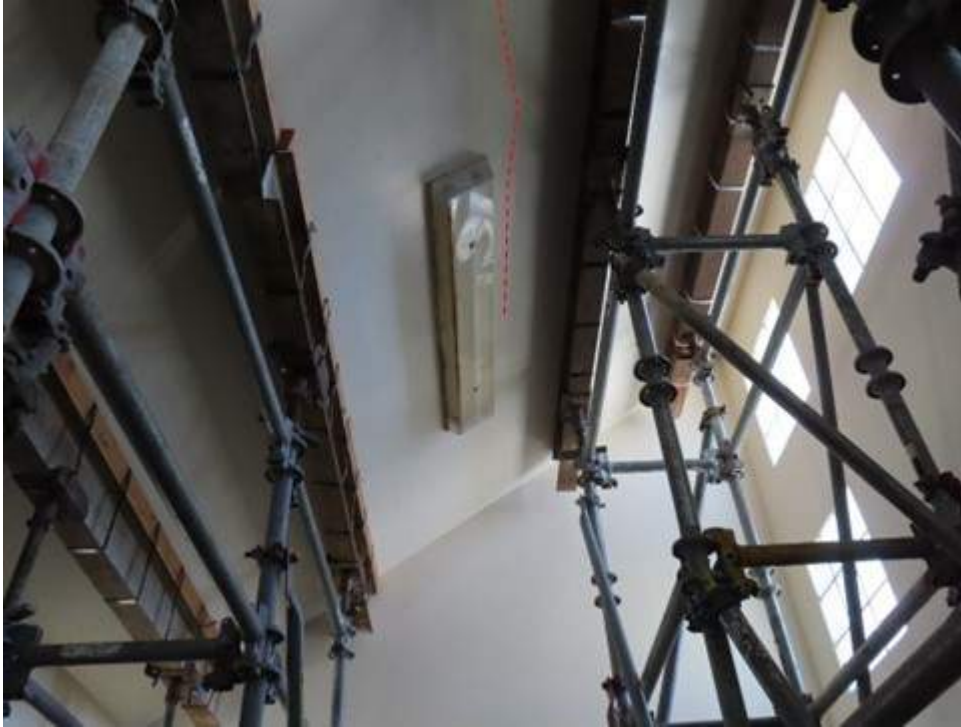
**Photo 27**

- Sizeable cracks in the ceiling and wall finishes (Appendix A, Photos 27 & 28) and cracks and gaps within the tile assembly particularly at inside wall corners and at tile ledges (Appendix A, Photo 29). The location and pattern of cracking indicate wall movement.
- Water stains and chipped paint exist on the non-

Sizeable cracks exist in the plaster ceiling and wall finishes. The location and pattern of cracking indicate wall movement.

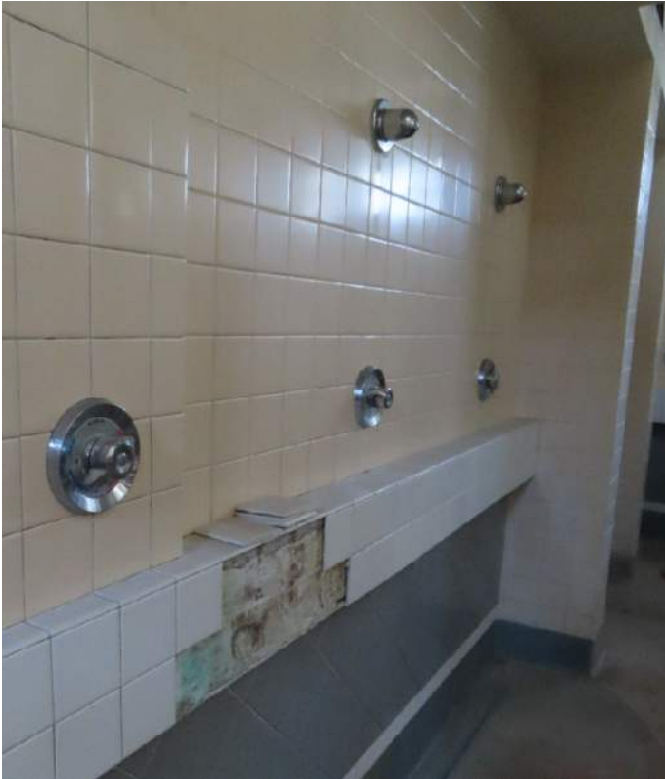
Debonded ceramic tiles exist on the small shelf below the shower valves and heads. The mortar bed under the debonded tiles is discolored and discontinuous.

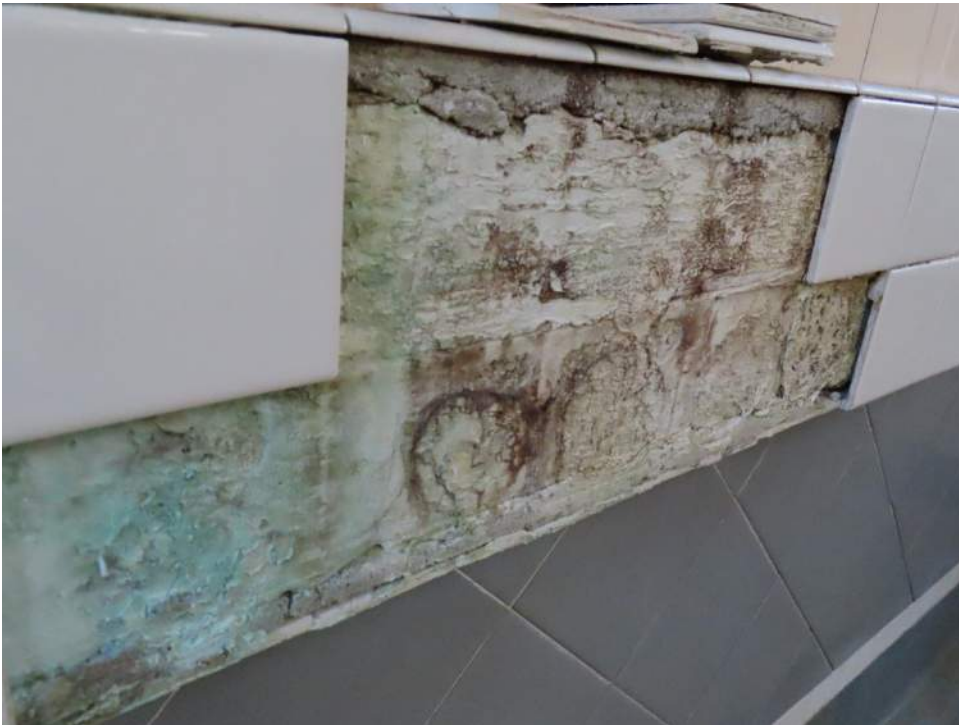
**Photo 34**

Building A  
Shower facilities

Debonded ceramic tiles expose the underlying discolored and discontinuous mortar bed.

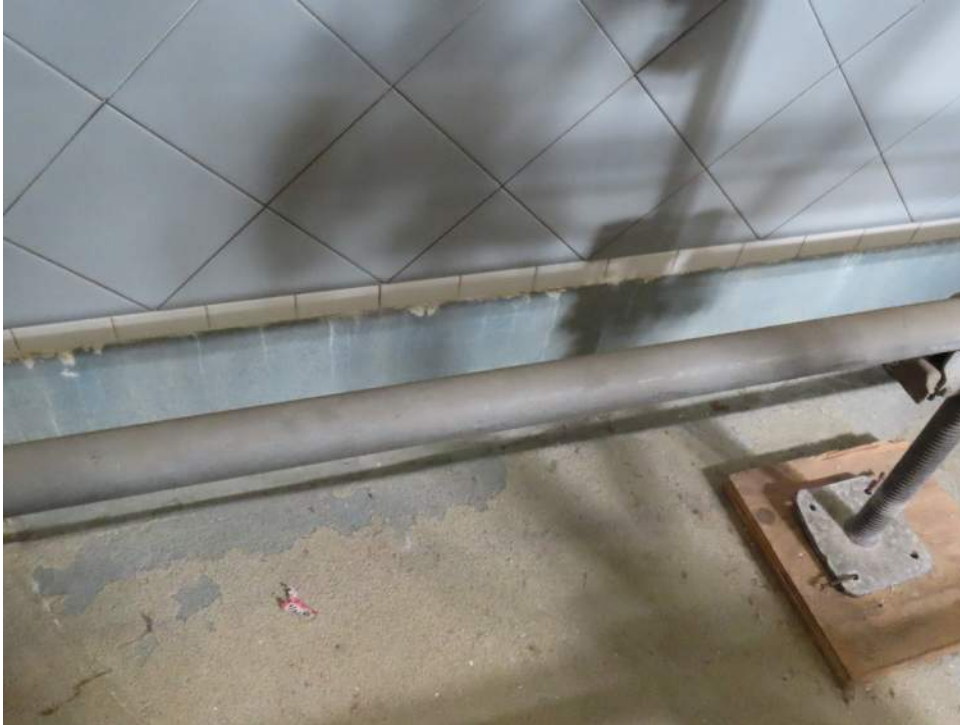
**Photo 35**

- Debonded ceramic tiles expose a discolored and discontinuous mortar bed (Appendix A, Photos 33 & 34)
- Pronounced efflorescence and discolored residue exist along the base of the tile walls, around shower escutcheon plates, and at tile grout lines (Appendix A, Photos 35, 36 & 37) indicative of water leakage through the tile assembly.
- At an interior wall opening, we observed ceramic tile over a mortar bed over expanded wire lath over 2 layers of grade D building paper. It appears that these two layers of building paper were installed as the shower membrane. Current shower wall standards require a waterproofing membrane inside the shower area extending the full height of the tile assembly and water vapor management.

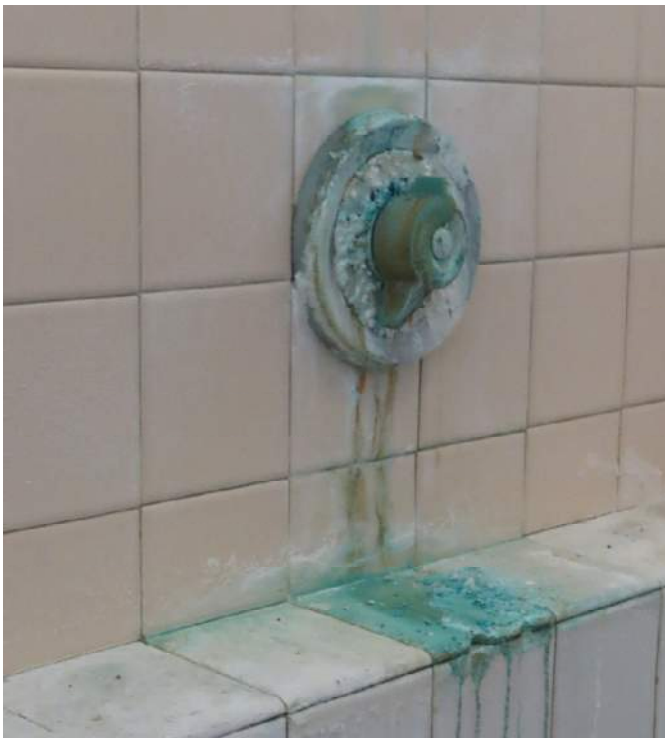
**Photo 36**

Building A  
Shower facility

Pronounced efflorescence and green residue exist around shower control escutcheon plates.

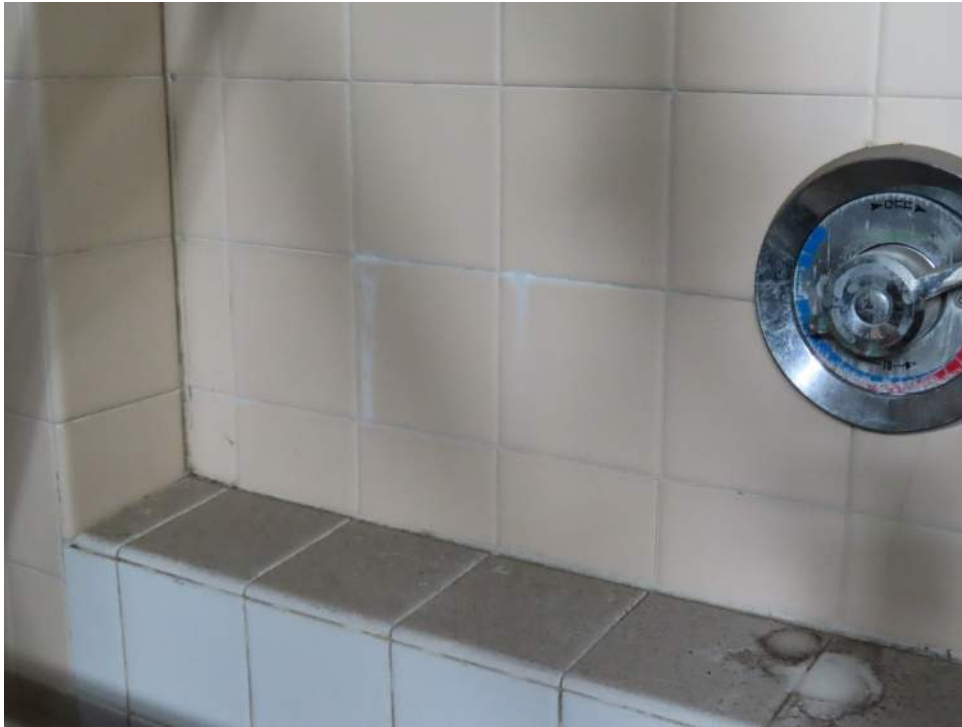
**Photo 37**

Building A  
Shower facility

Efflorescence and  
gray/white residue exist on  
the tile grout and tiles.
