Home Inspection Report

1226 Jackson Street, Santa Clara

Luis Sevilla
April 4, 2018

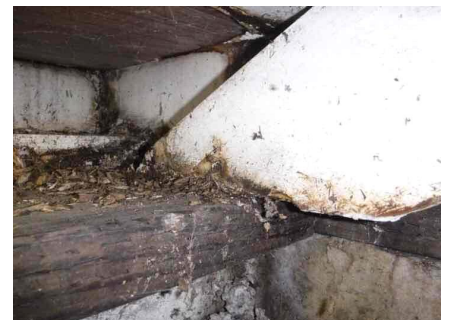
Photo 34

- ! 2. The wood members at the crawl space under the front stairs and front left area show evidence of water damage. We recommend the services of a licensed structural pest control operator for investigation of this condition. (See Photo 34)

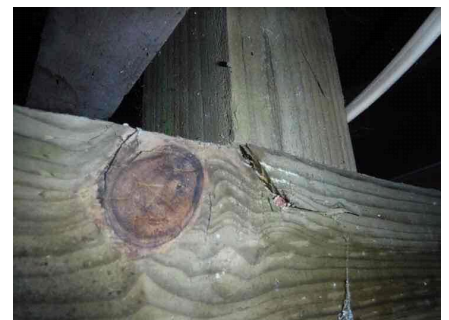
Photo 31

1. Foundation cracking and/or movement was observed at the foundation walls in the basement. The rate of movement cannot be predicted during a one-time inspection. A thorough evaluation of this condition is beyond our qualifications. For additional information we recommend a licensed foundation specialist be retained. (See Photo 12)
2. The wood members at the crawl space under the front stairs and front left area show evidence of water damage. We recommend the services of a licensed structural pest control operator for investigation of this condition. (See Photo 34)
3. One or more beams are damaged or cracked at the crawl space. We recommend repair or replacement, in accordance with present standards. It is recommended that a qualified licensed contractor be consulted for these repairs (See Photo 31)

- ! 3. One or more beams are damaged or cracked at the crawl space. We recommend repair or replacement, in accordance with present standards. It is recommended that a qualified licensed contractor be consulted for these repairs (See Photo 31)

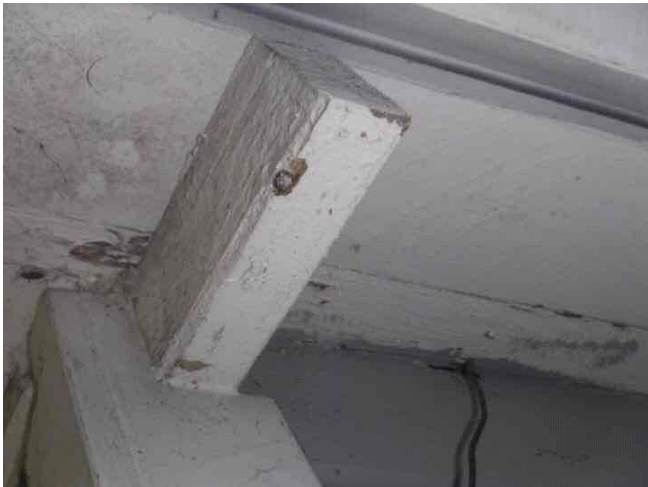
Photo 25

13. Water damage was observed to the rafters at the rear garage structure. We recommend the services of a licensed general contractor and/or structural pest control company. (See Photo 25)

- ! 4. Cracked or broken exterior window glass at the rear should be replaced. (See Photo 8)
- ! 5. Water damage was observed to the rafters at the rear garage structure. We recommend the services of a licensed general contractor and/or structural pest control company. (See Photo 25)

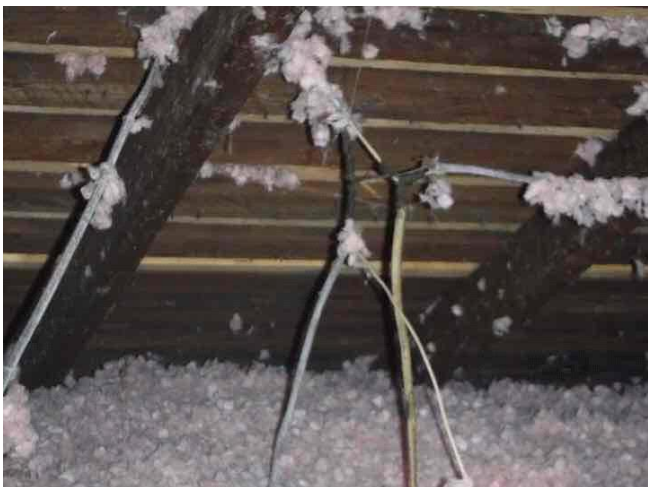
Photo 29

22. Running splices, which are improper connections outside of a junction box, were observed in the attic and crawlspace. We recommend connections be joined with approved connectors inside a junction box to prevent accidental contacts or mechanical damage. (See Photo 29)

- ! 1. Running splices, which are improper connections outside of a junction box, were observed in the attic and crawlspace. We recommend connections be joined with approved connectors inside a junction box to prevent accidental contacts or mechanical damage. (See Photo 29)

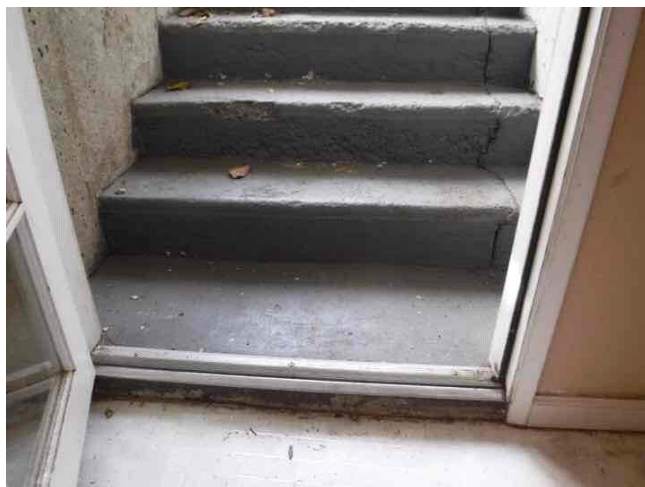
Photo 38

19. The steps at the rear appear to be non-conforming. This could create a potential fall hazard. We recommend the services of a licensed general contractor. (See Illustration 3R) (See Photo 38)

- ! 9. The missing trim at the right should be replaced and caulked. (See Photo 5)
- ! 10. The steps at the rear appear to be non-conforming. This could create a potential fall hazard. We recommend the services of a licensed general contractor. (See Illustration 3R) (See Photo 38)
