Facility Condition Assessment Report

Machado Park

City of Santa Clara, California

FINAL DRAFT
January 31, 2018

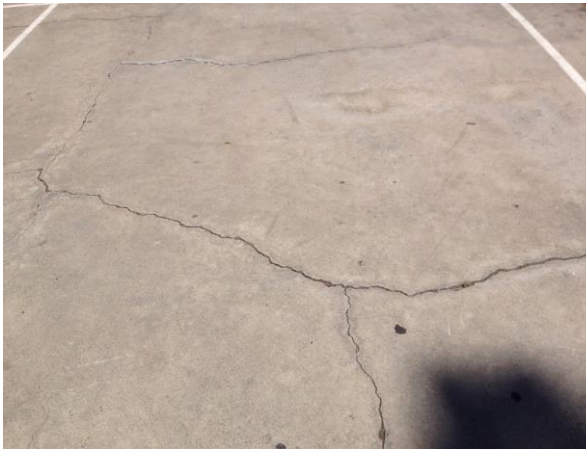
Asset Assigned Common Name (if applicable): Sports Court 01
Area/Floor (if applicable): Grounds
Asset ID: CSC002312
Asset Category (if applicable): Sports Courts
Quantity/Unit of Measure: 2900 / SF
Estimate: \$72,731
(Escalated to Priority Year)
Priority Year Description: 03 - Address deficiency or Capital Requirement in Year 03
Deficiency Description: Concrete court shows evidence of damage.
Description of Work: Replace concrete court.
Comment:

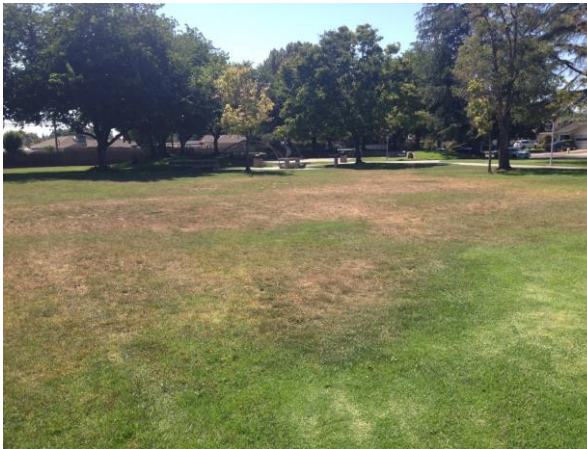
Asset Assigned Common Name (if applicable): Landscaping 01
Area/Floor (if applicable): Grounds
Asset ID: CSC002311
Asset Category (if applicable): Landscaping
Quantity/Unit of Measure: 1500 / SF
Estimate: \$4,436
(Escalated to Priority Year)
Priority Year Description: 01 - Address deficiency or Capital Requirement in Year 01
Deficiency Description: *Natural turf areas show evidence of damage.*
Description of Work: *Repair natural turf areas.*
Comment:

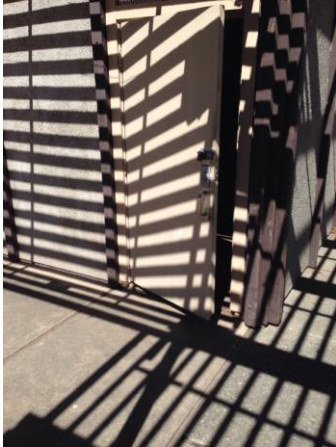
Asset Assigned Common Name (if applicable): Building 01

Comment: Store door and hardware.

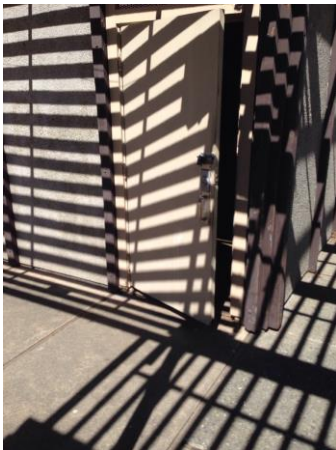
Asset Assigned Common Name (if applicable): Building 01

Comment: Electrical door and hardware.

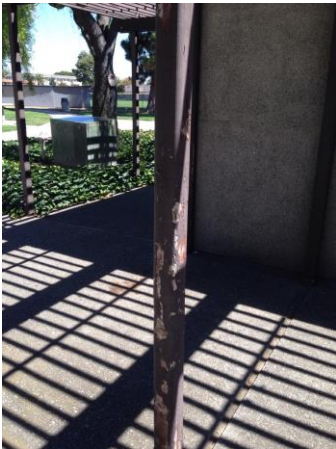
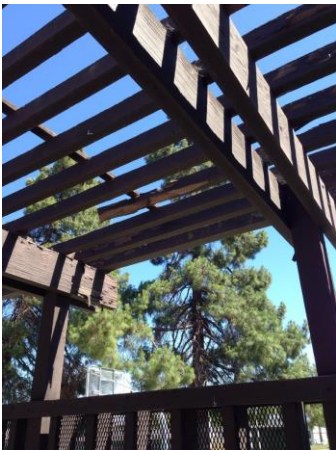
- The wood trellis is in need of replacement.
- The patio concrete is cracking and is in need of replacement.
- The interior casework is in need of replacement.

Asset Assigned Common Name (if applicable):	Building 01
Area/Floor (if applicable):	Exterior Trellis / 1
Asset ID:	CSC003482
Asset Category (if applicable):	Building
Quantity/Unit of Measure:	3403 / SF
Estimate: (Escalated to Priority Year)	\$294,055
Priority Year Description:	05 - Address deficiency or Capital Requirement in Year 05
Deficiency Description:	Existing 4x4 wood post and 2x8 beam trellis has deteriorated.
Description of Work:	Demolish existing wood trellis and replace with similar structure.
Comment:	Deteriorating wood trellis.

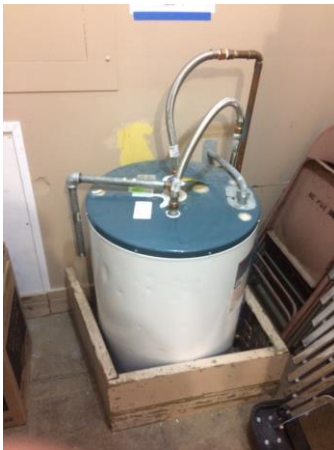
Asset Assigned Common Name (if applicable): EWH

Comment: 30-gallon storage.
