Subject: Secretary of the Interior's Standards Analysis, 1184 Washington Street, Santa Clara, CA

Introduction

Brewster Historic Preservation has been engaged to prepare a Secretary of Interior's Standards (SIS) analysis for proposed alterations to an historic property at 1184 Washington Street in Santa Clara. Located in Santa Clara's Old Quad neighborhood, the property is occupied by the historic Calvin Russell House, a Gothic Revival Style residence built circa 1861.¹ This exceptionally rare property is on the City's list of historic properties and is listed on the California Register of Historic Resources (CRHR) with a status code rating of '3S' meaning it 'appears eligible individually eligible for the National Register of Historic Places through survey evaluation.' The property was most recently evaluated in 2021 by architectural historian, William Kostura, who confirmed its local and state historic significance.²

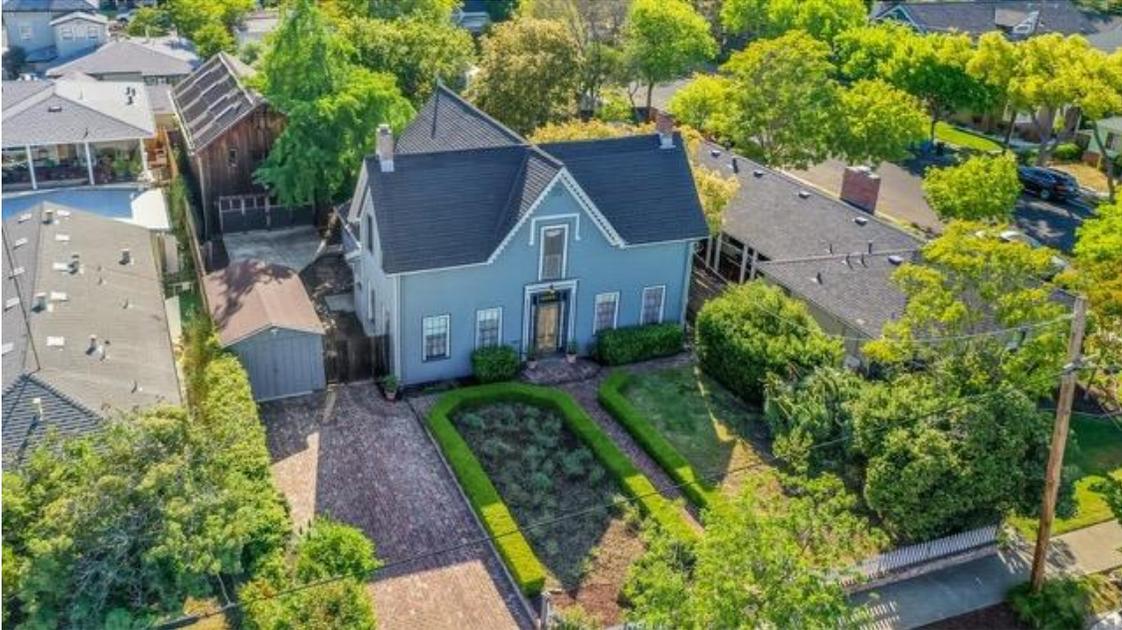
Aerial view of 1184 Washington Street – east (front) elevation looking generally west

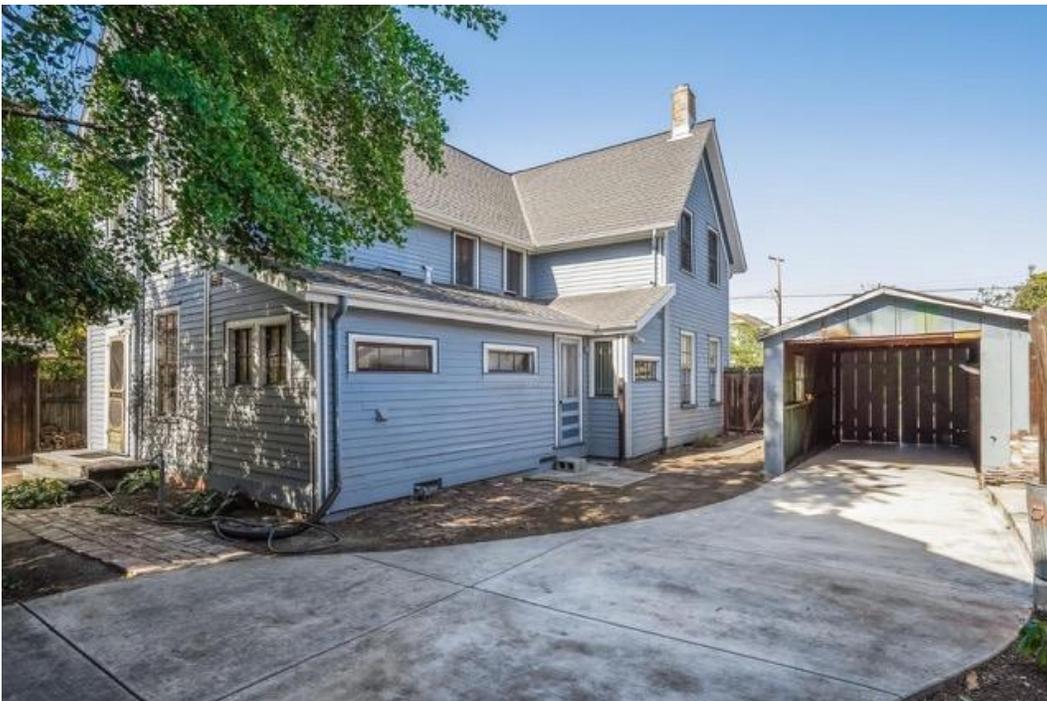
1184 Washington Street – south (side) and partial west (rear) elevations looking generally northeast

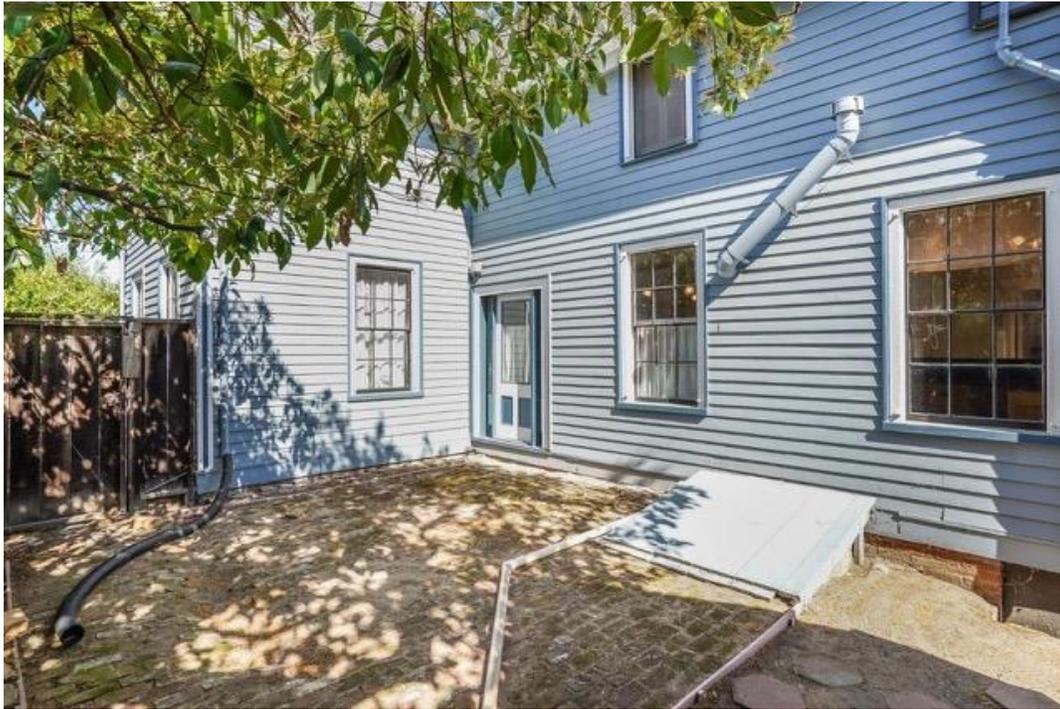
1184 Washington Street – partial north (side) and west (rear) elevations looking generally southeast

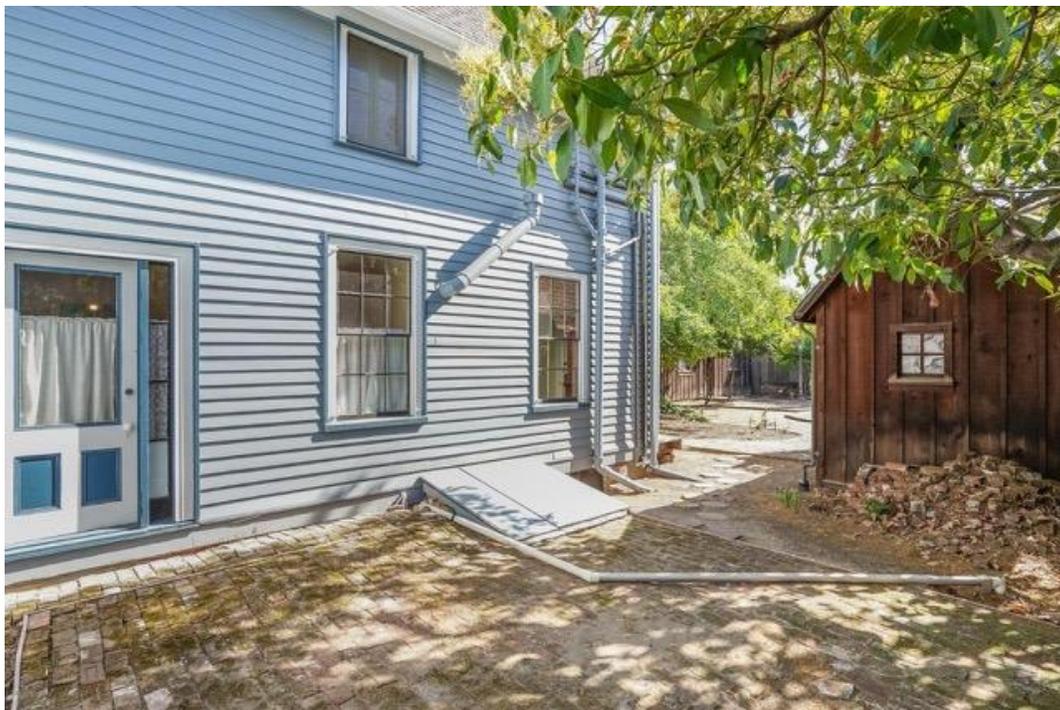
1184 Washington Street – partial north (side) elevation looking generally southwest

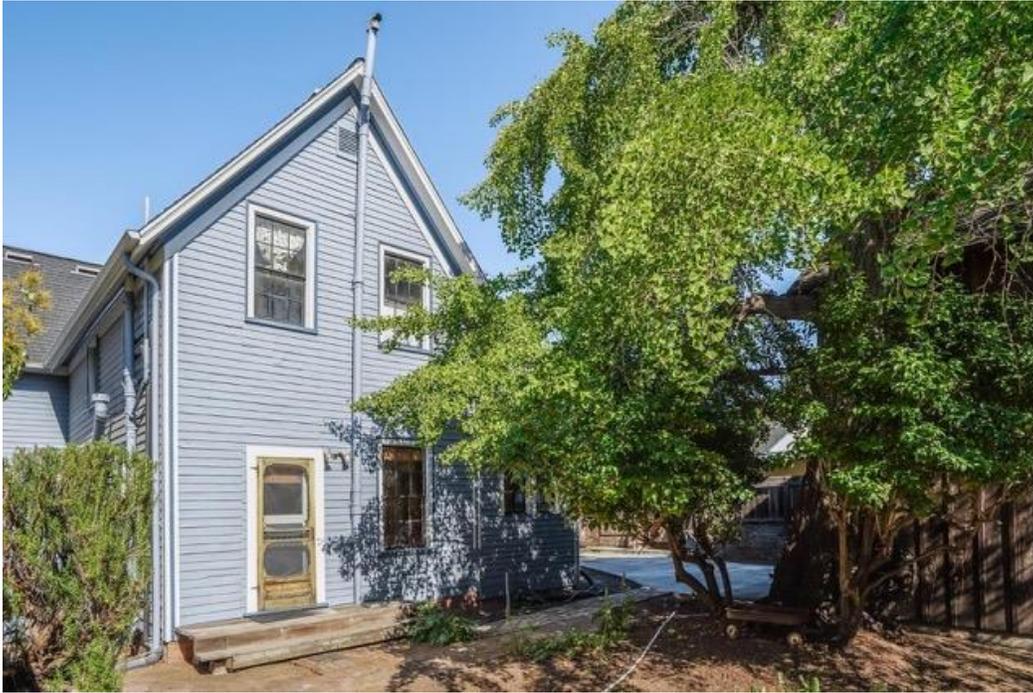
1184 Washington Street – partial west (rear) elevation looking generally east

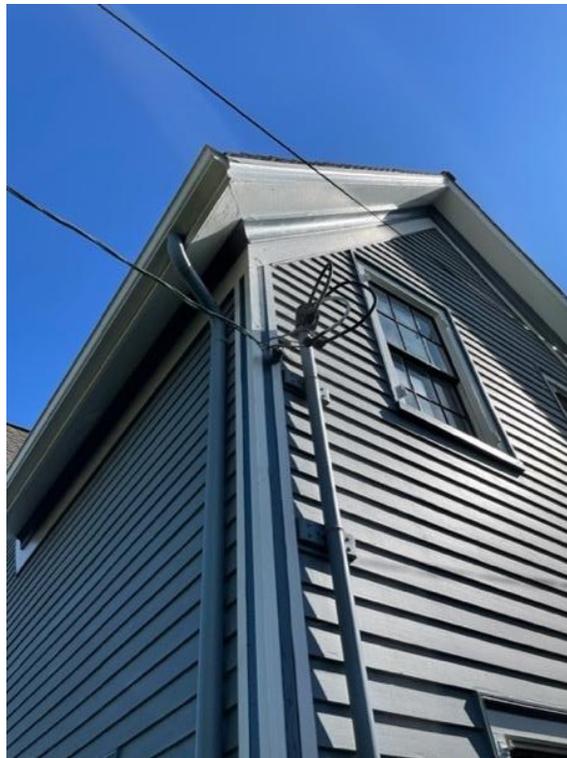
1184 Washington Street – detail of partial west (rear) and north (side) elevations looking southeast
