RE 820 Civic Center Drive, Clara- Review of Changes to Approved

Plans- Garage/carport and bathroom addition,

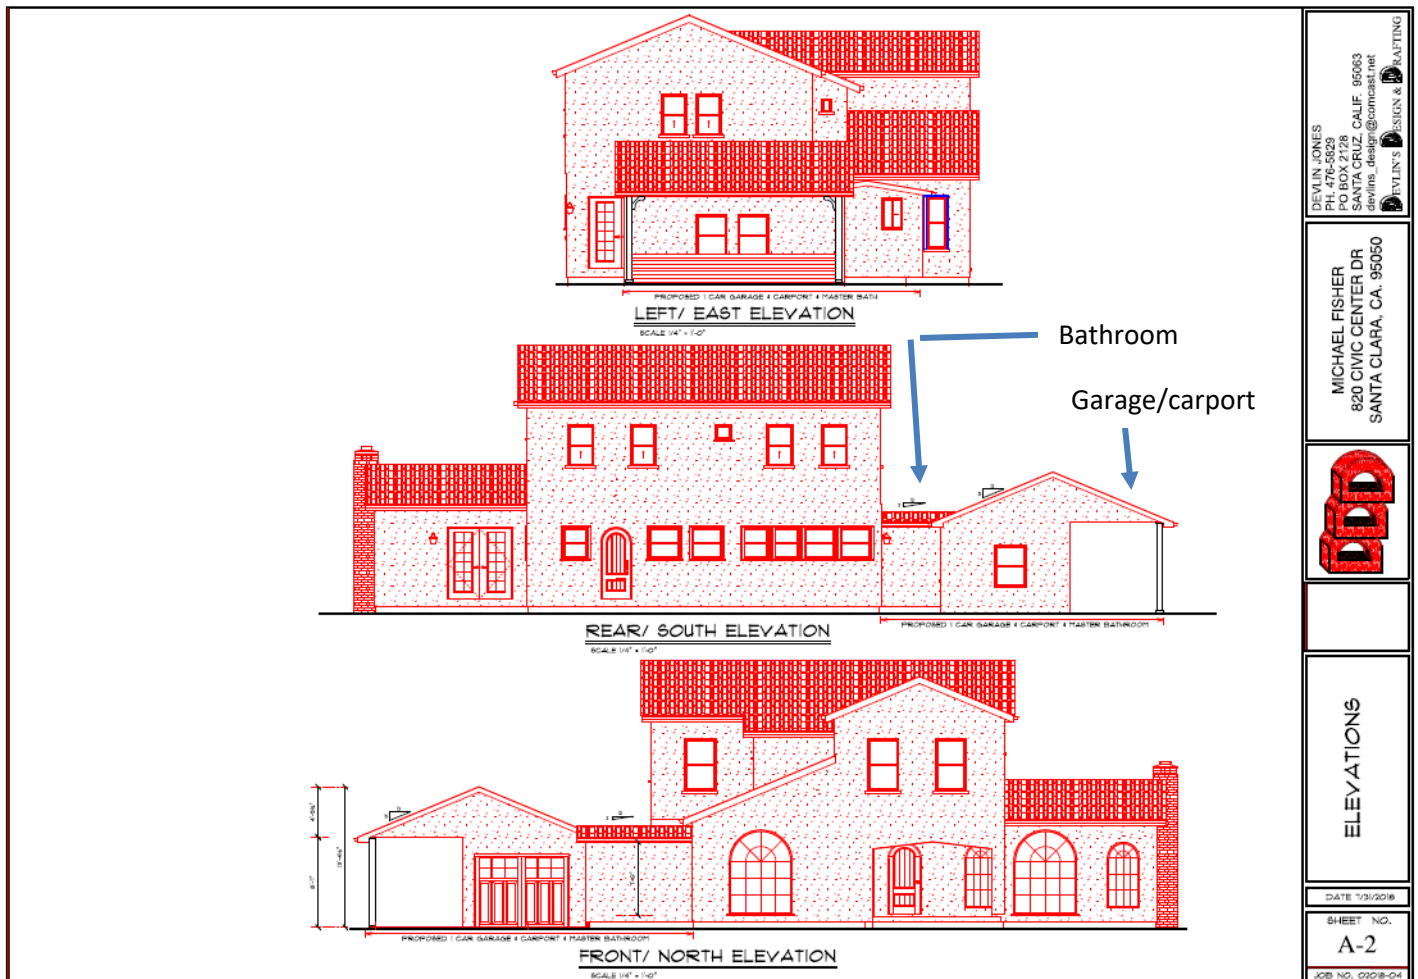
**Figure 2 : Sheet of elevations showing the proposed bathroom addition and the new garage and carport. From the side the garage will screen the lower portion of the house. From the rear, the house is not visible and the new garage/carport will be only slightly visible from Alviso St. From the front the garage/carport is seen set back from the house as a separate structure. The bathroom set back from the front façade of the historic house and is attached to the historic house. This is a minor addition, on a secondary façade and will be covered with plain stucco and roof tiles that are similar to the historic building. The small addition is designed to be compatible with the front view of the historic house.**

**East Façade** Changes are proposed for the east side façade- a secondary façade. However, the new garage building and addition will be seen from the front of the property as well as the side. Therefore, the addition and new garage must be considered for the change they make to the views of the front facade. The 100 sq. ft. addition is also considered for its impact to the historic building and its structure.

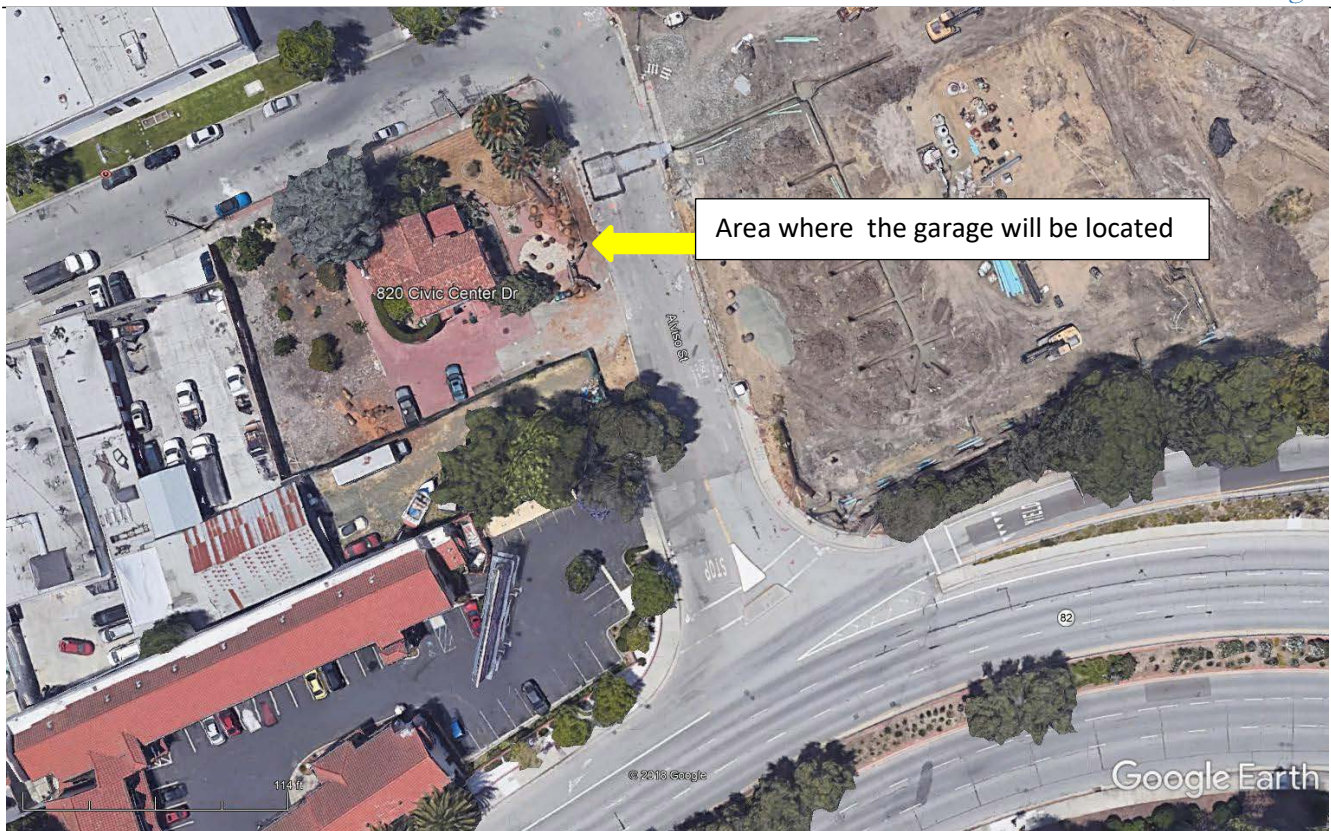
**Figure 820 Civic Center Drive**

**View: This aerial map shows the side of the house where the proposed garage will be constructed.**

The garage/carport is a new structure and not attached to the historic building. The proposed new structure does not remove or diminish the character defining- features of the historic building or site. The side yard proposed for the garage is a work area with deteriorated concrete and gravel. These are not character-defining features of the property.

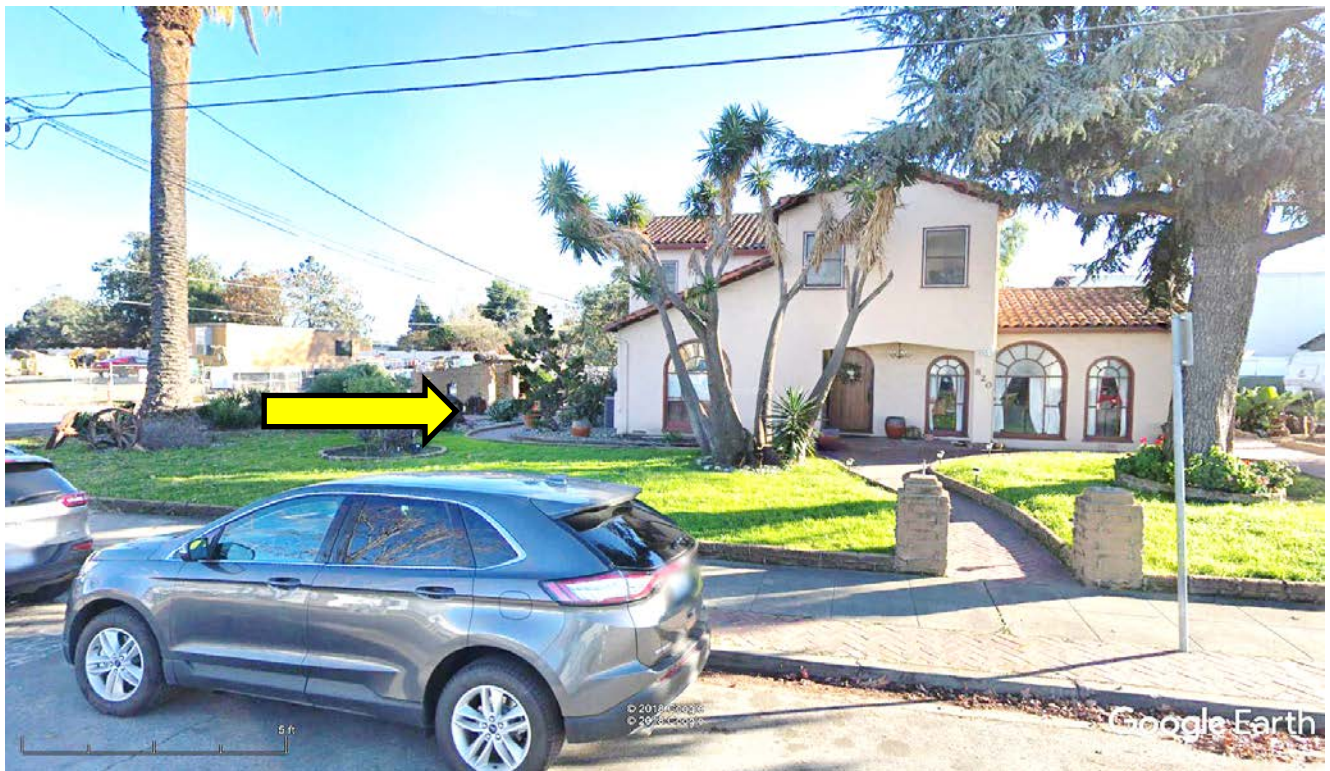
**Front View of the Historic House. Arrow points to the location for the new garage and bathroom.**

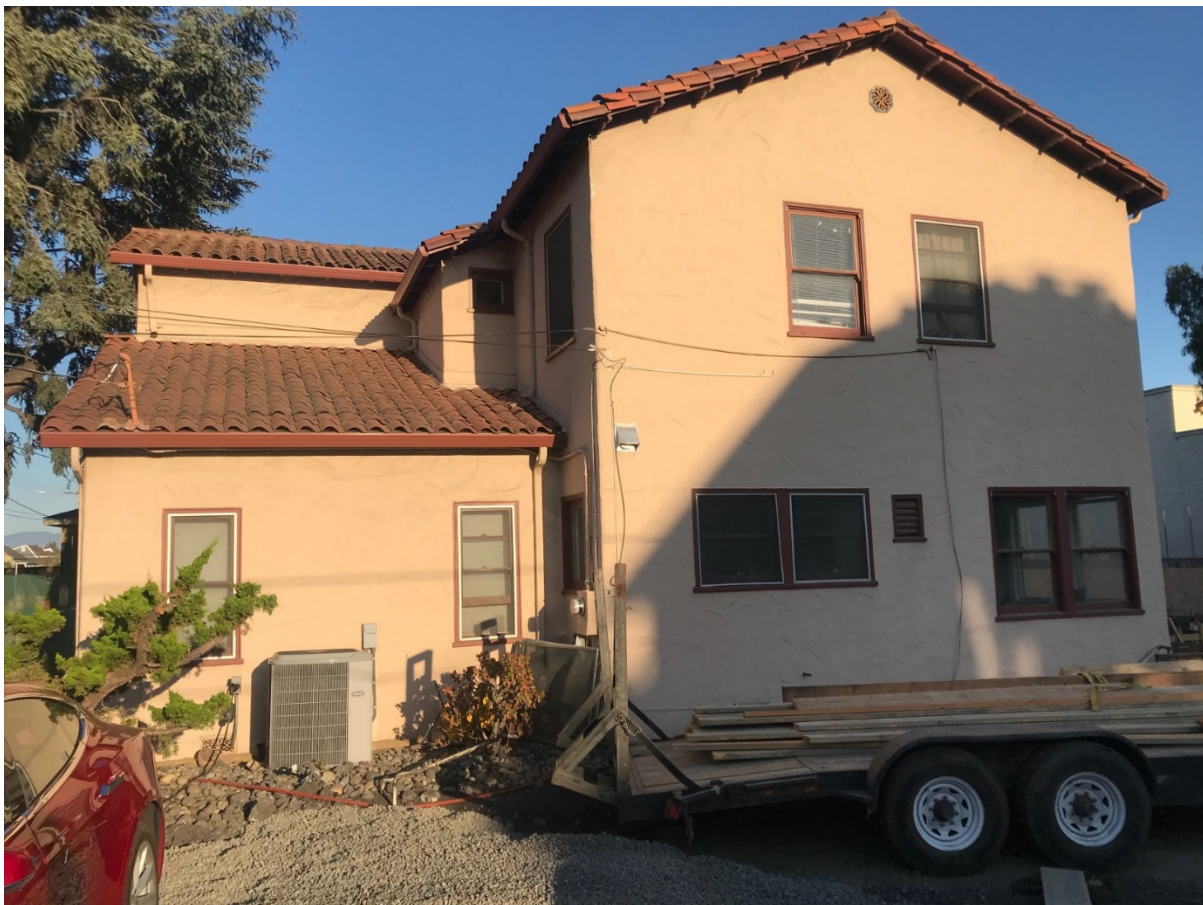
Photograph 820 Civic Center Drive, Santa Clara

View: The east façade of the historic house. Using this picture as a guide the proposed garage will be on approximately on the front side of the trailer with wood. Where the trailer is will be a garden.
