Project Proposal
1411 Lewis Street and 1444 Madison Street
Santa Clara, California

MADISON AND LEWIS STREET PROJECT DESCRIPTION

Location: 1411 Lewis Street and 1444 Madison Street

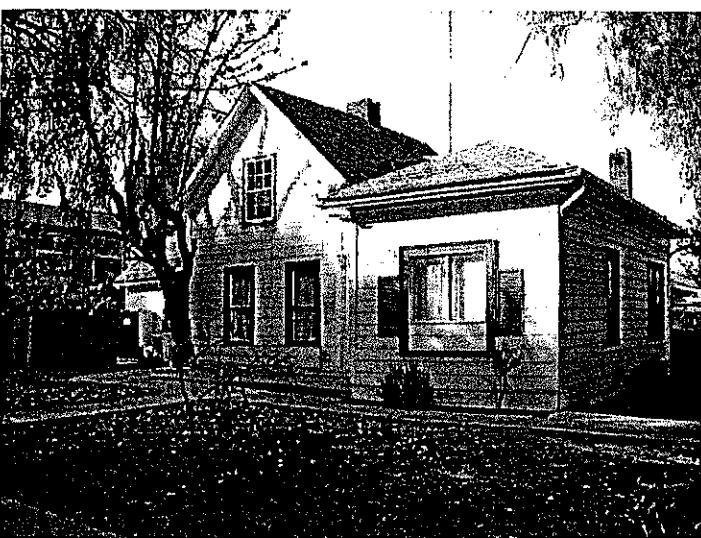
P5a. Photo or drawing (Photo required for buildings, structures, objects.)

P5b. Description of Photo: (View, date, accession #)
 View of the residence at 1411 Lewis Street from the southeast.

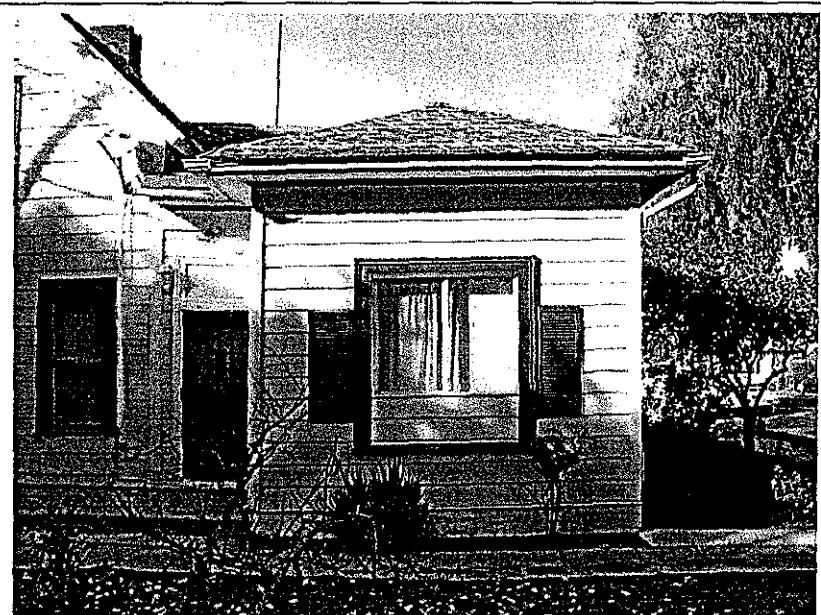
Photo 2: View of the eastern portion of the front façade.

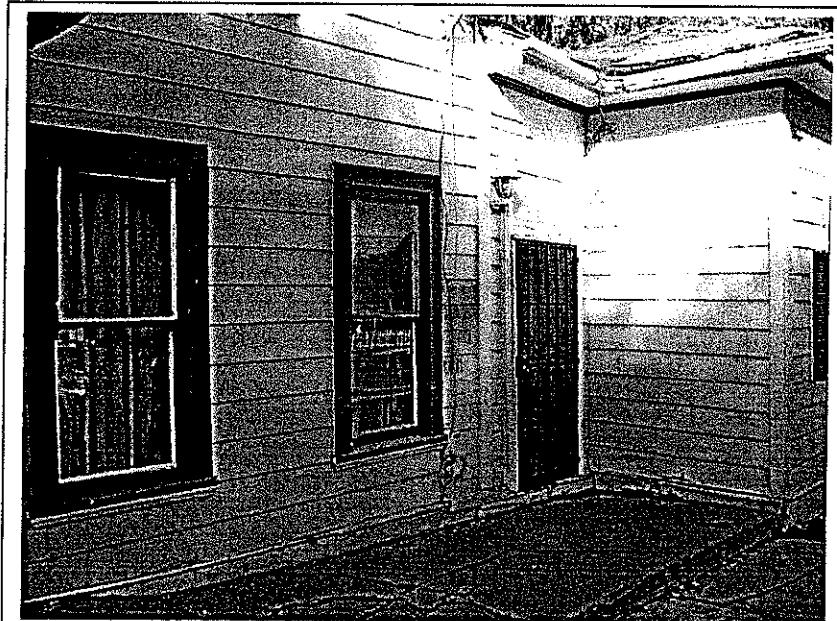
Photo 5: View of the front porch/entry area of the front façade.

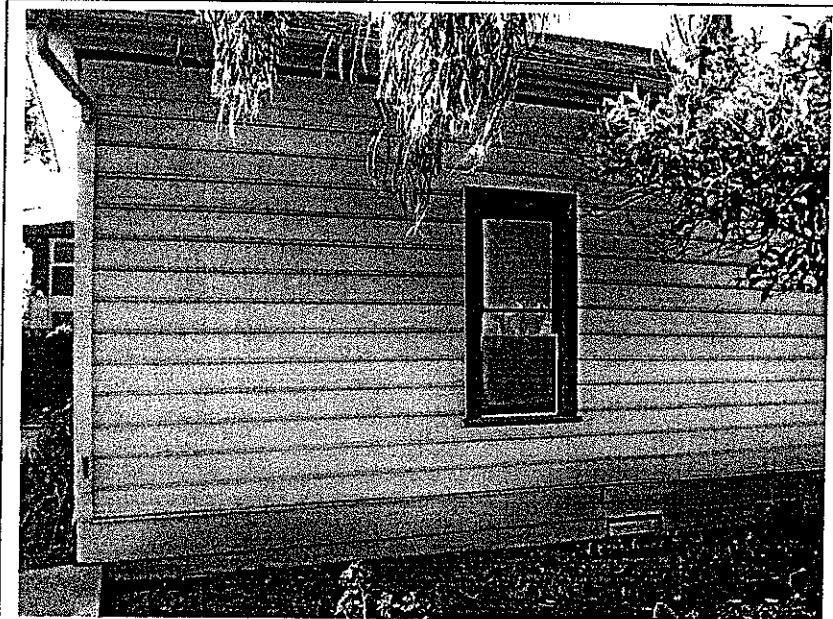
Photo 9: View along the front portion of the eastern façade.

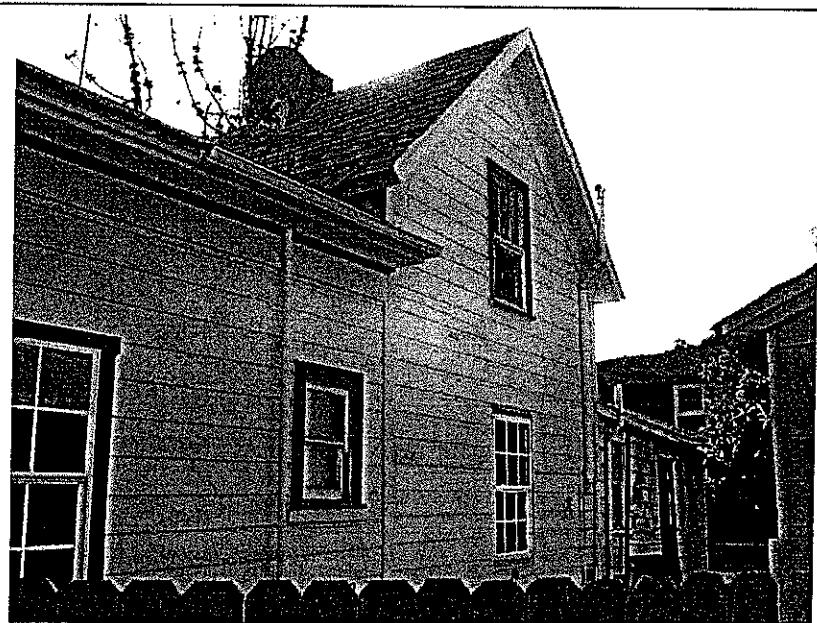
Photo 10: View of the upper portion of the rear façade.

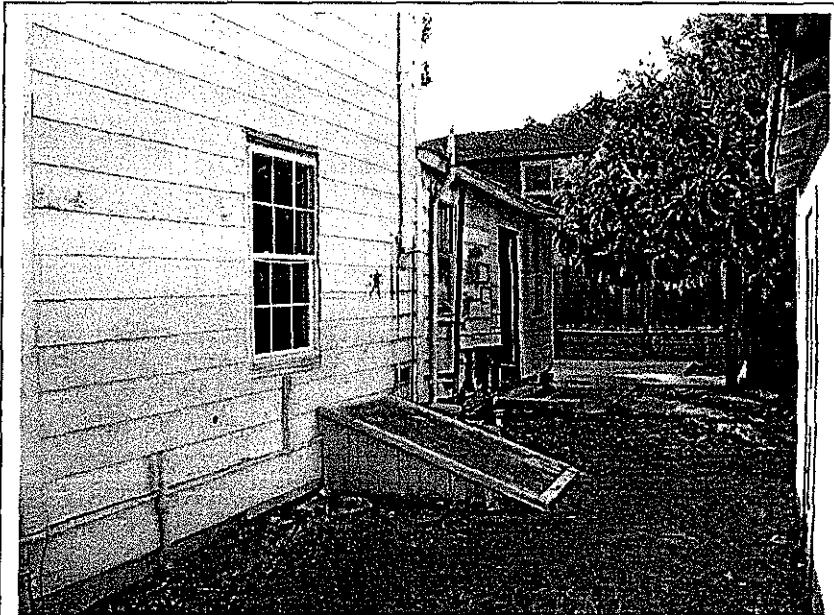
Photo 11: View of the lower portion of the rear façade.

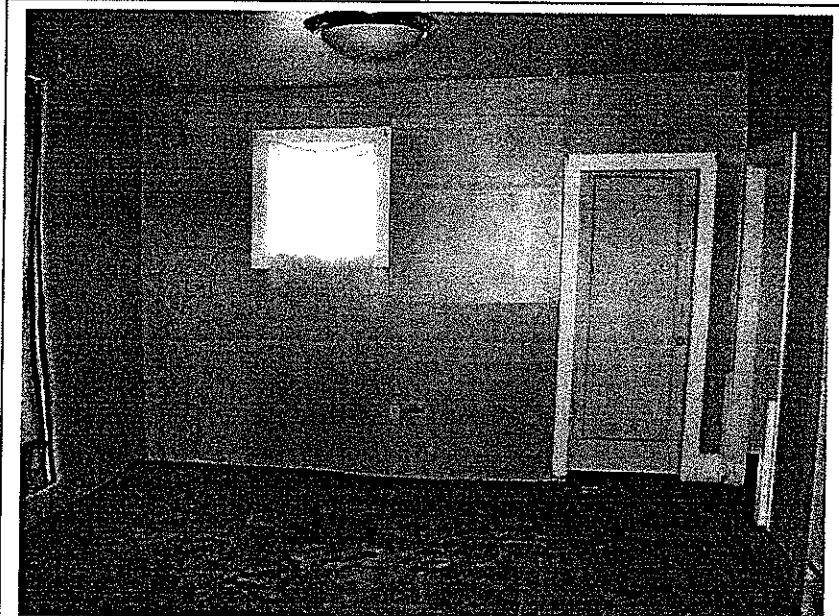
Photo 17: View of the living room.

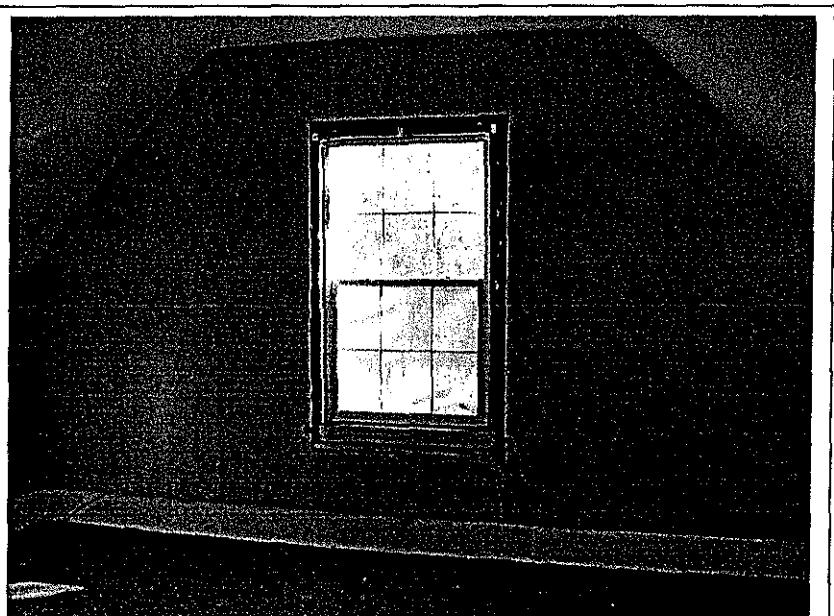
Photo 24: View of the upstairs loft area.

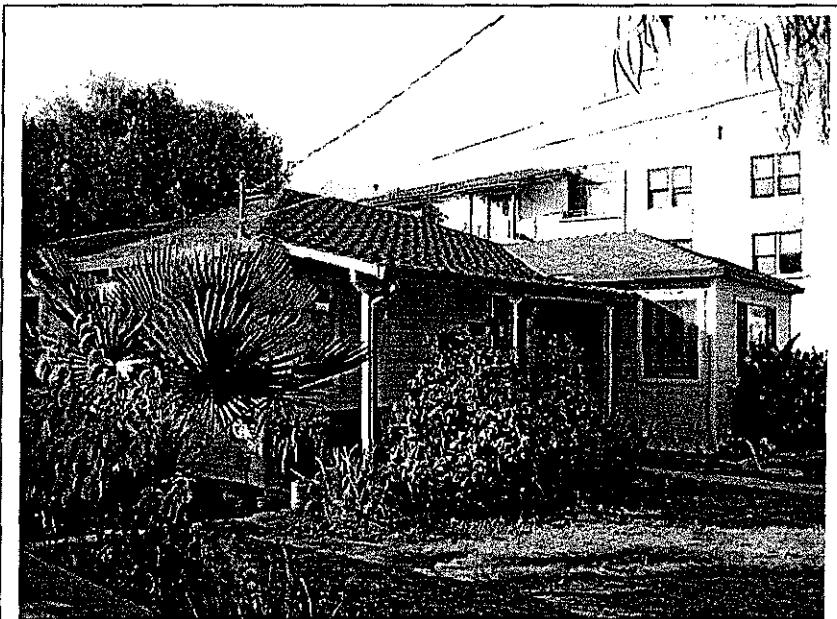
Photo 31: Oblique view of 1444 Madison Street.

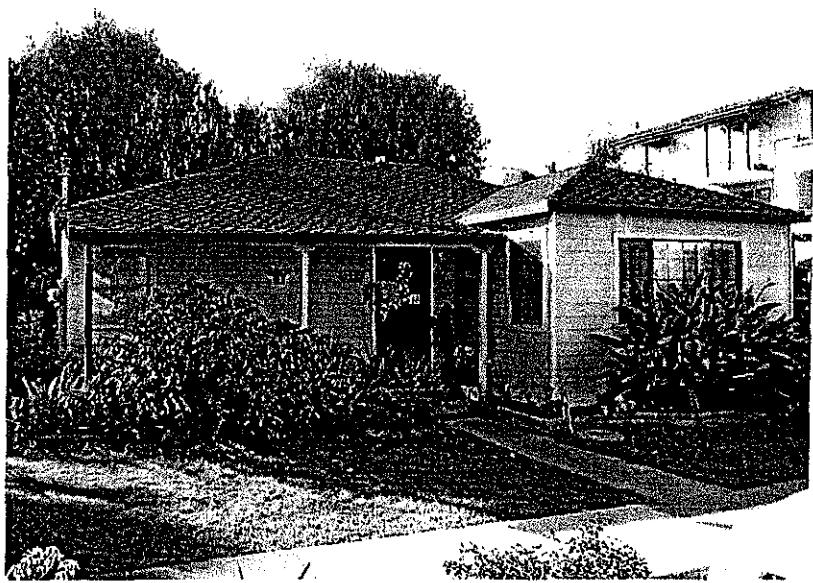
Photo 32: View of the front façade of 1444 Madison Street.

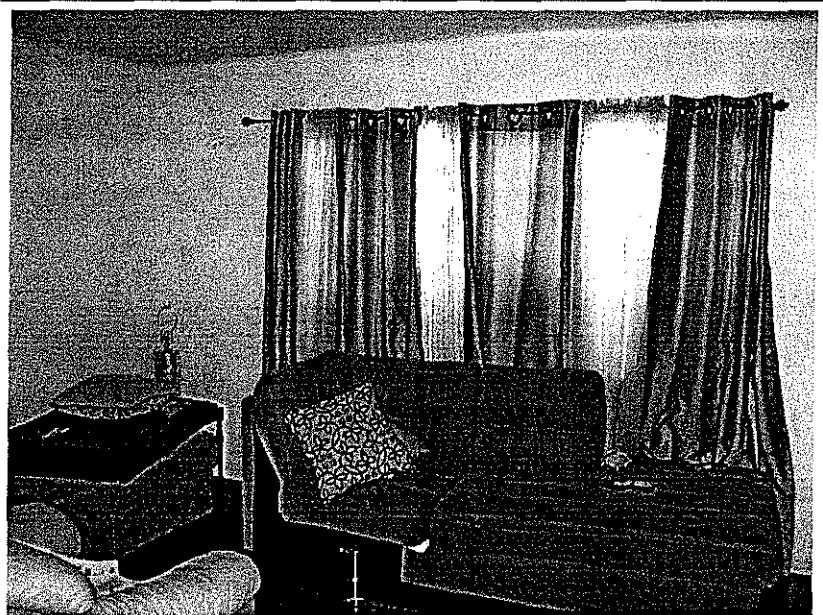
Photo 35: Interior view of the living room in front unit, 1444 Madison Street.

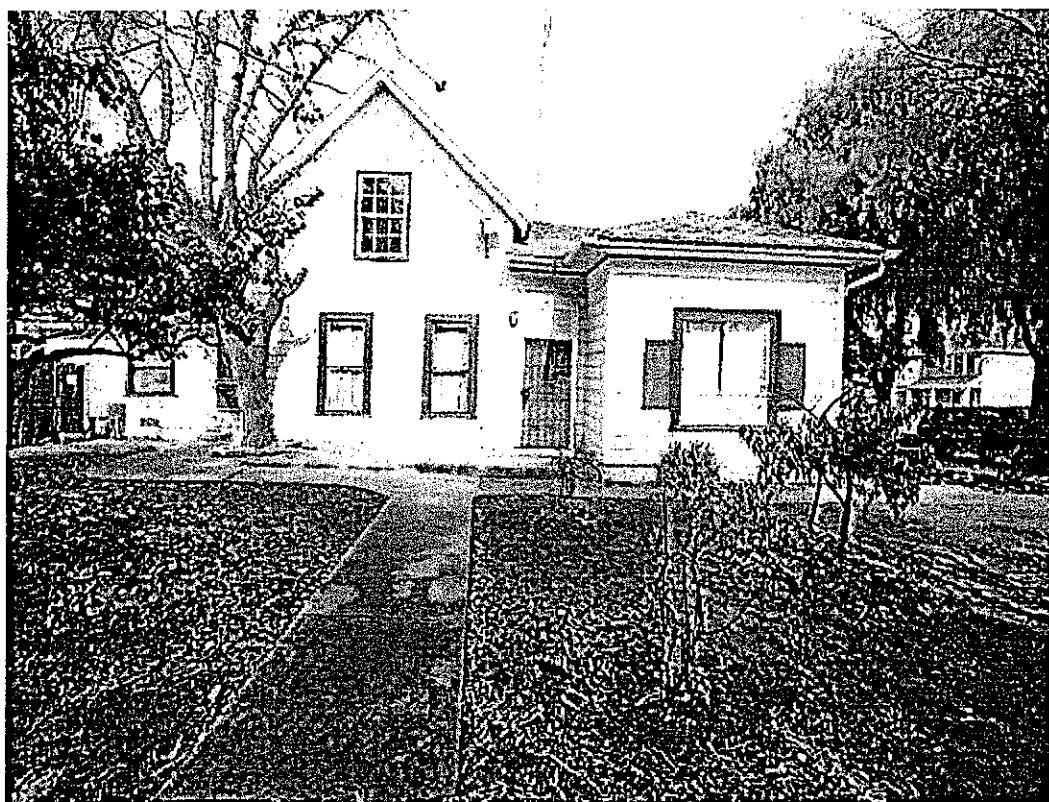
Figure 1: Residence as seen from Lewis St

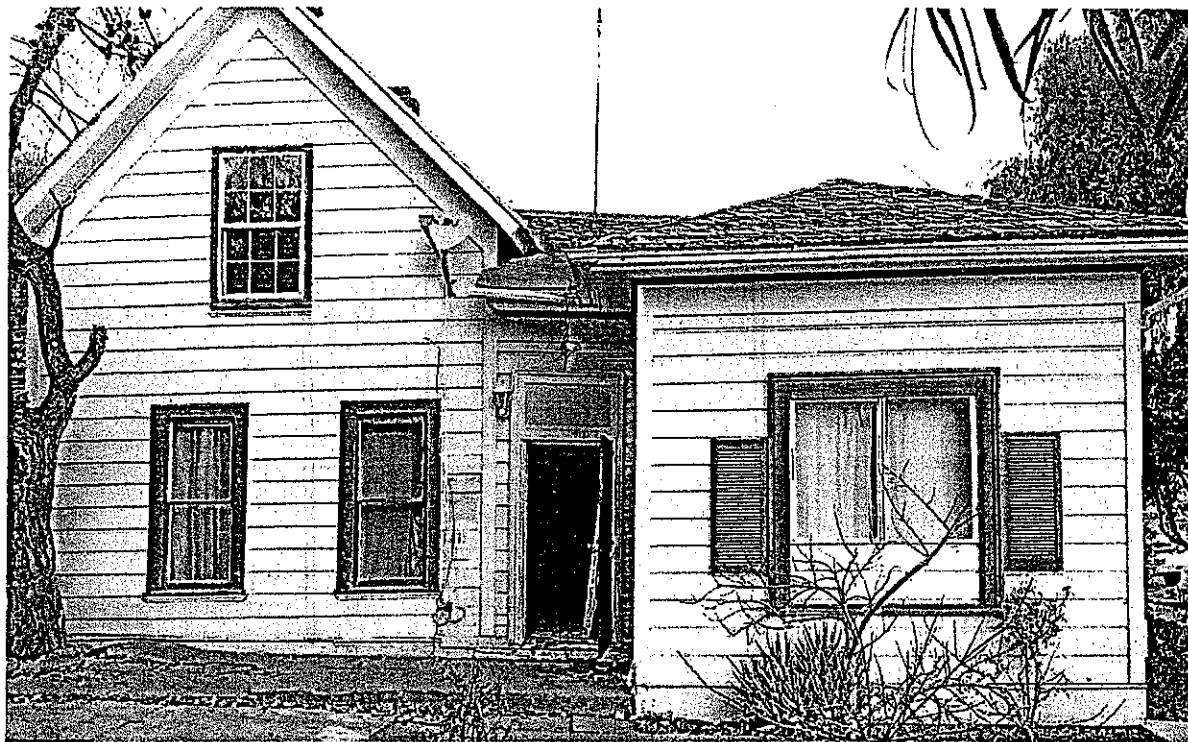
PHOTO 2: Front Elevation

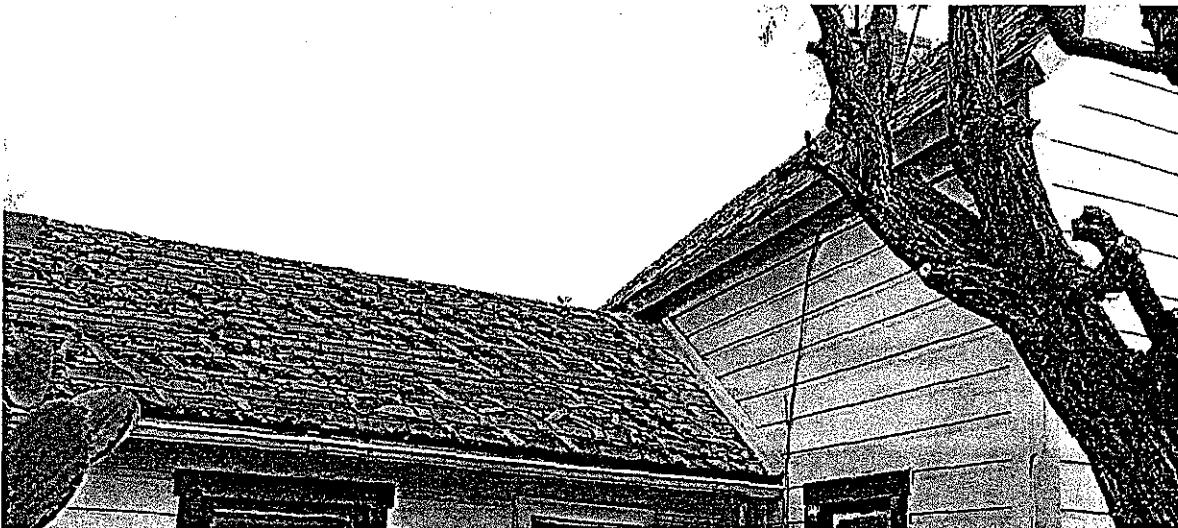
Figure 6: Roof at left side of structure

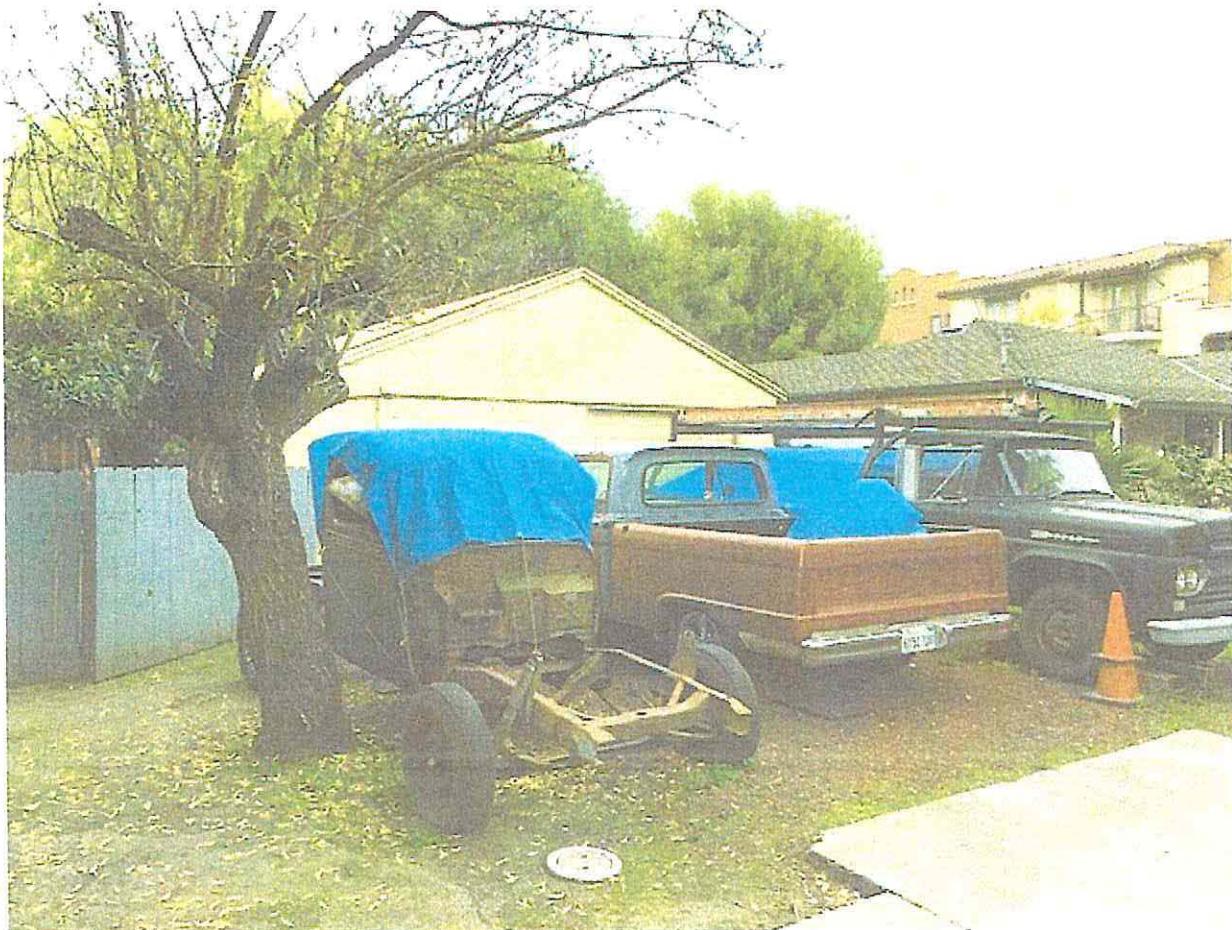
EXISTING GARAGE ON MADISON

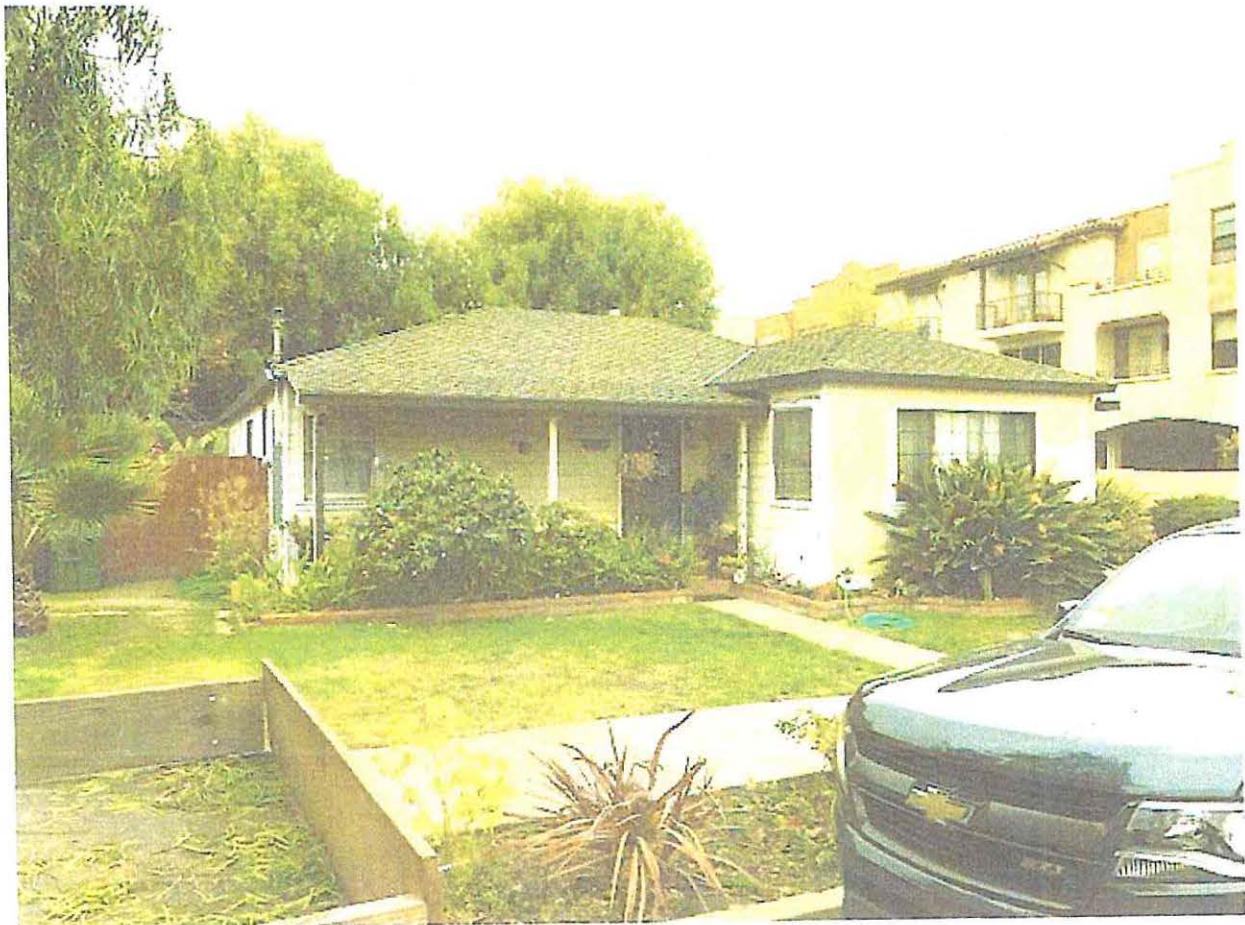
EXISTING DUPLEX AT 1444 MADISON STREET

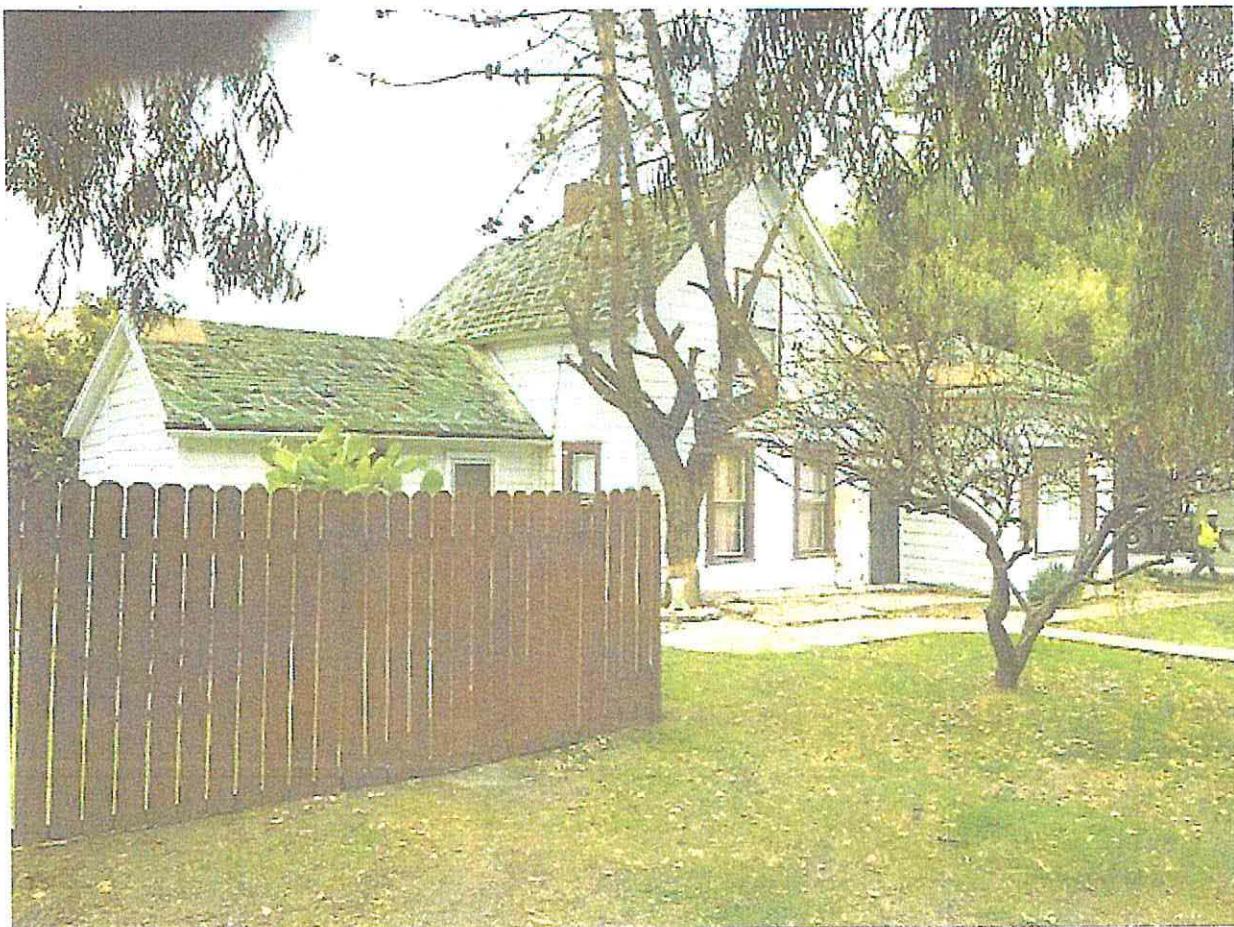
EXISTING UNINHABITABLE HOME ON 1411 LEWIS STREET

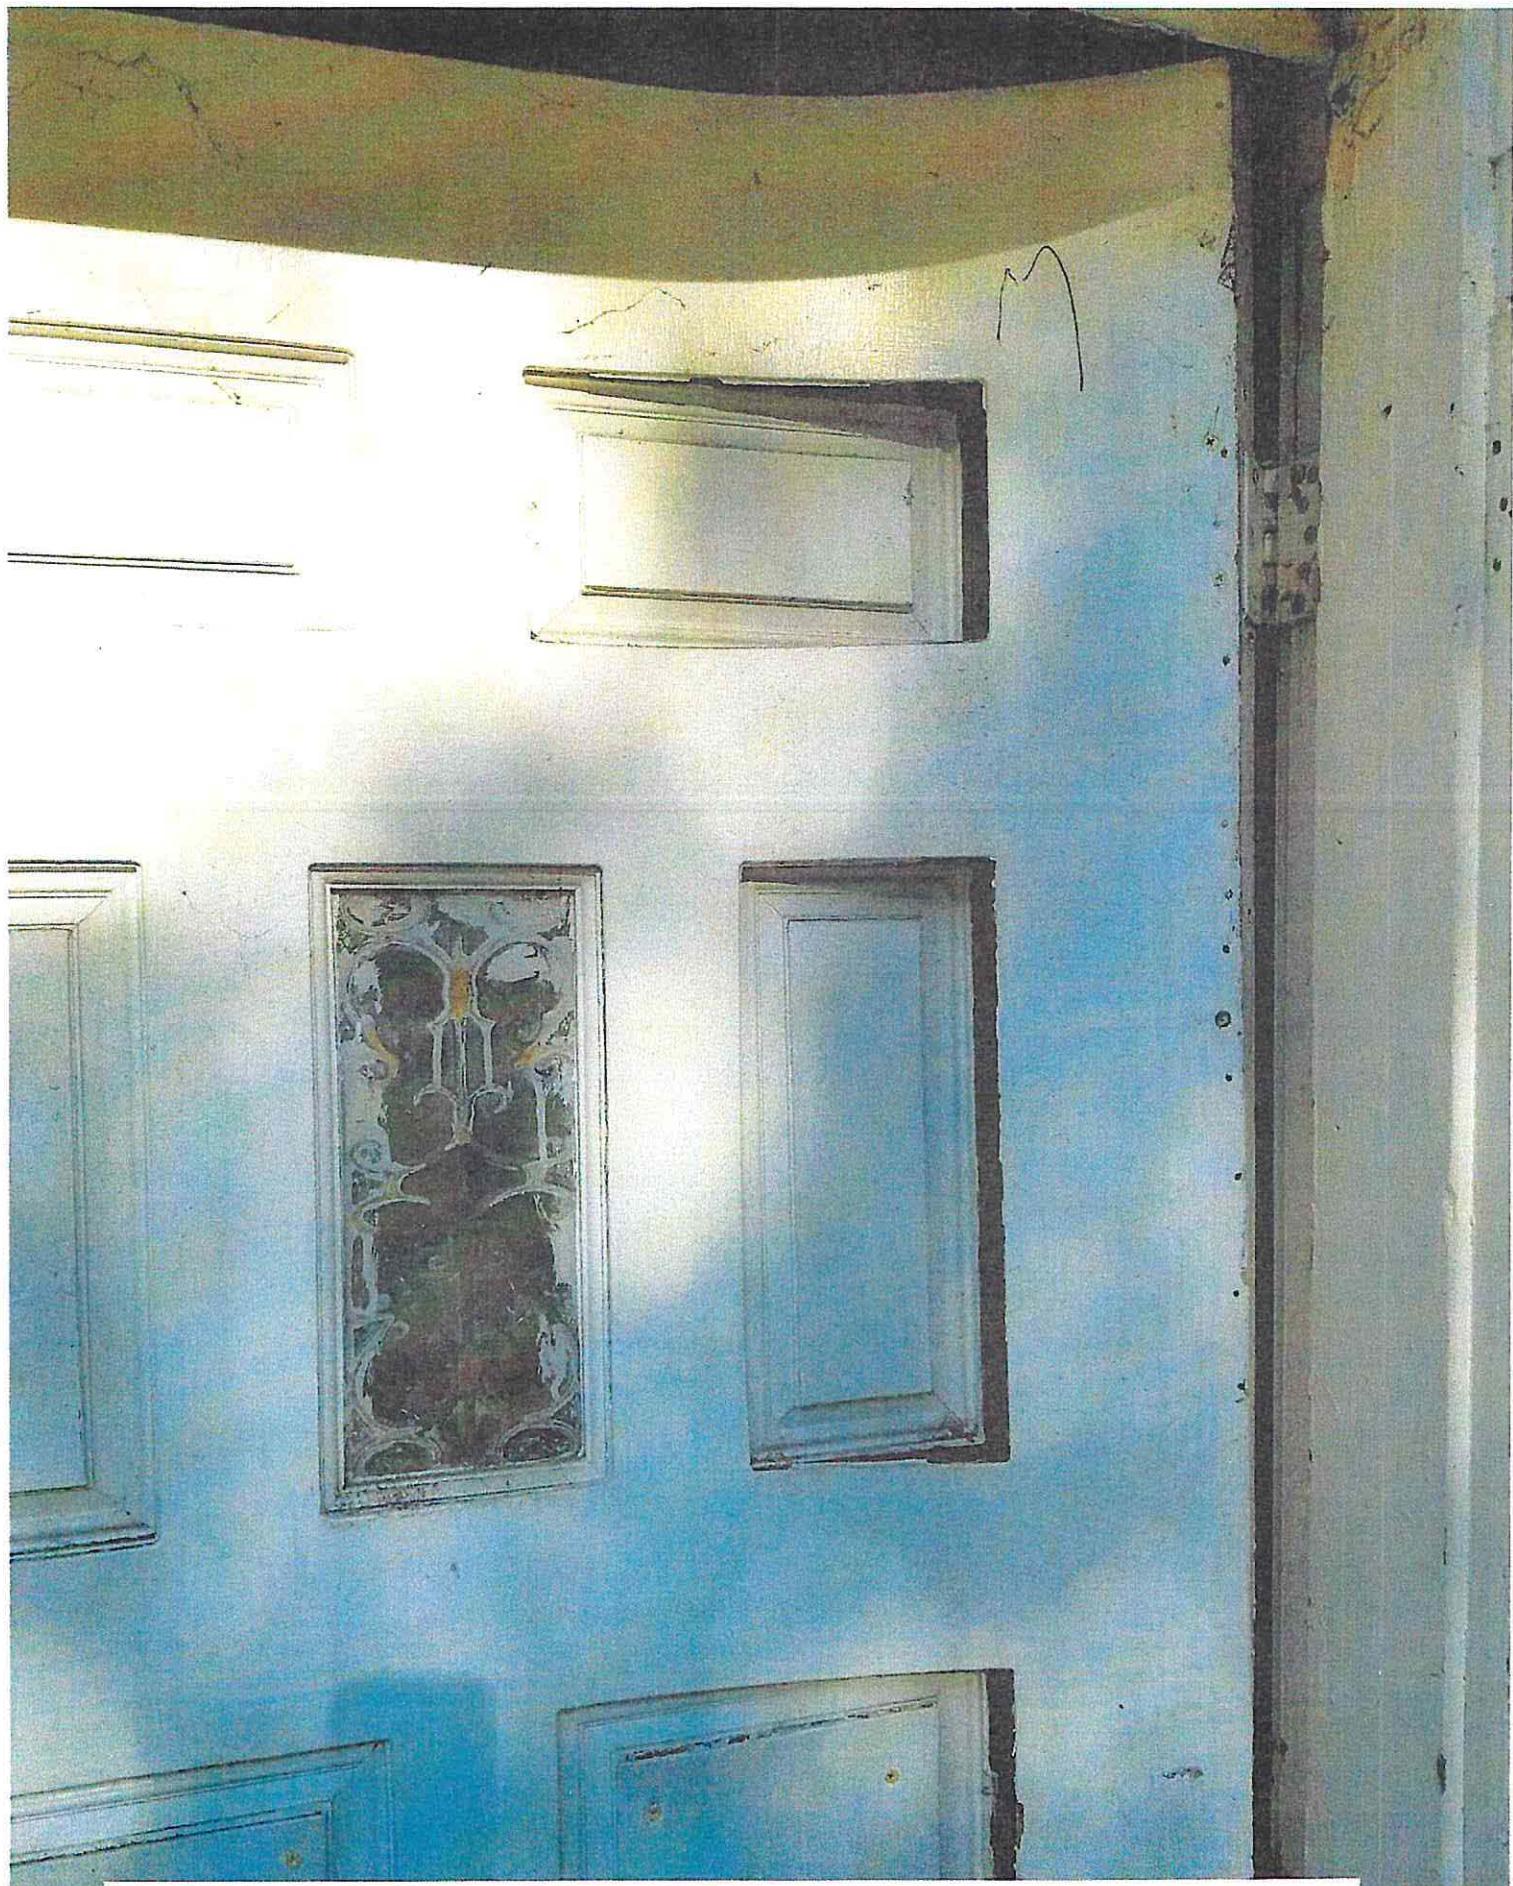
FRONT ENTRY DOOR – 1411 LEWIS STREET

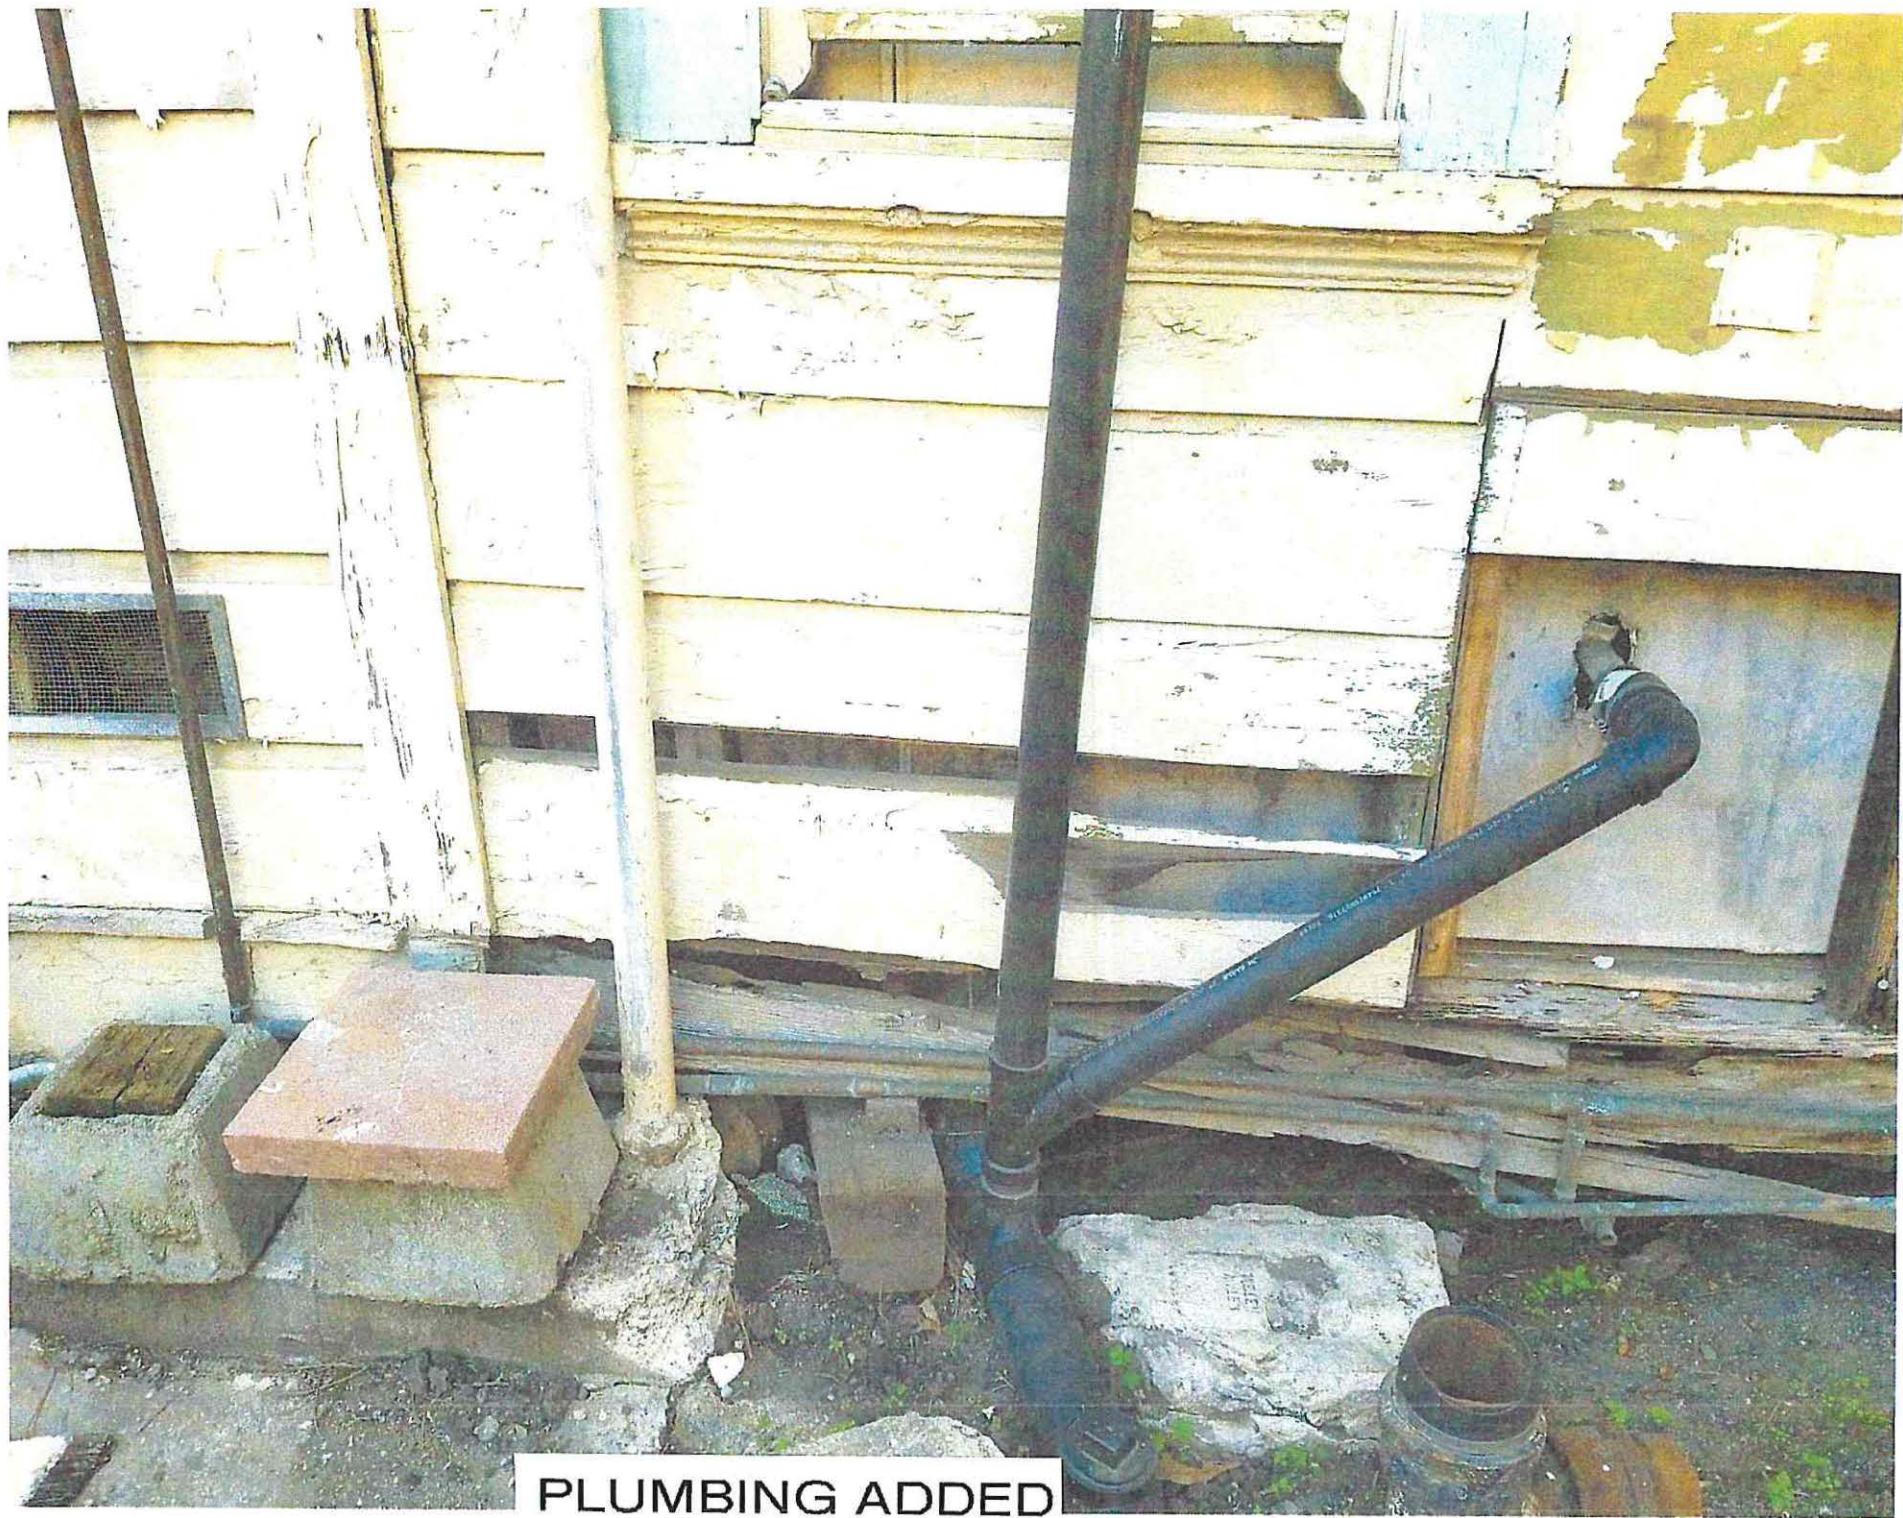
MISMATCHED SIDING WHERE ADDITION WAS DONE

DETERIORATED FRAMING, SIDING AND FOUNDATION
