**Project Proposal**  
**1411 Lewis Street and 1444 Madison Street**  
**Santa Clara, California**

# **MADISON AND LEWIS STREET PROJECT DESCRIPTION**

**Location: 1411 Lewis Street and 1444 Madison Street**

**March 5, 2018**

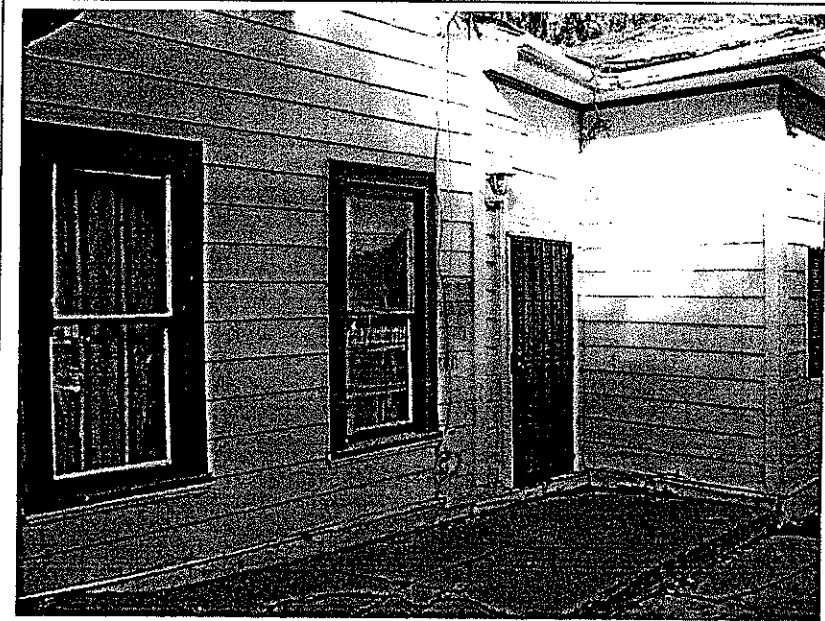
Photo 5: View of the front porch/entry area of the front façade.

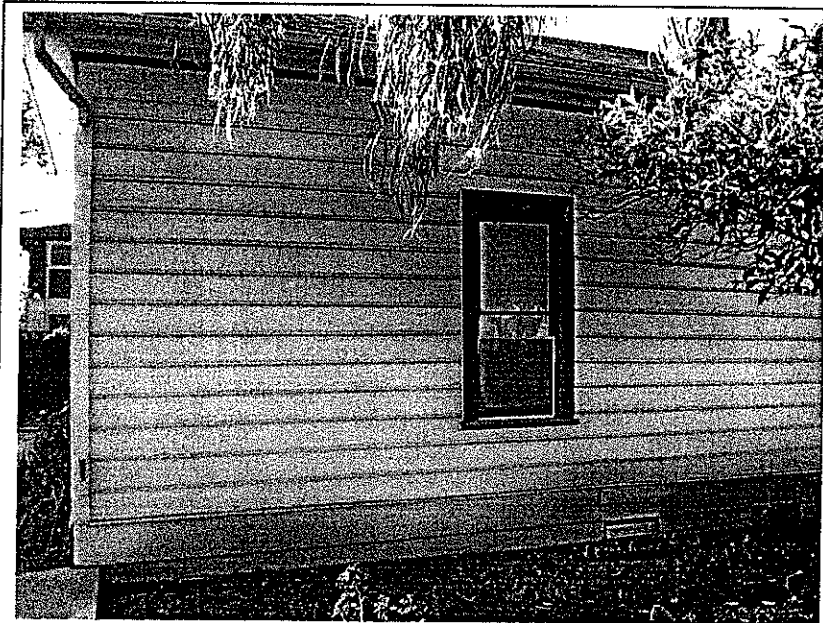
Photo 9: View along the front portion of the eastern façade.

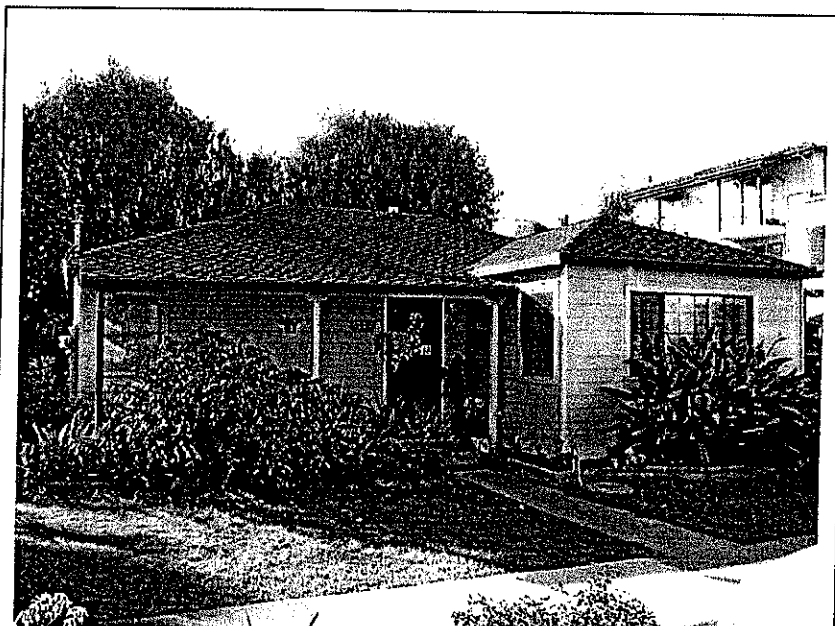
Photo 32: View of the front façade of 1444 Madison Street.
