Project Proposal
1411 Lewis Street and 1444 Madison Street
Santa Clara, California

MADISON AND LEWIS STREET PROJECT DESCRIPTION

Location: 1411 Lewis Street and 1444 Madison Street

March 5, 2018

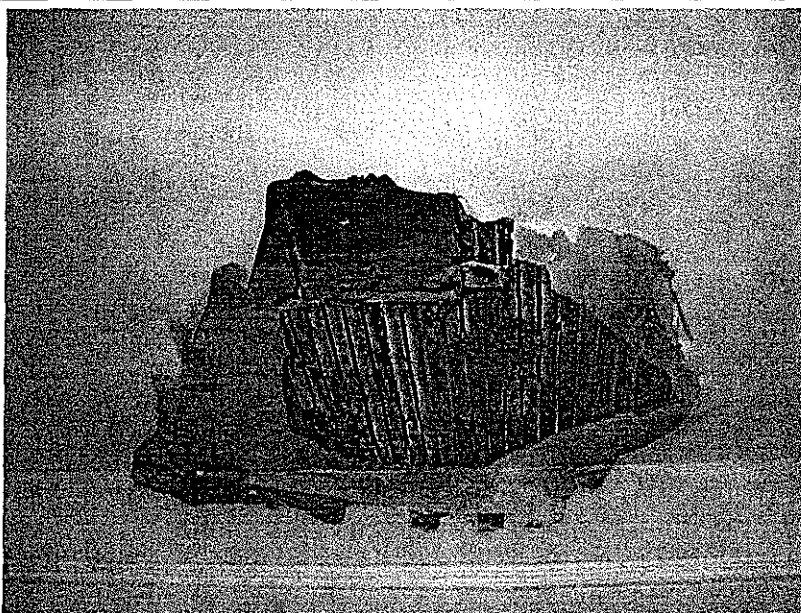
Photo 20: Detail of exposed lathe in the kitchen ceiling.
