Project Proposal
1411 Lewis Street and 1444 Madison Street
Santa Clara, California

MADISON AND LEWIS STREET PROJECT DESCRIPTION

Location: 1411 Lewis Street and 1444 Madison Street

March 5, 2018

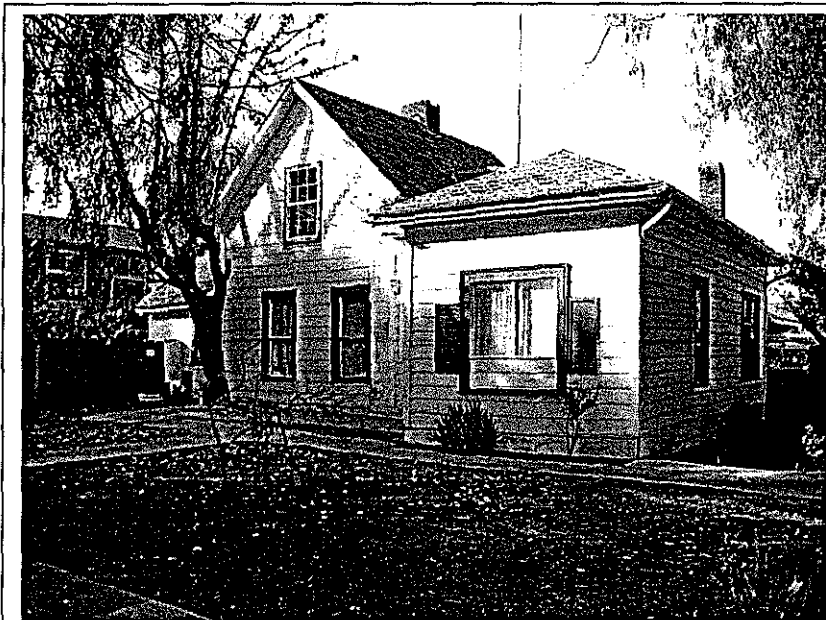
Photo 1: View of the front façade of 1411 Lewis Street

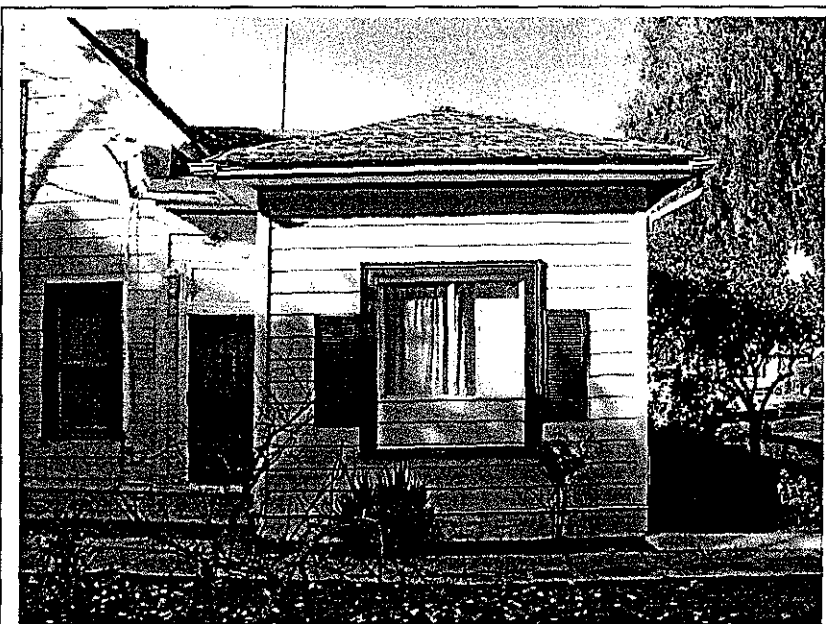
Photo 2: View of the eastern portion of the front façade.

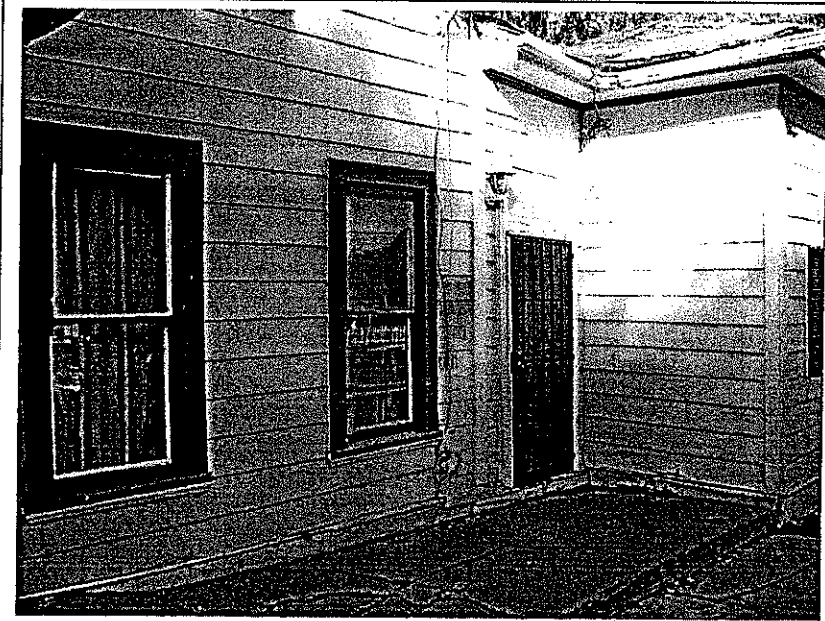
Photo 5: View of the front porch/entry area of the front façade.

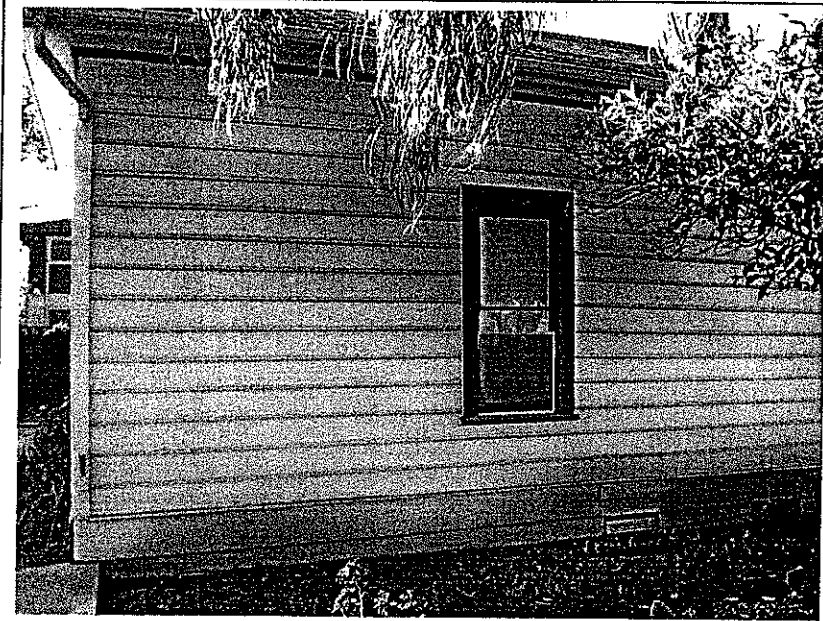
Photo 9: View along the front portion of the eastern façade.

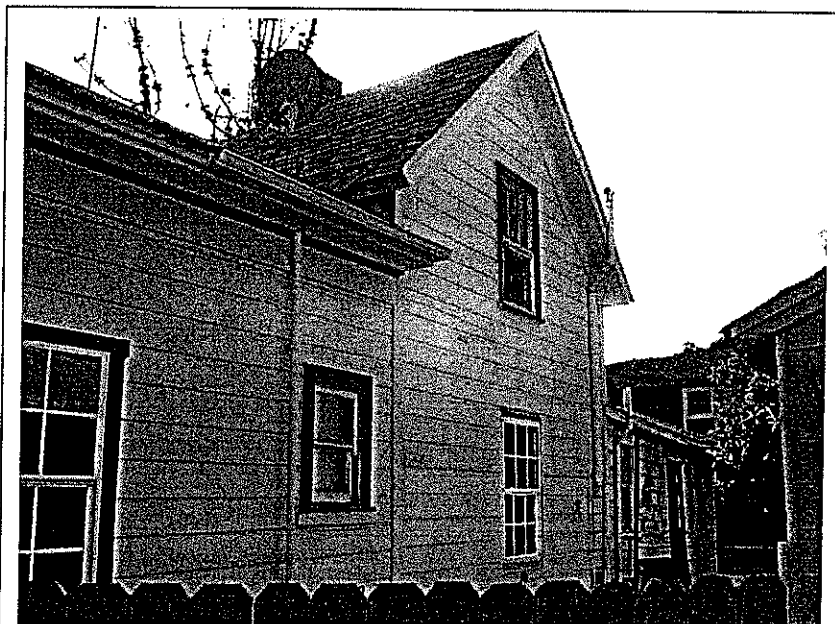
Photo 10: View of the upper portion of the rear façade.

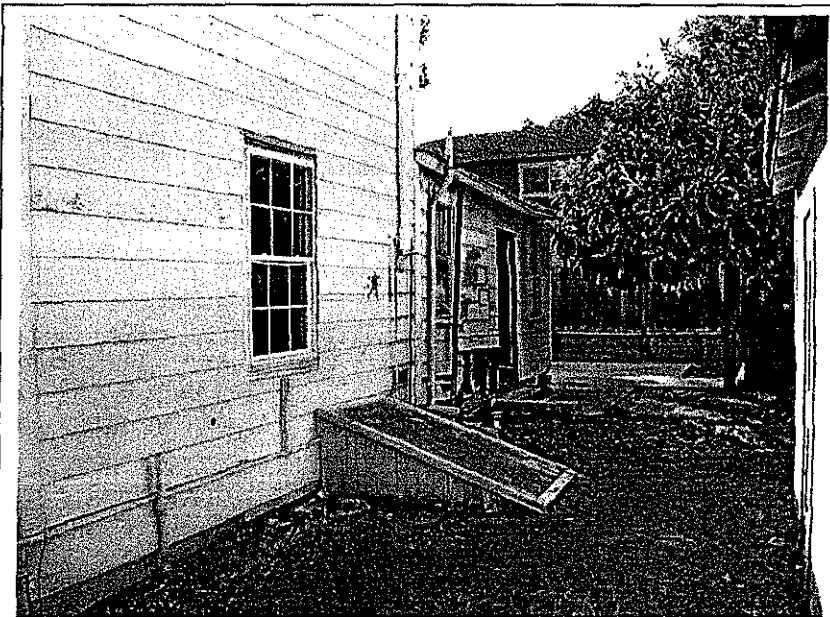
Photo 11: View of the lower portion of the rear façade.

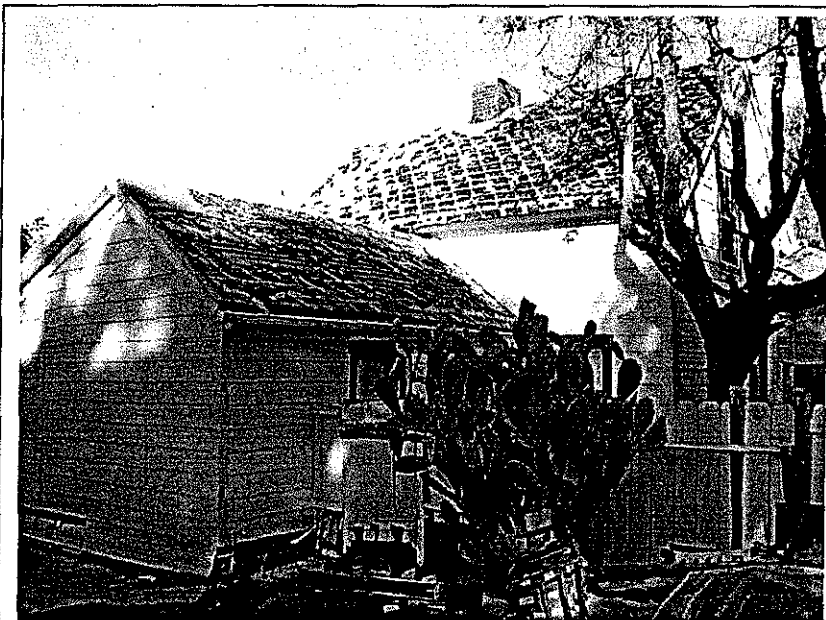
Photo 15: Oblique view of the residence from the southwest.

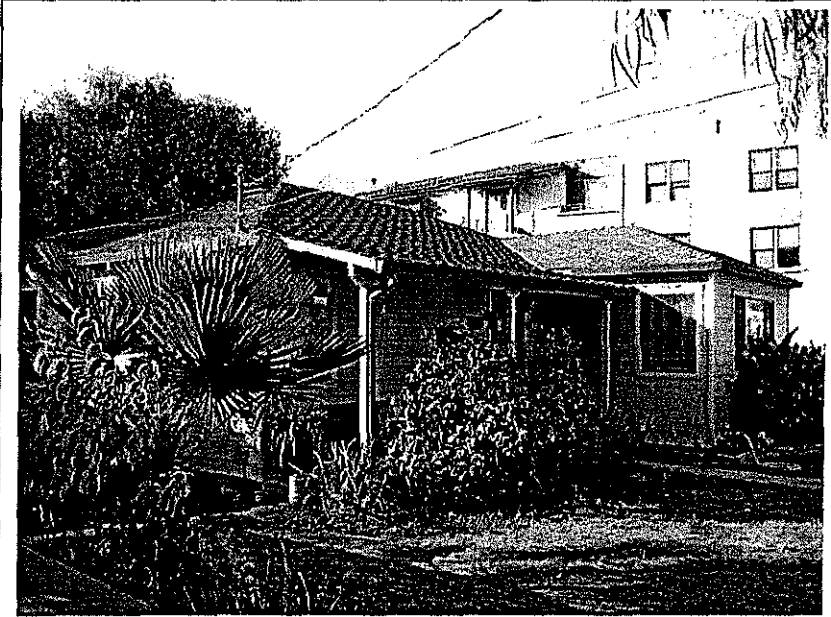
Photo 31: Oblique view of 1444 Madison Street.

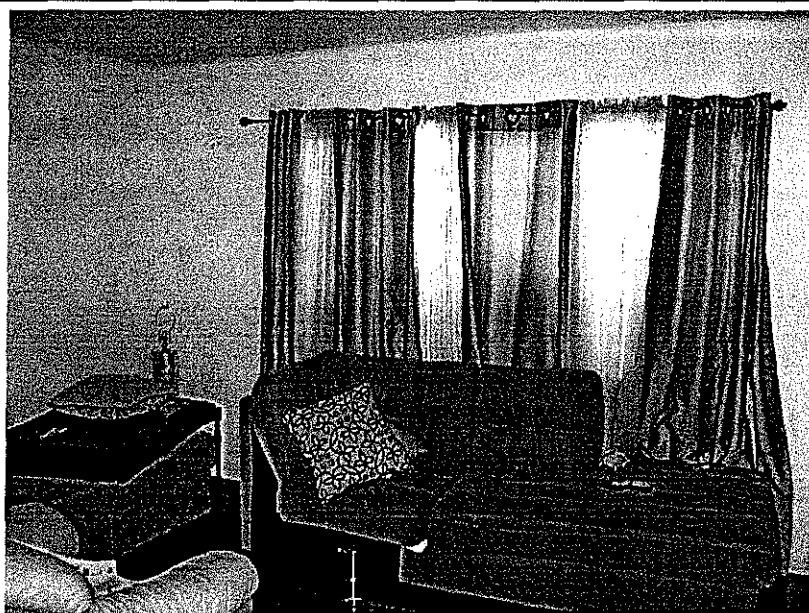
Photo 35: Interior view of the living room in front unit, 1444 Madison Street.

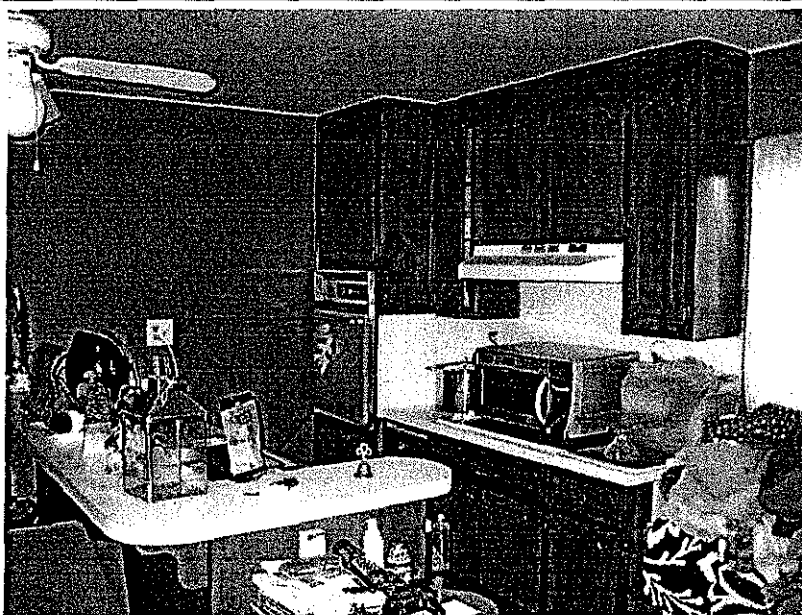
Photo 36: View of the kitchen in the front unit.
